# National Transportation Safety Board

CEN24LA018

## **MATERIALS LABORATORY**

Factual Report 24-006

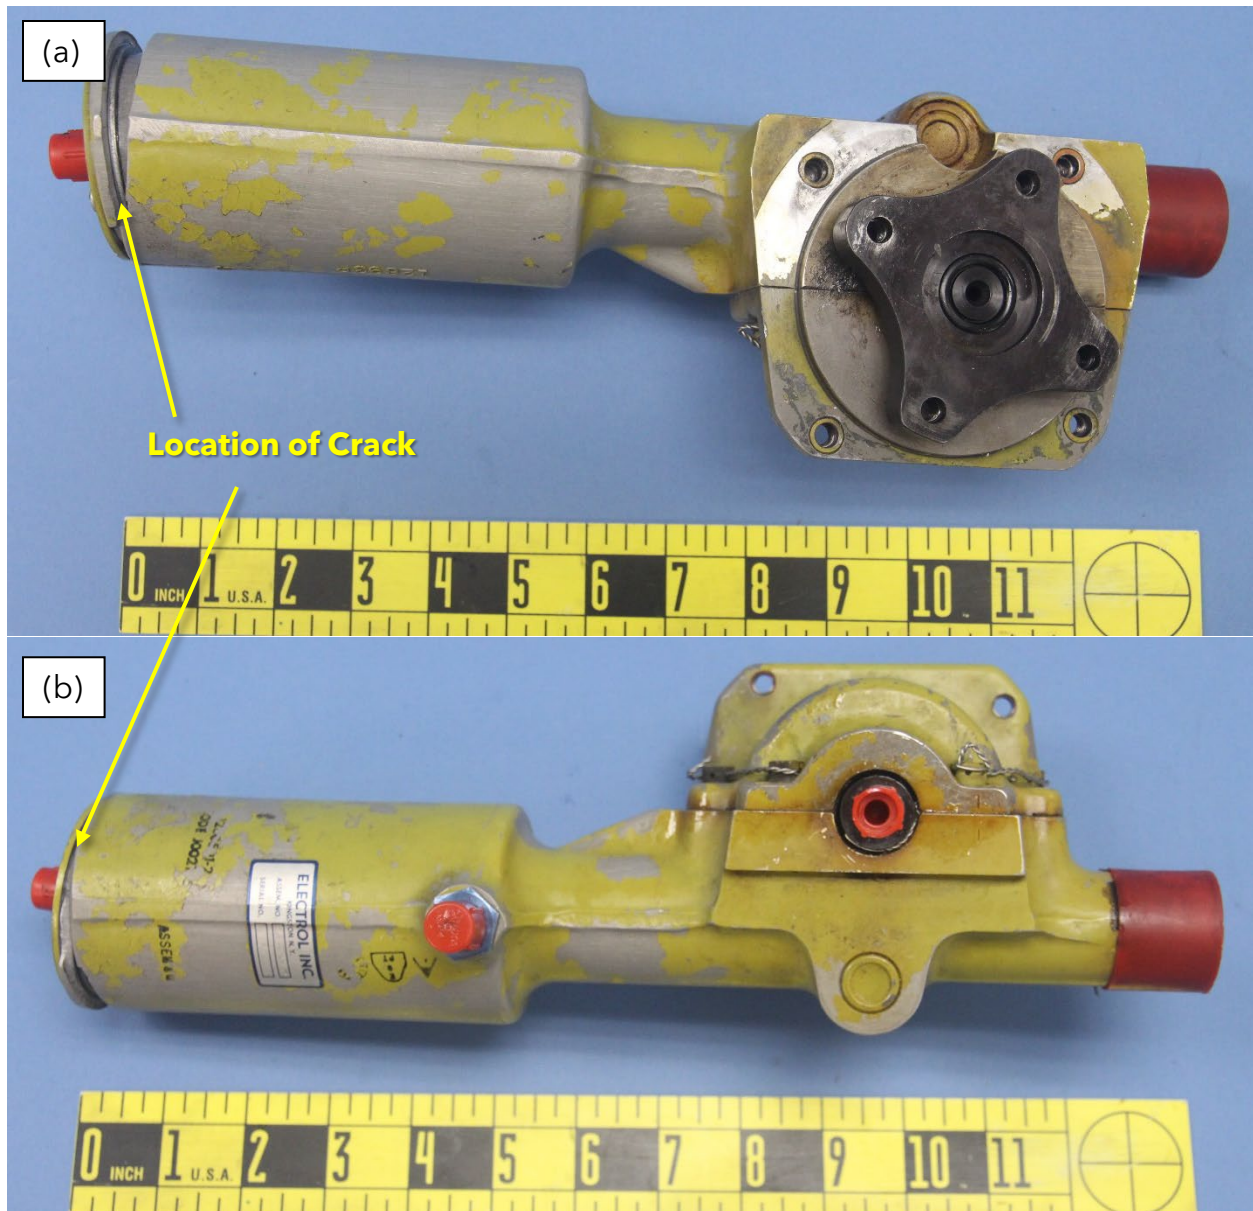
The cracked hydraulic actuator is illustrated in Figure 1 and Figure 2, as received from different sides. The part had cracked around the barrel, with circumferential components. Figure 3 shows the identification markings for the actuator. The embossed markings on the barrel stated:

**Figure 1.** The hydraulic actuator, as received.

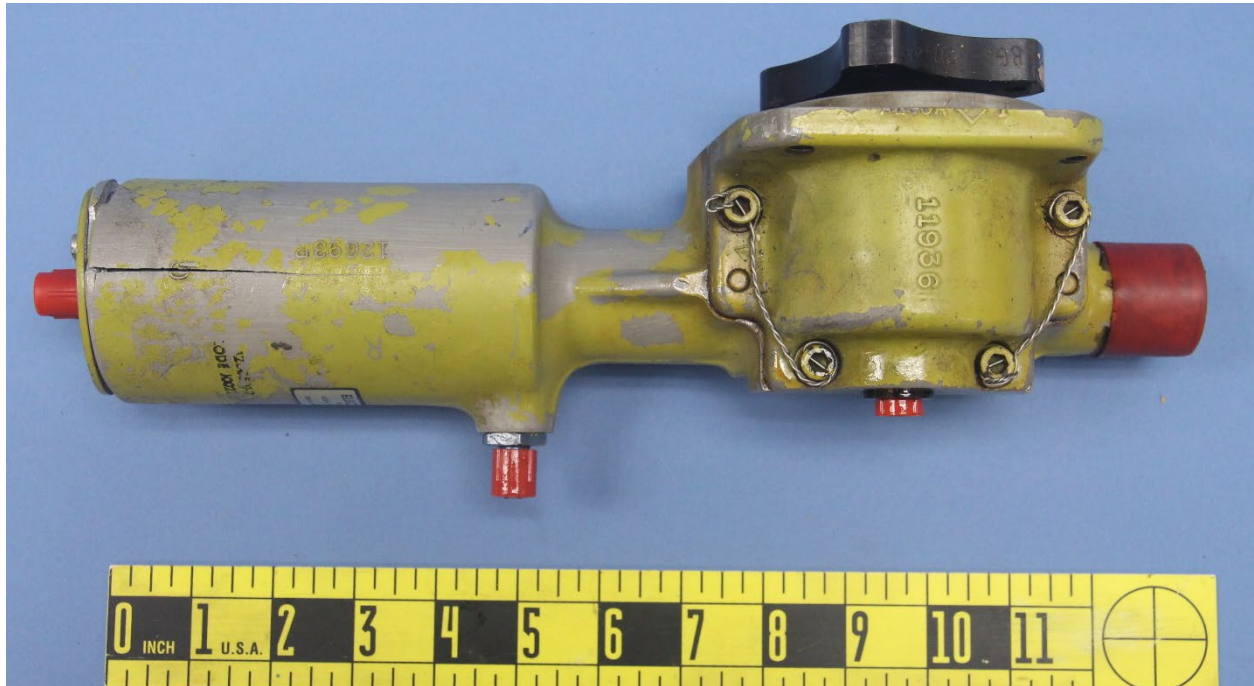
**Figure 2.** View of the hydraulic actuator, viewed opposite that in Figure 1b. This shows the longitudinal crack on the housing barrel.

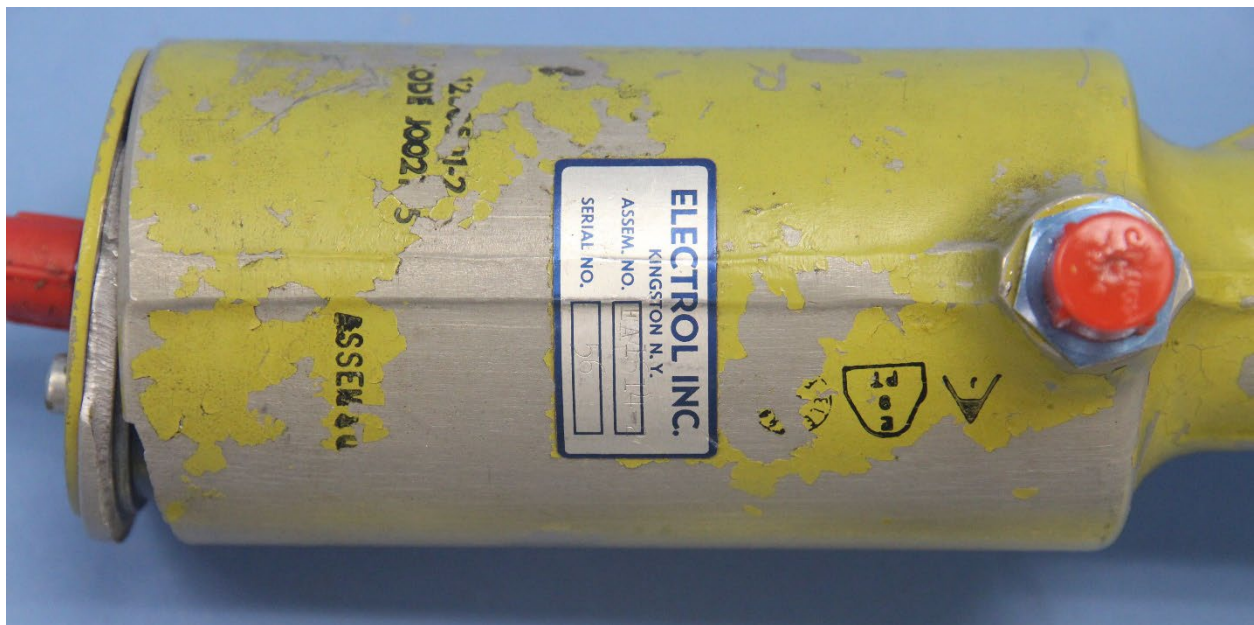
**Figure 3.** View of the markings on the housing barrel of the actuator, with the circumferential crack on the right.

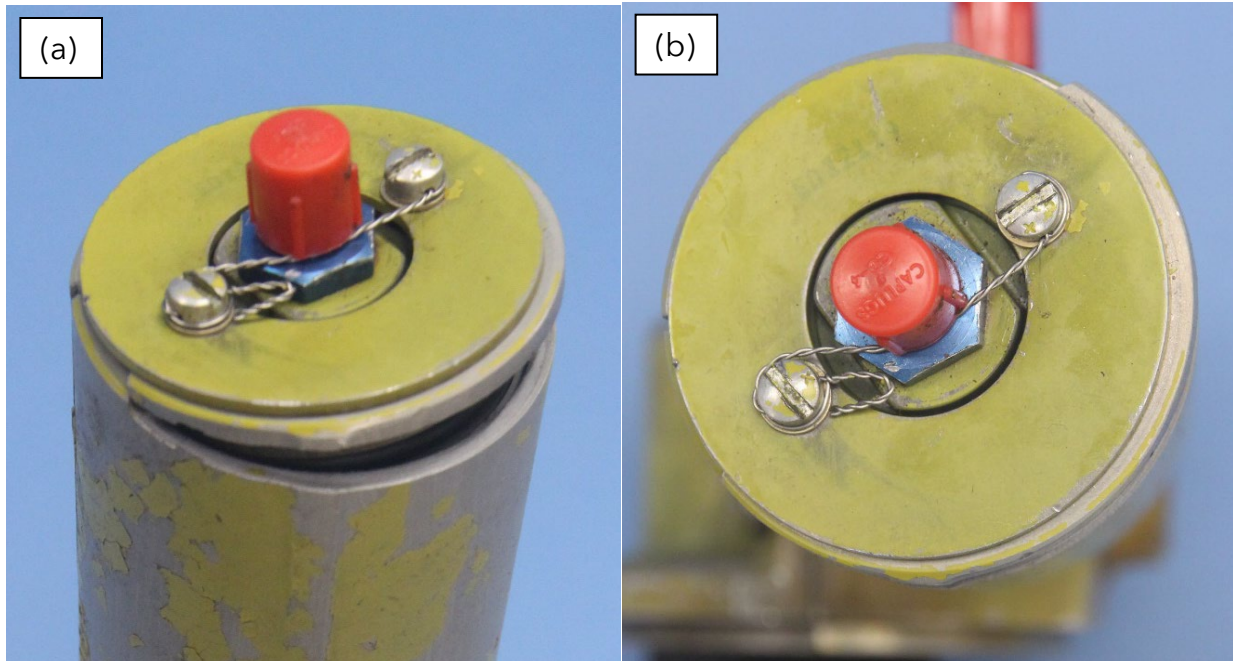
The part was cracked about the barrel section adjacent to the endcap, as illustrated in Figure 4. Figure 5 shows the transition from circumferential to a longitudinal crack along the housing barrel. Figure 6 demonstrates the longitudinal section of the crack, which extended along the barrel for 3.1 inches.

**Figure 4.** The end of the hydraulic actuator, showing the circumferential portion of the crack.

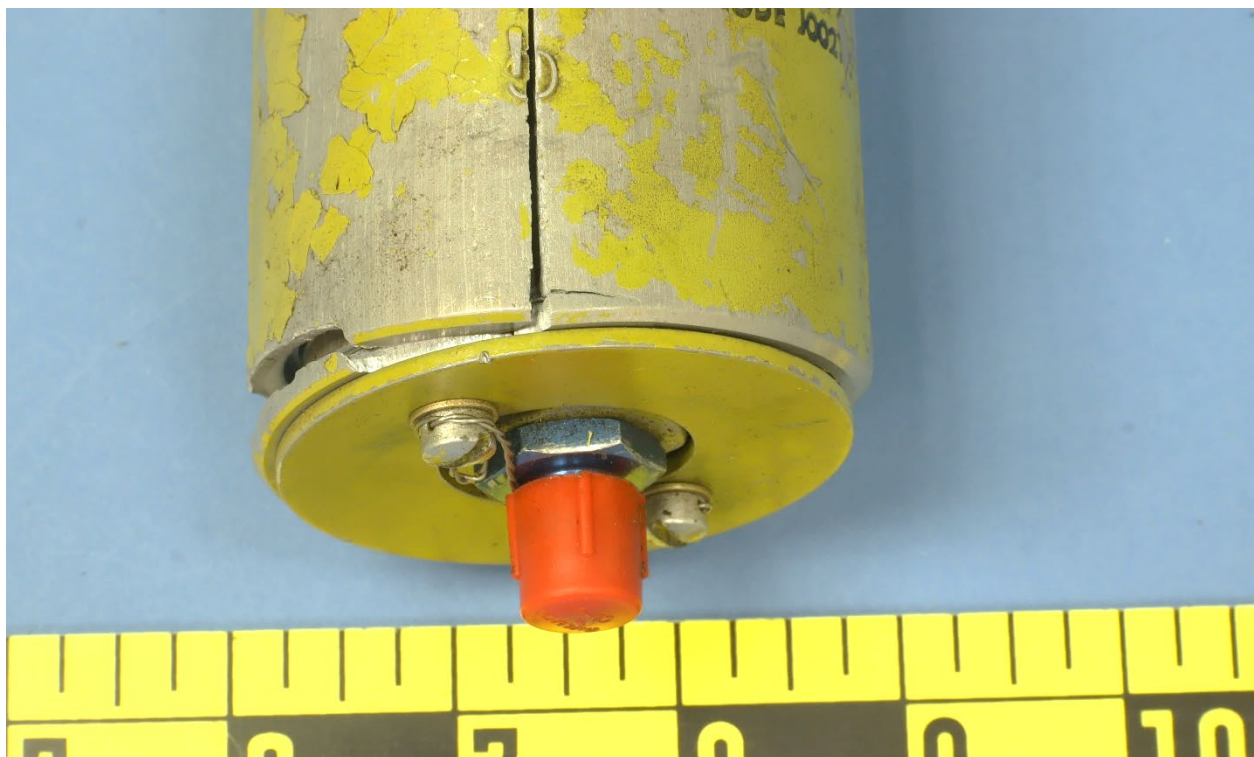
**Figure 5.** The longitudinal crack on the actuator housing, emanating from the circumferential crack (opposite the view in Figure 4a).

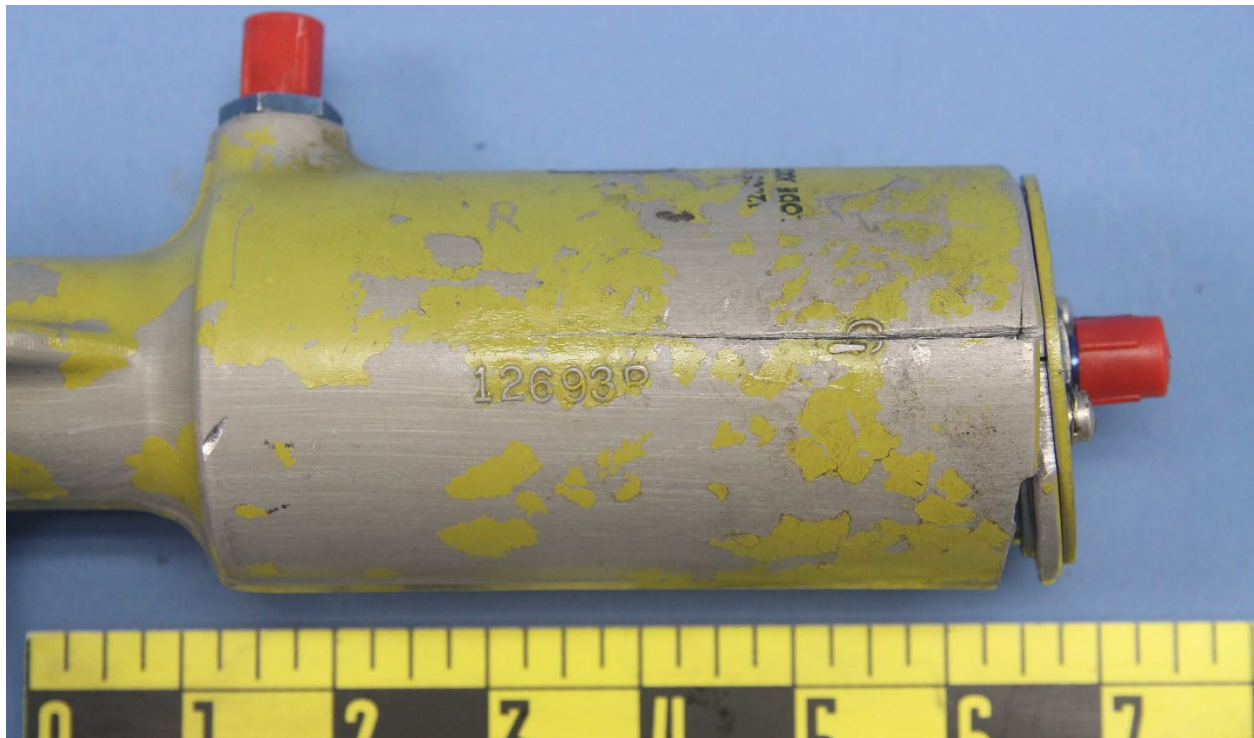
**Figure 6.** The longitudinal crack along the actuator housing barrel.

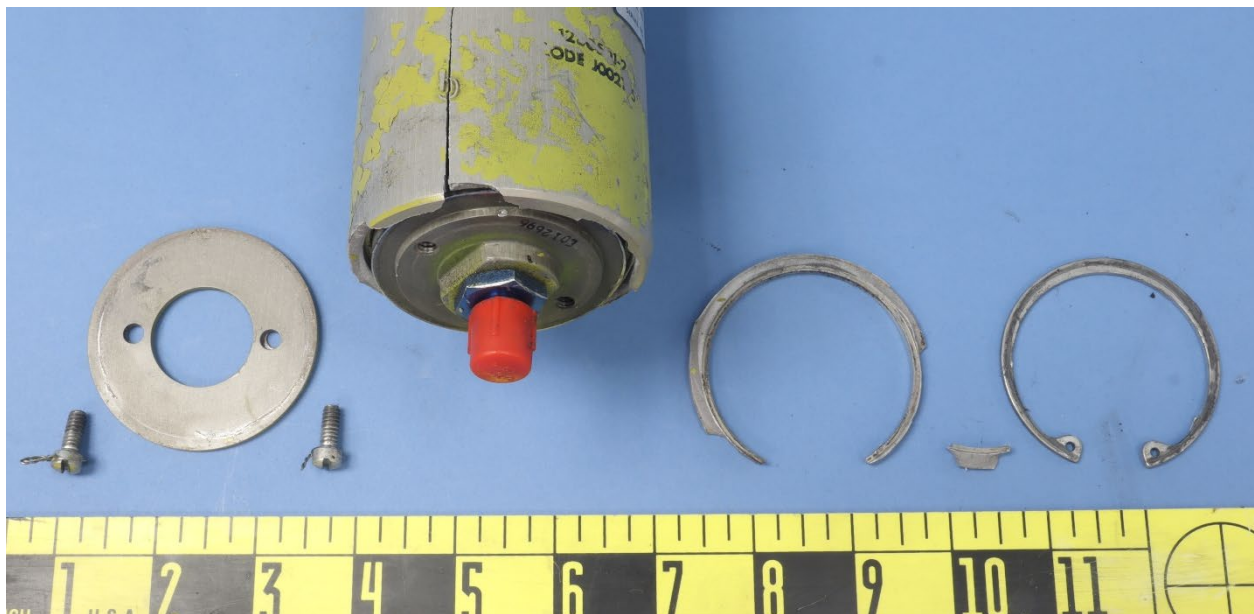
The end cap of the actuator was separated by sectioning the safety wire and removing the retaining screws. Once the endcap was removed, the extent of the circumferential cracking was revealed (Figure 7). The end flange had completely separated from the rest of the barrel, and the clip was still positioned inside a remnant of the groove seat. This circlip was removed and the separate pieces are laid out in Figure 7.

**Figure 7.** The cracked end of the actuator pictured in Figure 4, after removal of the screws and the end cap.

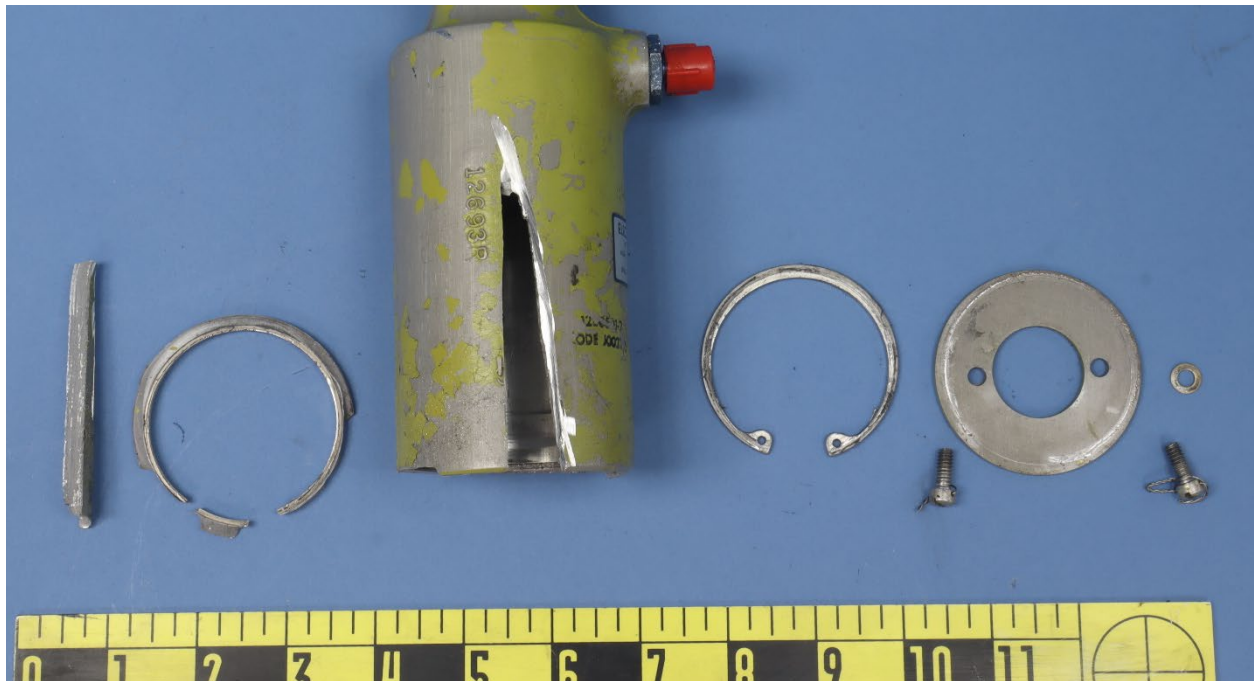
The barrel of the housing was sectioned at a 45° angle to separate the longitudinal crack face. Figure 8 illustrates the sectioned cracked area positioned next to the actuator body, with the retaining ring and endcap and other fractured pieces.

**Figure 8.** The cracked end of the actuator pictured in Figure 7a, after sectioning and removal of the cracked regions of the housing barrel.

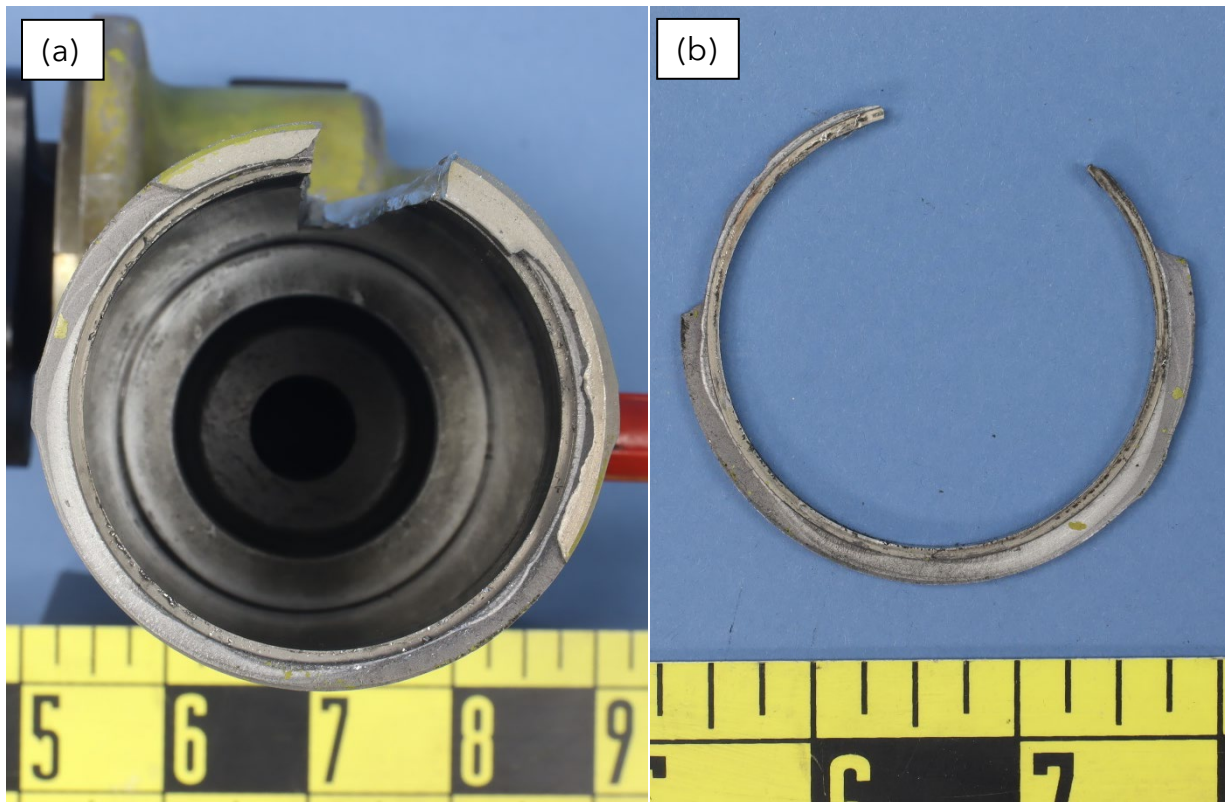
The mating fracture surfaces of the opened circumferential crack are shown in Figure 9. This fracture surface exhibited several thumbnail-shaped cracks, shown in Figure 10. As stated earlier, the length of the thumbnail cracking was 5.847 in long or 299° of the part circumference, illustrated in Figure 11a. The largest crack measured 2.85 inches or 145° of the circumference (Figure 11b). The crack depth was a maximum of 0.116 inches from the retaining ring, with the remaining cross section exhibiting subsequent fracture features. These thumbnail cracks initiated at a corner in the retainer clip groove.

**Figure 9.** The mating faces of the fractured end of the actuator, after sectioning and disassembly.

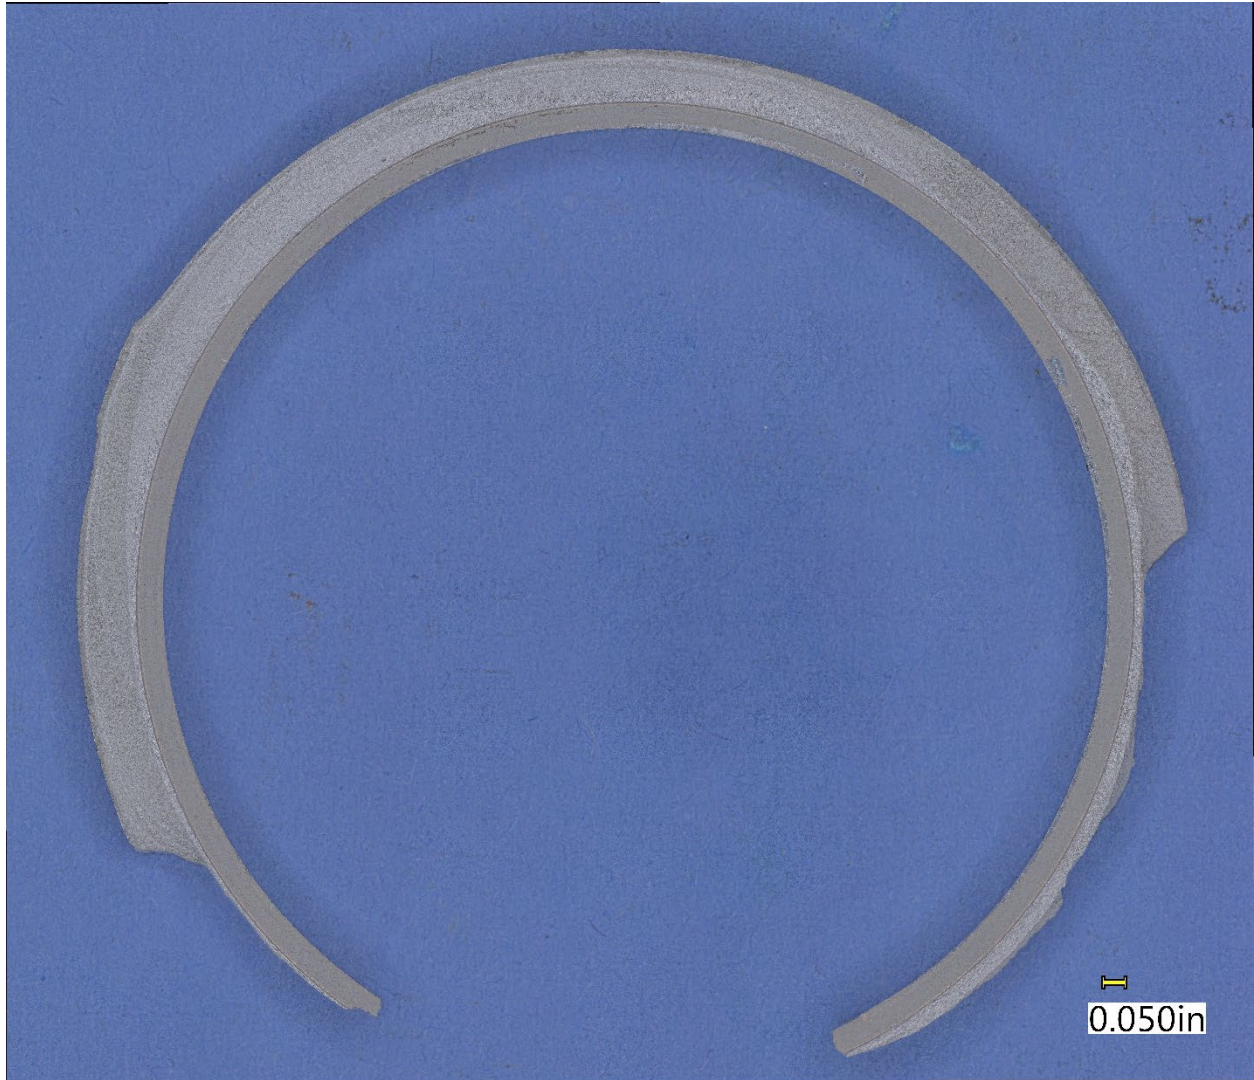
**Figure 10.** Montage of magnified images of the crack face of the circumferential crack, showing indications of progressive cracking.

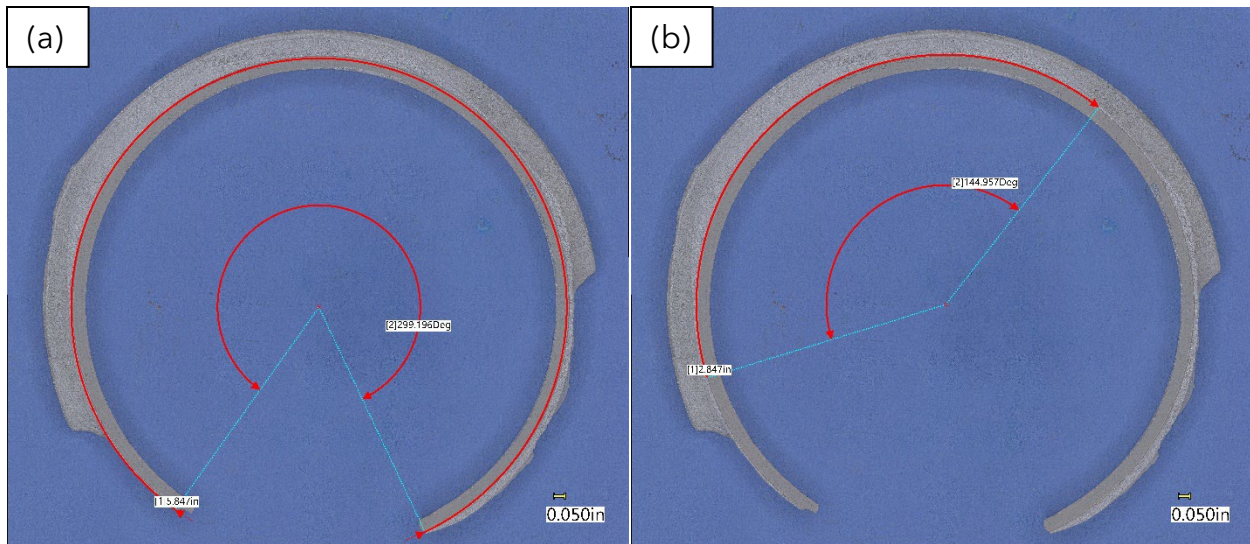
**Figure 11.** Measured regions of the fatigue cracking in Figure 11, showing (a) the total circumferential length exhibiting pre-existing cracks and (b) the largest crack.

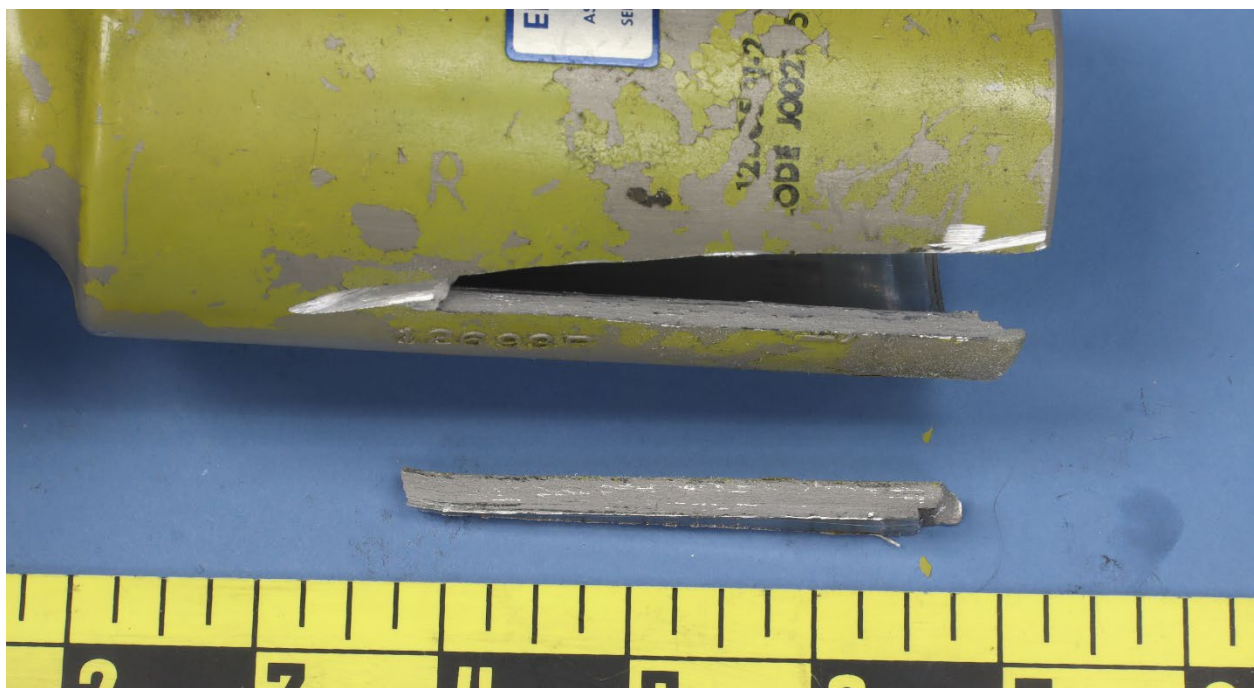
In contrast, the longitudinal crack exhibited a rough surface texture and a dull luster. The surface revealed V-shaped chevron marks pointing toward the circumferential crack at the endcap, consistent with fracture from that location. The mating sides of the longitudinal crack portion are shown in Figure 12.

**Figure 12.** Mating faces of the longitudinal crack, after sectioning to open the crack faces.

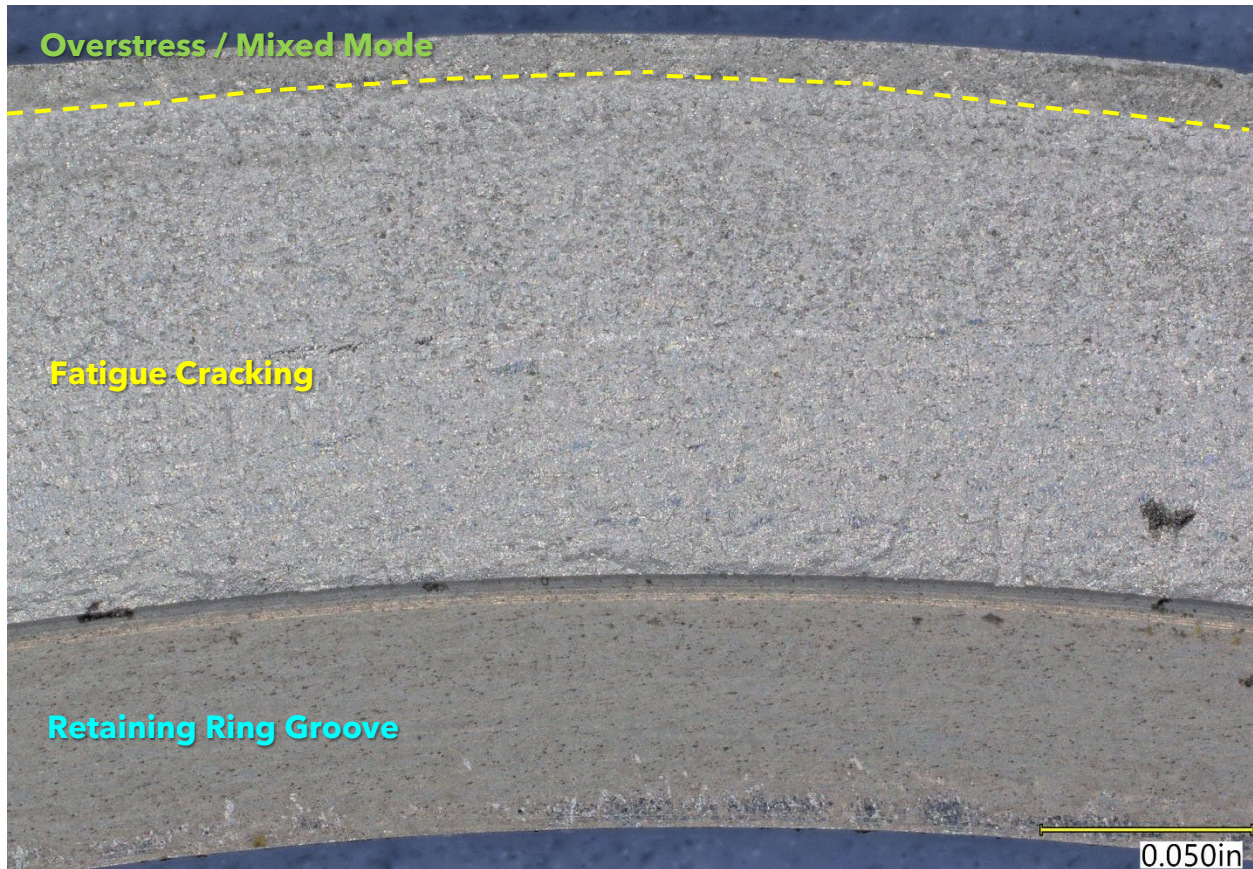
Figure 13 shows a closer view of the deepest area of the thumbnail crack on the outer circumferential fracture face. The middle part of this fracture surface exhibited crack arrest marks, consistent with progressive cracking, later determined to be fatigue. The fatigue cracks originated from the retaining ring groove. Figure 14 shows a closer view of the crack along this groove, with multiple initiation sites identified by yellow arrows. The crack propagation directions are annotated with dashed white arrows.

**Figure 13.** The fatigue crack in Figure 11, showing the area of crack initiation.

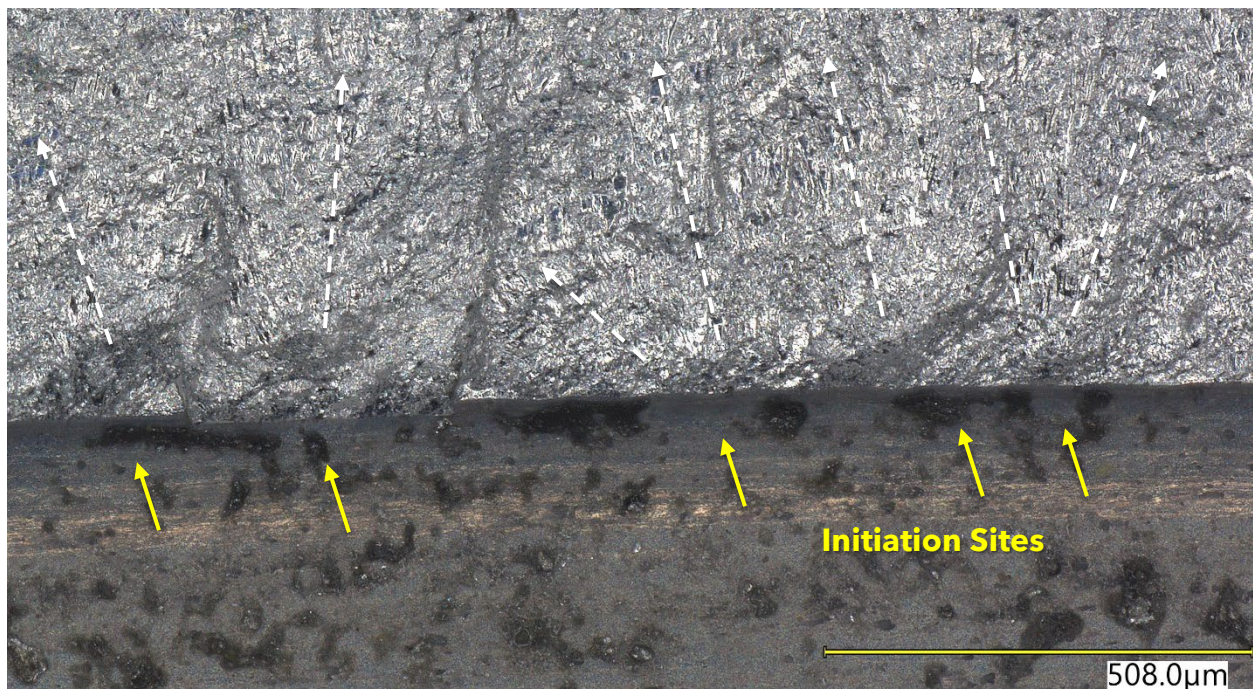
**Figure 14.** Closer view of the crack initiation area, with some initiation sites identified (yellow arrows) and the local crack growth directions annotated (white arrows).

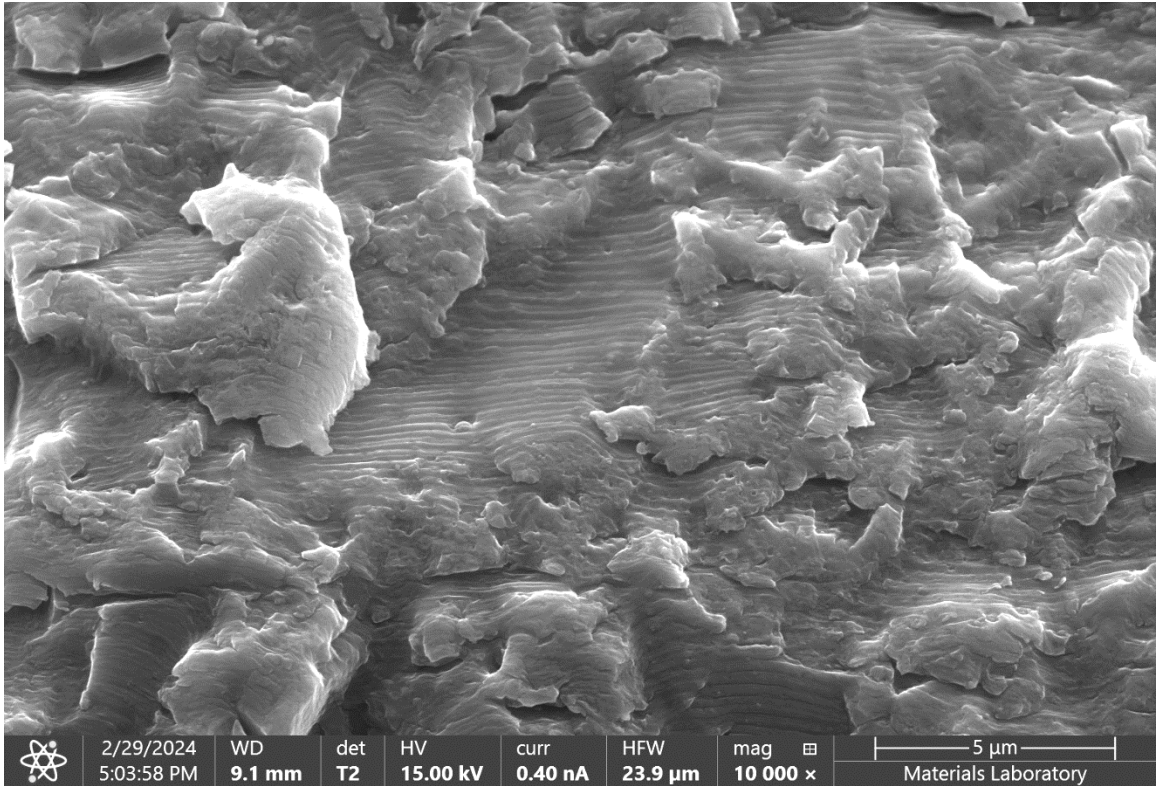
initiation region in Figure 13 and 14. As shown in this figure and Figure 16, the thumbnail crack exhibited striations consistent with fatigue crack propagation. Portions of the fracture surface outside the fatigue crack revealed mostly dimple rupture, consistent with subsequent overstress fracture (Figure 17). However, there were also isolated fatigue striations, indicating an area of mixed-mode fracture. One such region was typified in the location shown in the backscattered micrograph of Figure 18.

**Figure 15.** Secondary electron (SE) micrograph of a typical area of the fatigue crack in Figure 13, showing multiple areas of fatigue striations.

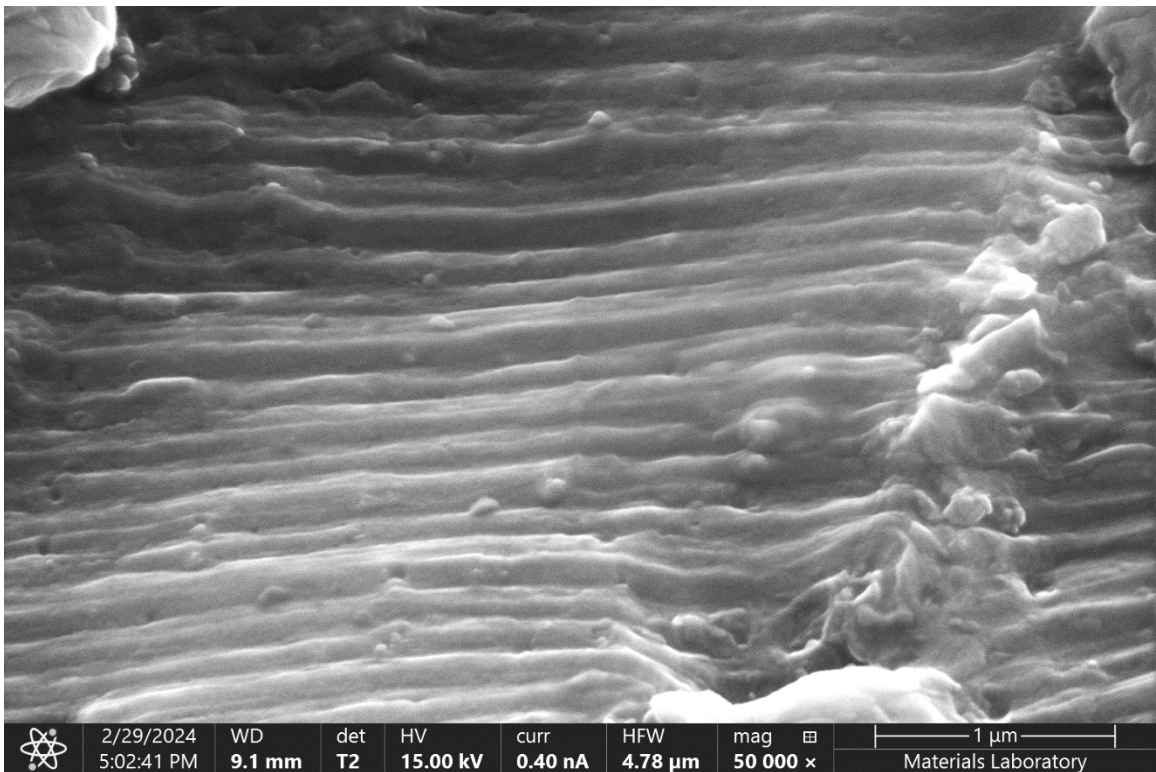
**Figure 16.** SE micrograph of a closer view of the fatigue striations in Figure 15.

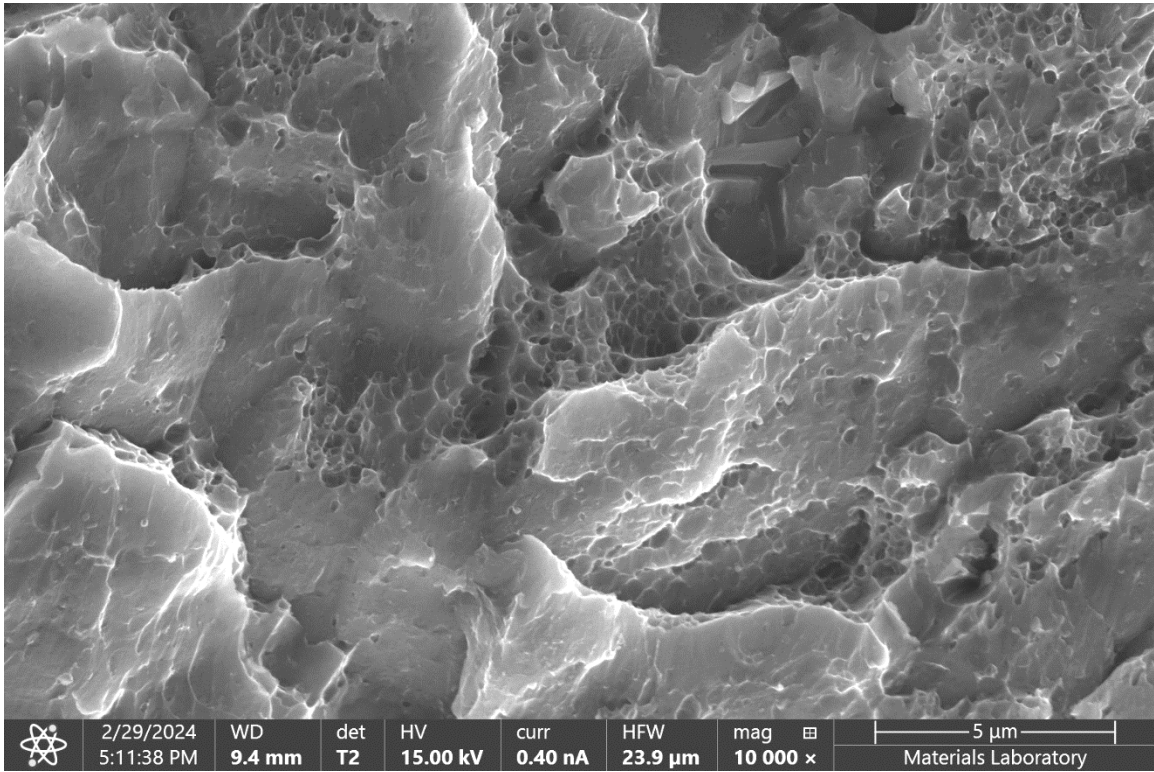
**Figure 17.** SE micrograph of dimpled rupture in the area outside the primary fatigue crack.

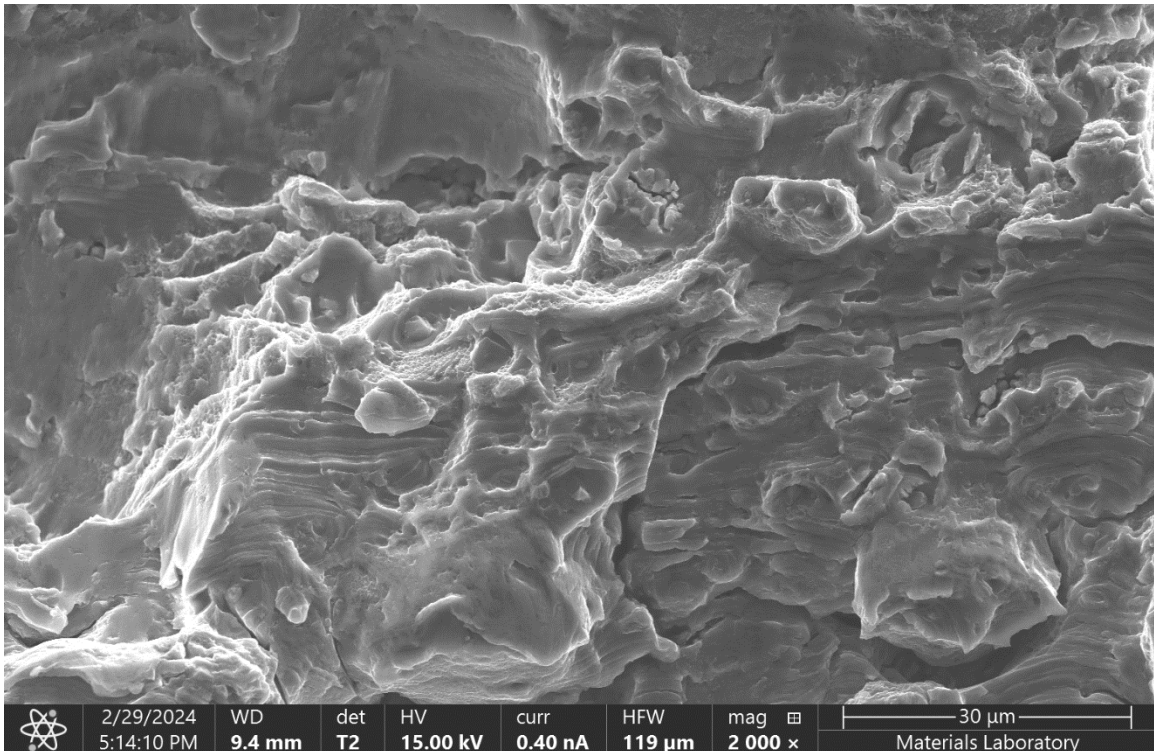
**Figure 18.** SE micrograph of the mixed mode area outside of the primary fatigue crack, showing dimpled rupture and striations.

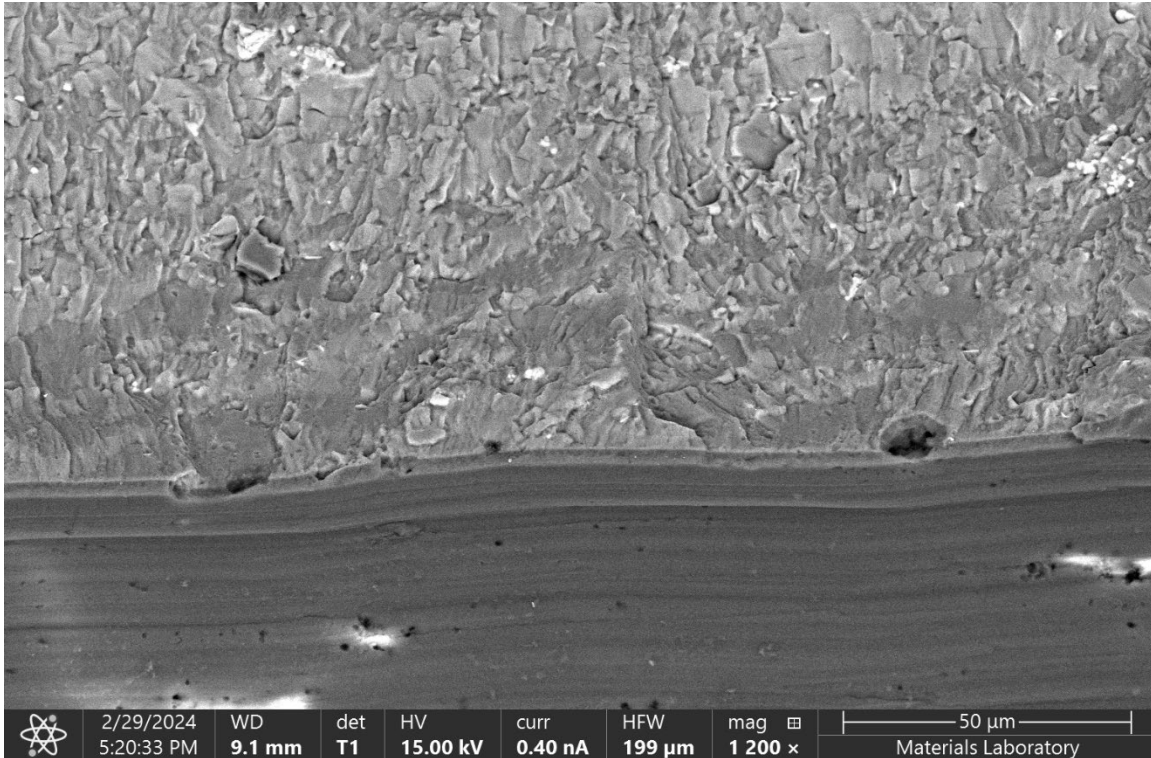
The thumbnail-shaped fatigue cracks exhibited ratchet marks, consistent with multiple fatigue crack initiation. Two of these initiation sites are illustrated in Figure 19. Along these initiation sites, small corrosion pits were observed, as exemplified best in Figure 20. Most of the fatigue crack initiation sites along retaining ring groove edge contained pits, such as shown in Figure 20. Figure 22 also revealed the corrosion pit at this site exhibited a darker contrast surface layer in backscattered mode with a small pit-like valley.<sup>1</sup>

**Figure 19.** Backscattered electron (BE) micrograph of one of the fatigue crack initiation sites on the cylinder groove.

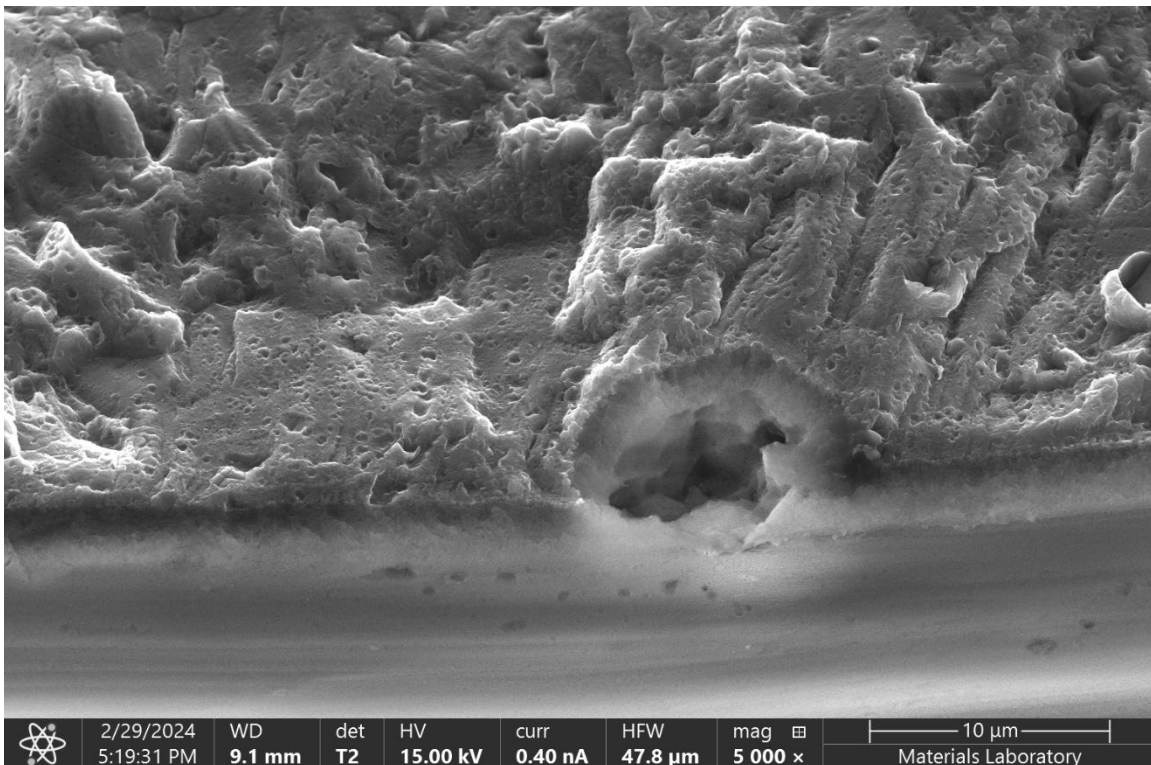
**Figure 20.** SE micrograph of the corrosion pit at the initiation site in **Figure 19**.

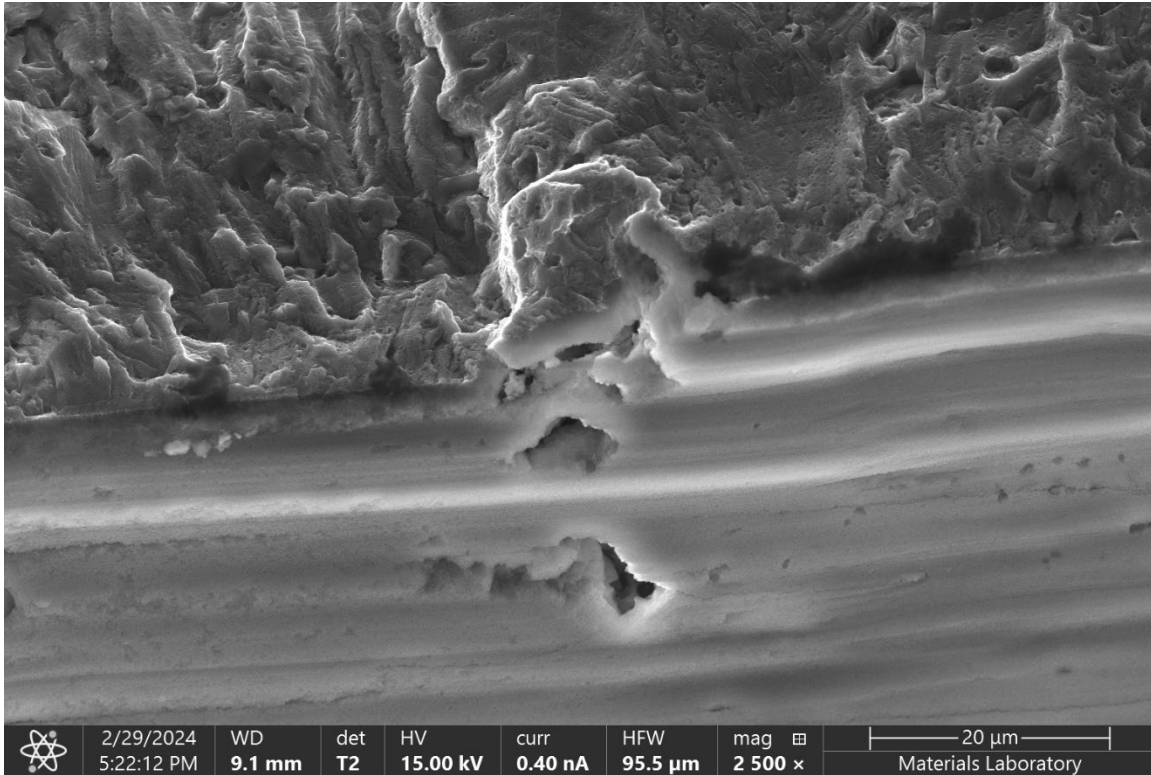
Examination of the material using energy dispersive x-ray spectroscopy (EDS) found it to be consistent with aluminum oxide. This surface layer of oxide and inward depressions were typical of the other fatigue crack initiation sites along the retaining ring groove. These sites also contained cadmium, consistent with cadmium plating remnants from the clip that sat in the groove.

**Figure 21.** BE micrograph of a second crack initiation site, showing charging (nonconductive) compounds along the groove.

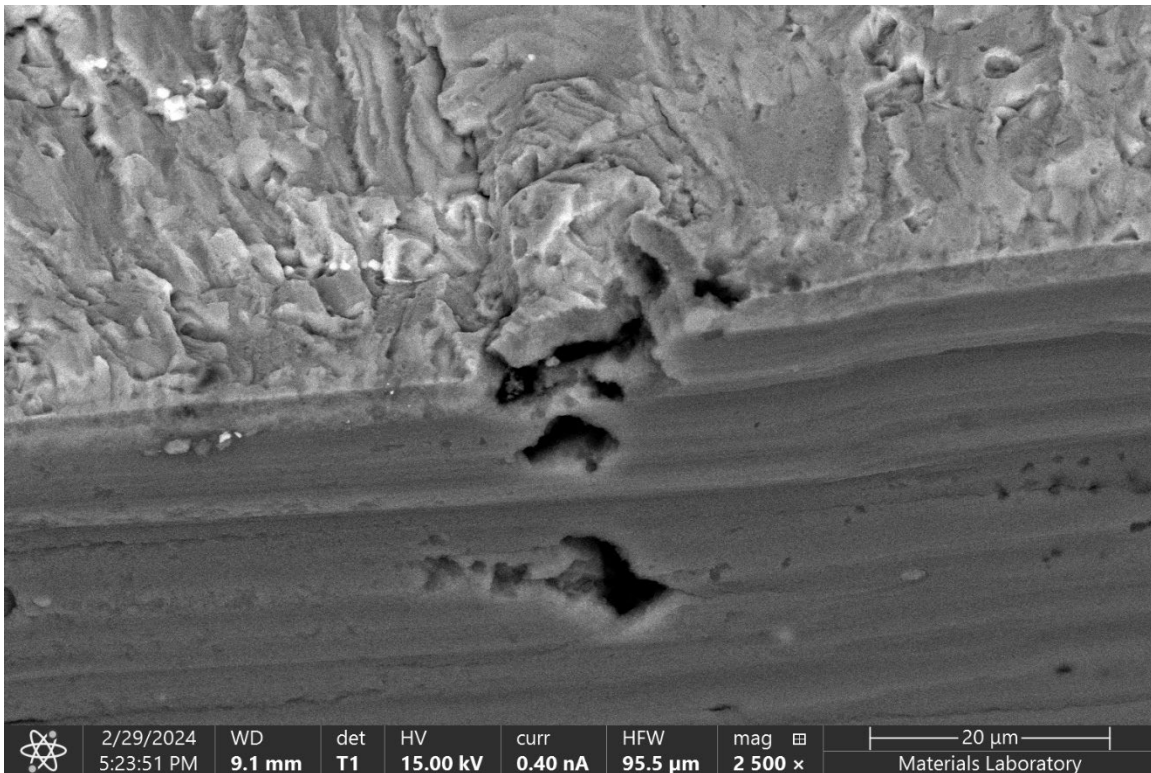
**Figure 22.** SE micrograph of the initiation site edge, showing a small groove (arrow).
