# National Transportation Safety Board

CEN24LA018

## **MATERIALS LABORATORY**

Factual Report 24-006

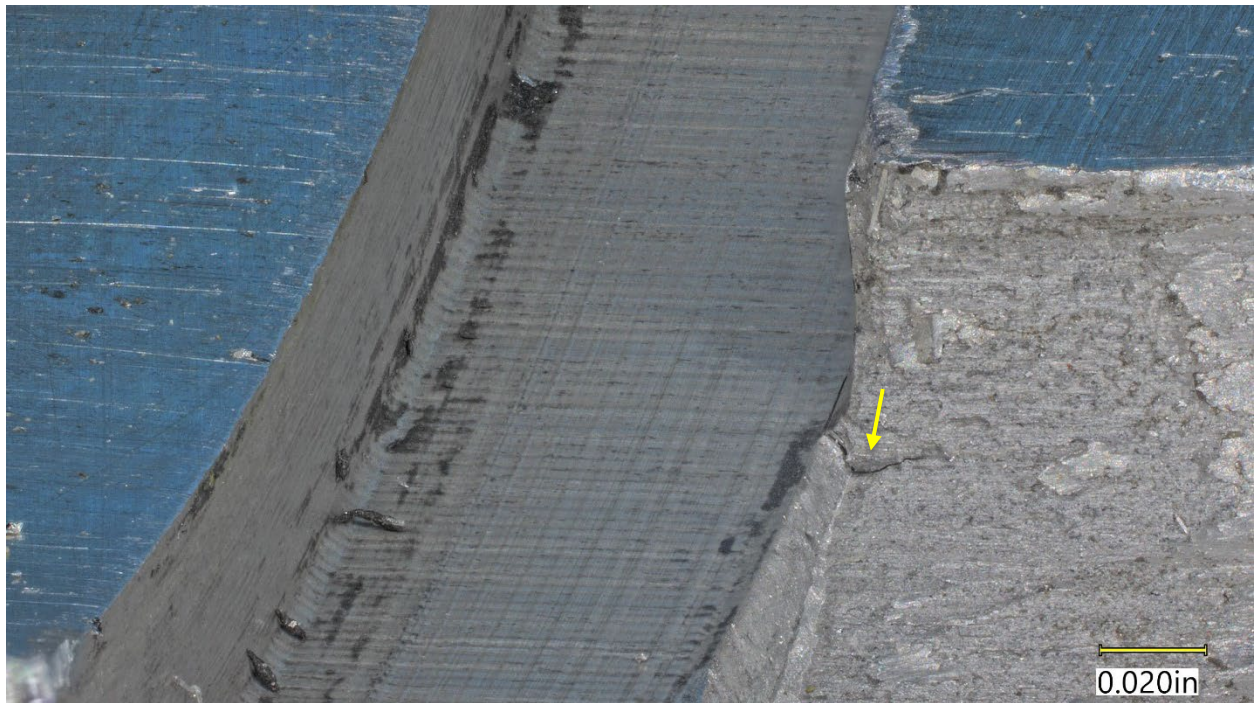
The mating fracture surface and circlip groove was also examined, and Figure 23 and 24 show additional cracks along the outboard corner of the groove, which had propagated into the area of the longitudinal crack (denoted by yellow arrows in both figures). These figures show the cracking emanating from the outboard corner of the groove. On the opposite inboard corner of the groove, intermittent cracking was also observed, as illustrated in Figure 25. This layered and discontinuous nature of these cracks were consistent with multiple crack initiation sites, like the fatigue cracking on the outboard fracture surface. Closer views of the inboard crack shows areas of darker, less reflective material (Figure 26). This material was consistent with area of localized corrosion and pitting.

**Figure 23.** View of the clip groove, showing cracking (arrow) along the corner with the separated mating fracture surface.

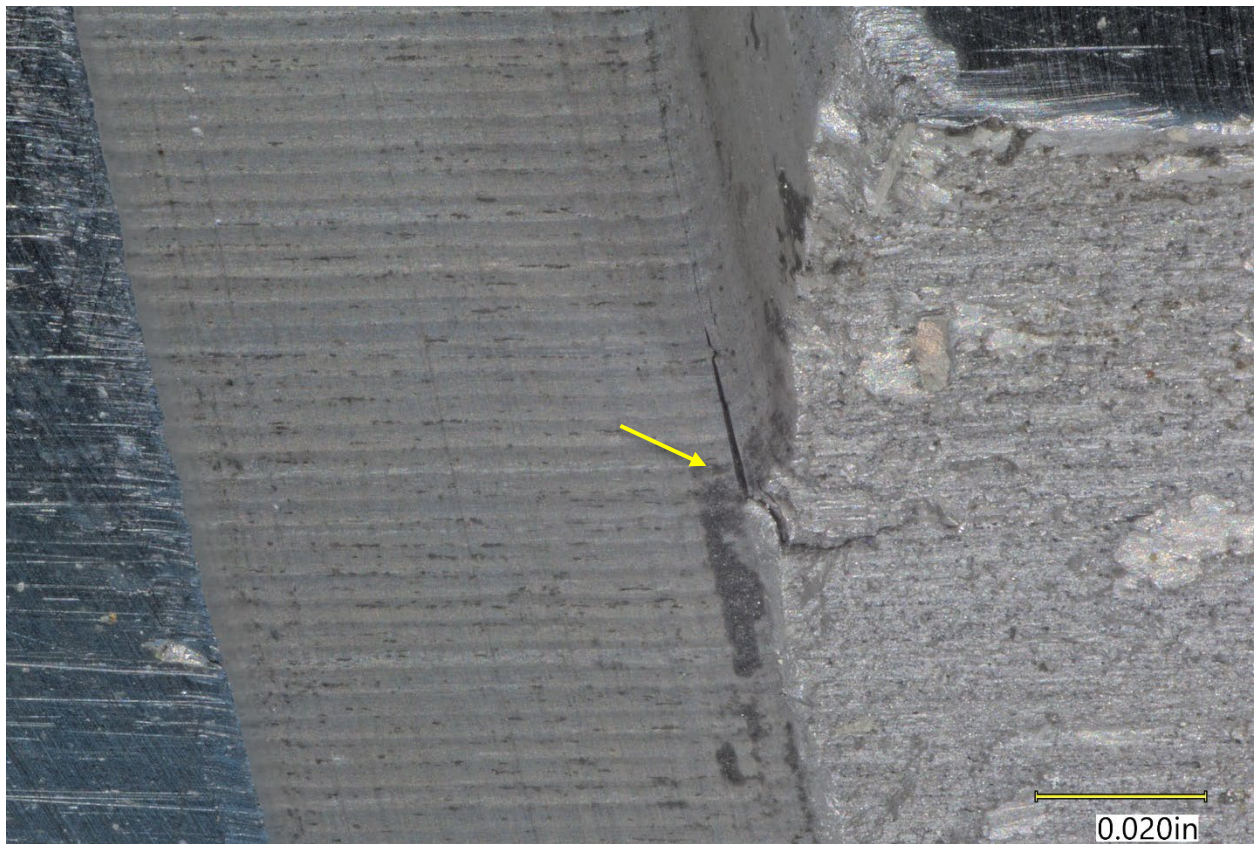
**Figure 24.** View of the secondary crack off the outboard groove corner, opposite angle showed in Figure 25. The crack is identified by the yellow arrow.

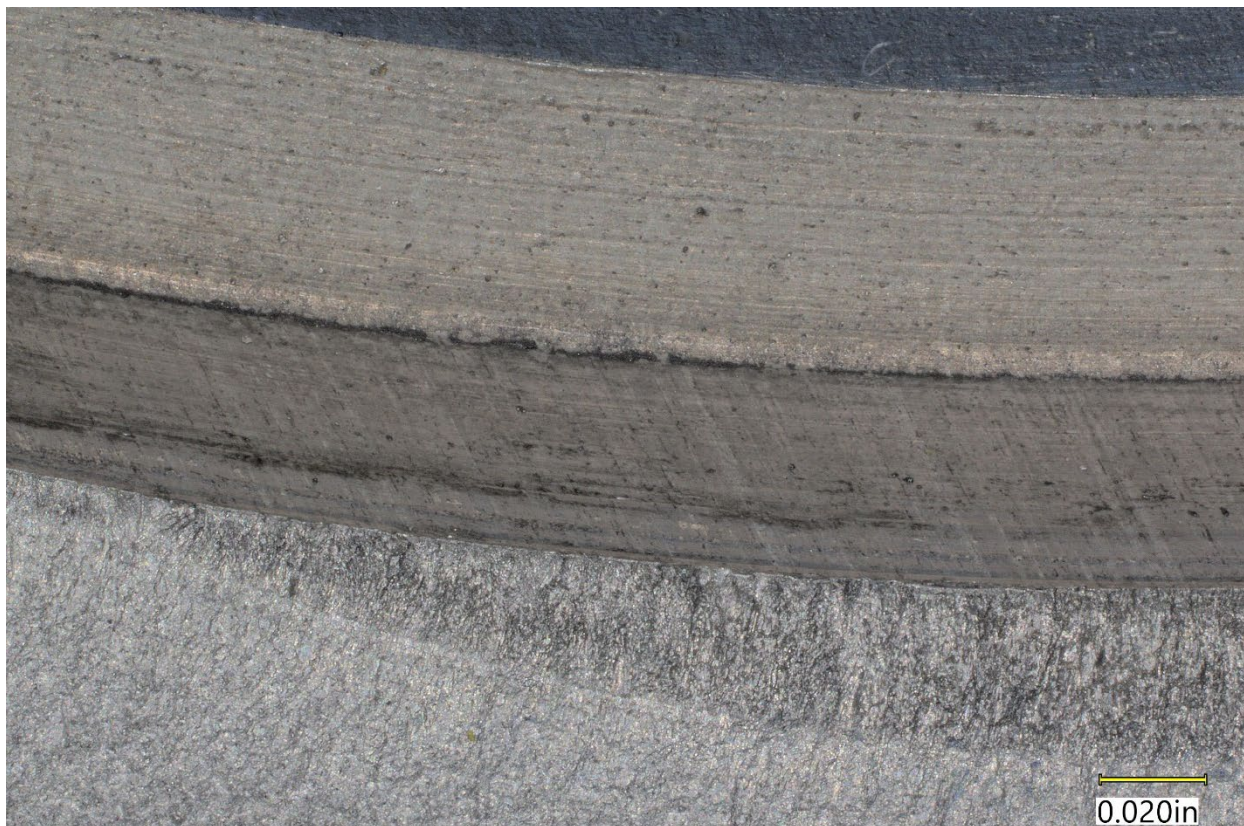
**Figure 25.** Additional cracking along the inboard corner of the groove opposite the fracture surface (lower portion).

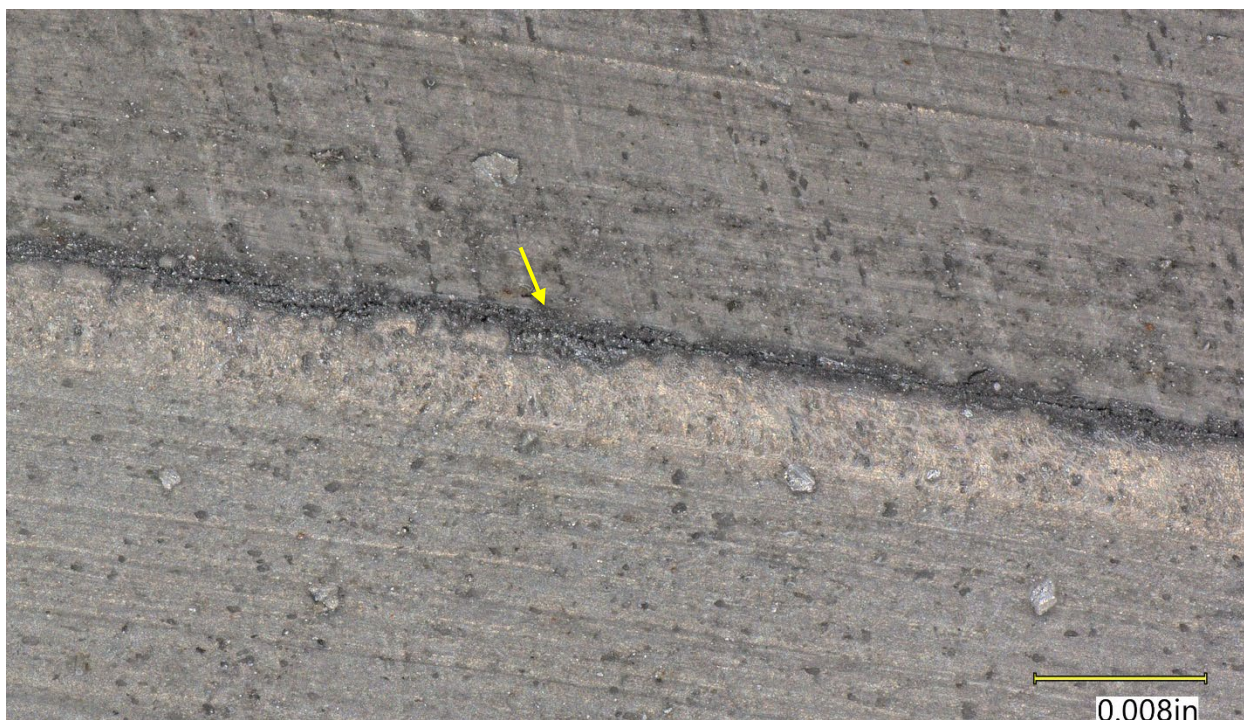
**Figure 26.** Closer view of the inboard corner cracks, collocated with pitting (dark).

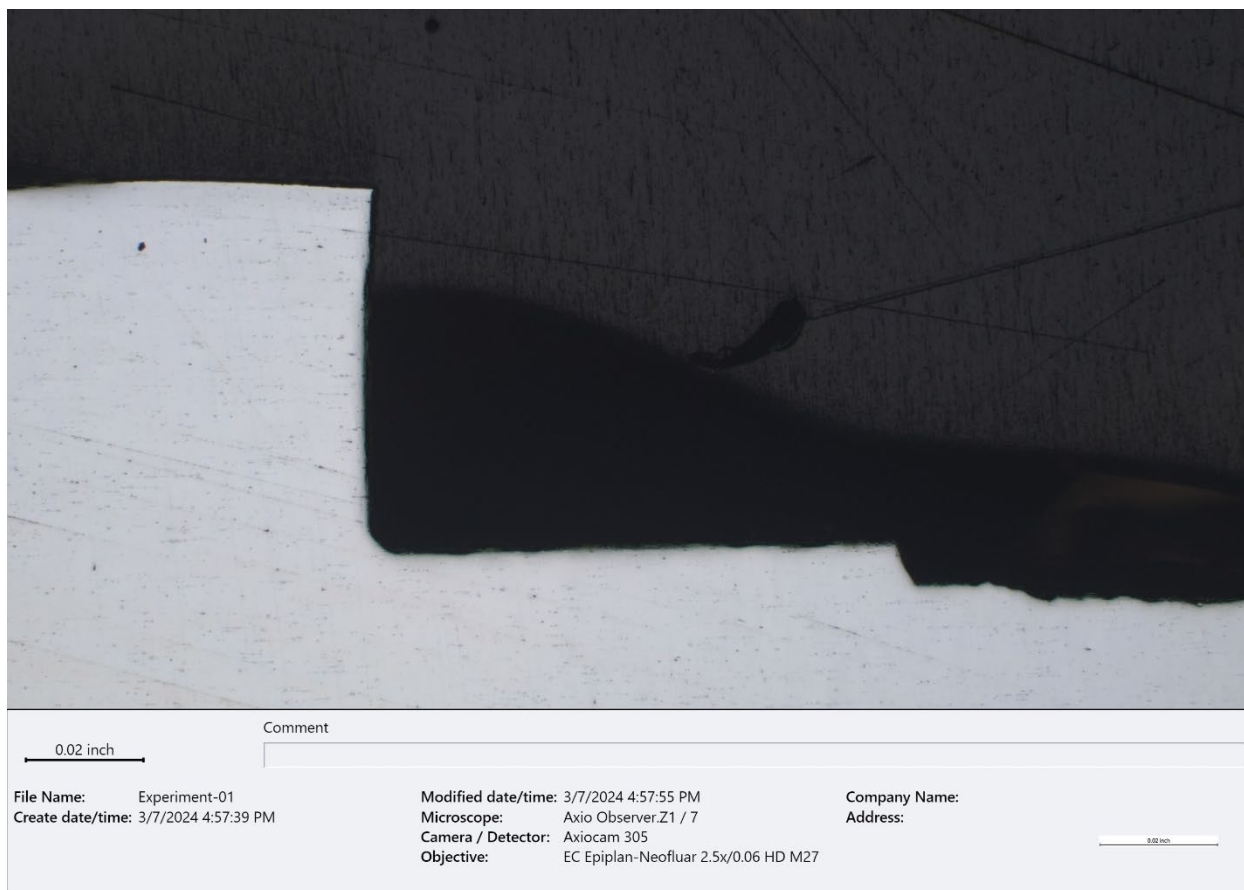
A portion of the actuator housing was cross-sectioned through the clip groove. Figure 27 shows this cross-section after mounting and polishing. Overall, the microstructure exhibited grain flow consistent with wrought material processing. As shown in Figure 27, the angled fracture had propagated out of the lower right (outboard) corner of the groove. Figure 28 shows closer views of this cross section of the groove floor. Typical of the initiation sites on the fracture and inboard crack, there

These features were consistent with fatigue cracking having initiated along the retaining ring groove of the actuator. Propagating outward in a circumferential direction, once the fatigue crack grew to its terminal size, the remainder of the cross-section fractured from mixed overstress and fatigue. This cracking led to part of the housing barrel fracturing in overstress, allowing the release of the internal pressurized hydraulic fluid.

**Figure 27.** Bright-field (BF) optical metallograph cross-section of the actuator retaining ring showing an angled crack propagating from the left groove radius (~25X, as polished).

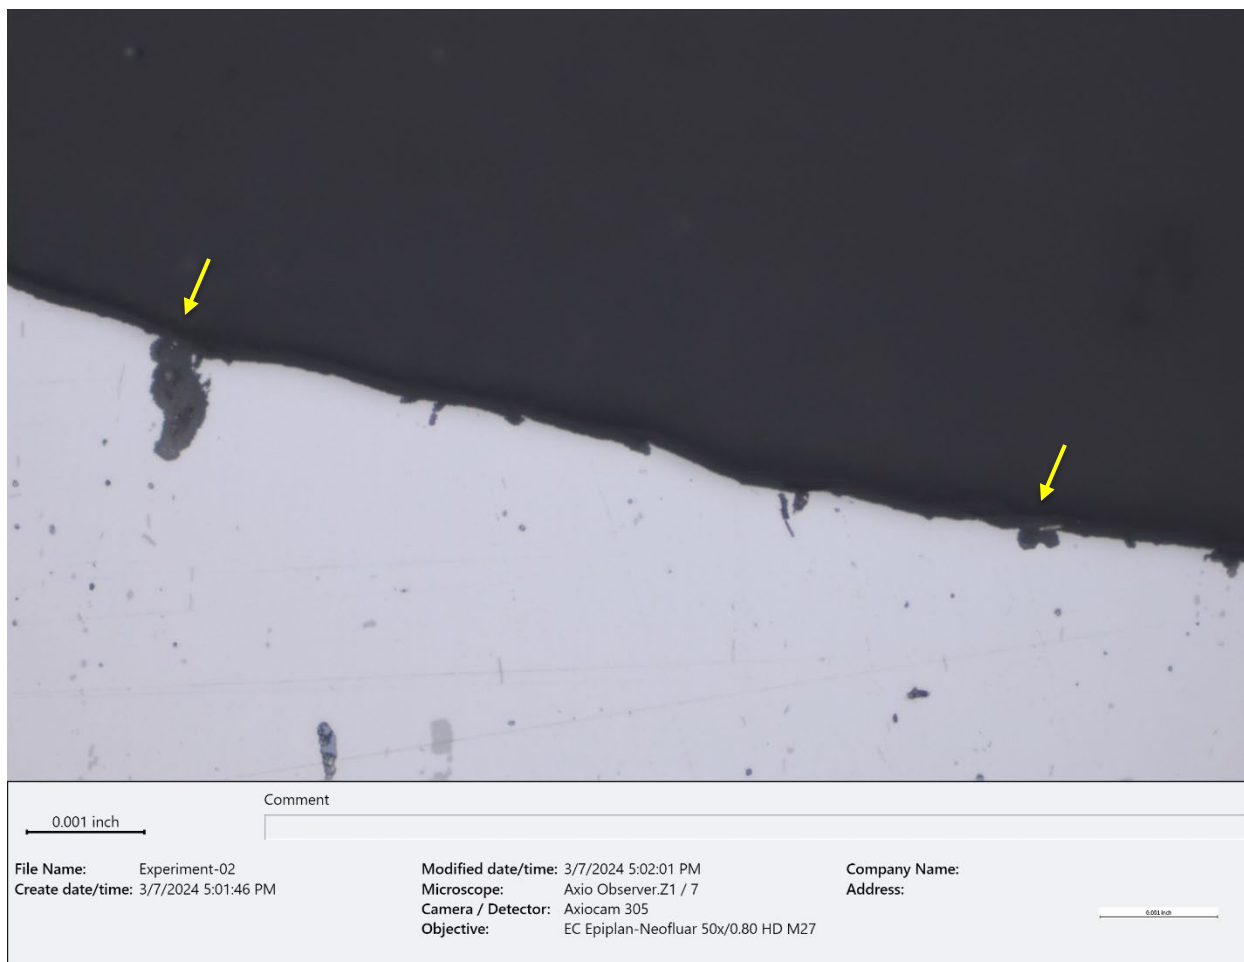
were small corrosion pits present, which contrasted darker against the cross sectioned housing metal alloy.

**Figure 28.** BF optical metallograph showing a closer view of corrosion pits from the lower groove surface in Figure 27 (~200X, as polished).
