National Transportation Safety Board

CEN24LA018

## **INVESTIGATION PHOTOGRAPHS**

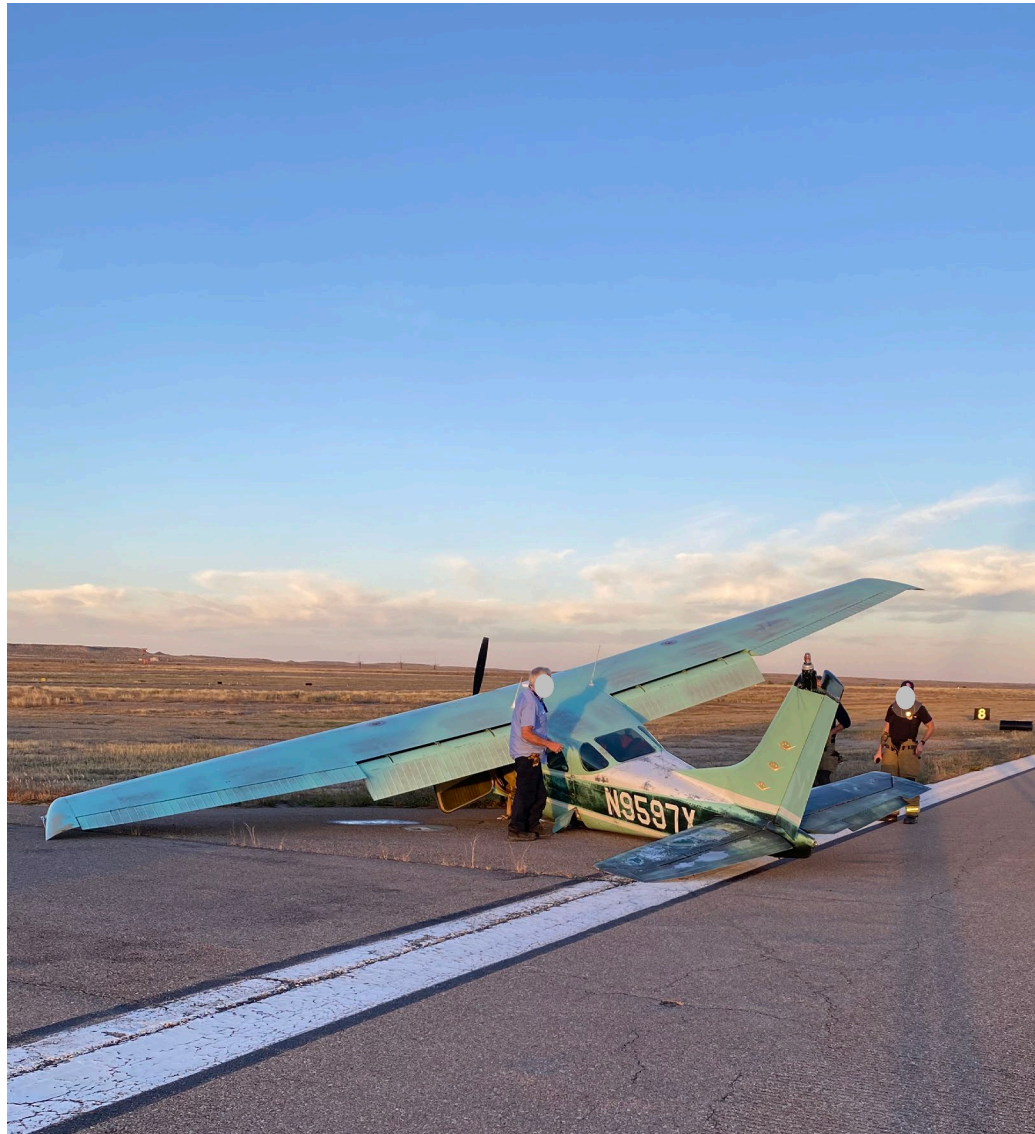
**Photograph 1 - Accident site (Courtesy of FAA)**

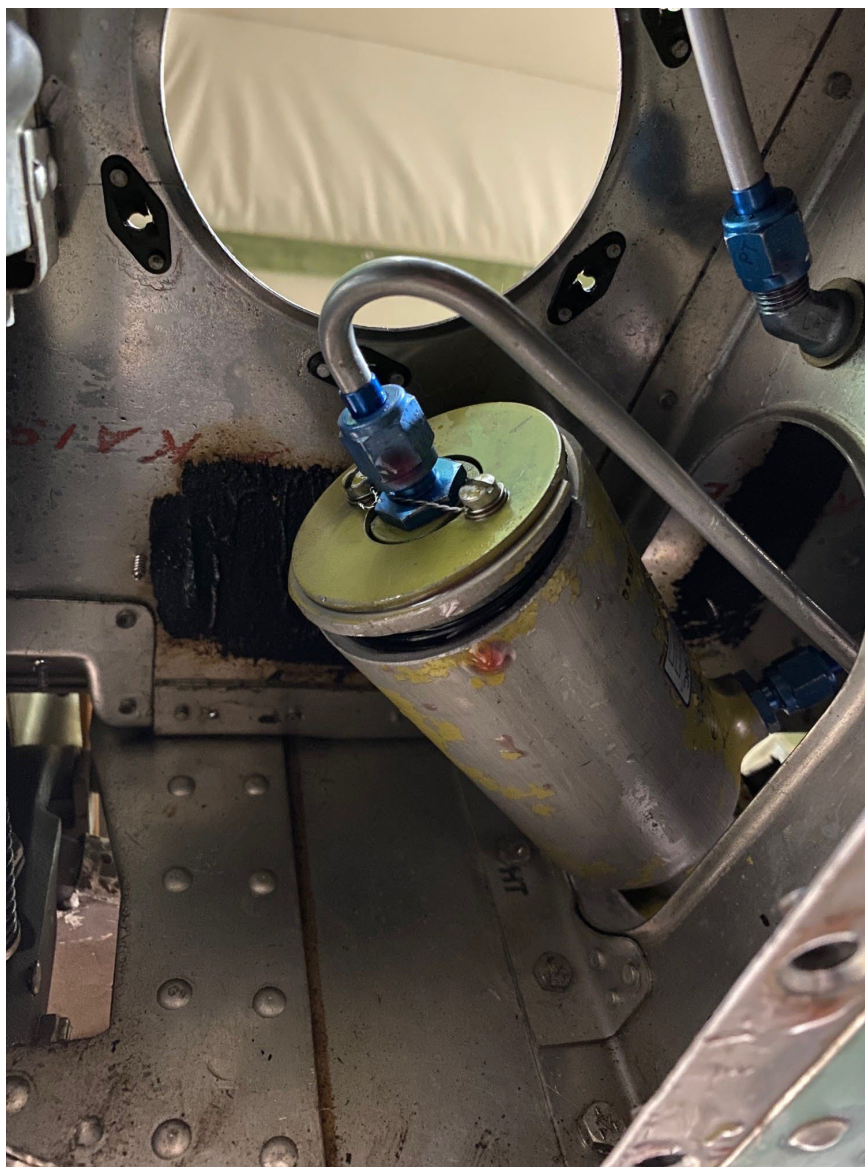
**Photograph 2 - Fractured actuator (courtesy of pilot)**
