CEN24LA023

## INVESTIGATION PHOTOGRAPH

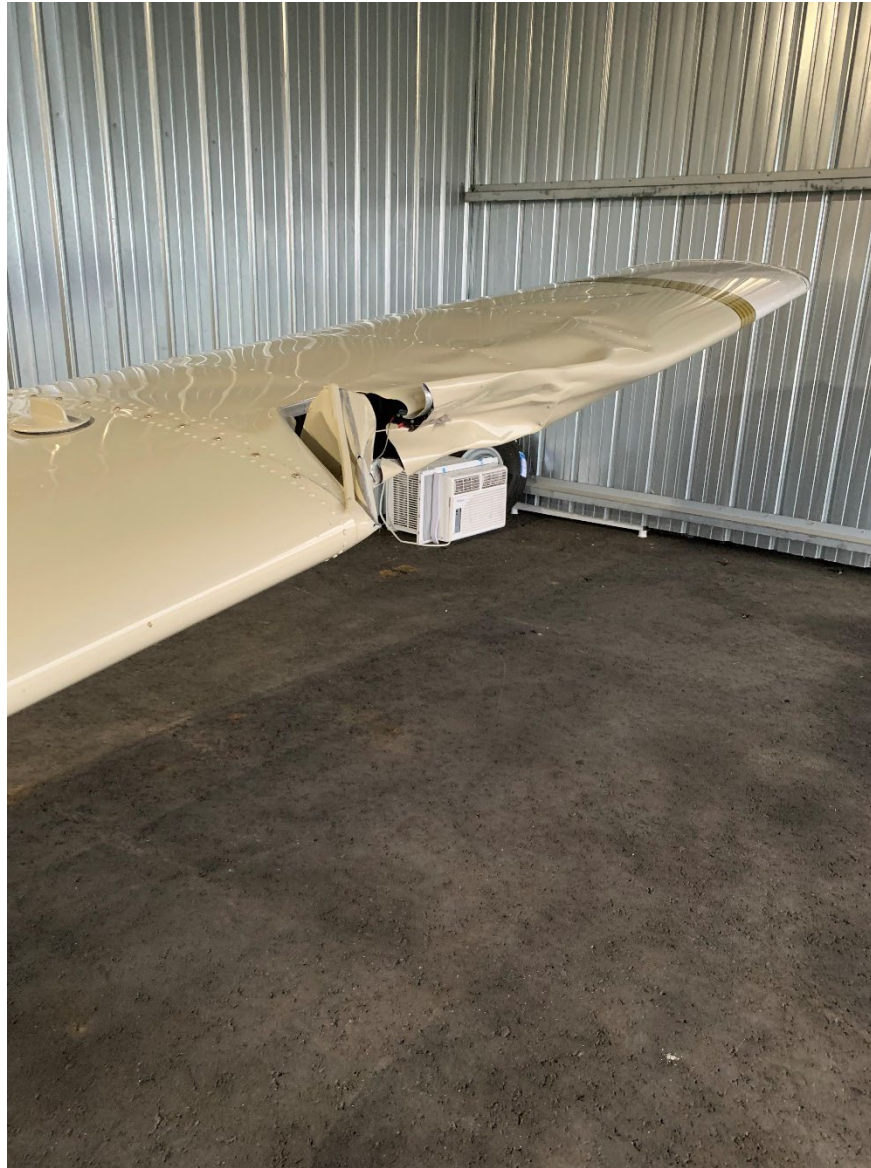
**Photograph 1 - Damaged left wing (Courtesy of the Federal Aviation Administration)**
