# National Transportation Safety Board

CEN24LA038

## **MATERIALS LABORATORY**

Factual Report 24-063

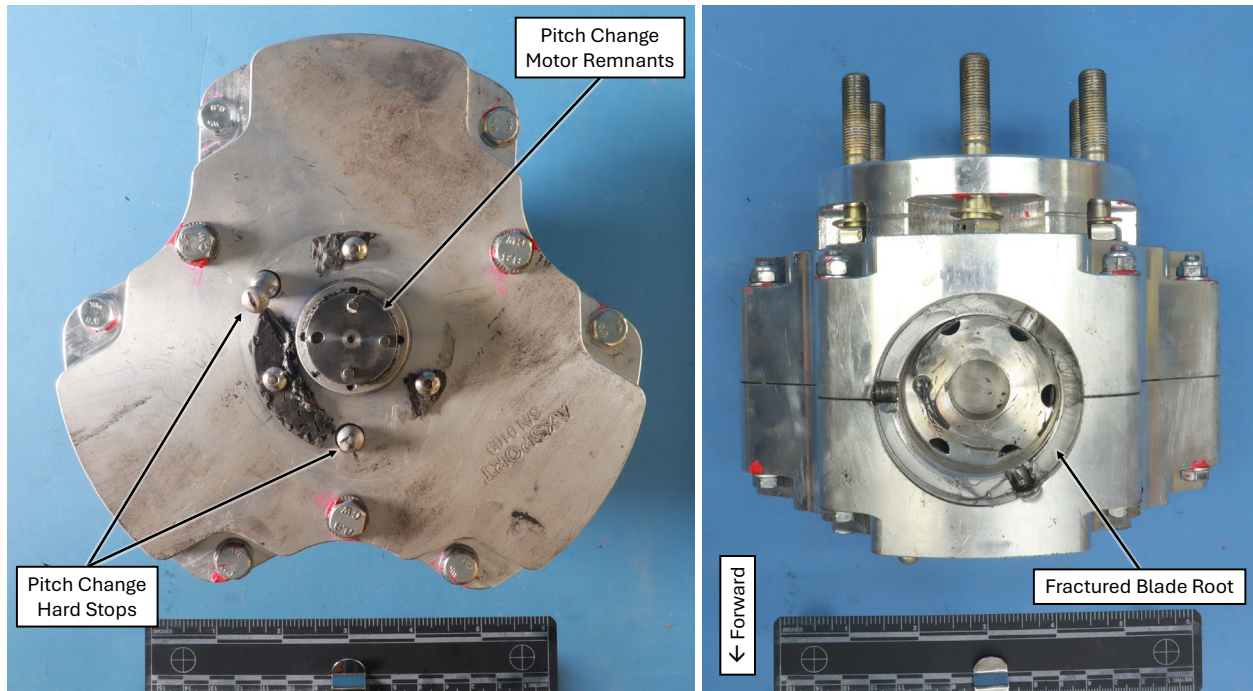
The NTSB materials lab received portions of the propeller hub and two propeller blades which had been removed from the hub as shown in figures 1 and 2. A portion of the third blade root was fractured and was retained in the hub as shown in the right image of figure 1. The outboard portion of the blade was not recovered. The two recovered blades were measured to be consistent with a 70-inch diameter propeller. The following identification information was engraved on the forward face of the hub:

The pitch change motor had partially separated from the forward face of the hub and the pitch change hard stops were bent. The lower pitch change hard stop, as oriented in figure 1, was fractured through the reduced section in a manner consistent with overstress separation. A combination of on-scene photographs and identification markings on the pitch change block were used to establish the blade positions which will be referred to as 1, 2, and 3 throughout this report. No identification markings attributable to blade position were observed on the blade roots. Blade 2 was fractured through the metallic root section which was retained in the hub as indicated in the right image of figure 1.

**Figure 1.** Photographs of the propeller hub as received looking aft (left) and looking axially inboard along the bore of blade position 2 (right). A portion of the fractured blade 2 root was retained in the hub as indicated in the right image.

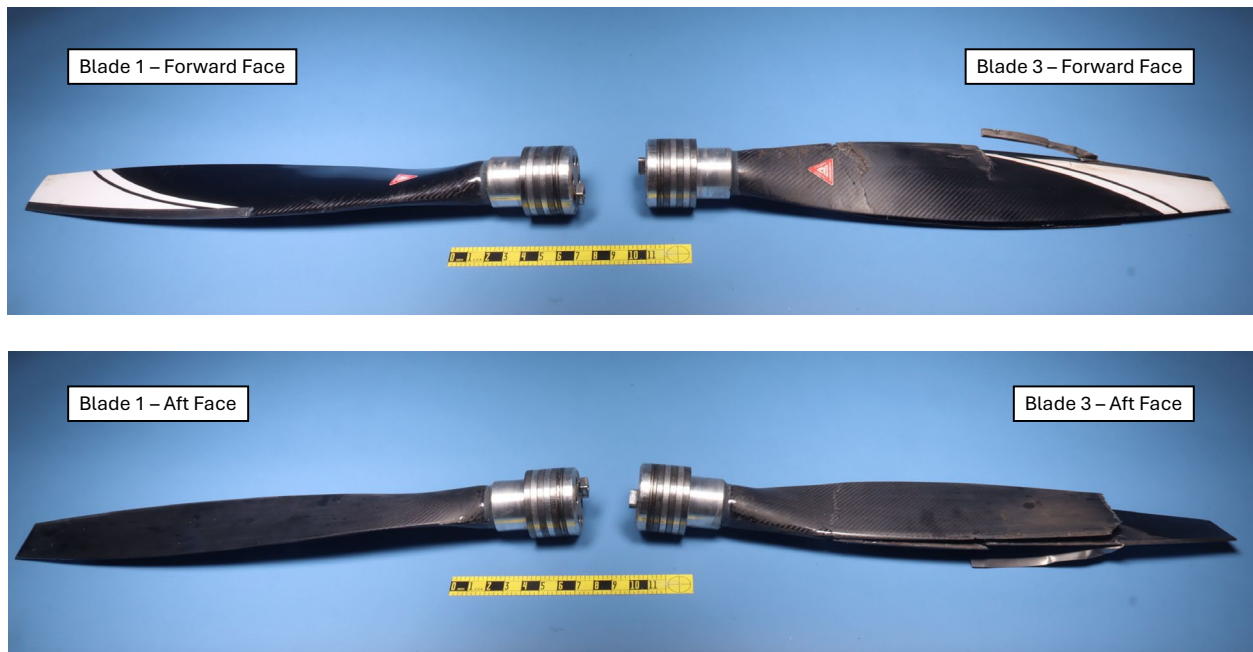
Blade 1 appeared mostly intact, however Blade 3 exhibited partial chordwise cracks and spanwise separation as shown in figure 2. The inboard portion of the leading edge abrasion strip had partially separated from the blade and exhibited bending and buckling deformation. Partial spanwise separation of the composite blade was observed along the leading and trailing edges and through the aft side of the foam core. Soil deposits were impacted within the leading edge split. An ultraviolet light inspection was performed over the surfaces of blades 1 and 3 for evidence of organic deposits, and no relevant fluorescing indications were observed. The damage signatures observed on Blade 3 were consistent with ground impact forces.

**Figure 2.** Photographs of the other two propeller blades as received. Blade 1 (left) was relatively undamaged whereas Blade 3 exhibited damage from ground impact.

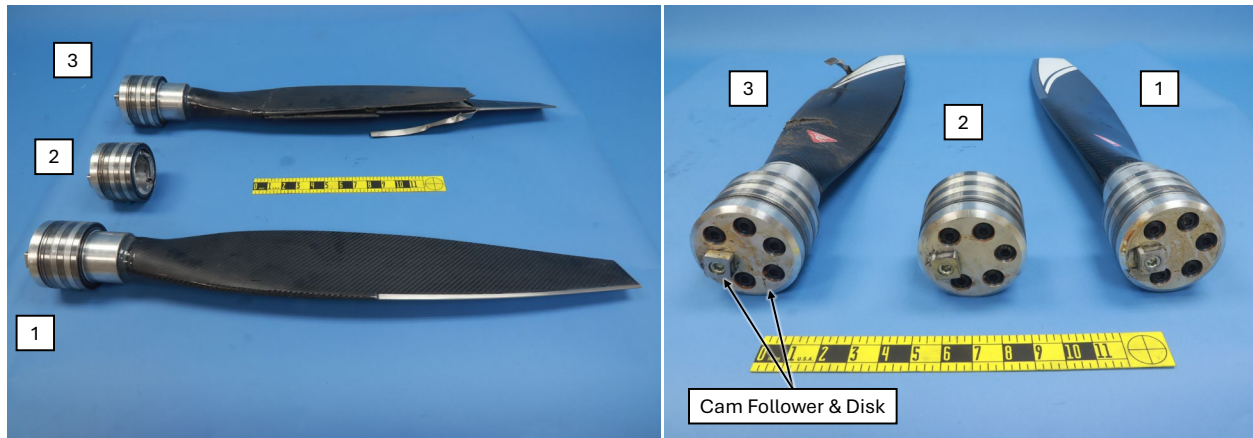
The hub was partially disassembled to remove the fractured blade root which is shown with the other propeller blades in figure 3. Each blade root was fitted with three cartridge style bearings separated by spacer rings with a needle roller thrust bearing with washers located between the last cartridge bearing and the cam follower disk which was secured to the base of the blade root by five button head cap screws and one socket head cap screw which received the blade cam follower.

**Figure 3.** Photographs of the three propeller blades after removal of the fractured blade 2 root from the hub.

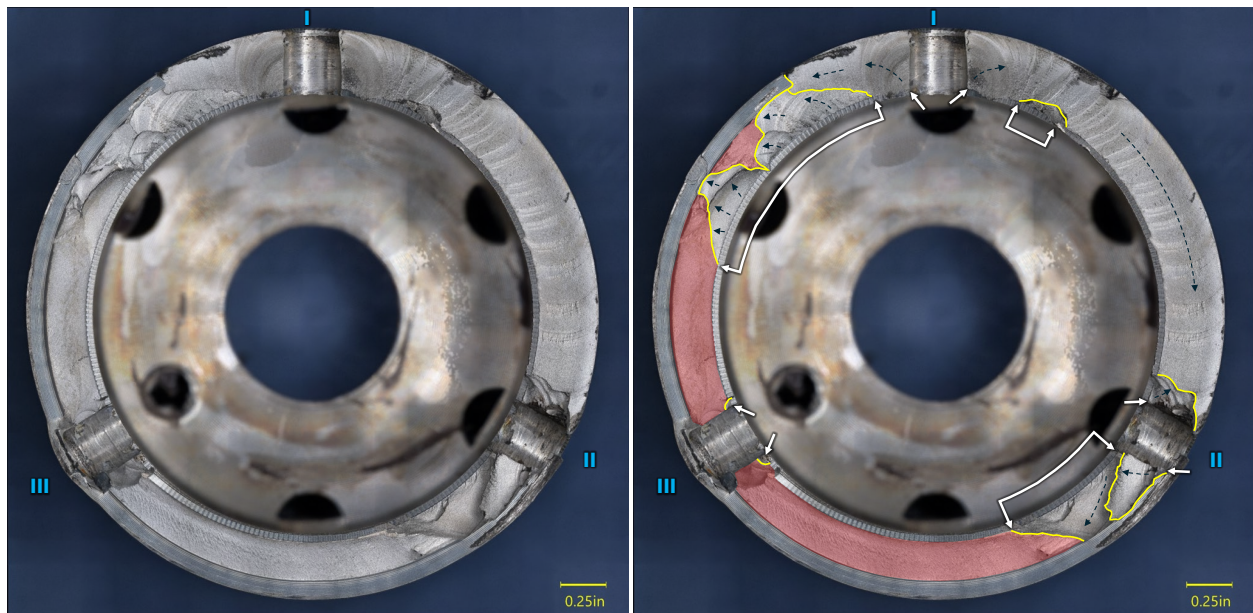
The fracture surface of Blade 2 was oriented transversely through the hollow cylindrical blade root between 2.6 - 3.1 inches from the base of the cam follower disk and intersected three evenly spaced radial holes. The cam follower disk, bearings, and spacers were removed from the fractured blade root which was then cleaned ultrasonically using soap and water followed by ethanol. The left image in figure 4 shows a digital microscope image of the cleaned fracture surface, viewed inboard along the blade axis, with the radial holes labeled as I, II, and III for the purposes of this report. The same image is shown on the right, annotated to show fracture initiation and progression as detailed below.

At hole I, darker gray and brownish thumbnail shaped regions were observed extending from each corner of the hole at the inner surface of the blade root as indicated by white arrows. Curvilinear progression marks continued through the wall of the blade root and around toward holes II and III, as indicated by black dashed arrows, consistent with progressive crack growth. Spacing between curved bands of crack progression marks between holes I and II increased as the crack front grew towards hole II and areas rougher in appearance were observed between curved bands, consistent with increased stress amplitude and an increased rate of crack growth. Yellow boundary lines corresponded to intersections with additional progressive cracks which originated at hole corners and thread roots as indicated by white arrows and bracketed regions, with growth directions indicated by black dashed arrows. Closer views of these areas are shown in the following figures. Areas highlighted in red exhibited a rougher matte gray appearance, consistent with tensile and/or bending overstress during final separation.

**Figure 4.** Digital microscope image of the fracture surface of the root of blade 2 with radial holes labeled as I, II, and III. Right is an annotated view of the left image showing fracture origin areas (white arrows), progressive crack growth directions (black arrows), intersections of progressive crack regions (yellow lines), and overstress regions (red).

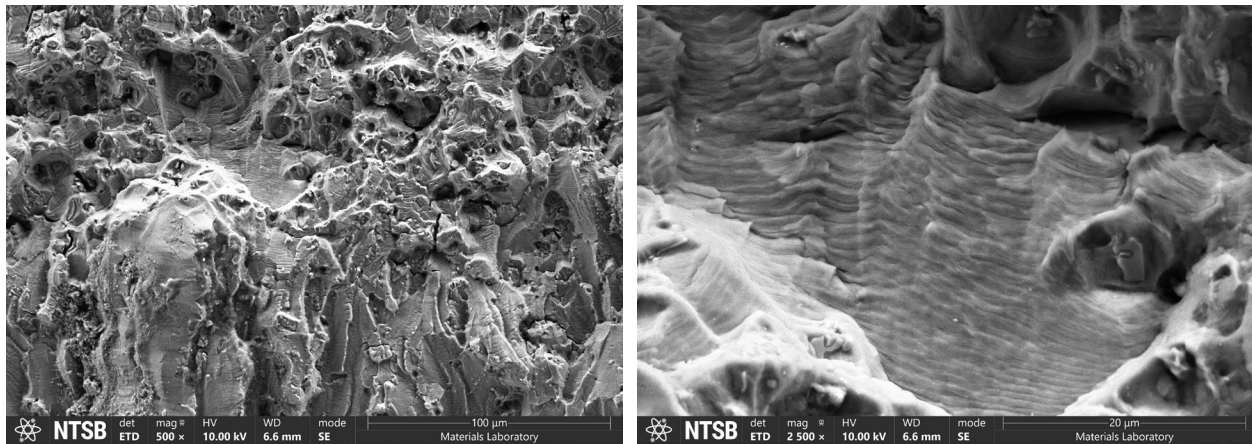
A scanning electron microscope (SEM) was used to examine the fracture surface. Typical SEM images are shown in figure 5 from the progressive fracture region located between holes I and II where macroscopic curved progression marks were observed. The lower magnification image on the left shows feathery regions of finer curved progression marks, oriented horizontally, interspersed with regions of dimpled features. The direction of crack growth is downward in these images. The fracture surface appearance was consistent with mixed-mode fracture dominated by fatigue under a relatively high stress amplitude as evidenced by ductile dimpled features which were consistent with overstress. The higher magnification image on the right shows finer curved striations within more prominent curved progression marks, consistent with a fatigue fracture mechanism with variable stress amplitudes.

**Figure 5.** Scanning electron microscope images (secondary electron detector) of the progressive fracture region of the blade root between holes I and II. The left image shows a lower magnification view of feathery regions with curved progression/arrest marks (oriented horizontally) which are interspersed with circular dimpled features. The right image shows a higher magnification view where finer fatigue striations are observed between more prominent curved progression marks. Crack growth direction is from top to bottom in these images.

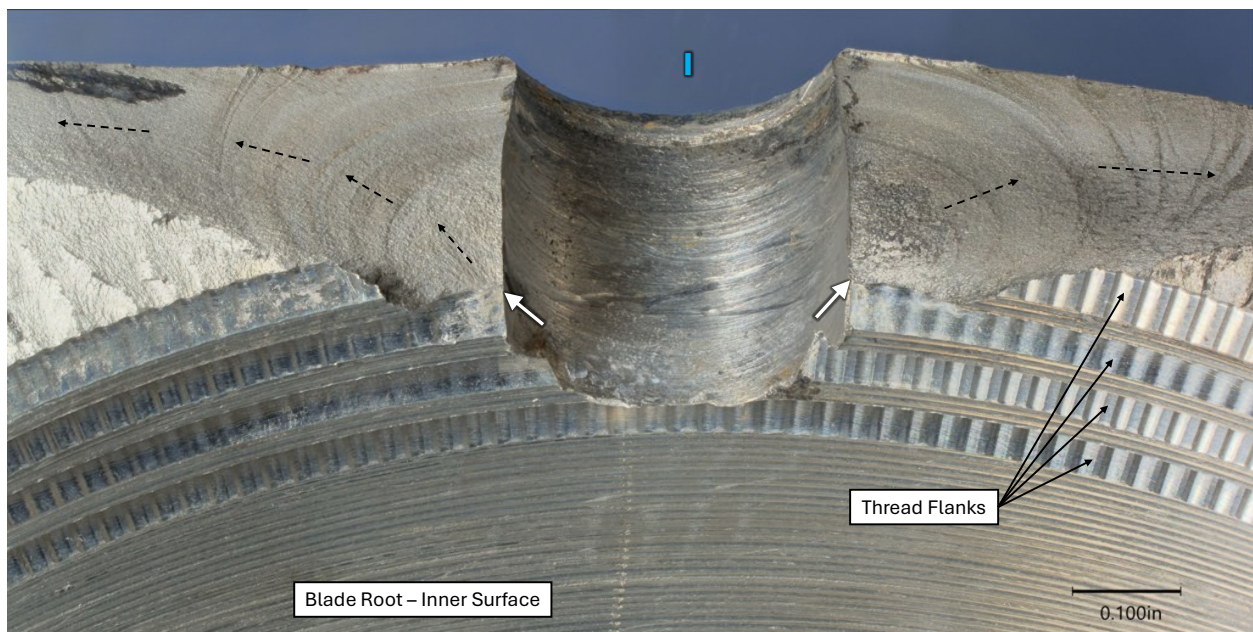
Figure 6 shows a closer tilted view of the primary fracture origin areas observed at the inner edges of hole I, indicated by white arrows. The fracture origins were located at thread roots which intersected the radial hole. Curved brown and dark gray progression marks oriented perpendicular to radial fracture features emanated away from the origins through the wall and around the blade root. The fracture surface near the origin on the right side of the hole as pictured exhibited a darker battered appearance, consistent with rubbing contact. The threads exhibited chatter marks along the flank surfaces.<sup>2</sup>

**Figure 6.** A digital microscope image (tilted view) of the inner surface of the fractured blade root showing the primary fatigue fracture origins (white arrows) where thread roots intersected the edges of radial hole I. Crack growth directions are indicated by black arrows, perpendicular to visible curved progression marks. Chatter marks were observed on the thread flanks and exhibited a wavy surface appearance.

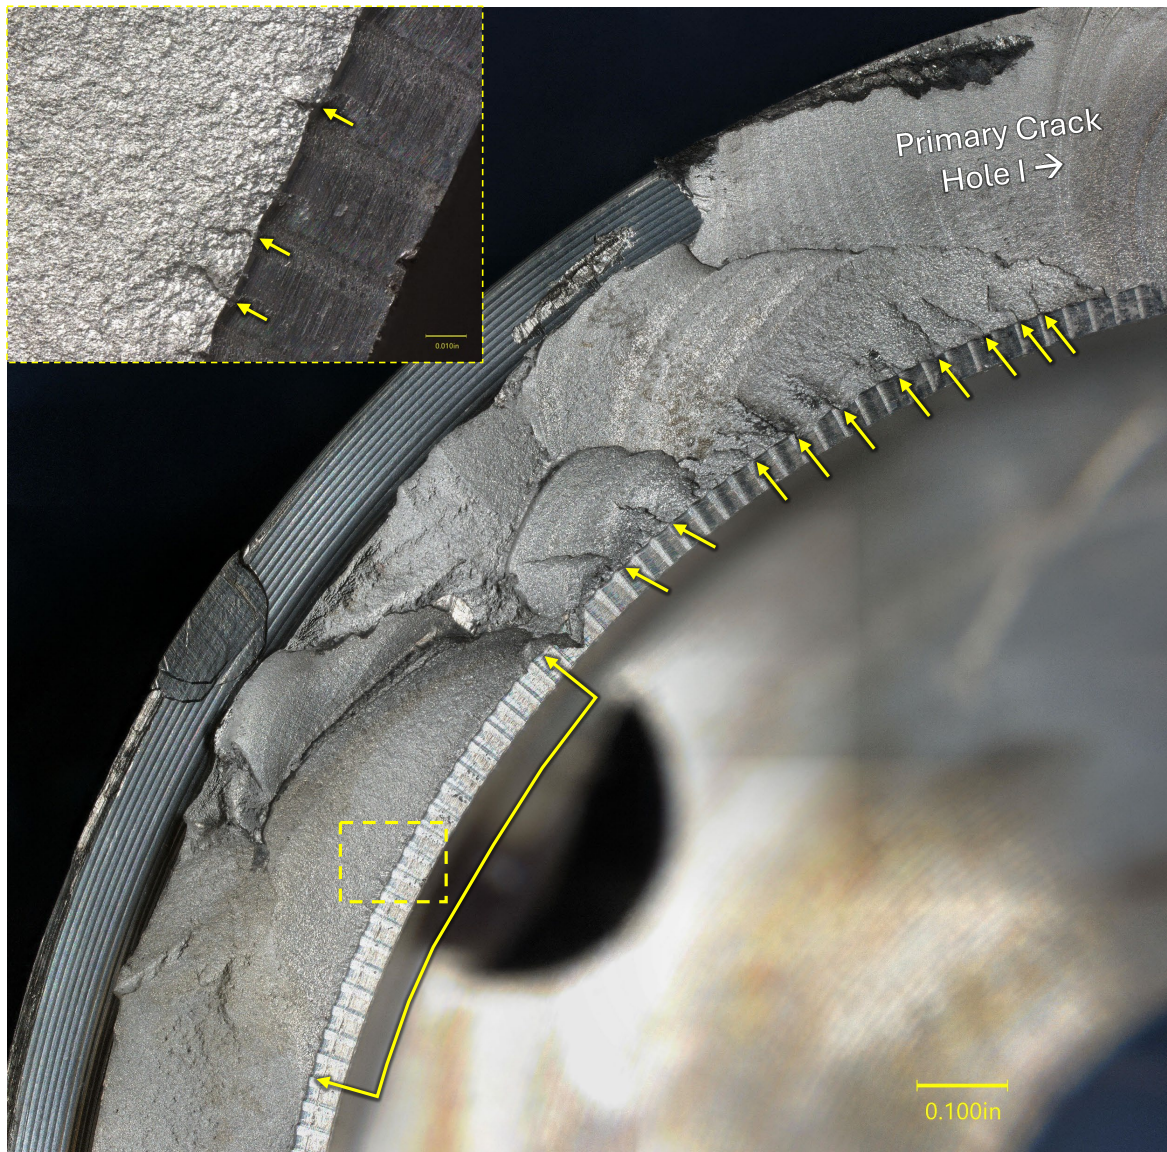
Figure 7 shows a closer view of a portion of the fracture surface adjacent to the primary fracture origin between holes I and III where multiple fatigue cracks were observed originating at the inner surface of the blade root along a thread root. Yellow arrows indicate visible ratchet mark features, consistent with multiple fracture initiation sites.<sup>3</sup> Curvilinear progression marks were observed extending through the

wall of the blade root towards the outer surface. Smaller ratchet mark features were observed extending from the thread root at the inner surface in the area indicated by a yellow bracket as shown more clearly in the inset image. The location of these ratchet mark features correlated well with the presence of chatter marks from the thread machining process.

**Figure 7.** Digital microscope image of the fracture surface adjacent to the primary fracture origin between holes I and III where multiple fatigue cracks were observed originating at the inner surface of the blade root along a thread root. Yellow arrows indicate visible ratchet mark features. The inset image shows a closer view of the boxed area.

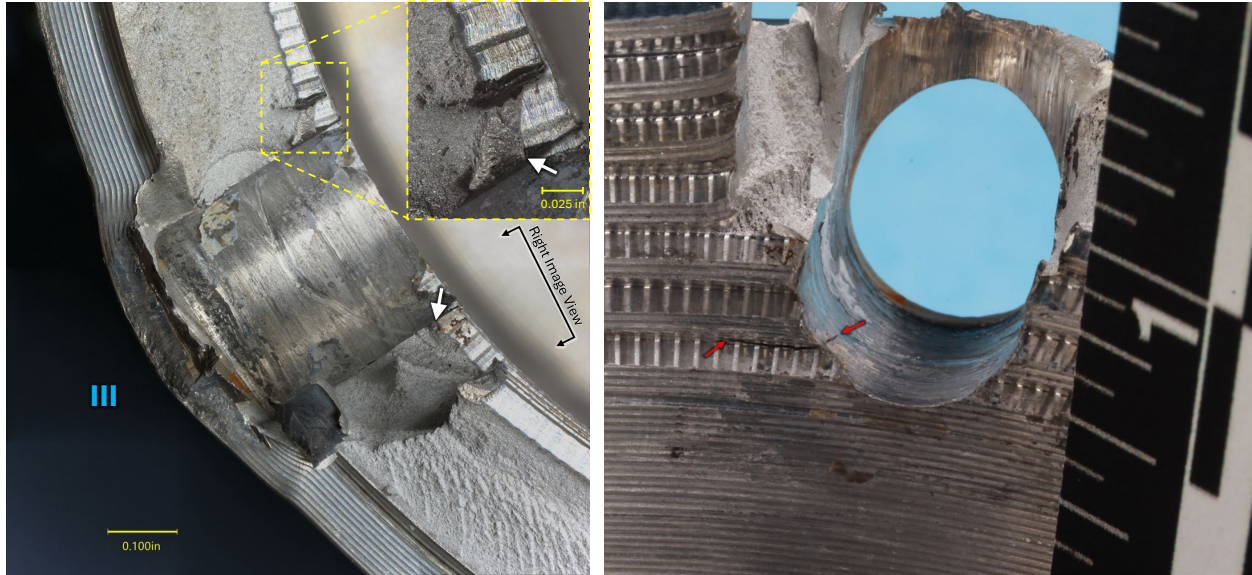
Figure 8 shows closer views of the fracture surface near hole III where two smaller thumbnail shaped progressive cracks were observed at the intersection of thread roots with the inner corners of the hole indicated by white arrows. The inset image shows a closer view of the thumbnail shaped crack observed on the upper side of the hole as oriented in this figure. The right image in figure 8 shows a radial view of the inner surface of the blade root at hole III. A visible crack was observed along the bottom thread root which extended along a portion of the hole surface as indicated between the two red arrows.

**Figure 8.** Digital microscope image (left) of the blade root fracture surface at hole III. Thumbnail shaped progressive cracks were observed to originate where thread roots intersected the hole edges at the inner surface as indicated by white arrows. A partial crack was observed in the bottom thread root as shown between red arrows in the right photo of the inner surface of the blade root at hole III.

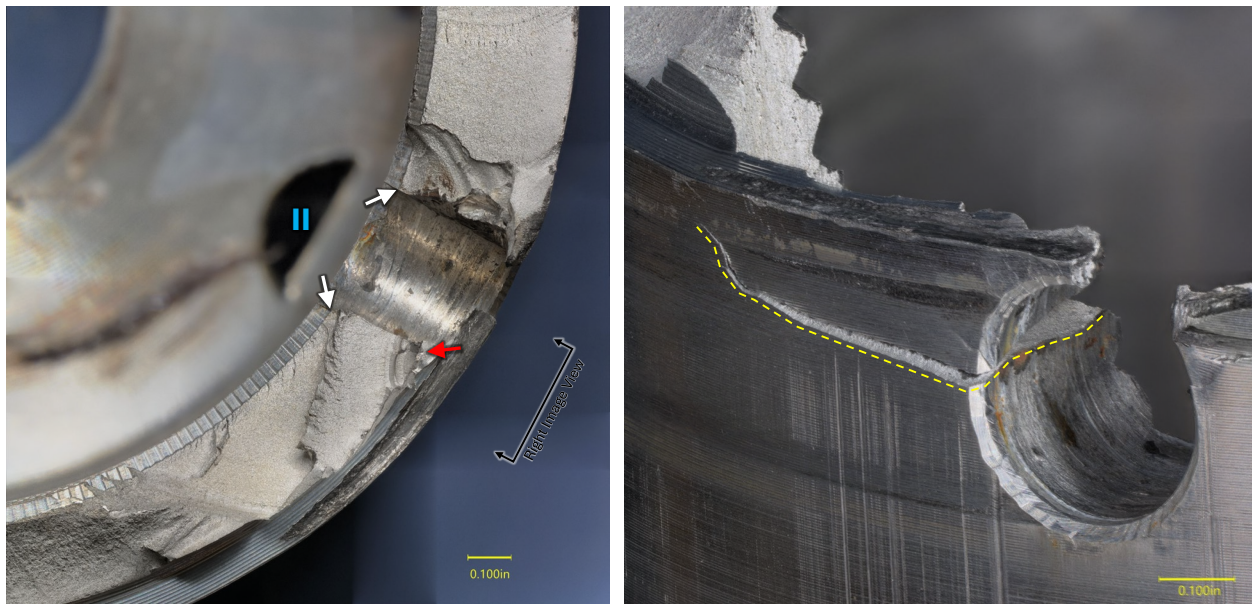
Figure 9 shows closer views of the fracture surface near hole II. Progressive cracks with curved arrest marks were observed extending from a thread root at the inner hole edges as indicated by white arrows. Ratchet marks were observed on the fracture surface extending from the thread root along the crack observed below the hole as oriented in this image. The right image shows a view of the outer surface of the blade root at hole II, where this crack had grown through the entire wall thickness of the blade root as highlighted by a yellow dashed line. The remaining ligament of material above this crack, when viewed from above, exhibited thumbnail shaped progressive cracks which initiated near the outer surface at the hole edge, indicated by a red arrow, and grew inward, consistent with a reversal in the load path.

**Figure 9.** Digital microscope image of the blade root fracture surface at hole II (left). Progressive cracks were observed to originate where thread roots intersected the hole edges at the inner surface as indicated by white arrows. The left image shows a view of this hole from the outer surface where the crack had grown through the blade root wall as indicated by a yellow dashed line. The ligament of material above this crack exhibited a secondary fatigue crack which initiated at the hole edge near the outer surface and grew inwards as indicated by the red arrow.

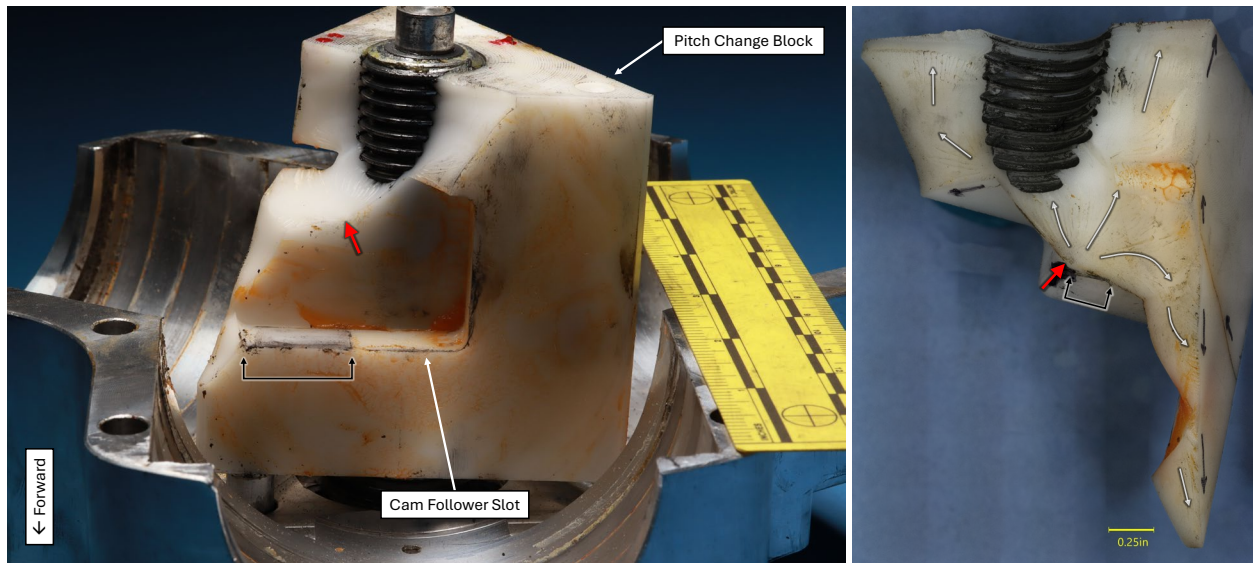
Figure 10 shows a view of the disassembled hub with the aft section removed, looking inward along the bore of blade position 2. The plastic pitch change block was fractured into two pieces between blade positions 2 and 3. Black greasy witness marks and gouged plastic were observed along the ledges of the cam follower slot, as indicated by black brackets, consistent with contact between the pitch change block and the cam follower from blade 2. The fracture originated at the corner radius of the L-shaped cam follower slot as indicated by red arrows on the larger and smaller mating fragments shown in the left and right images, respectively. Radial fracture ridges were observed extending away from the fracture origin area toward the free surfaces of the part as indicated by white arrows in the right image. The fracture was consistent with overstress separation.

**Figure 10.** Photographs of the mating pieces of the fractured pitch change block in the partially disassembled hub as viewed along the bore of blade position 2. The fracture initiated at a radius in the cam follower slot (red arrows) near contact marks (black brackets) and continued towards the free edges of the part as indicated by white arrows. Radial fracture features were consistent with overstress.

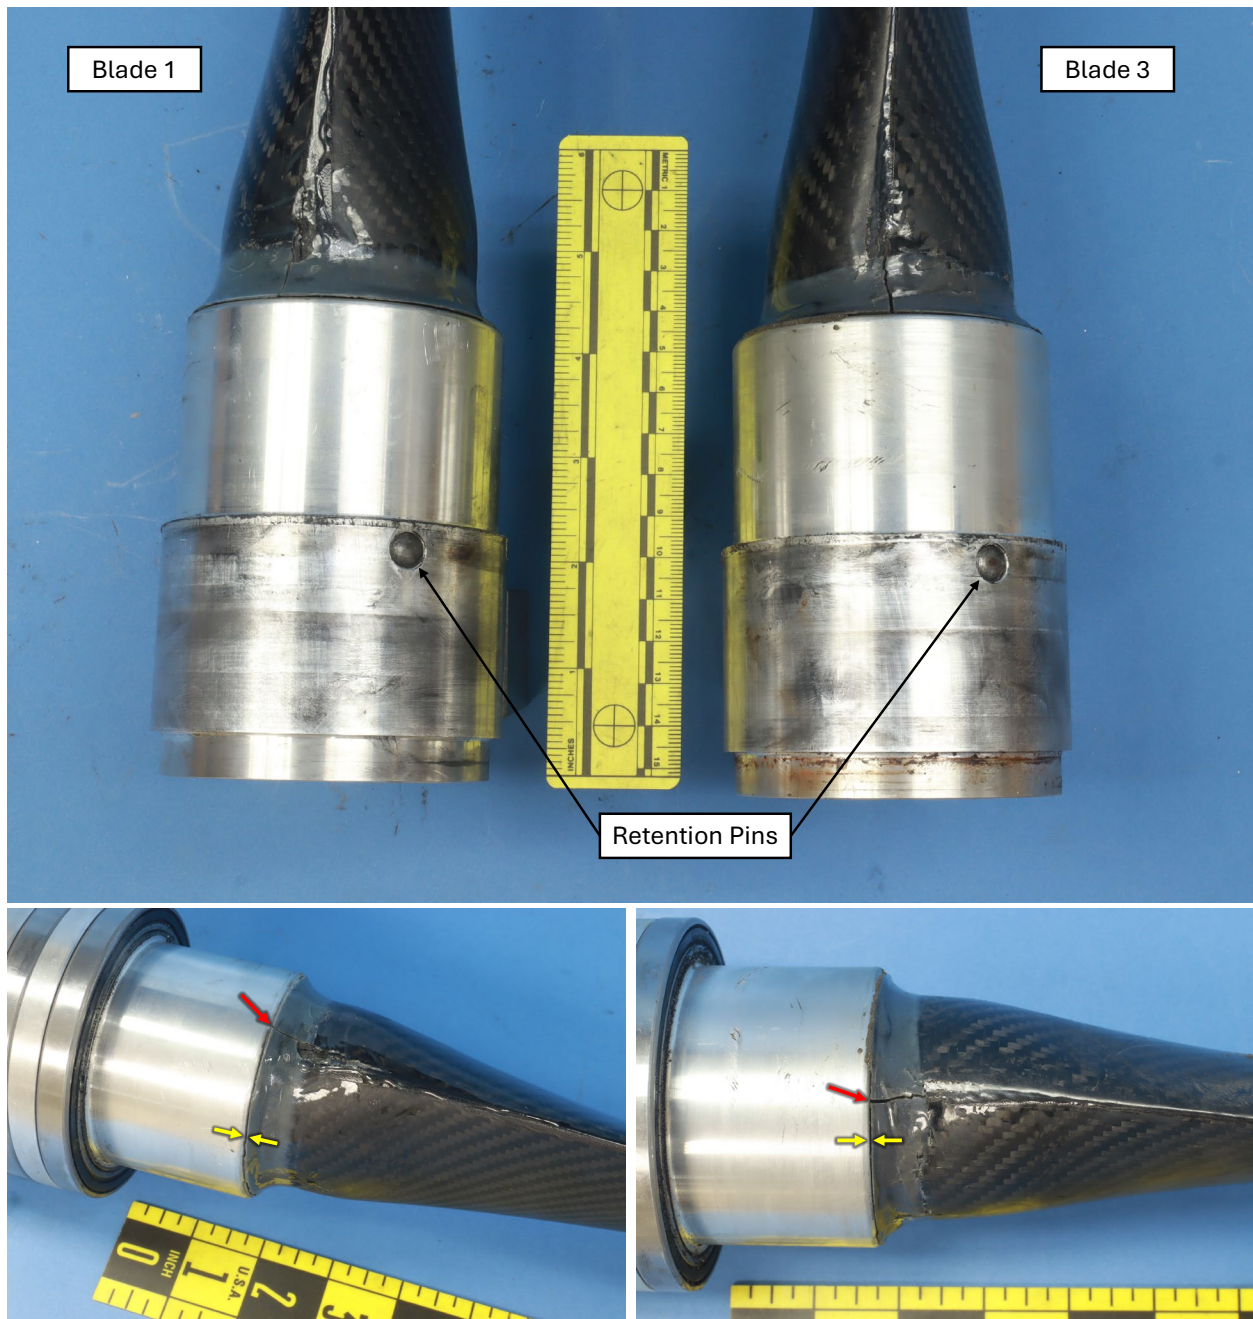
Figure 11 shows the root ends of blades 1 and 3 as viewed from the trailing edge side. The bearing elements have been removed from the blade roots in the upper image. Retention pins were observed in the radial holes through which blade 2

had fractured. Visual inspection of the outer surface of the metallic blade roots did not reveal any visible cracks. Spanwise cracks and chipped polymeric material were observed at the trailing edge side of the blade roots through a resin-rich fillet at the base of the composite blade where it interfaced with the metallic root section, as indicated by red arrows. Separation between the resin-rich fillet and the metallic root section was observed around the circumference of the interface, evidenced as a small gap, indicated by yellow arrows.

**Figure 11.** Photographs of the blade roots from blades 1 (left) and 3 (right) showing retention pins secured in the radial holes which were exposed when bearings and spacers were removed. Cracks and chipped resin at the trailing edge of the base of the composite section were observed (red arrows). A gap was observed at the base of a resin rich fillet where the composite section interfaced with the metallic root as indicated by yellow arrows.

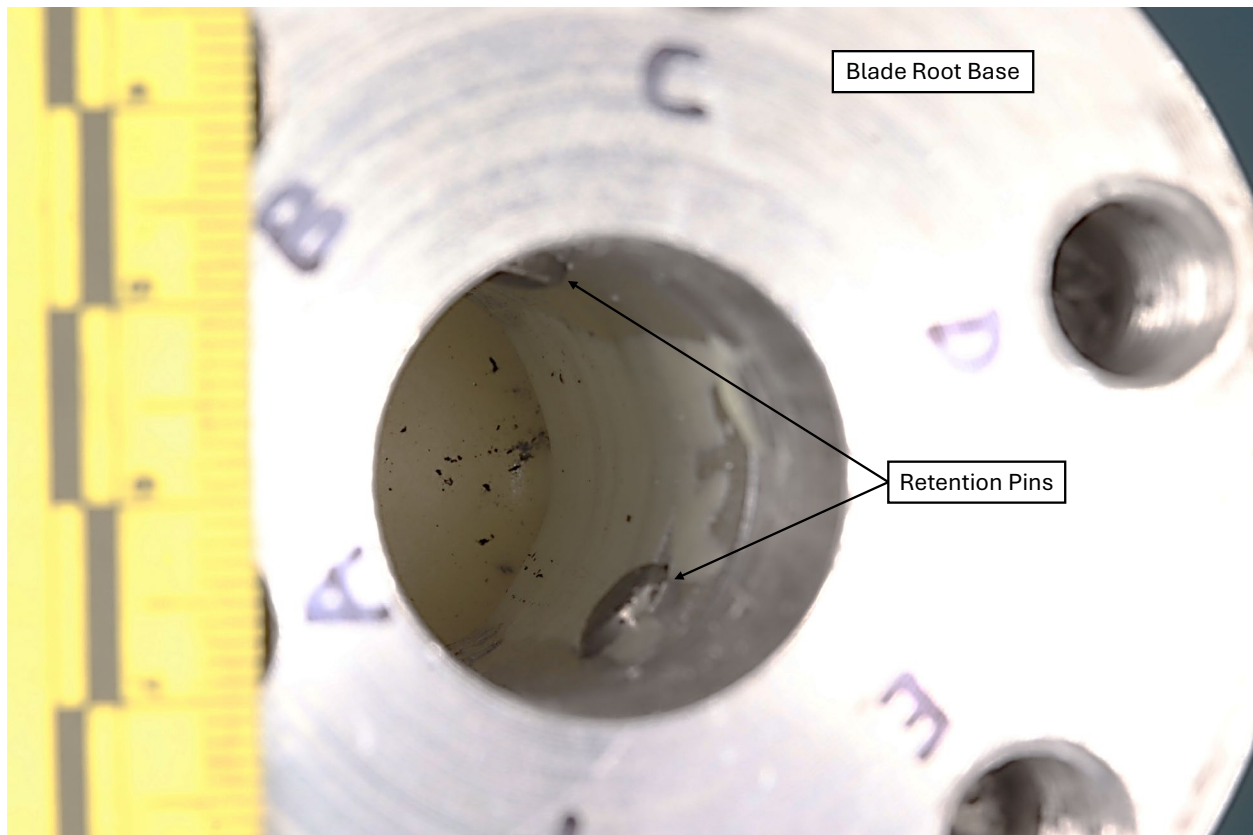
The interior of the metallic root sections of blades 1 and 3 were examined with a borescope. Visual inspection of the internal threads and radial holes were obscured by an inner metallic sleeve, foamlike filler material, and other adhesive type materials. The inner ends of the retention pins were observed to be engaged in the inner sleeve as shown in figure 12.

**Figure 12.** A typical view of the inner surface of one of the intact blade roots, after removal of the cam follower disk, showing retention pins engaged with an internal metallic sleeve.

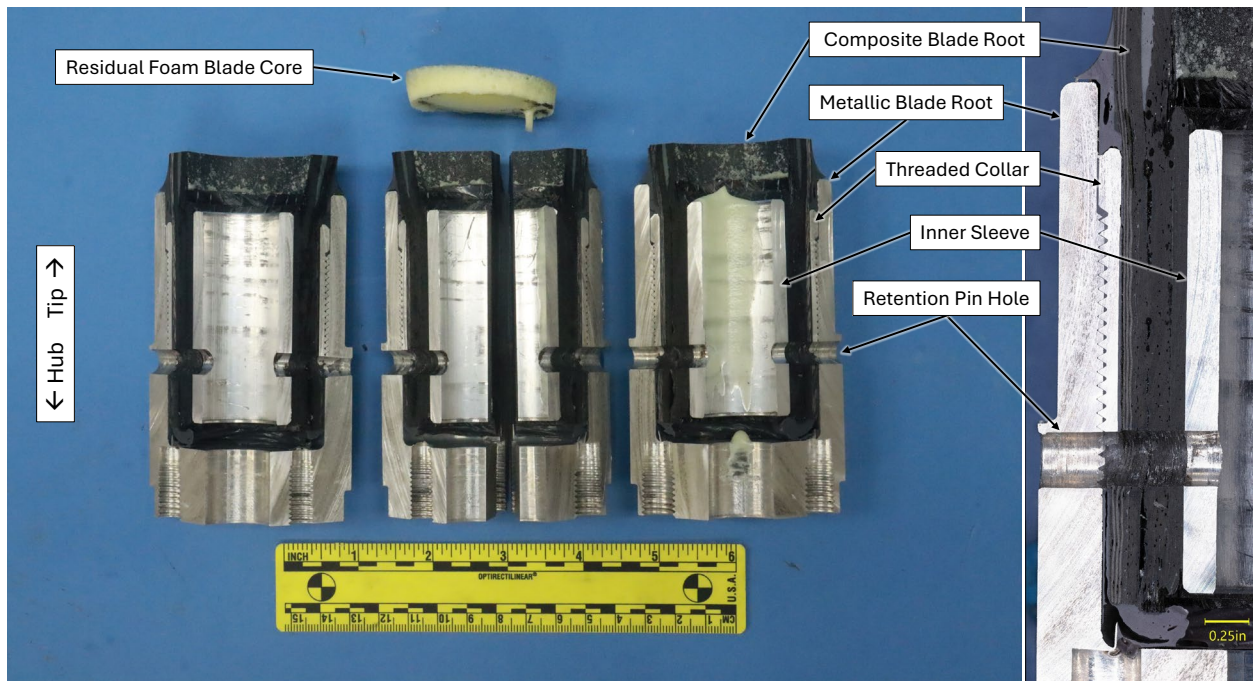
Blade 3 was sectioned for closer examination. The composite blade was cut chordwise approximately 0.5 inch above the metallic blade root. Additional spanwise section cuts were made through the root section at each of the retention pin holes. Figure 13 shows a photograph of the interior of the sectioned blade root, with a closer view of the typical cross section on the right. A metallic threaded collar which engaged the threads on the metallic blade root was observed around the outer surface of the composite blade root. A metallic inner sleeve was observed on the inner surface of the composite blade root.

**Figure 13.** Photograph showing an internal view of the blade root as sectioned through the retaining pin holes. A closer view of the typical cross section is shown on the right.

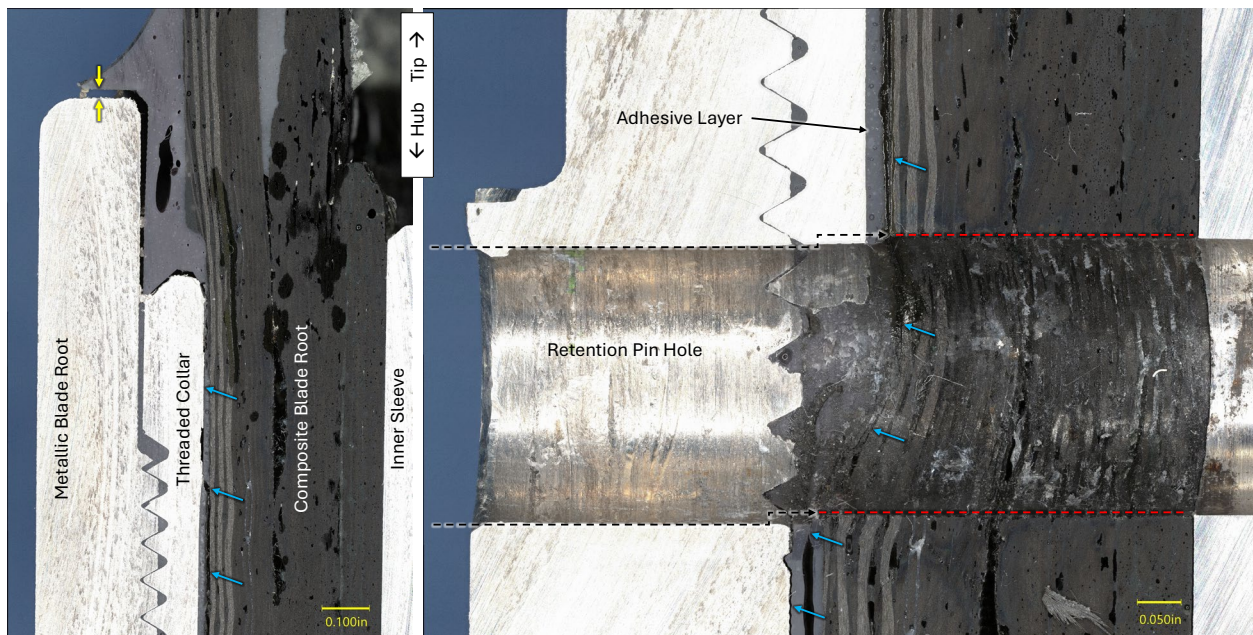
Figure 14 shows closer views of the typical blade root cross section at the tip end of the metallic blade root (left) and at the retention hole (right). The gap observed between resin fillet and metallic root section as documented in figure 11 was measured to be approximately 0.02 inch, indicated by yellow arrows in the left image. The composite blade root was disbonded from the metallic blade root and threaded collar as evidenced by separation of the adhesive layer and a near surface delamination of the composite blade root along the path indicated by blue arrows. An adhesive bond between the metallic blade root and the threaded collar appeared to remain intact. Voids were observed within the composite portion of the blade root. The section of the retention pin hole within the composite blade root, indicated by red dashed lines in the right image, was shifted relative to the hole through the metallic blade root, indicated by dashed black lines. This observed offset was consistent with pin bending loads relative to the composite and metallic blade roots.

**Figure 14.** Digital microscope images of the typical blade root cross section showing a gap between the composite and metallic sections (yellow arrows). The composite root section was disbonded from the threaded collar and metallic blade root and delaminated near this adhesive joint along the path indicated by blue arrows. The composite section of the hole (red dashed lines) was shifted relative to the metallic section (black dashed lines).

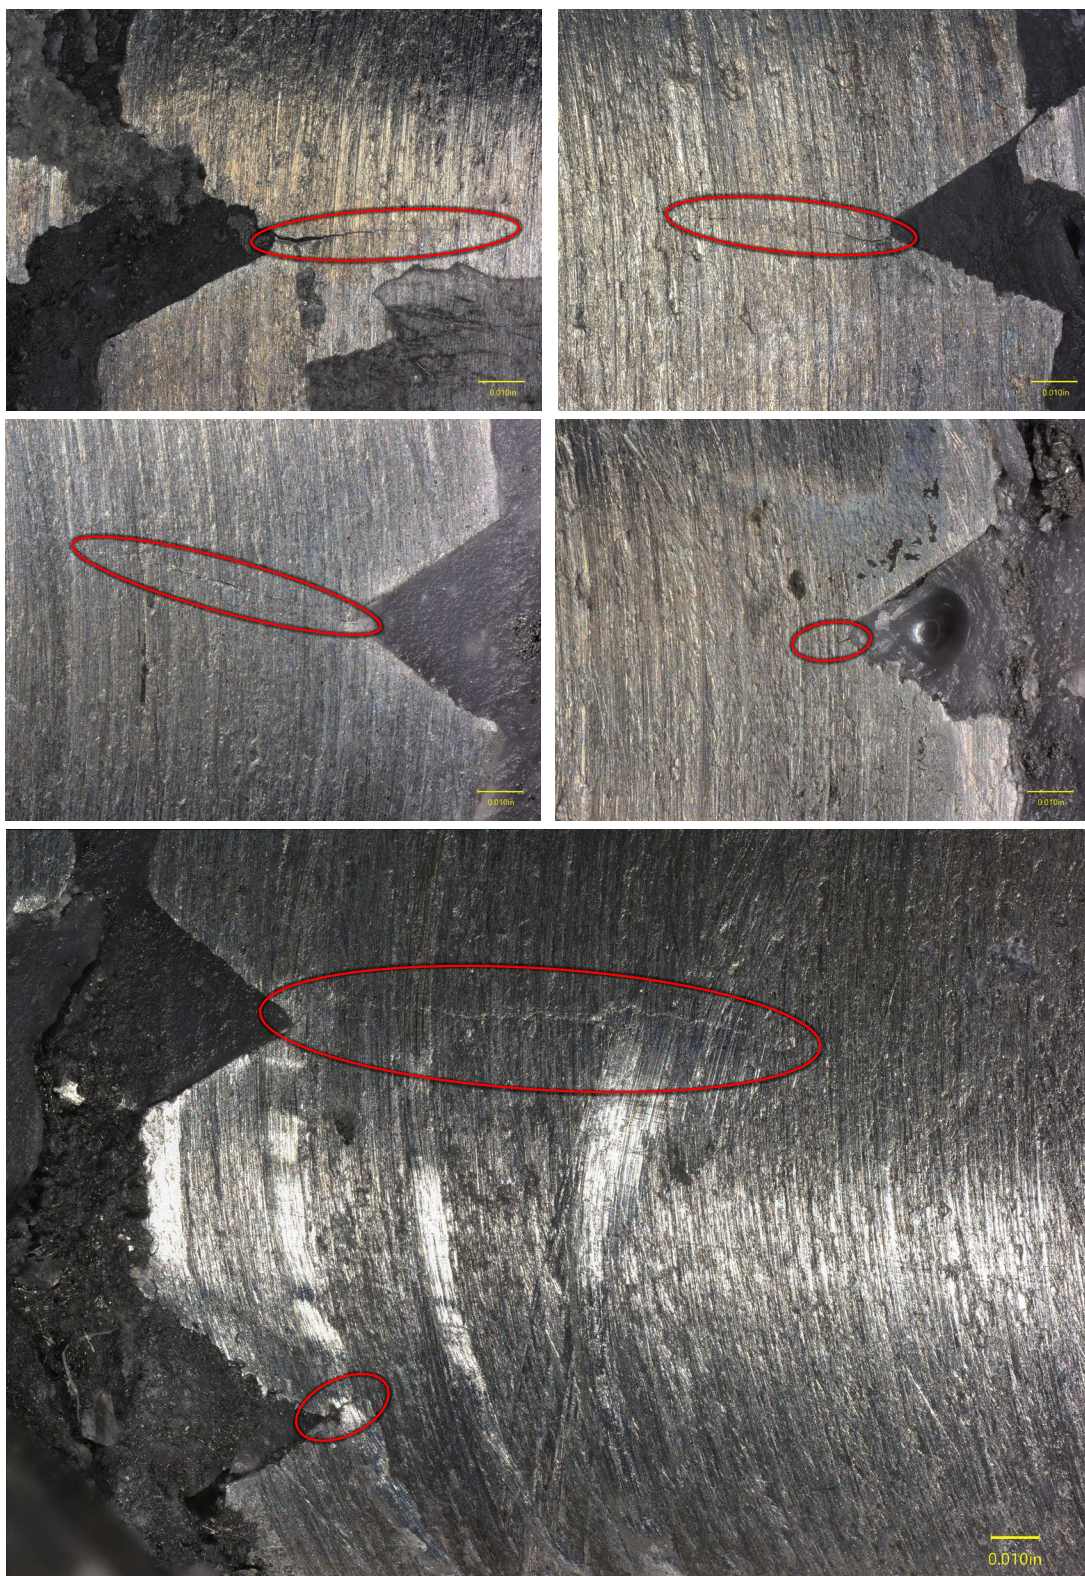
The cross sectioned holes in the metallic blade root were examined more closely. Several relatively flat crack profiles were observed extending toward the outer surface from thread roots as circled in digital microscope images presented in figure 15. These visible crack profiles ranged in size from 0.008 inch to 0.097 inch and were consistent with progressive fatigue cracks.

**Figure 15.** Digital microscope images of the retention pin hole through the metallic blade root showing flat crack profiles extending from the thread roots toward the outer surface as circled in red.
