# National Transportation Safety Board

CEN24LA039

## ENGINE EXAMINATION

Location: Ozark, Missouri  
Date: November 17, 2023  
Time: 1524 Central Standard Time  
2124 Coordinated Universal Time  
Airplane: N16253, Piper PA-32-300

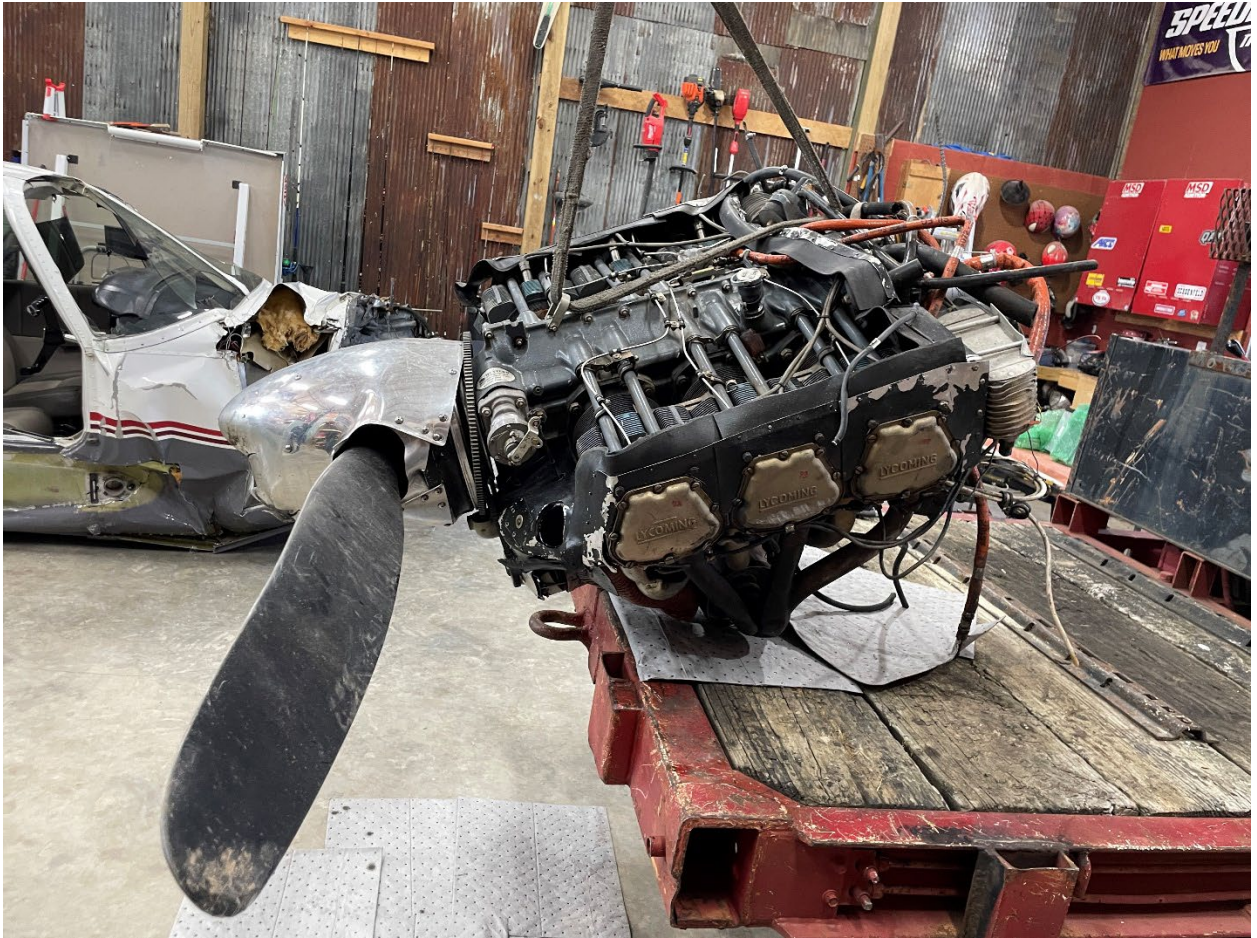
**Figure 1 Engine (NTSB Photo)**

The engine had been impact separated from the airplane and was hoisted to facilitate the examination. The propeller remained attached to the engine via the propeller flange.

There was no obvious damage to the crankcase or accessories. All fuel lines appeared to be properly secured. Since the engine was separated from the fuselage, engine control continuity could not be established.

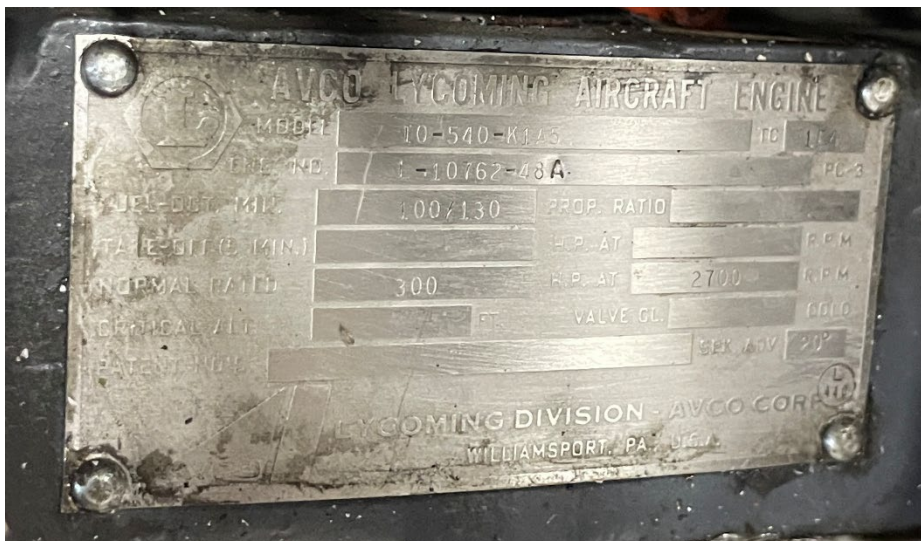
**Figure 2 Data Tag (NTSB Photo)**

The engine was a Lycoming IO-540-K1A5 engine, s/n L-10762-48A.

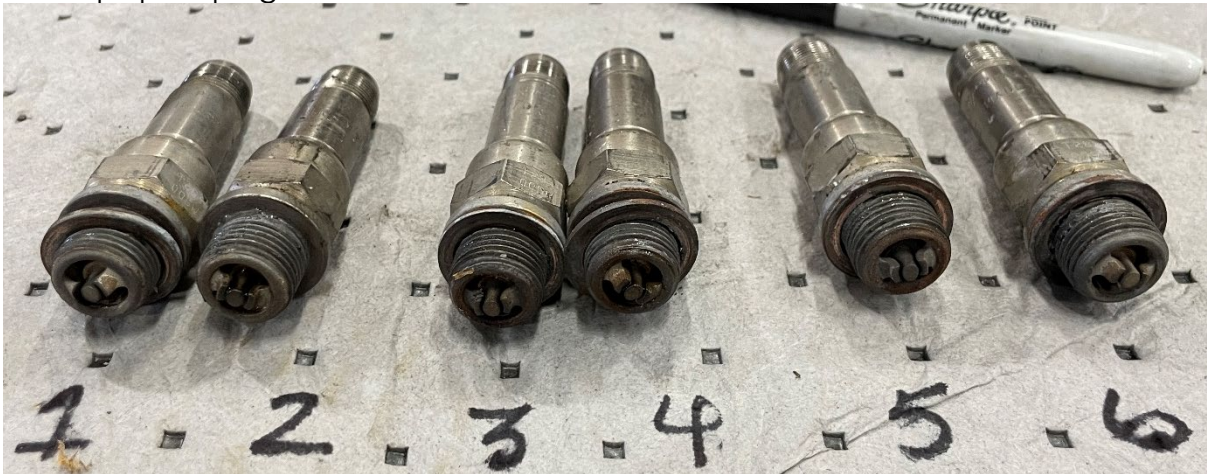
**Figure 3 Top Spark Plugs (NTSB Photo)**

The top spark plugs were removed and were unremarkable.

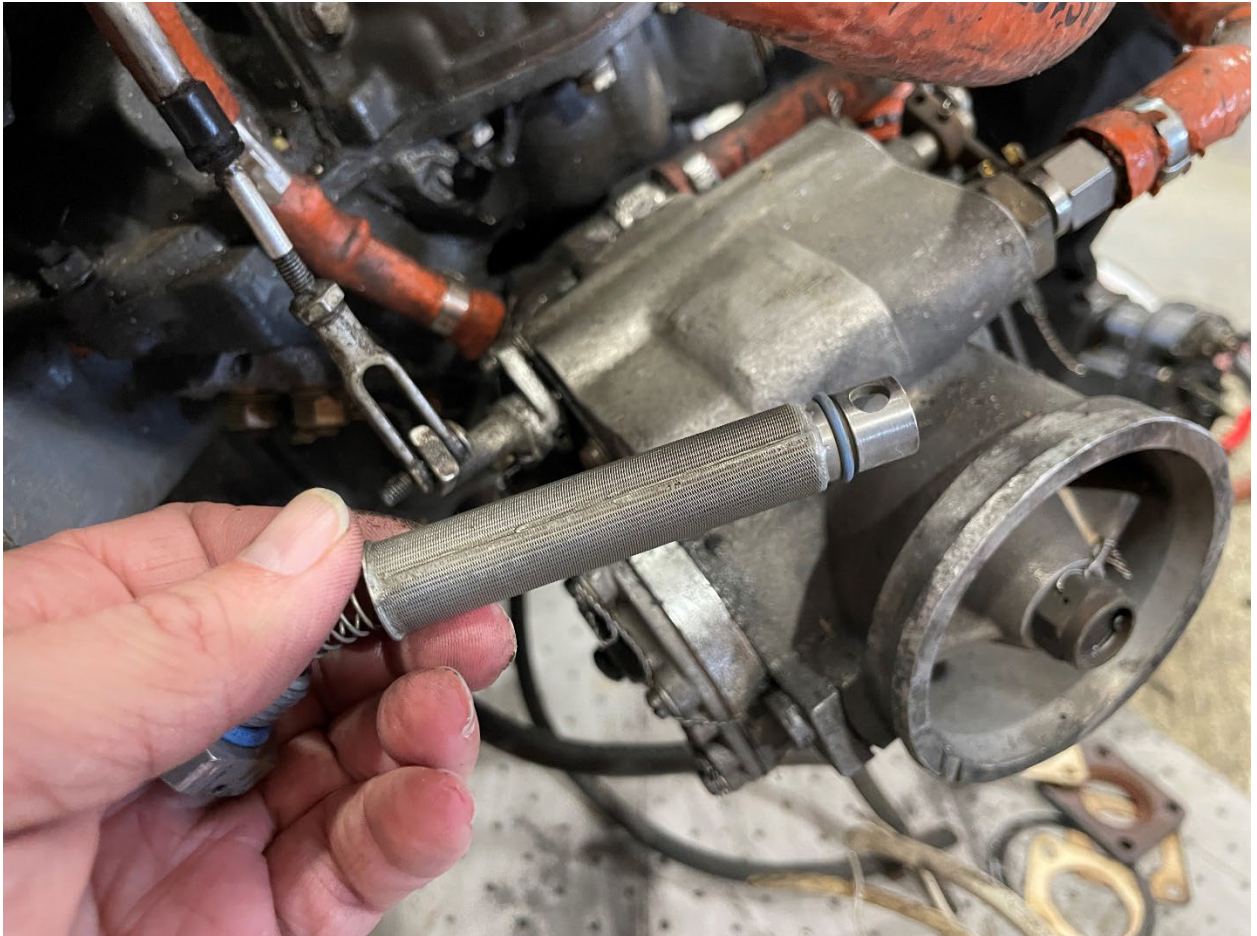
**Figure 4 Inlet Fuel Screen (NTSB Photo)**

The throttle and mixture arms on the fuel servo actuated without resistance from stop to stop. The fuel inlet screen was removed and found to be clear of debris. A residual amount of fuel was extracted from the fuel servo and tested for the presence of water using a water-detection paste; the fuel tested did not contain water.

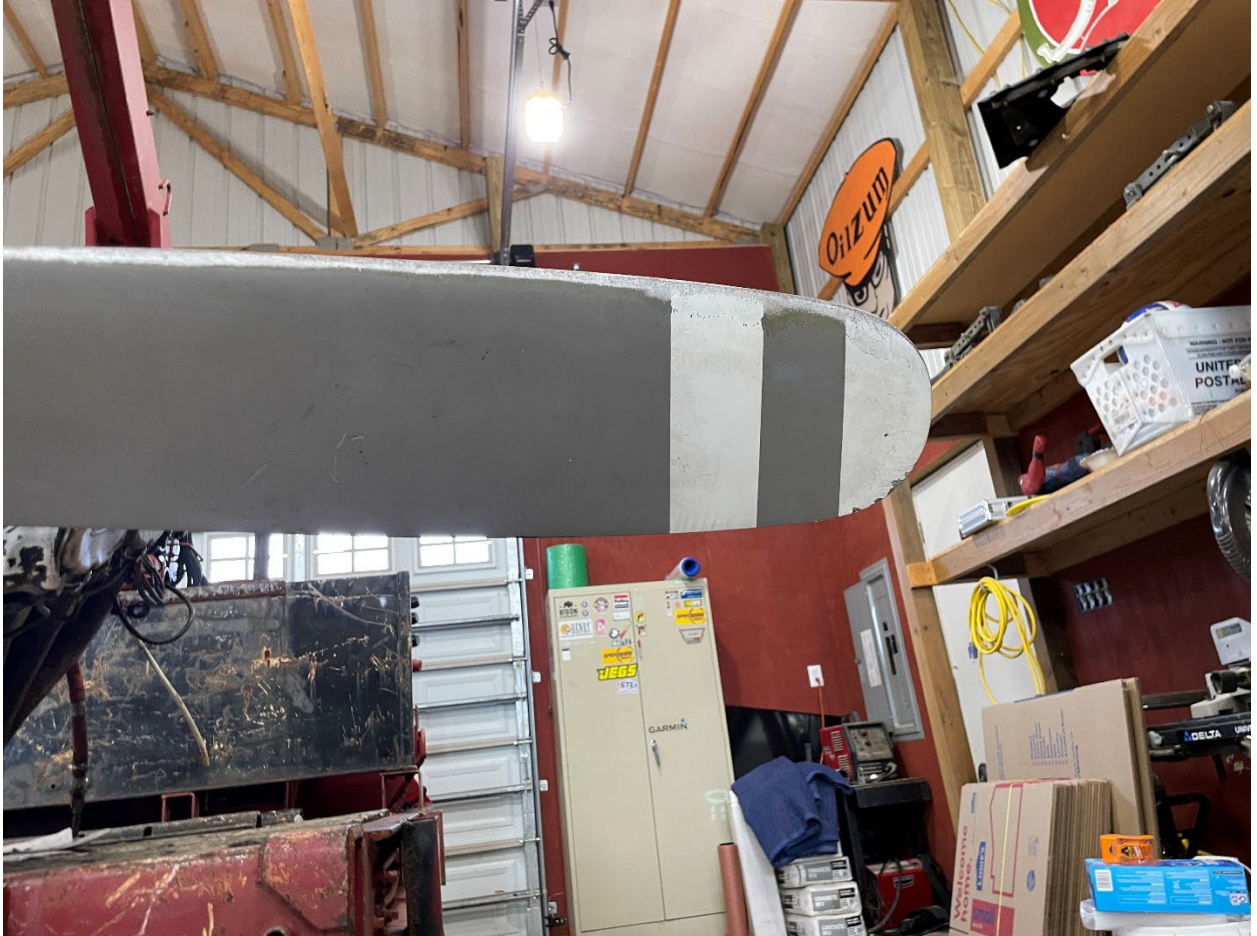
**Figure 5 Blade A**

Blade A exhibited leading polishing, but remained relatively straight and undamaged.

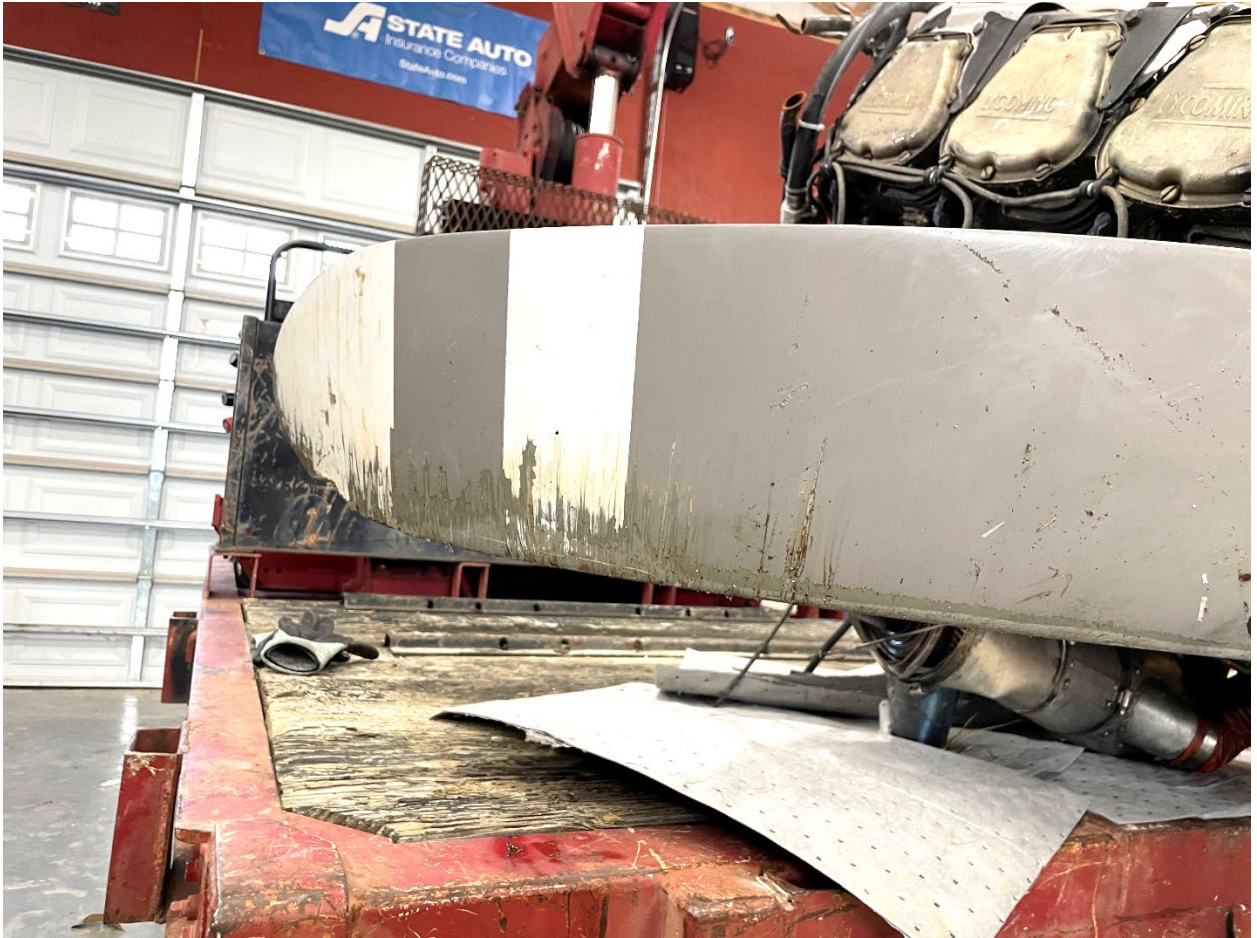
**Figure 6 Blade B**

Blade B had several nicks and gouges on its leading edge. There was also leading edge polishing and chordwise scratches. The blade was bent slightly rearward near the blade root.
