CEN24LA051

## INVESTIGATION PHOTOGRAPHS

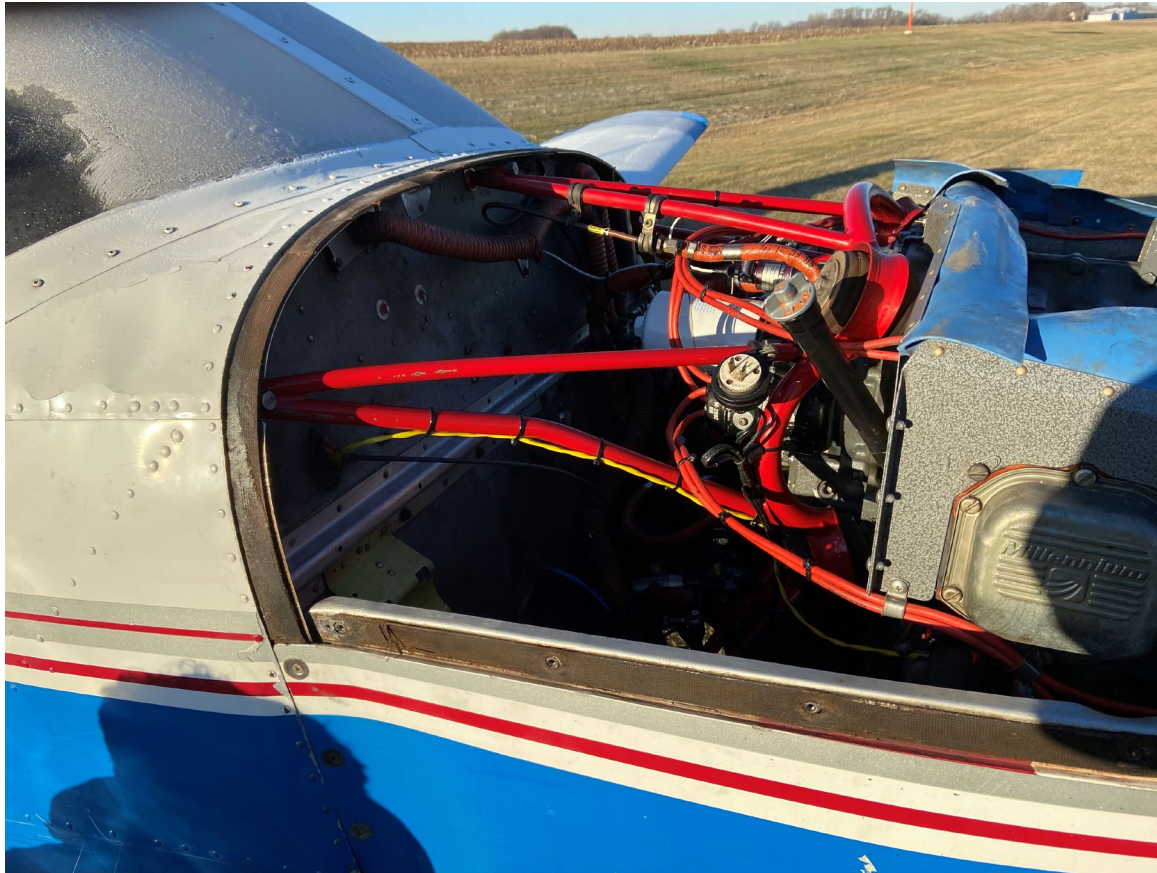
**Photograph 1 - Engine Mount and Firewall (Courtesy of Pilot)**

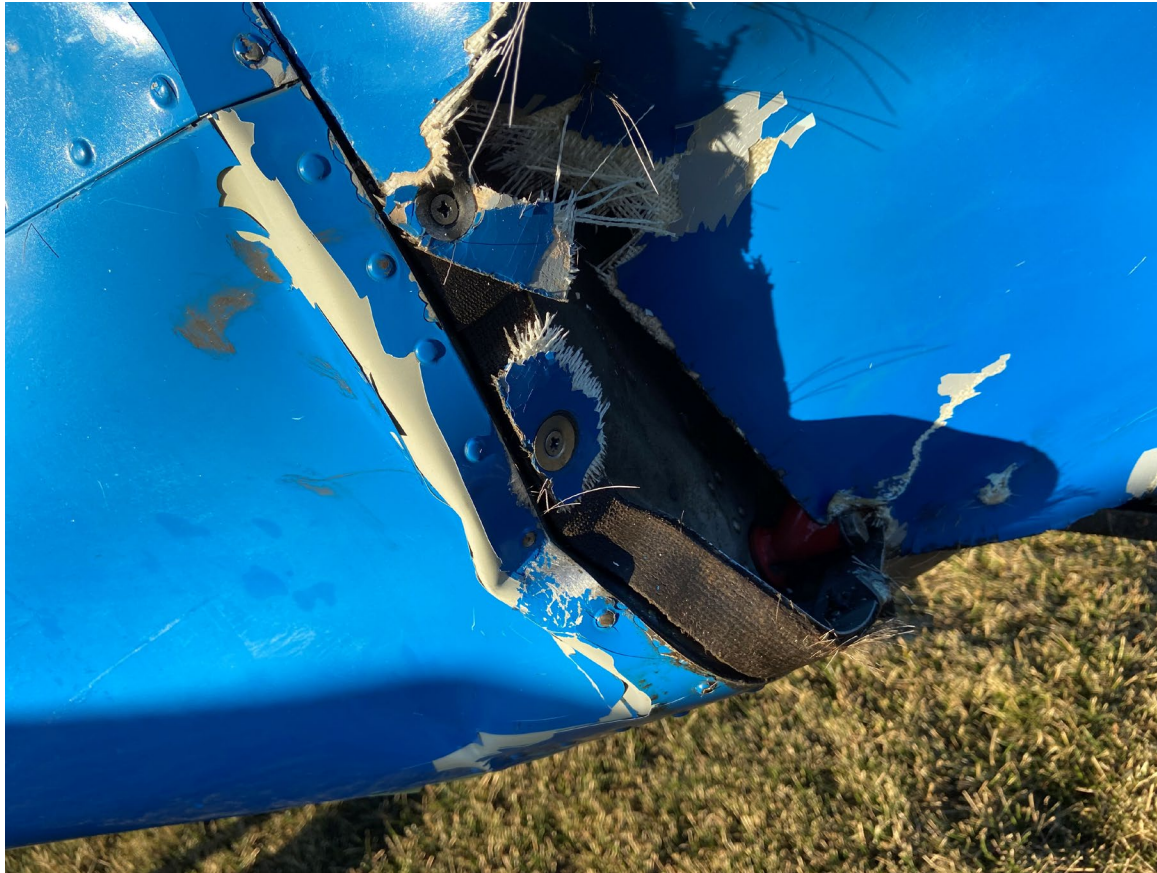
**Photograph 2 - Lower Right Fuselage Damage (Courtesy of Pilot)**
