# National Transportation Safety Board

CEN24LA052

## **MATERIALS LABORATORY**

Factual Report 24-045

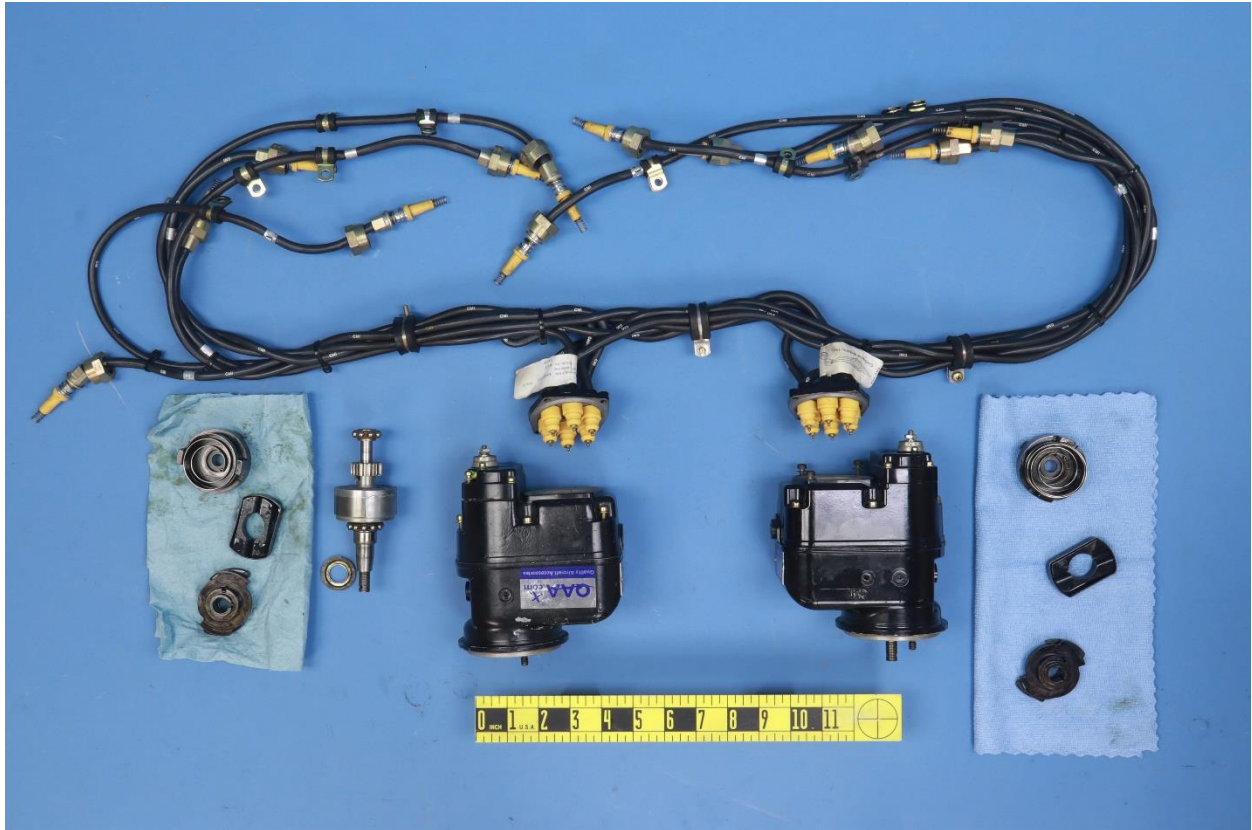
The left magneto, right magneto, and ignition system wiring harness from a Continental Motors O-470-R aircraft engine were sent to the NTSB Materials Laboratory for examination (figures 1 and 2). The engine reportedly lost power at an altitude of about 3,000 feet above ground level.

**Figure 1.** Left magneto components, right magneto components, and ignition system wiring harness as received.

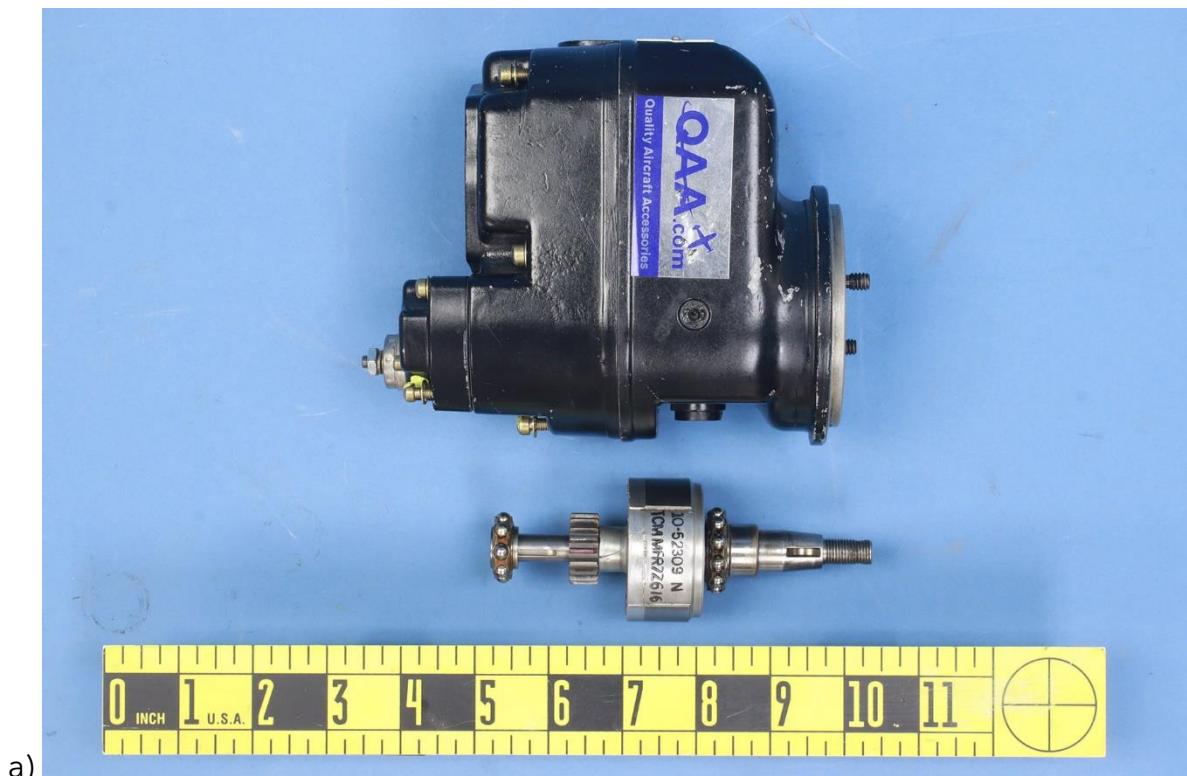
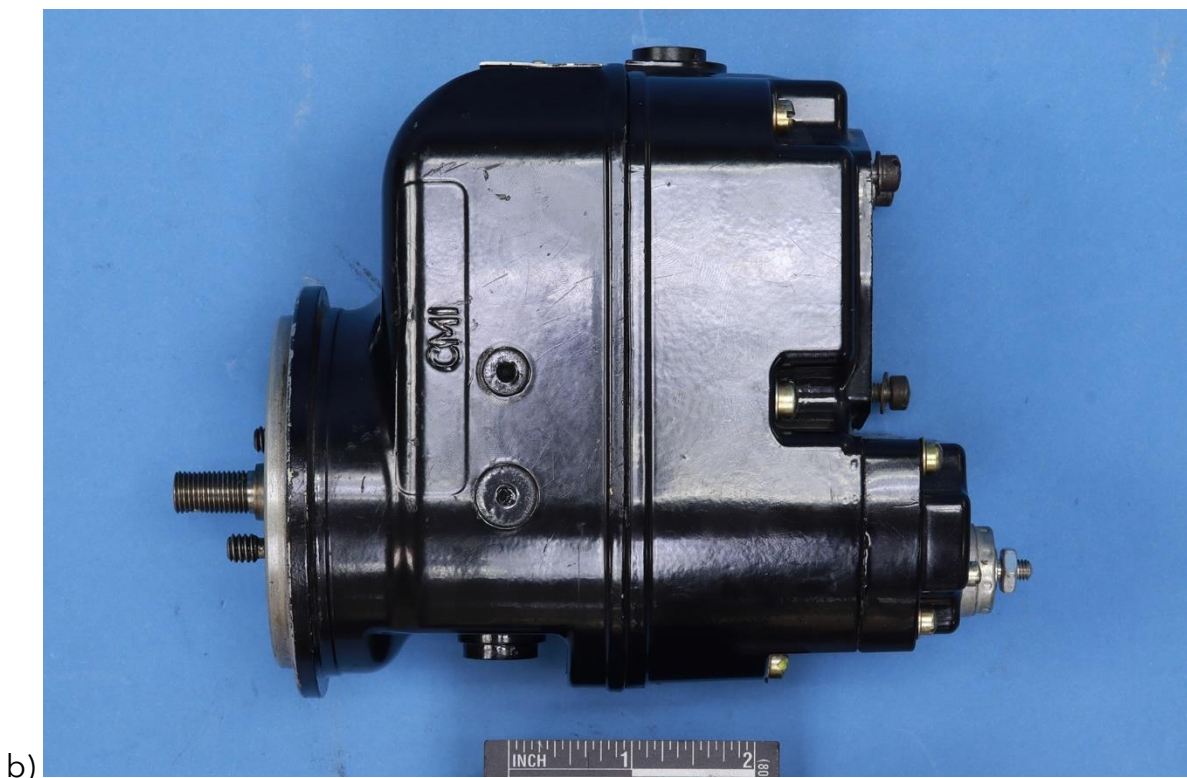
**Figure 2.** Magnetos as received: a) left magneto with rotor removed and b) right magneto.

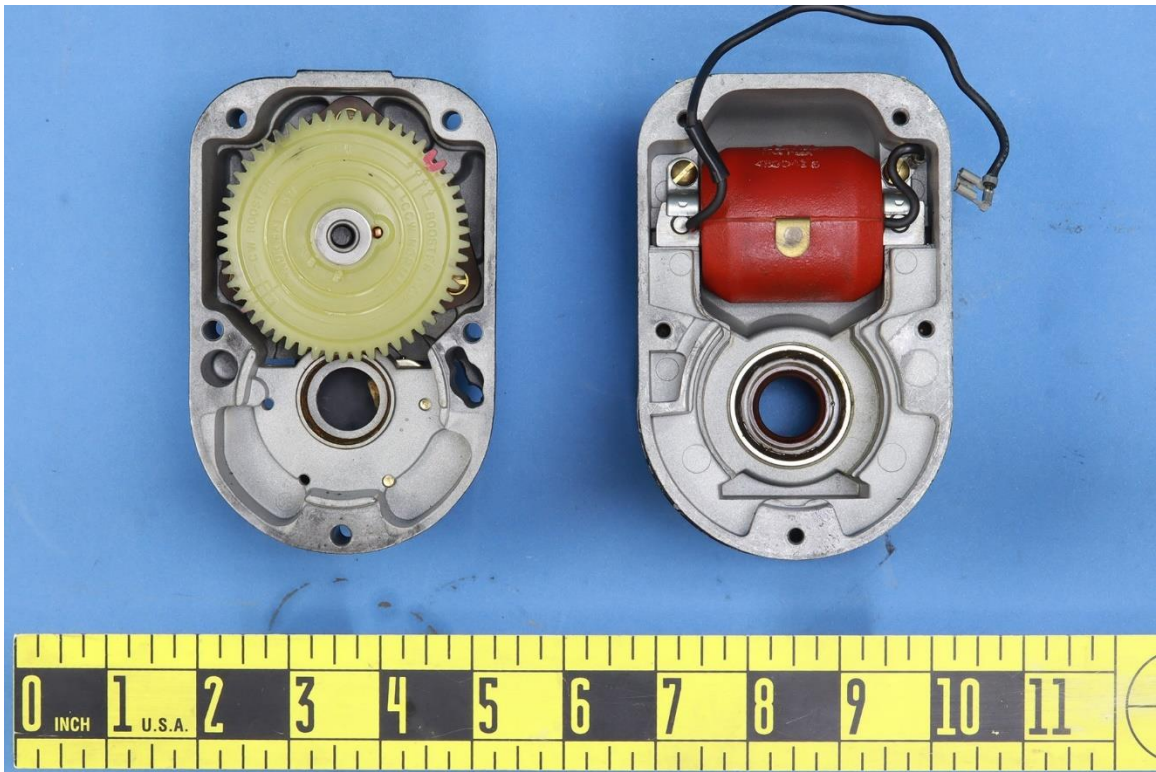
Upon opening the left magneto housing, the left magneto exhibited signs of oily residue, carbonization, and arcing damage between the distributor gear's electrode and the distributor block electrodes. None of the rotor bearing components, carbon brush, or coil showed any notable features (figure 3). The rotor itself was damaged as discussed below.

**Figure 3.** Left magneto after separating the housing.

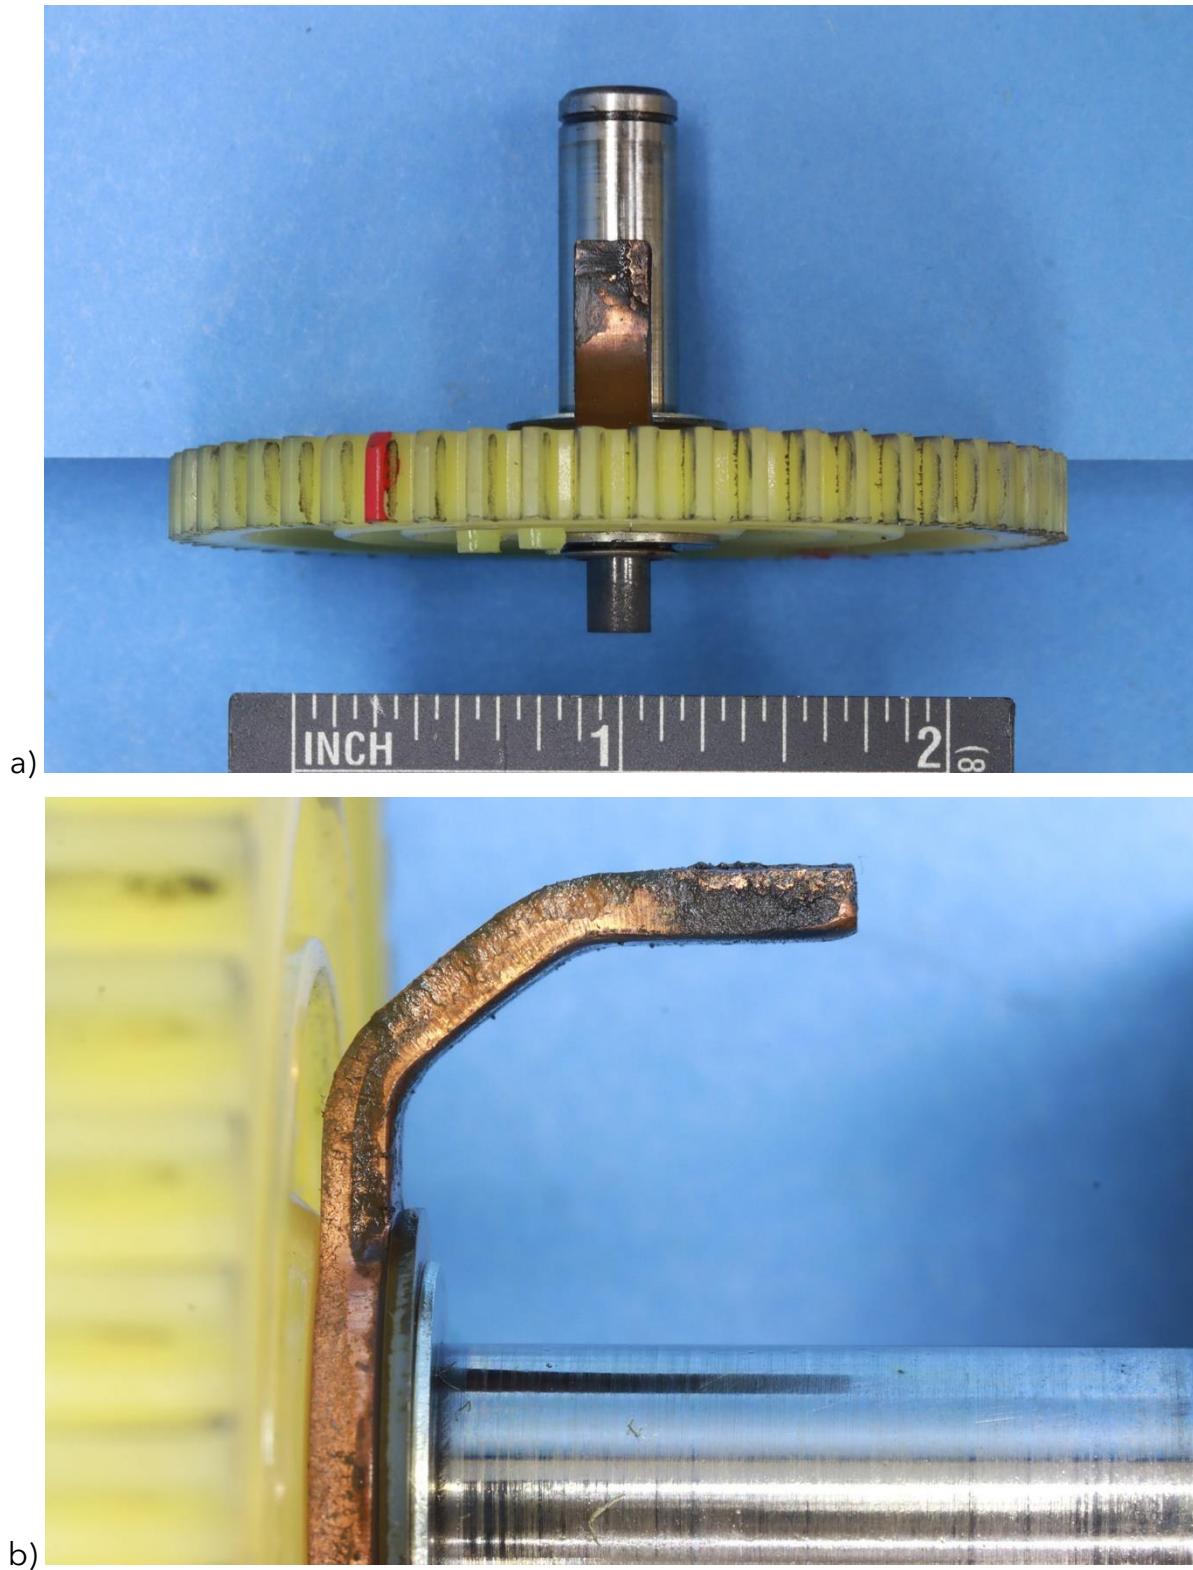
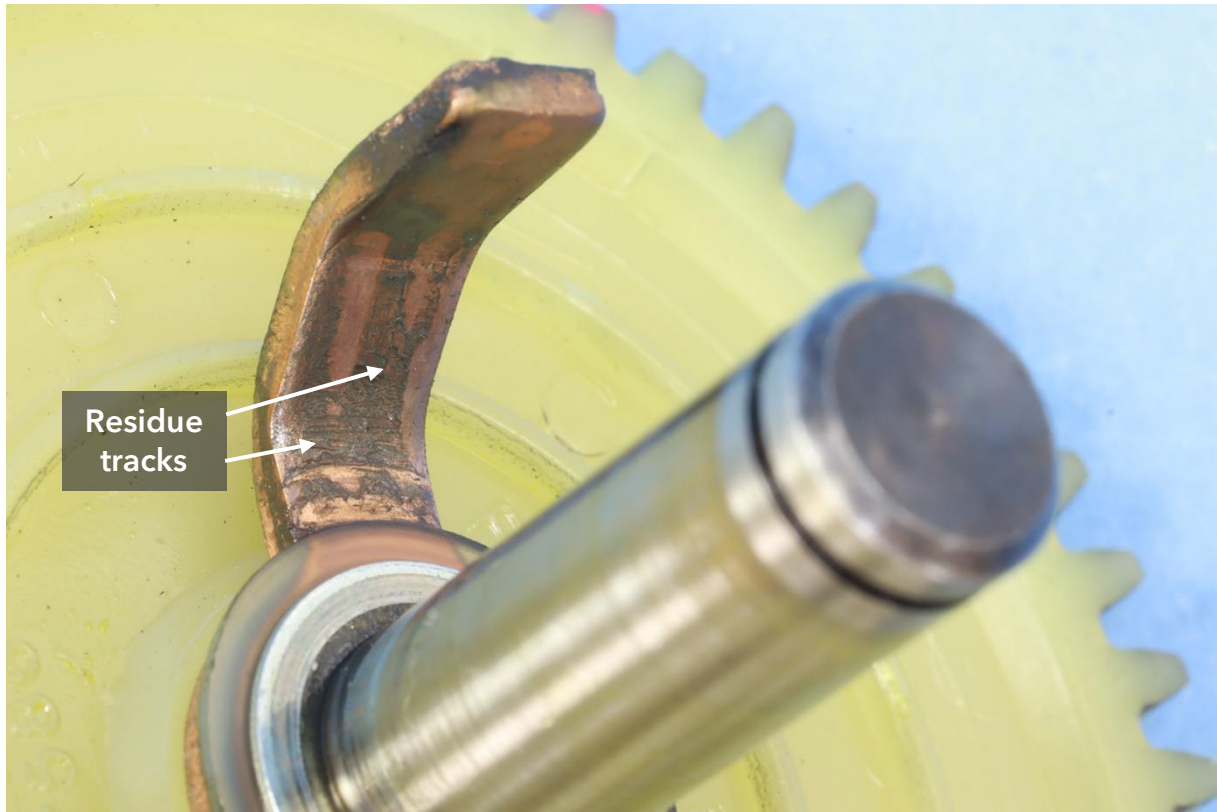
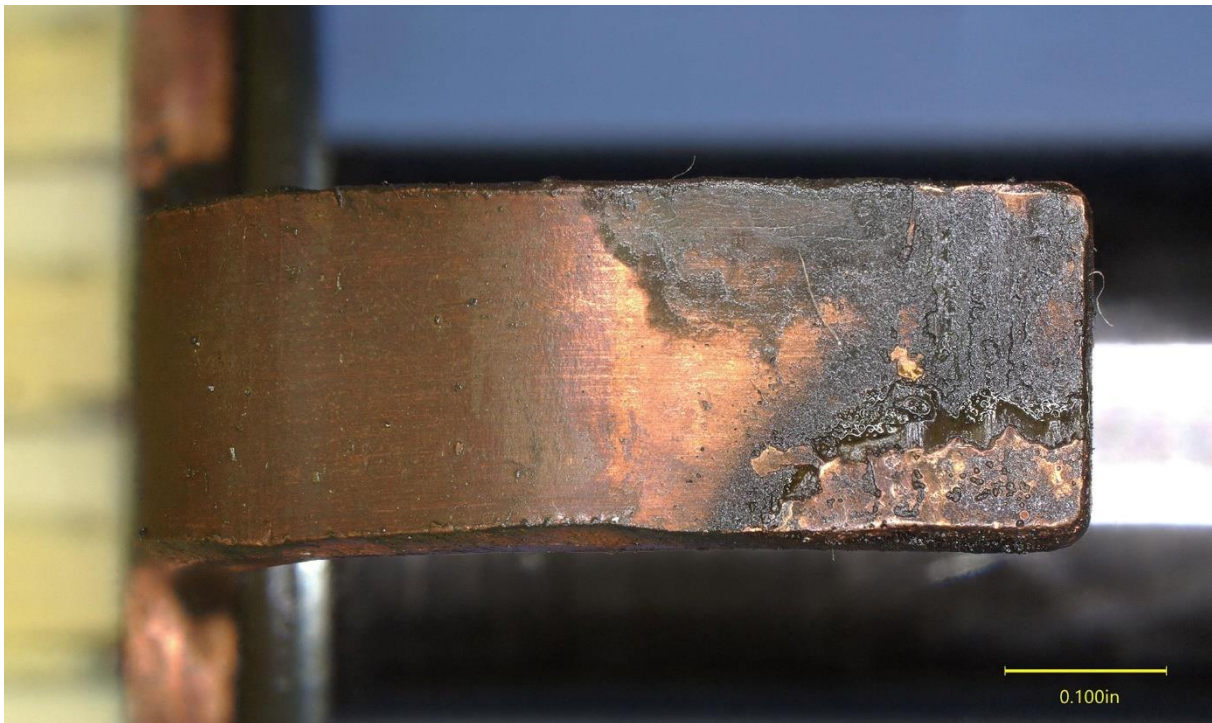
Regions of the distributor gear electrode were covered by a layer of carbonized material (figures 4a - d). The radially inward facing side of the electrode

(figure 4c) exhibited tracks of oily residue that ran from the gear's central shaft to the outer contact surface of the electrode. The distributor block electrodes had melted and resolidified where they came into proximity with the gear electrode, consistent with arcing damage (figures 5a - c). Oil droplets were seen adhered to the felt strip that surrounded the distributor bushing (figure 6).

**Figure 4.** Left magneto gear electrode showing carbonization of oily residue: a) overview of gear; b) side view of electrode;

**Figure 4 (cont.).** c) electrode viewed radially outward; and d) radially inward view of electrode.

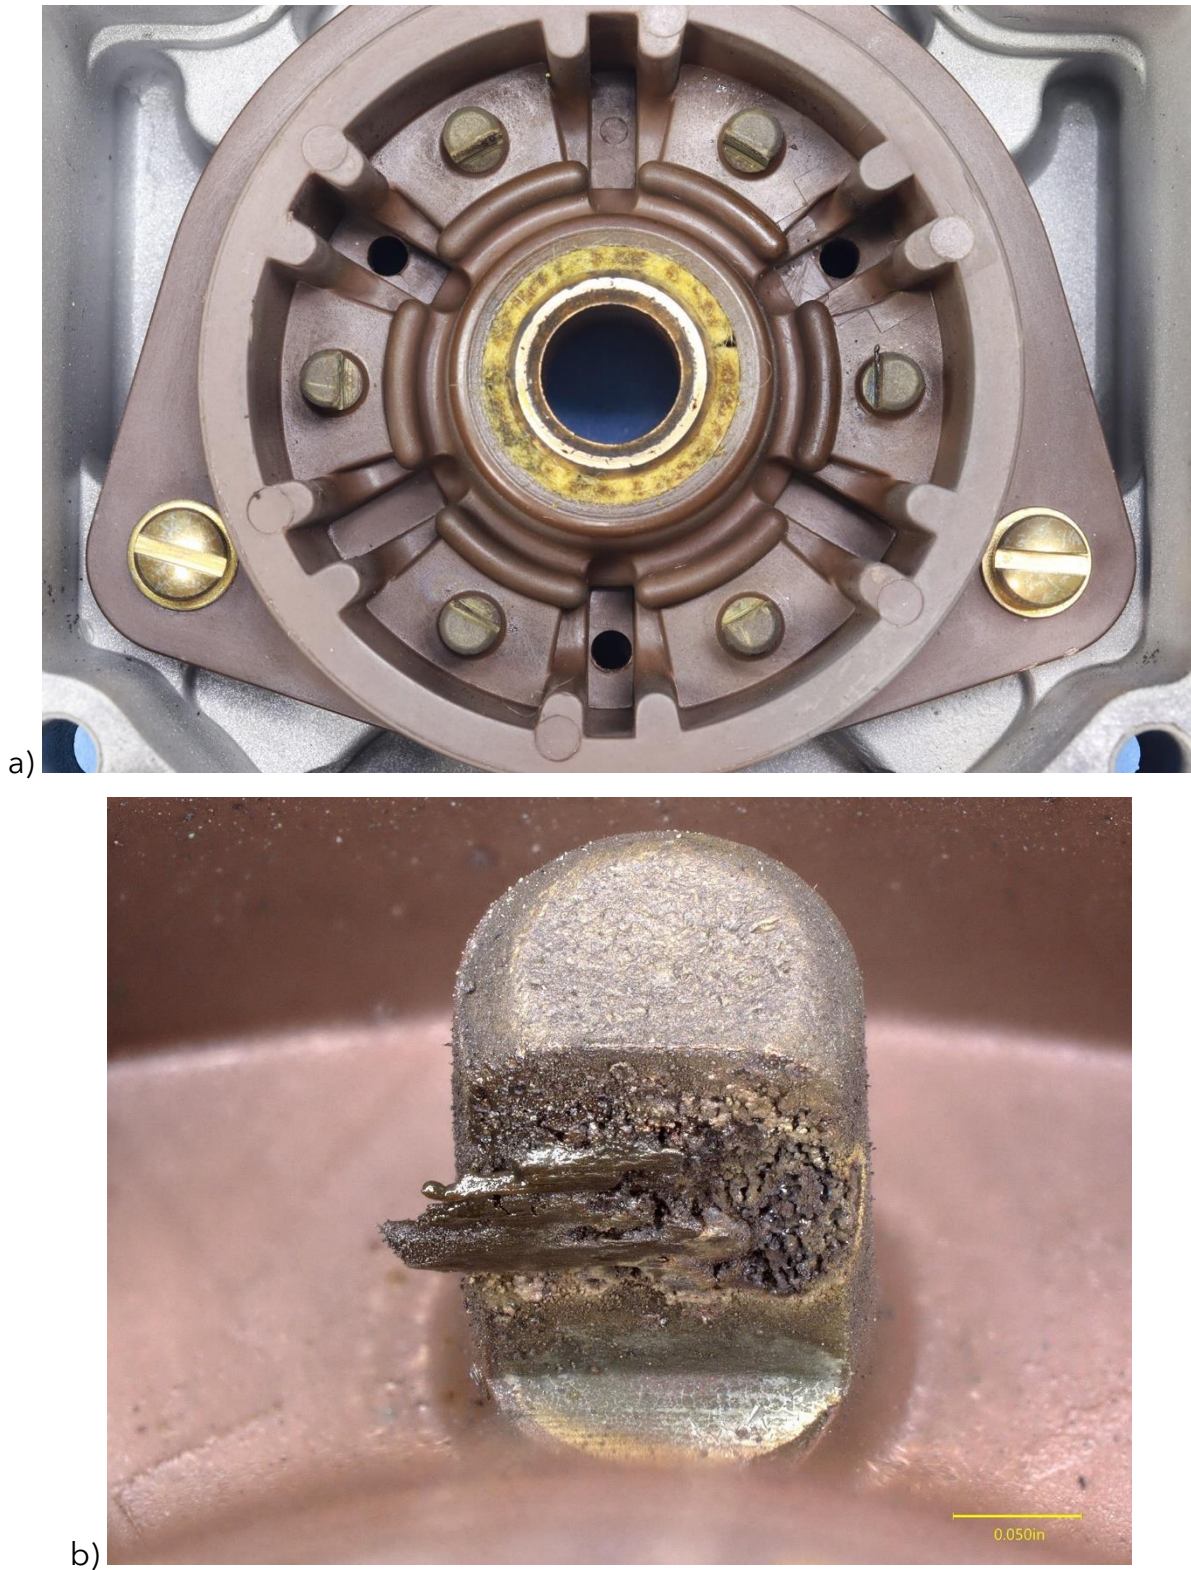
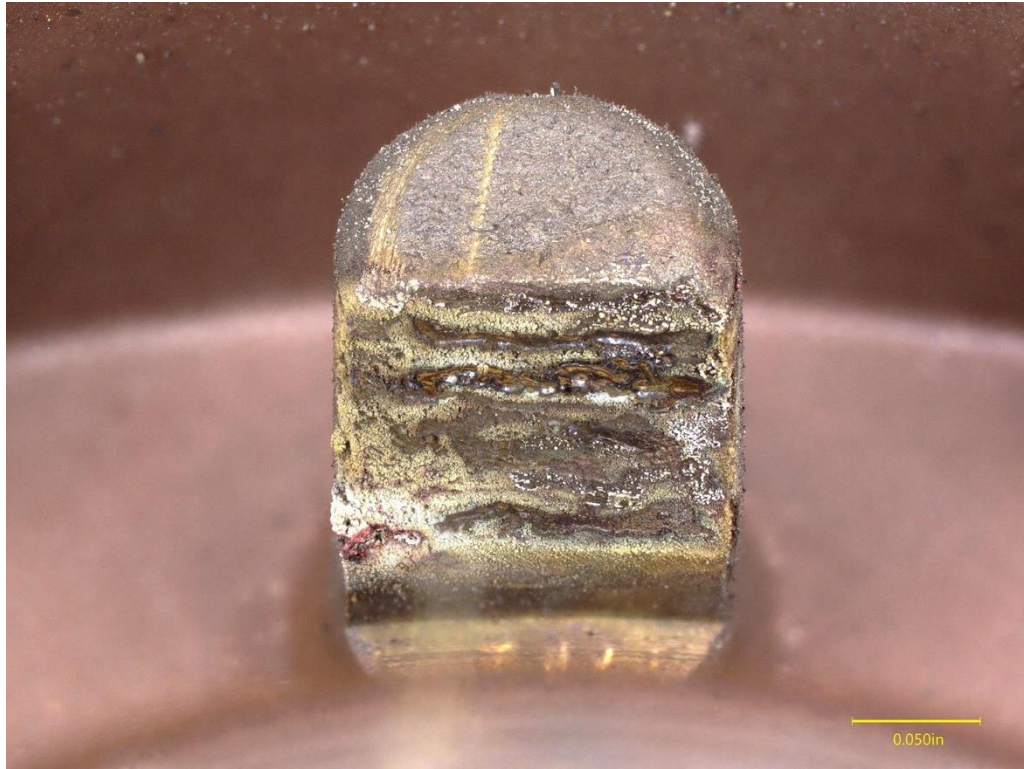
**Figure 5.** Images of electrodes in the distributor block: a) overview image; b) arcing and metal smearing on a distributor electrode; and

**Figure 5 (cont.).** c) arcing damage on a second distributor electrode.

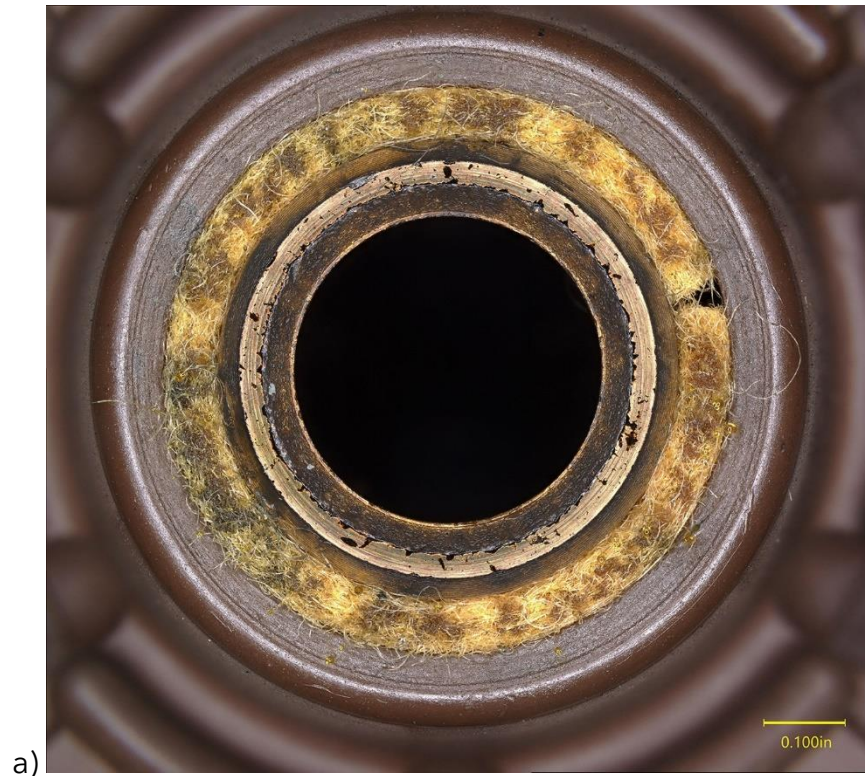
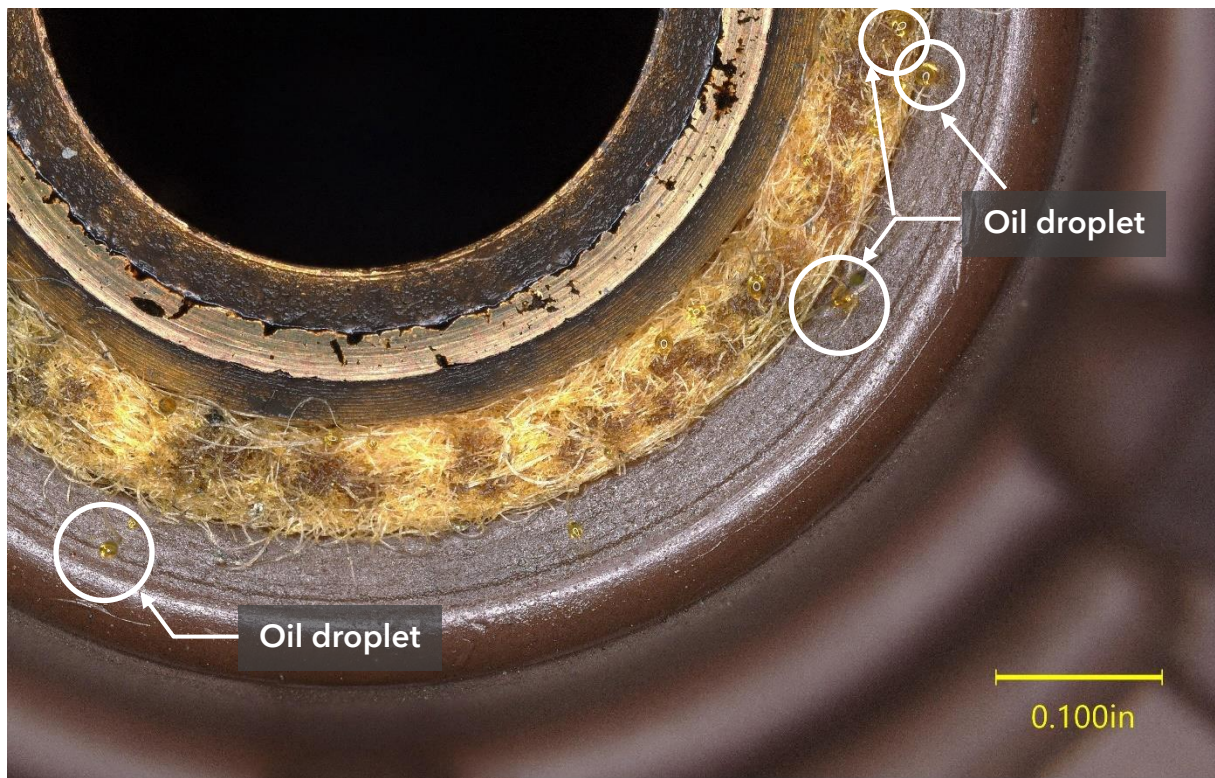
**Figure 6.** a) Distributor bushing and surrounding felt strip on the electrode side of the distributor block and b) higher magnification image indicating droplets of oil.

CAUTION: Do not lubricate the felt strip (81) with Distributor Block Lubricant.

- 8) Install a new dry felt strip (81) in groove on electrode side of distributor block. When strip is properly installed (Figure 7-1), approximately 0.125 inch of the bushing shall be exposed above the felt strip.
- 9) Before installing new felt washer (82) into the distributor block (79), saturate the washer with 10-391200 Distributor Block Lubricant. Blot excess oil from the washer until the flat surfaces take on a "frosted" appearance, and seat the felt washer in the recess on the tower side of the distributor block.

- 3) Form the felt strip (81) in a ring and install it *dry* in the deep groove next to the distributor block bushing so that it does not interfere with the washers (76, 77).
- 4) Saturate a new, or clean serviceable felt washer (82) with P/N 10-391200 distributor block lubricant. Blot excess oil from washer (82), until the flat surfaces take on a "frosted" appearance. Seat washers in the recesses on the tower side of the distributor block (79).

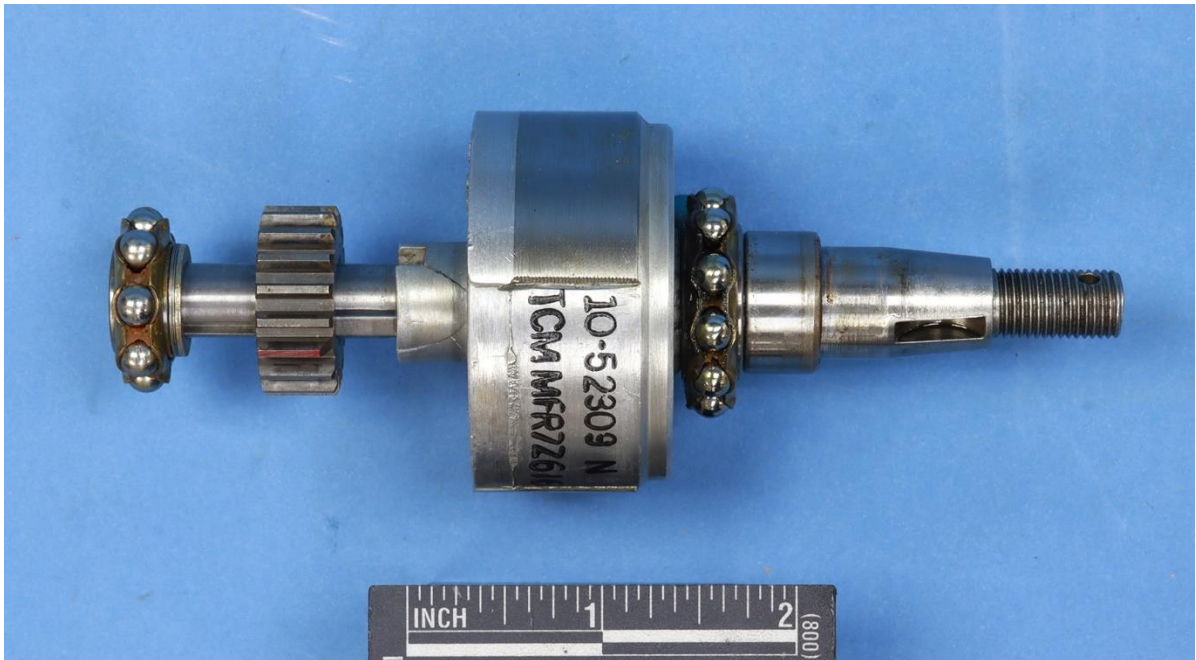
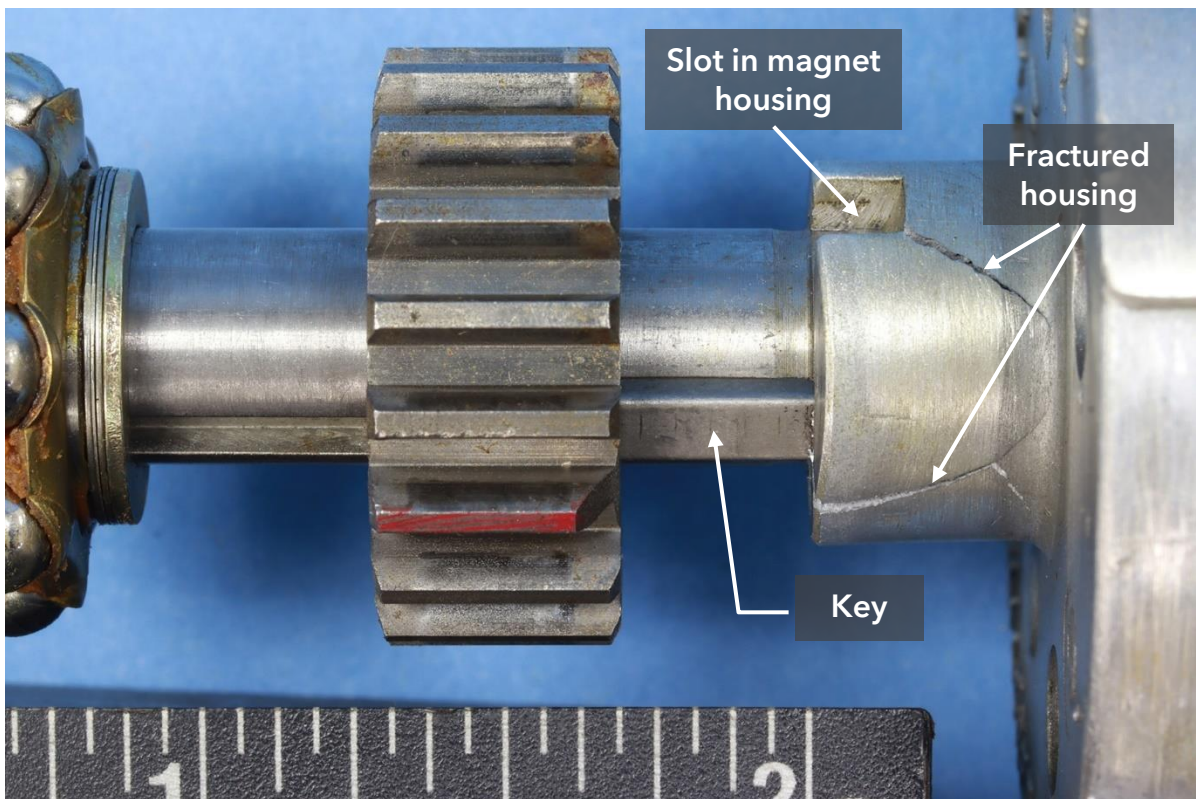
The rotor exhibited signs of damage from overload. By design, the rotor shaft housed a key that rotationally locked the magnet by mating with a slot in the magnet housing (figures 7a - b). The key (and thus the rotor shaft) had rotated relative to the magnet, fracturing the magnet housing. The fracture surfaces were examined using a stereomicroscope and the fracture features were consistent with overstress.

**Figure 7.** a) Image of the left magneto rotor and b) image showing the fractured magnet housing and the rotation of the shaft relative to the magnet.

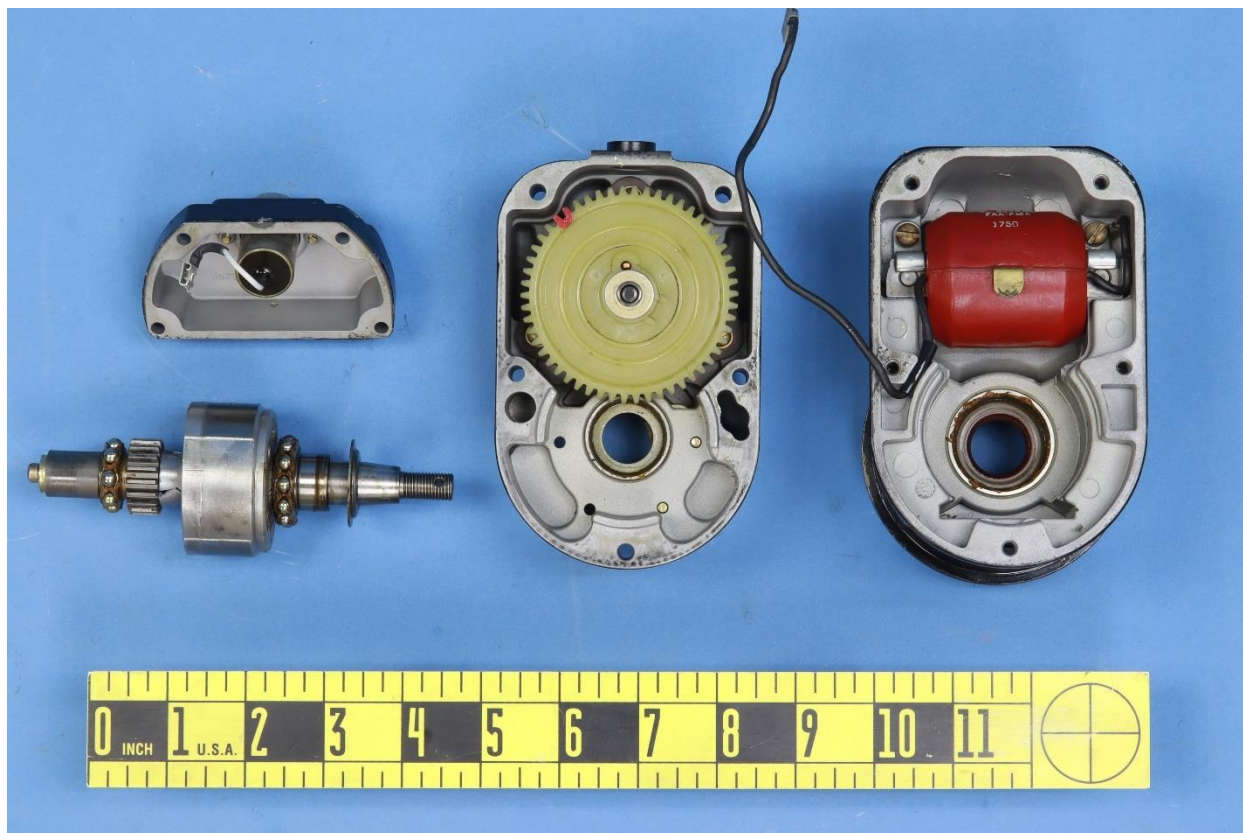
The right magneto housing was opened, and internal components also exhibited similar signs of oily residue, carbonization, and arcing damage between the distributor gear's electrode and the distributor block electrodes. None of the rotor bearing components, carbon brush, or coil showed any notable features (figure 8). Regions of the distributor gear electrode were covered by a layer of carbonized material (figures 9a), and the distributor block electrodes had melted and resolidified where they came into proximity with the gear electrode (for example, figures 9b). Oil droplets were seen adhered to the felt strip that surrounded the distributor bushing (figure 10).

**Figure 8.** The right magneto after opening the housing.

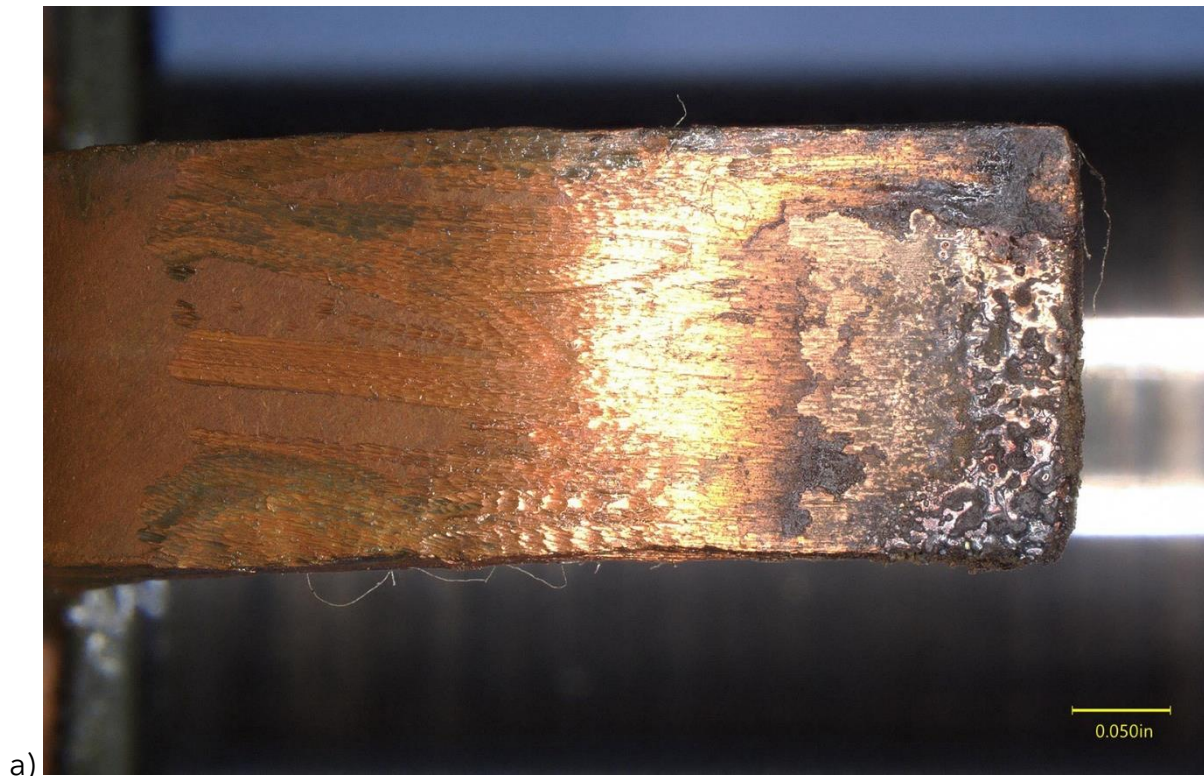
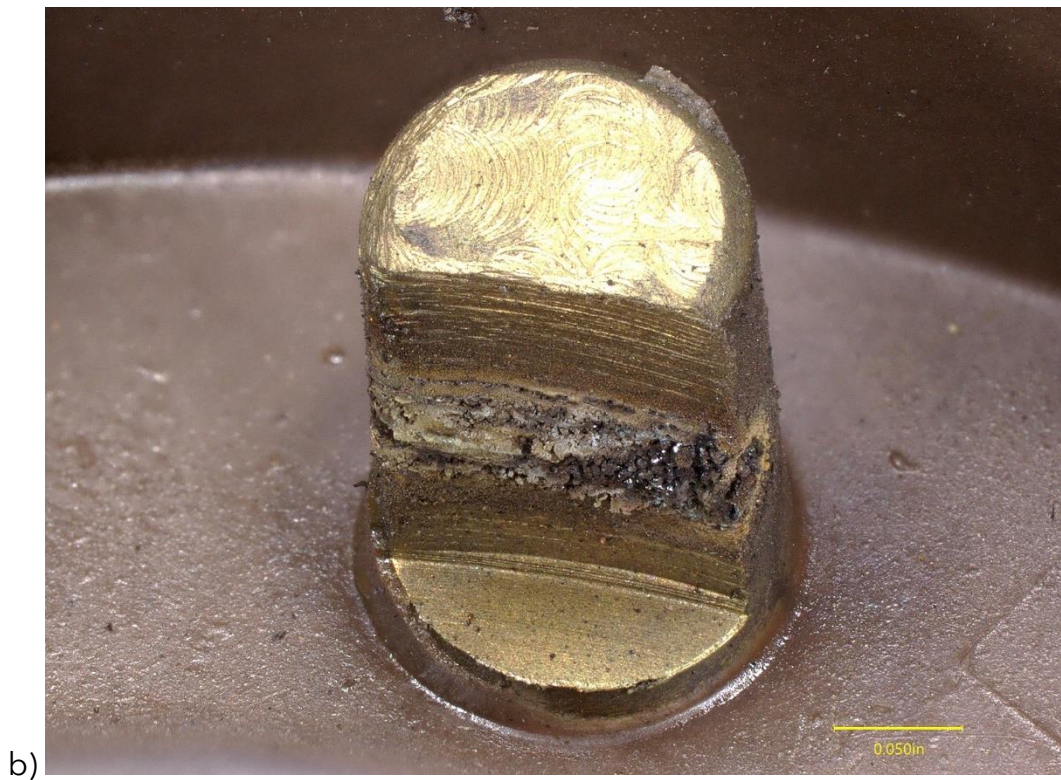
**Figure 9.** a) Right magneto gear electrode showing carbonization and b) right magneto distributor block electrode showing arcing damage.

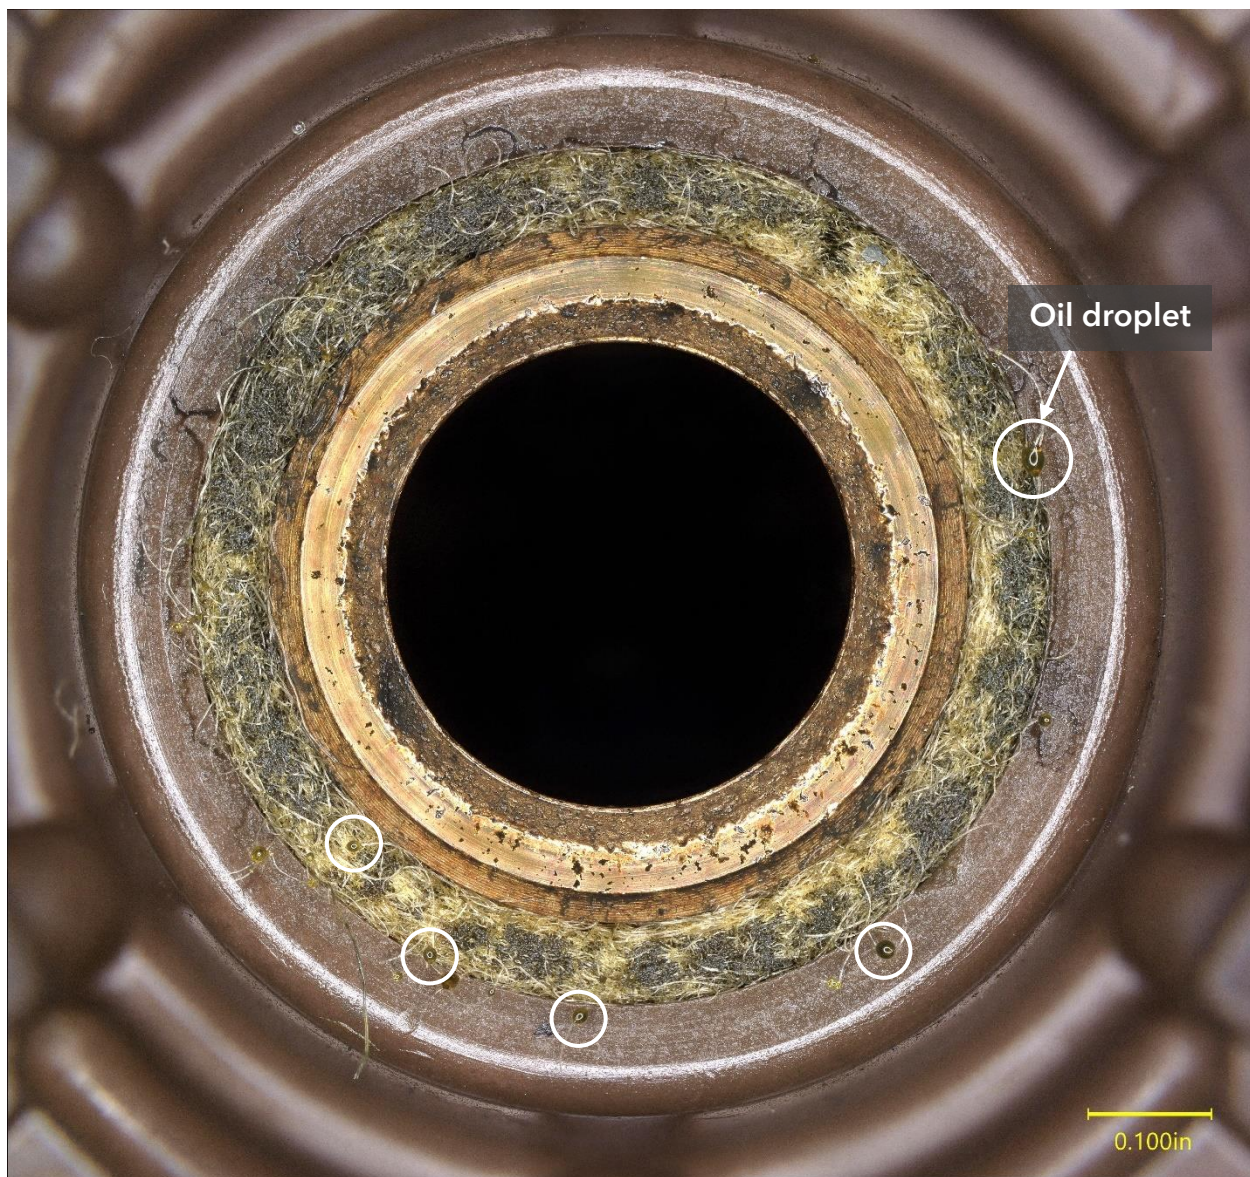
**Figure 10.** Right magnetos distributor bushing and surrounding felt showing droplets of oil.

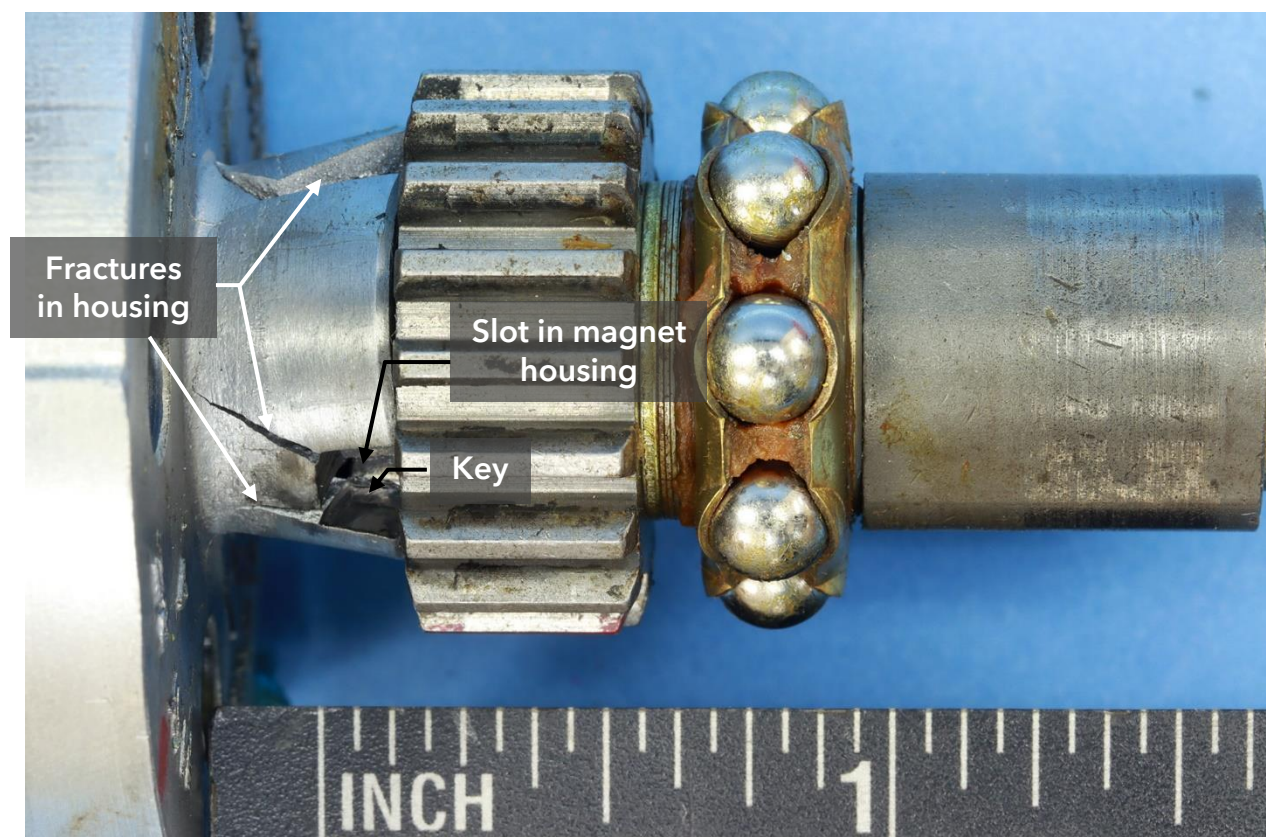
The rotor exhibited signs of damage from overload. The key had rotated relative to the magnet, fracturing the magnet housing (figure 11). The fracture surfaces were examined using a stereomicroscope and the fracture features were consistent with overstress.

**Figure 11.** Image of the right magneto rotor showing the fractured magnet housing and the rotation of the key (coupled to the shaft) relative to the magnet.
