# National Transportation Safety Board

CEN24LA052

## EXAMINATION SUMMARY

Location: Manitowoc, WI  
Date: 11/30/2023  
Time: 1513 CDT  
Aircraft: Cessna 182; N8880T

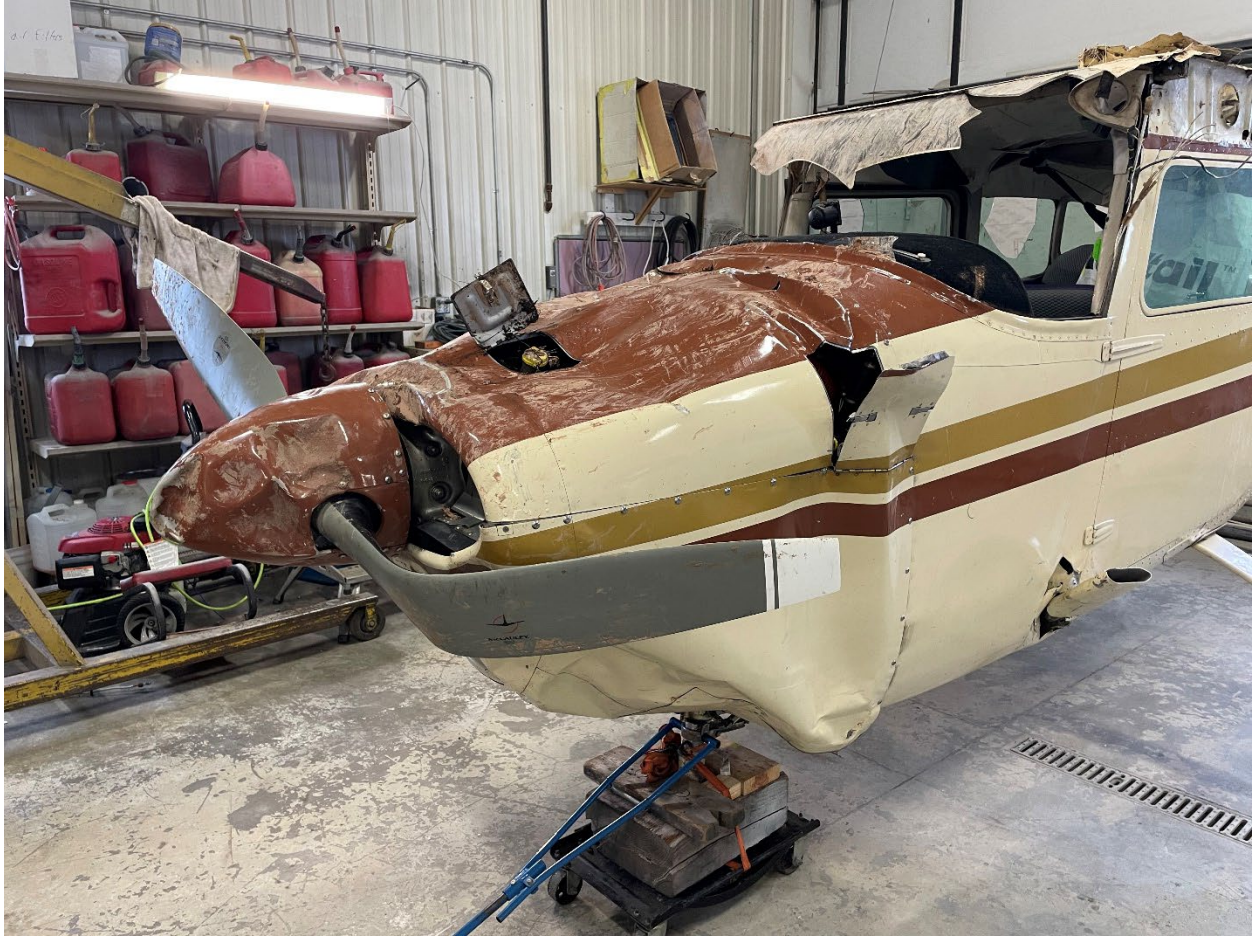
The airframe and engine were recovered by Myers Aviation, Oshkosh, Wisconsin. The aircraft logbooks were not available at the time of the examination. Visual examination of the airframe and Continental O-470 engine (serial number 131515-5-R) revealed the upper and lower cowlings displayed impact damage.

Airframe and engine

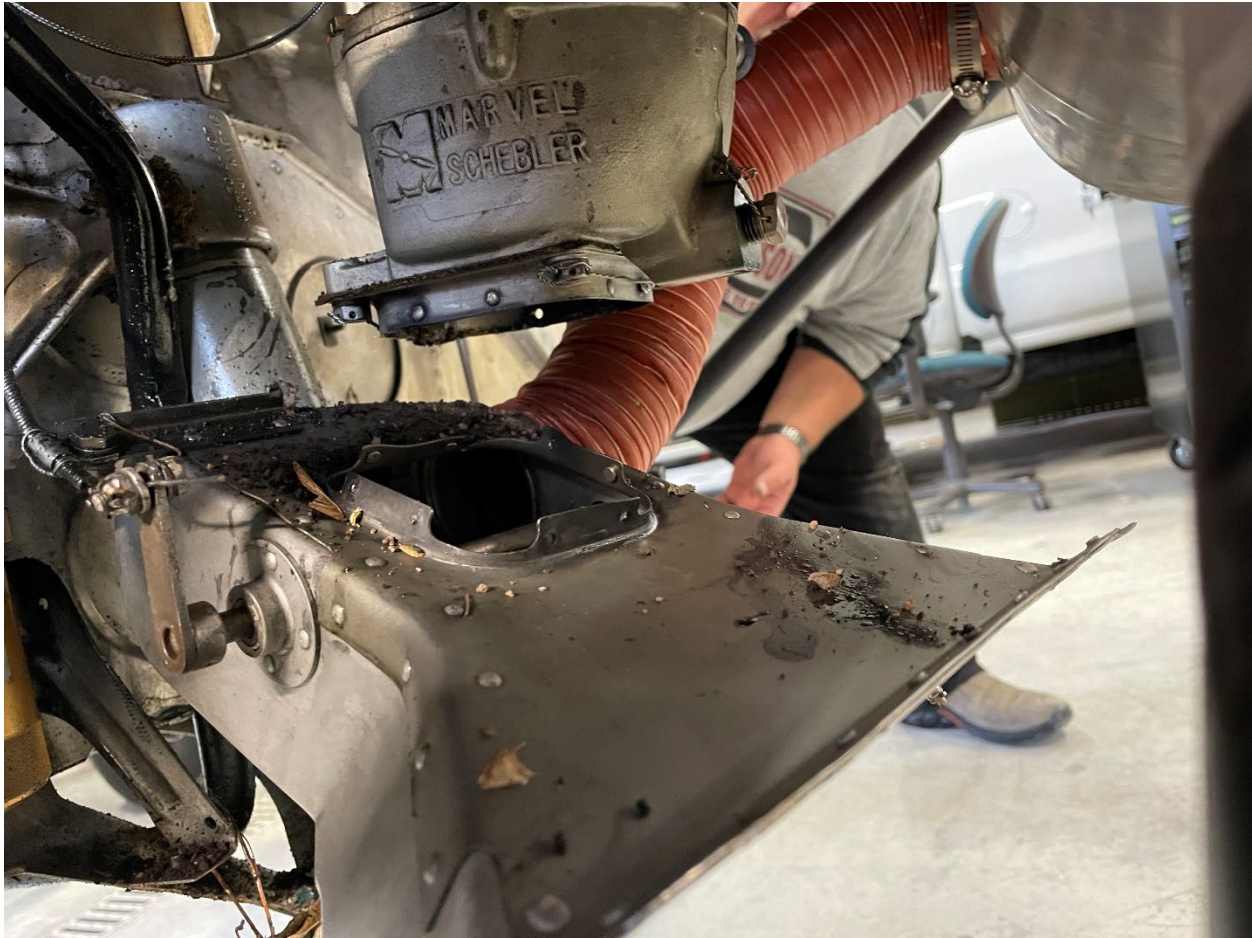
The cowlings were removed, and no evidence of an uncontained engine failure was noted. The carburetor airbox was separated from the carburetor; the attach rivets appeared sheared and impact damage to the engine cowling was noted near the airbox and carburetor.

Airbox and carburetor

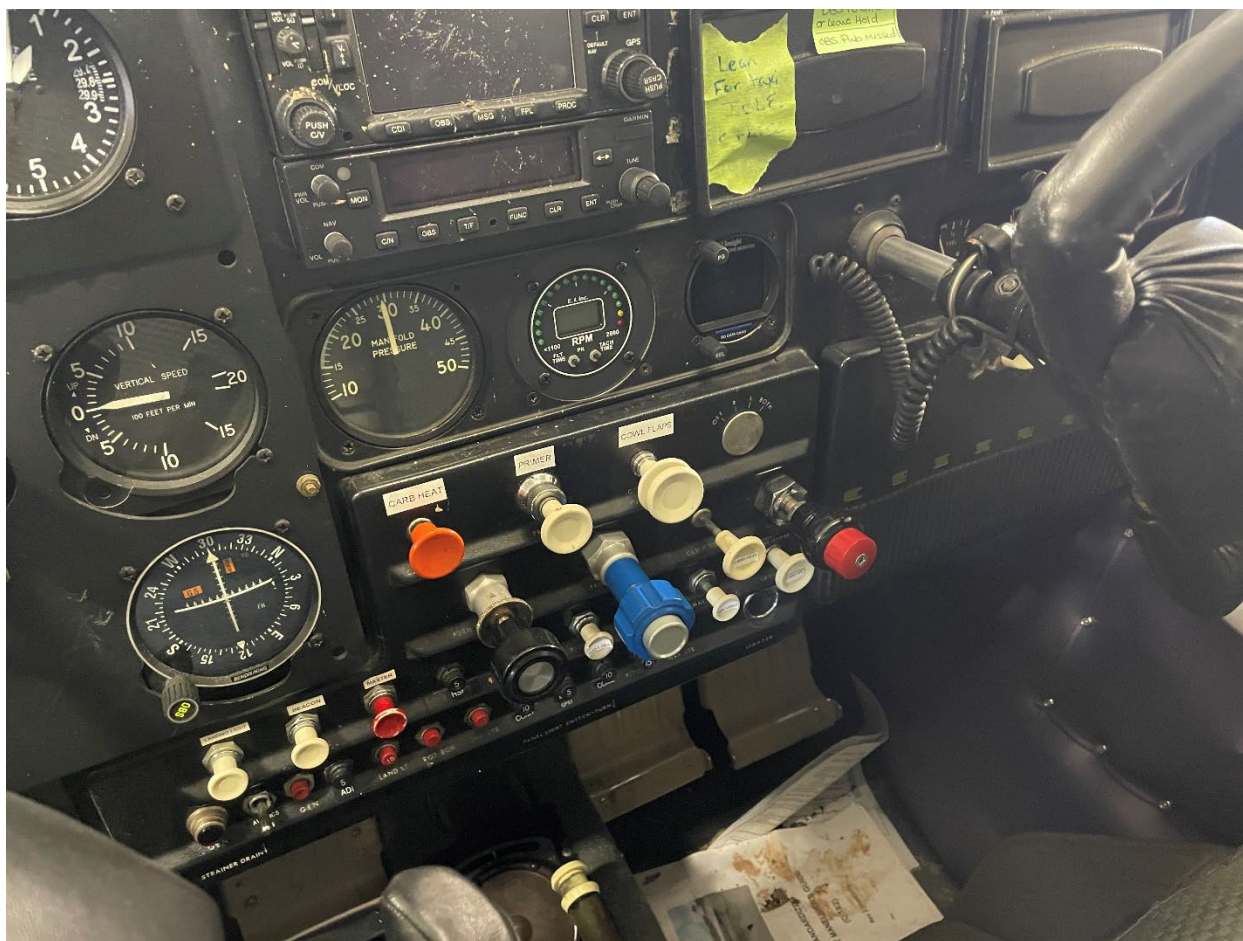
The airplane HOBBS meter indicated 0173.2 hours. Continuity from the cockpit engine controls (throttle/mixture) was confirmed to the carburetor, and the controls moved freely when manually manipulated. Carburetor heat control continuity was confirmed to the carburetor airbox, and the control moved freely when manually manipulated.

Cockpit engine controls

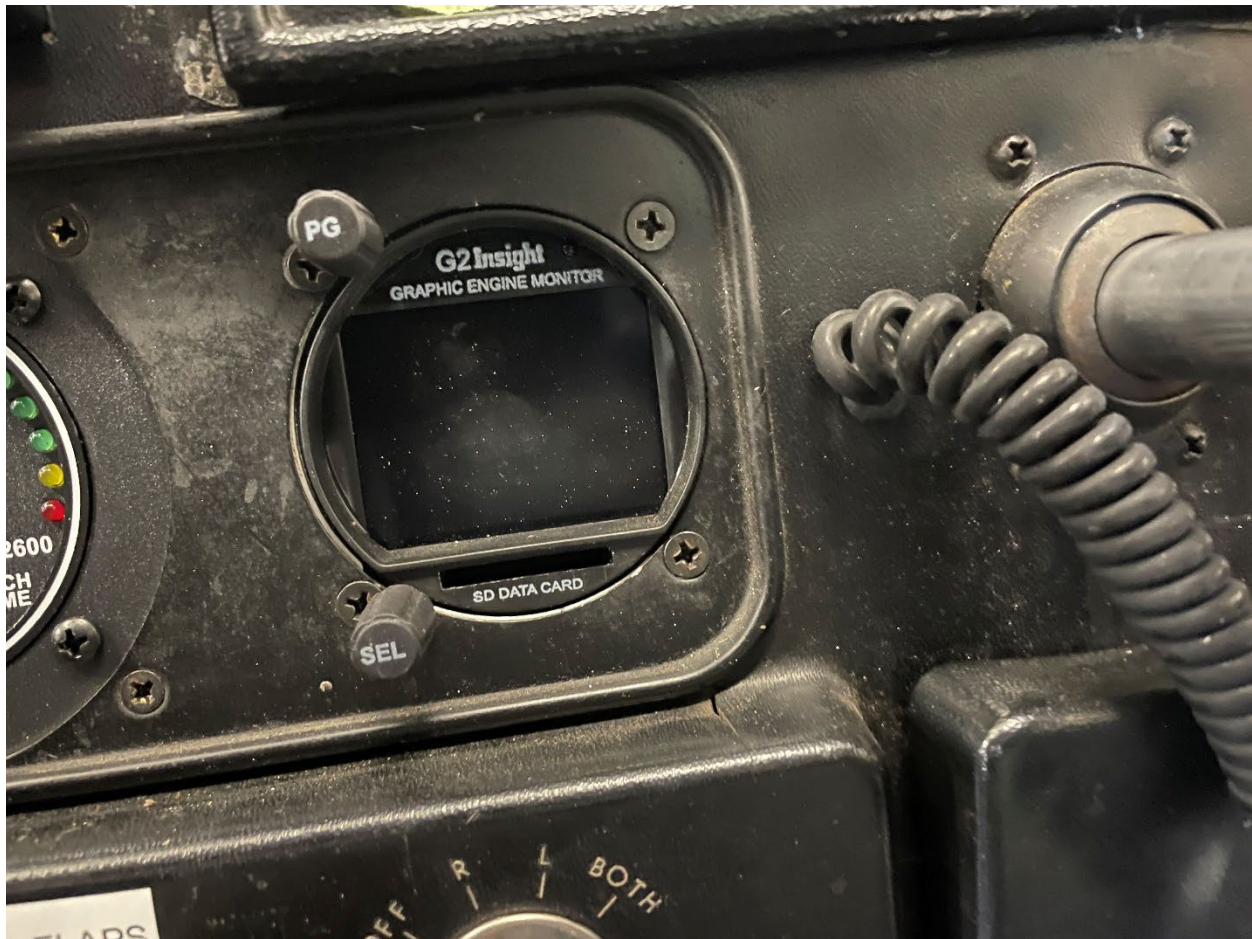
The instrument panel contained an Insight G2 graphic engine monitor, and an SD data card was installed. The SD card was removed, and the accident flight data was extracted from the SD card.

Insight G2 graphic engine monitor (SD card removed)

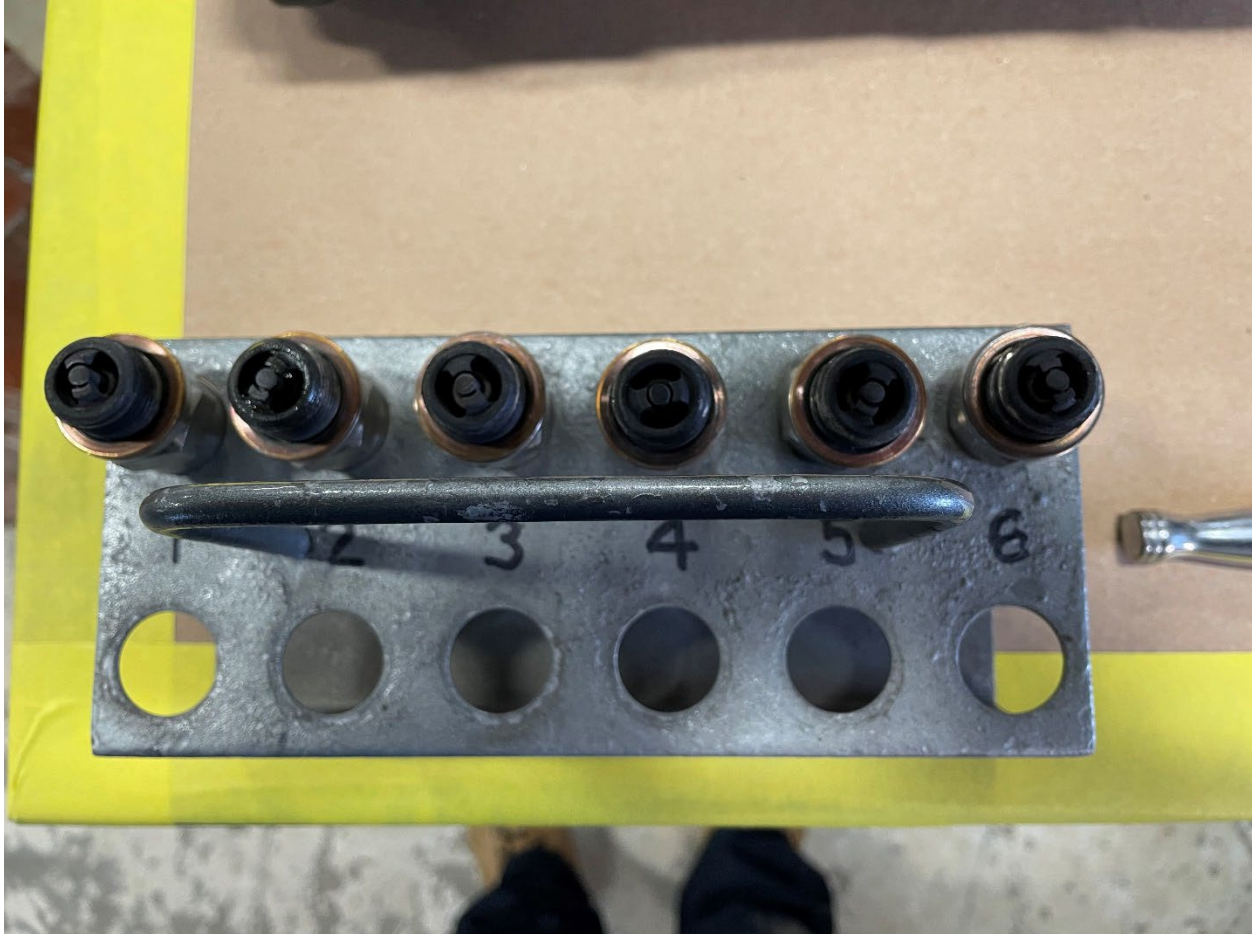
The top sparks plugs were removed, and thumb compression and suction were noted on all 6 cylinders when the propeller was manually rotated. The spark plug electrodes were in a normal condition per the Champion Aerospace service manual. Mechanical continuity throughout the engine and accessories was confirmed when the propeller was manually rotated.

Top spark plugs

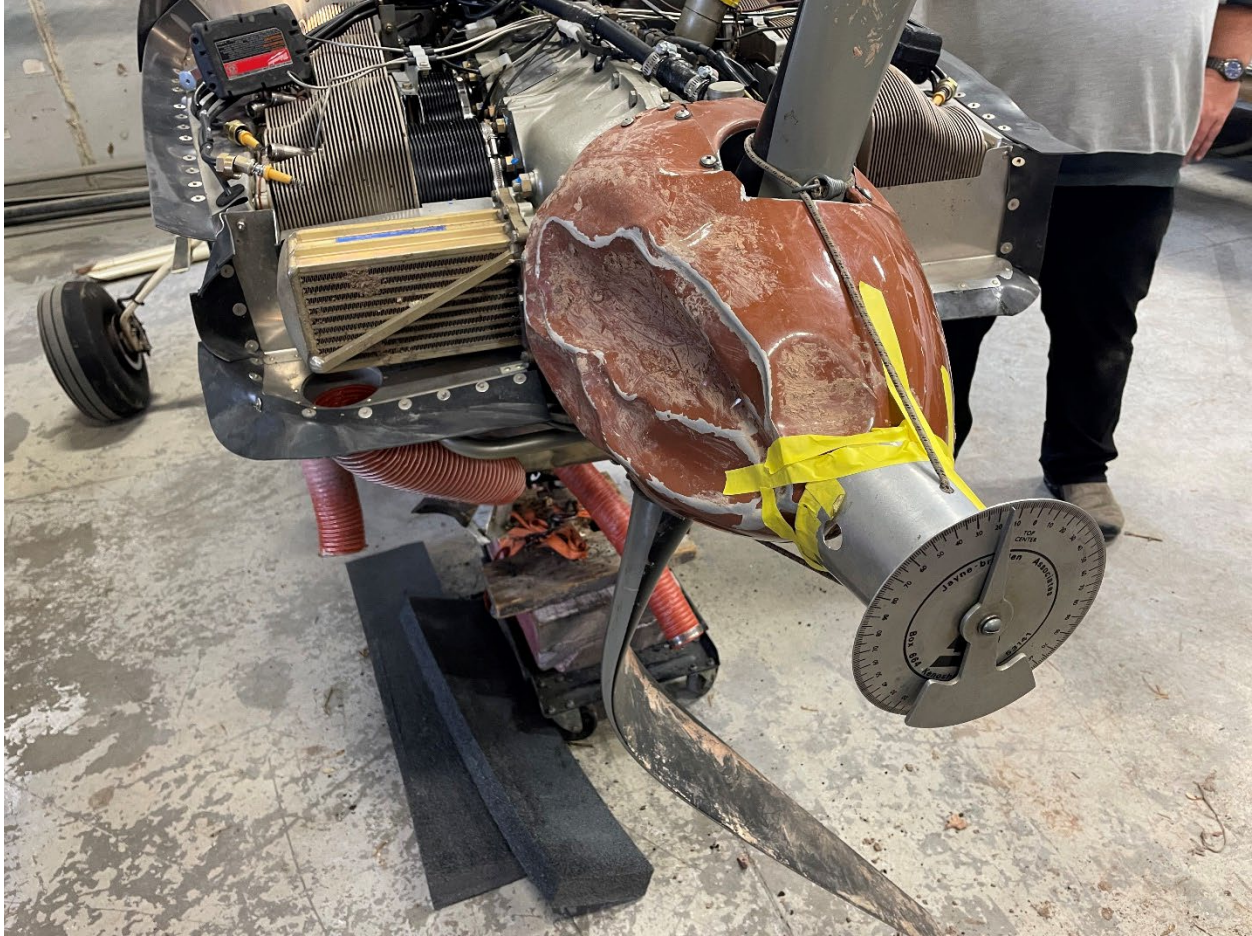
Engine magneto timing for the left magneto was 18 degrees before top dead center, and the right magneto was 20 degrees before top dead center. The engine timing indicator was mounted on the damage spinner via tape and timing results were estimated.

Engine timing indicator mounting

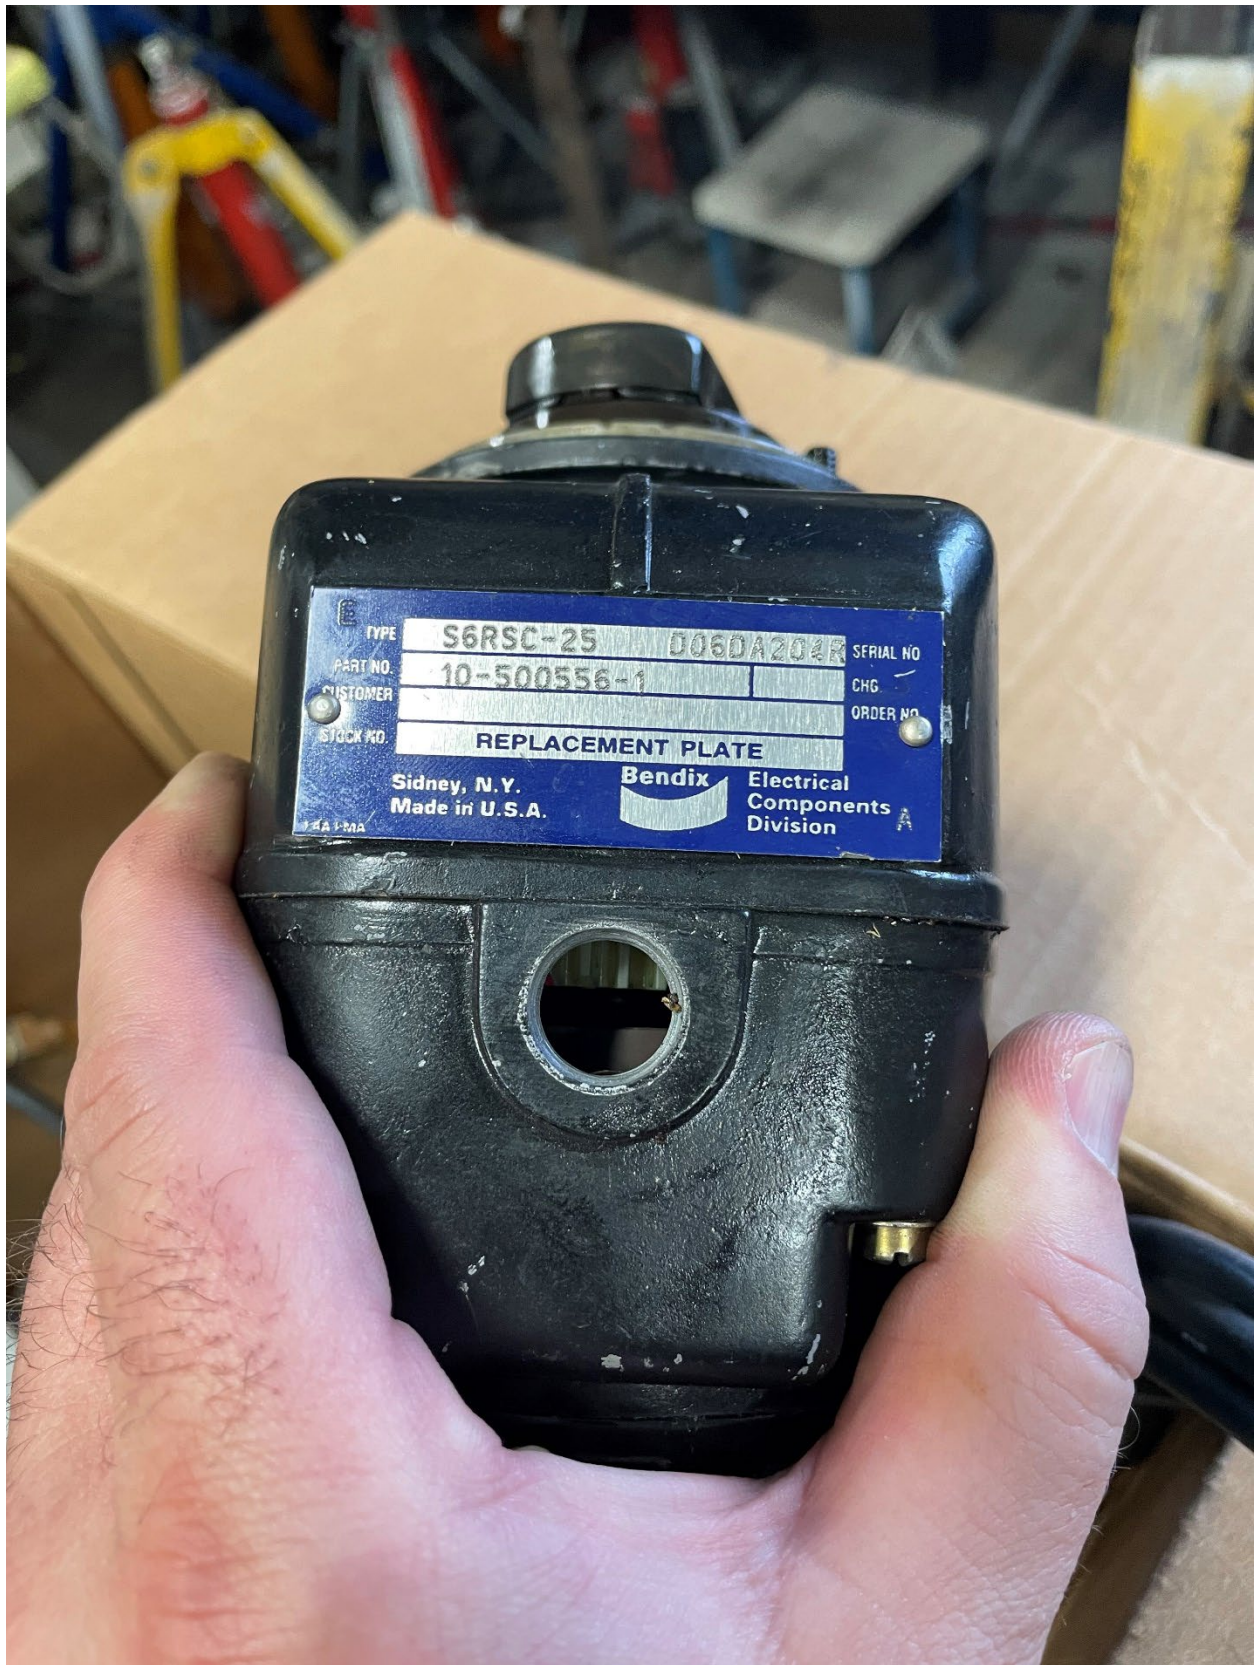
The left and right magnetos and ignition harnesses were tested by removing the p-leads and rotating the propeller. No spark was noted on the top or bottom ignition harness lead coil springs.

Left magneto

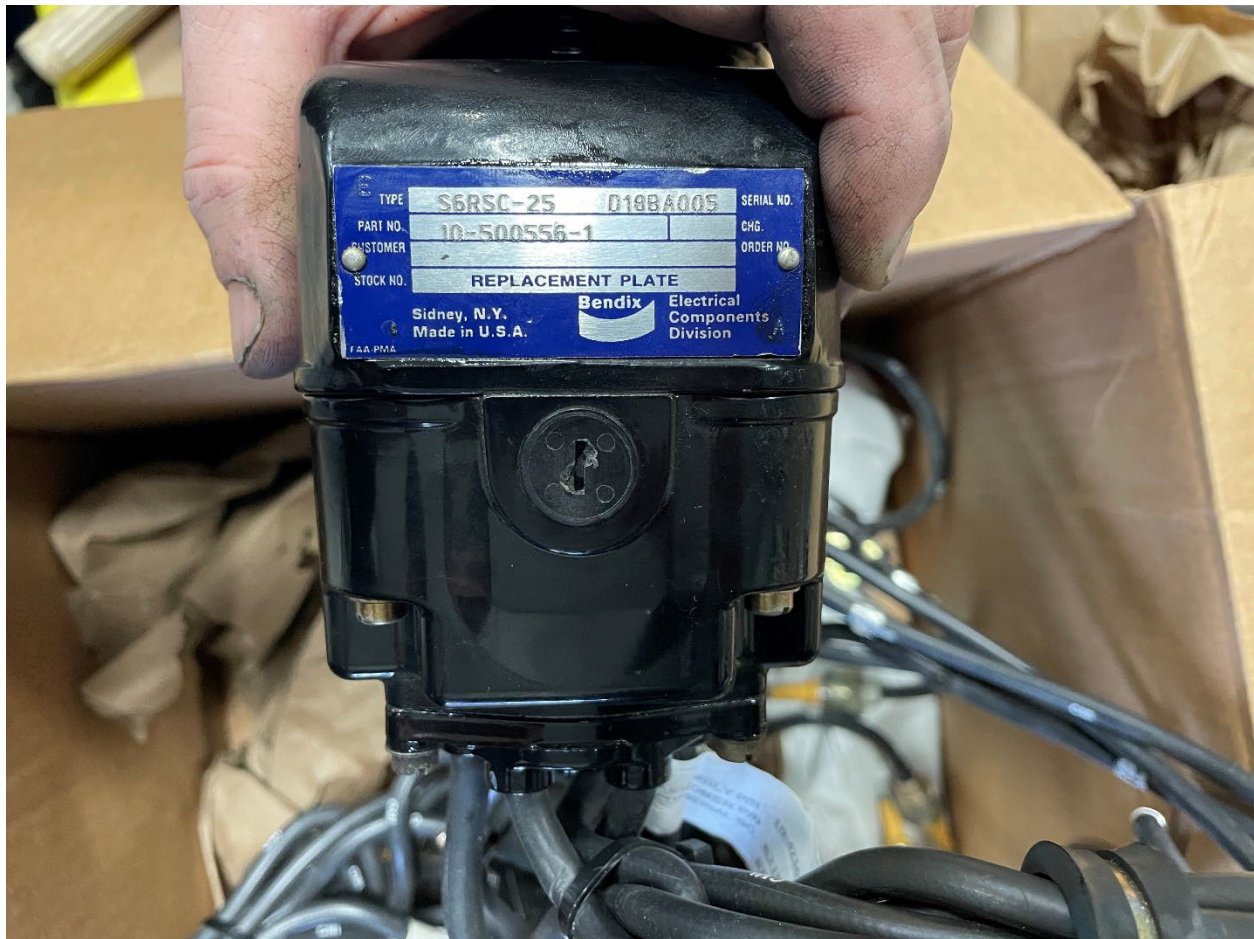
Right magneto

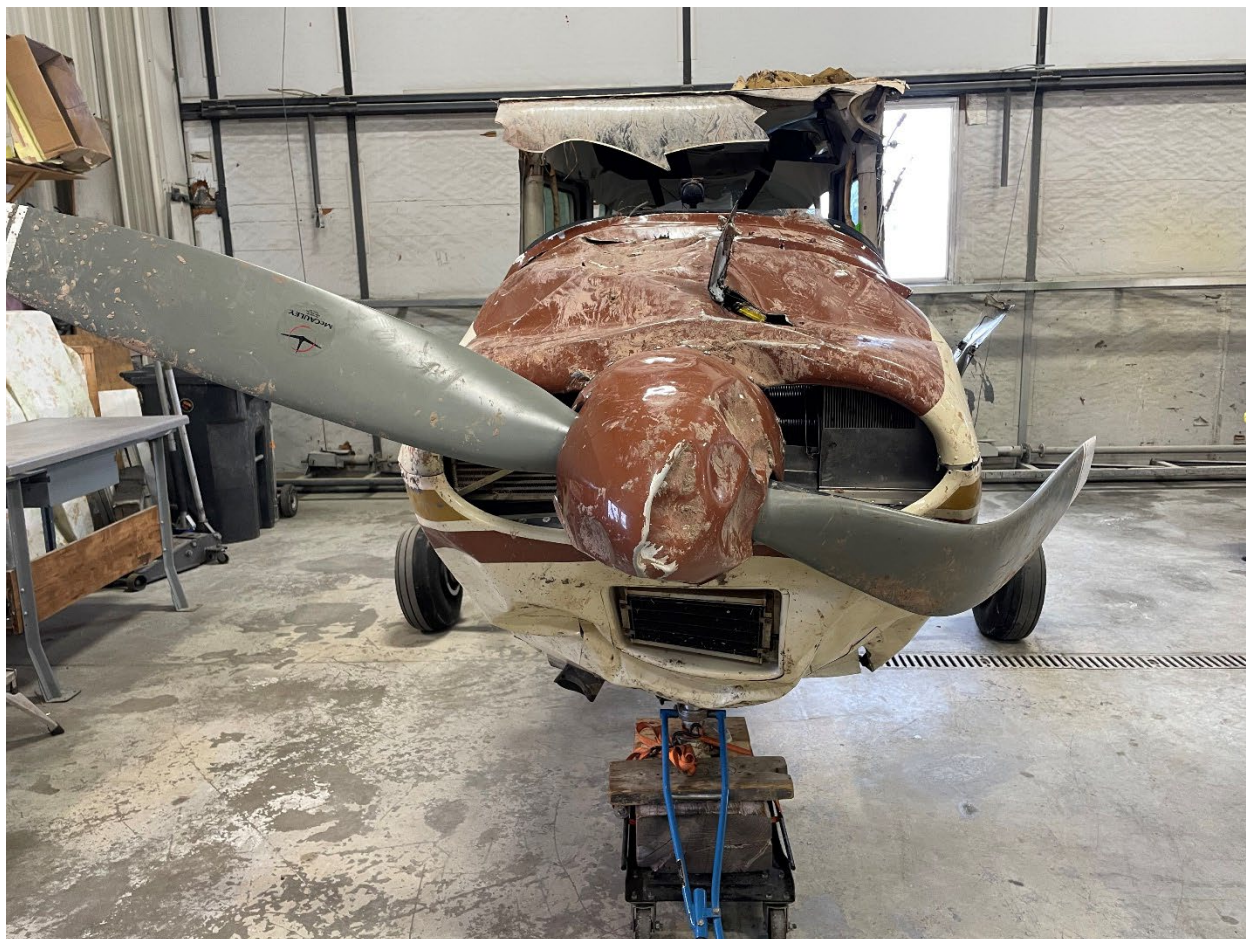
The McCauley two-blade constant speed propeller remained attached to the engine crankshaft. One blade appeared to be undamaged and secure in the hub. One blade was bent aft about mid-span and loose in the propeller hub.

Propeller assembly
