CEN24LA052

## INVESTIGATION PHOTOGRAPHS

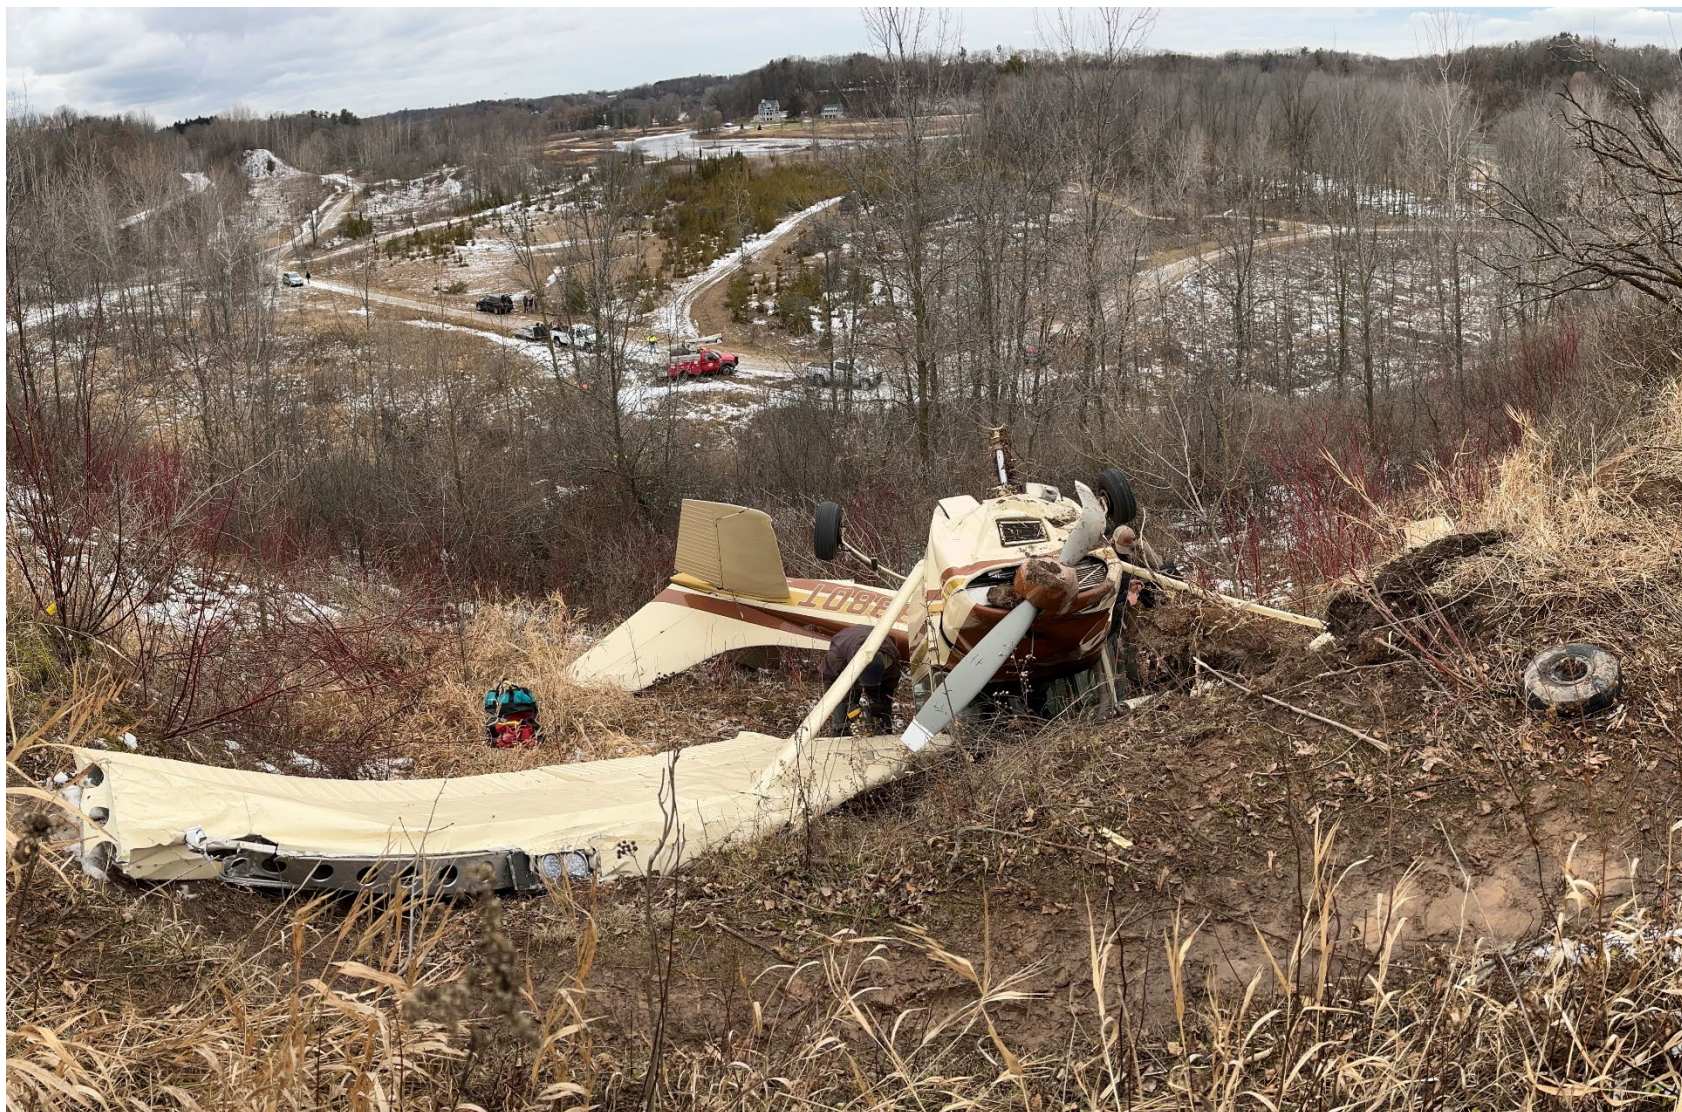
**Photograph 1 - Front view of accident airplane (Courtesy of FAA)**

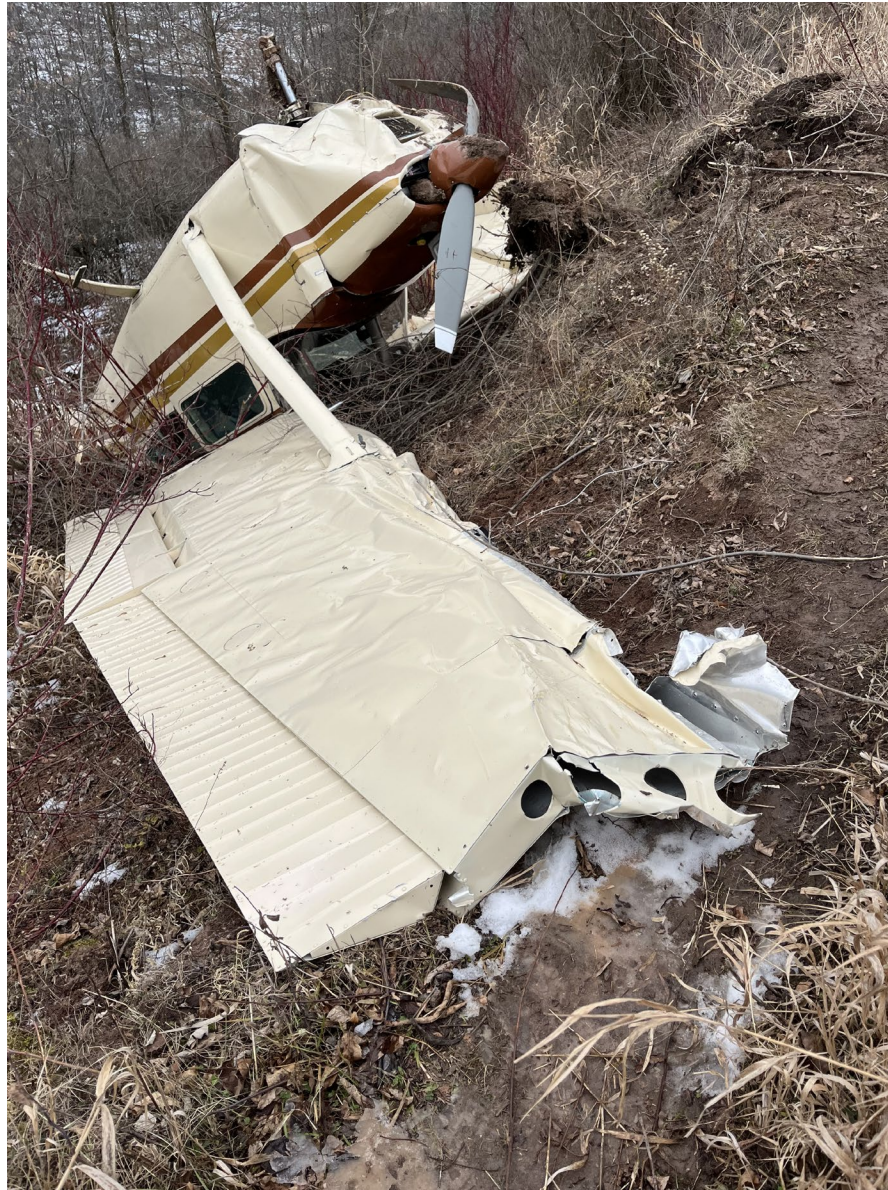
**Photograph 2 - Side view of accident airplane (Courtesy of FAA)**

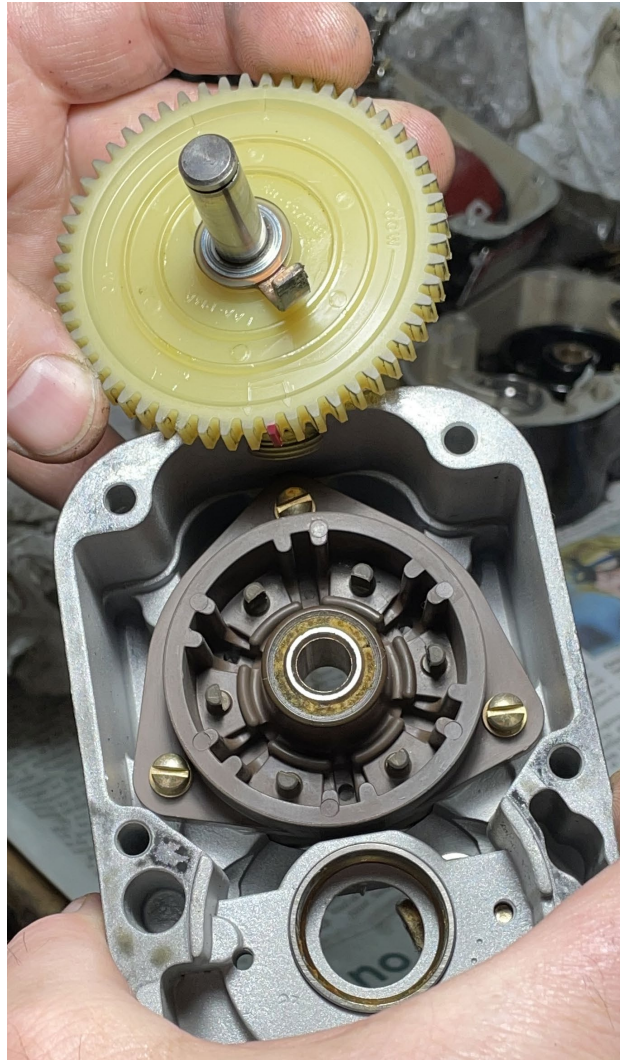
**Photograph 3 - Left magneto distributor block and rotor.  
Note arcing damage to electrodes and oil saturated felt in the center of the distributor.  
(Courtesy of NTSB)**

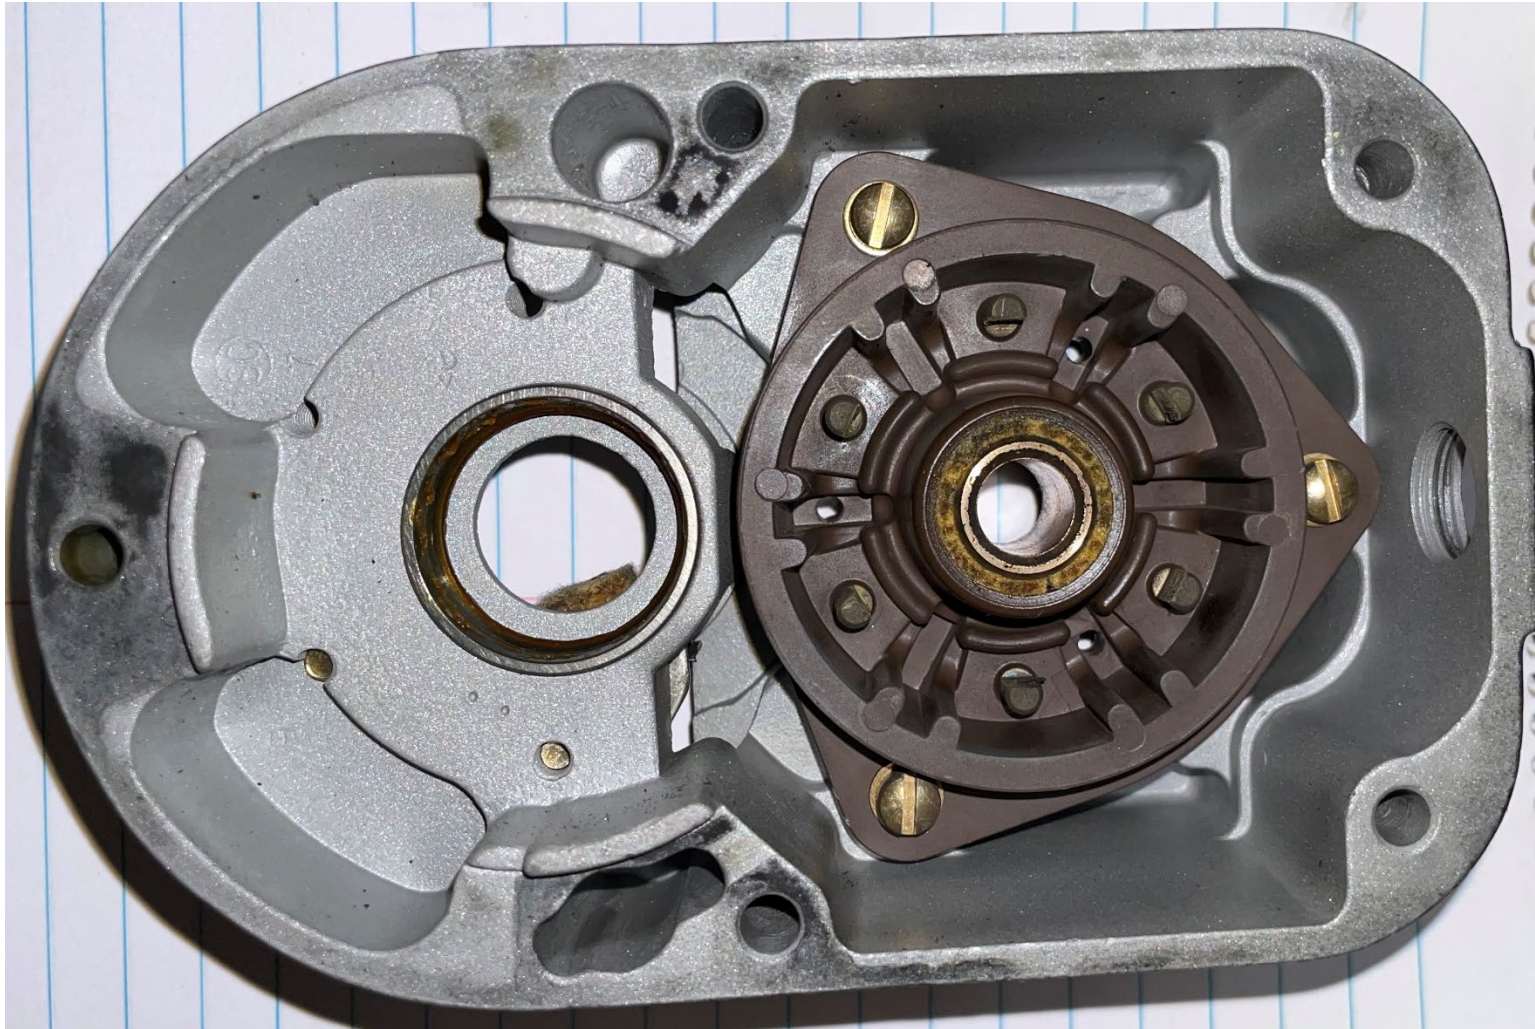
**Photograph 4 - Right magneto distributor block**  
**Note arcing damage to electrodes and oil saturated felt in the center of the distributor.**  
**(Courtesy of NTSB)**
