CEN24LA054

## INVESTIGATION PHOTOGRAPHS

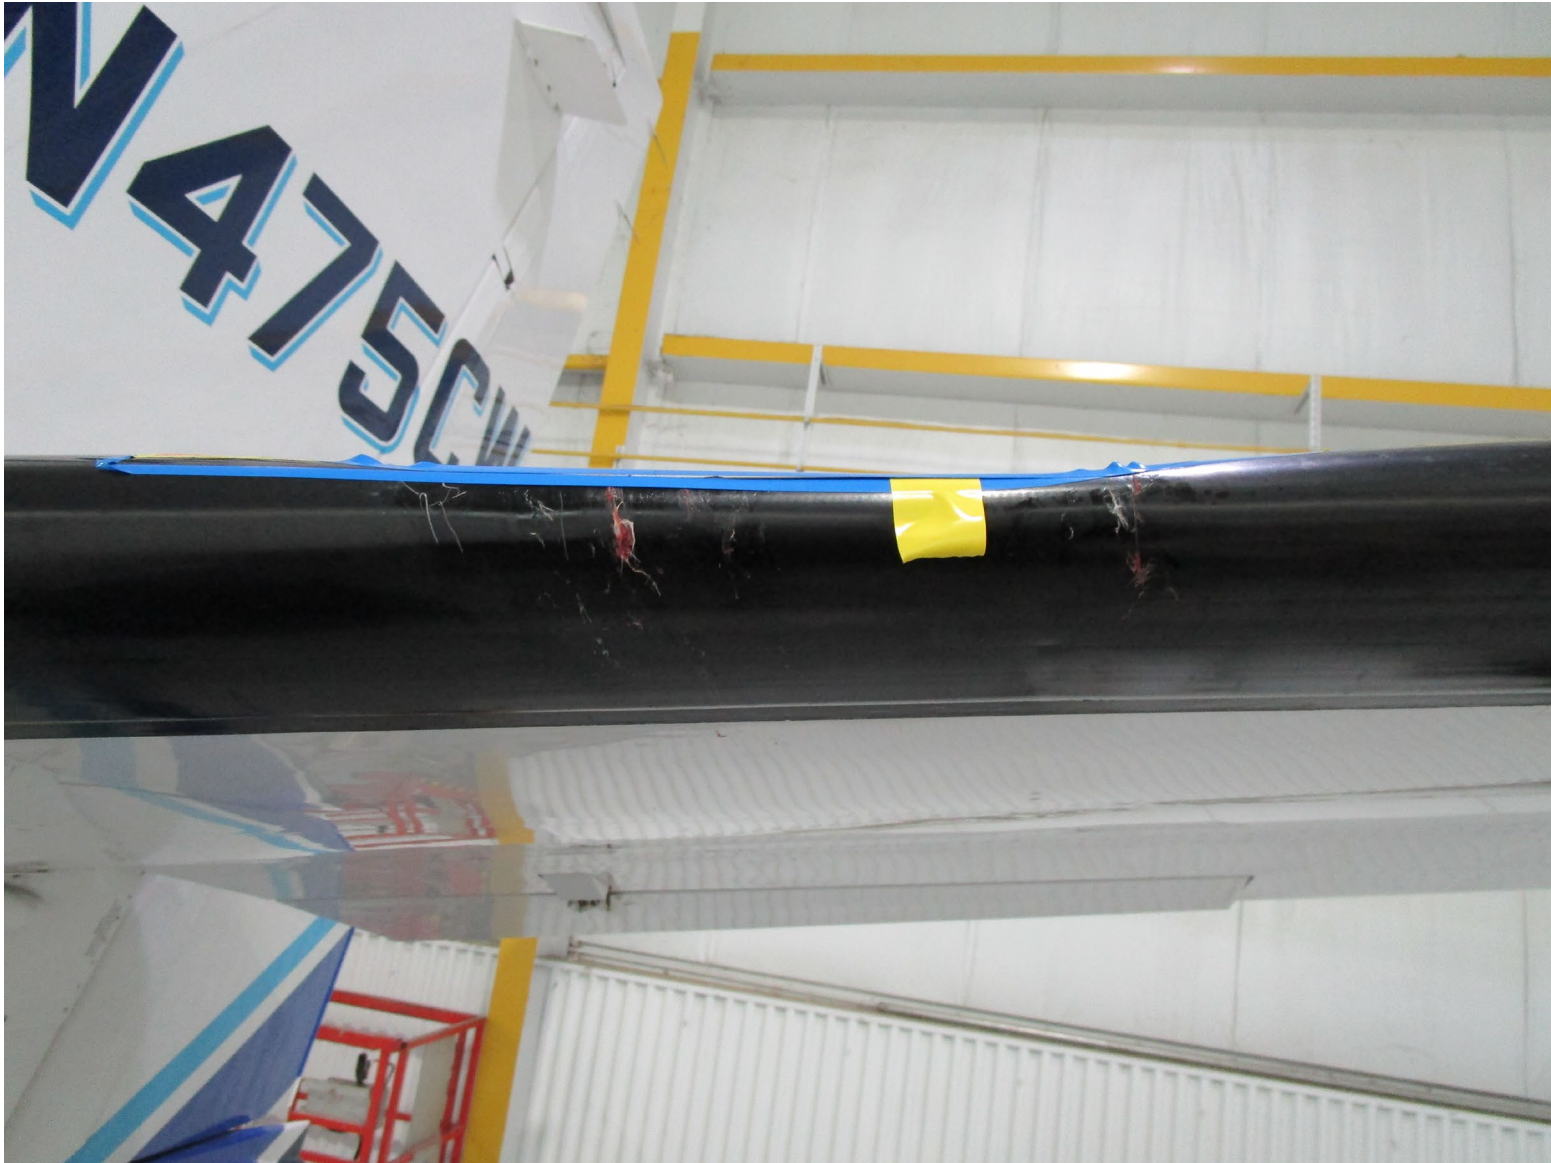
**Photograph 1 - Left Horizontal Stabilizer Damage (Courtesy of Airplane Operator)**

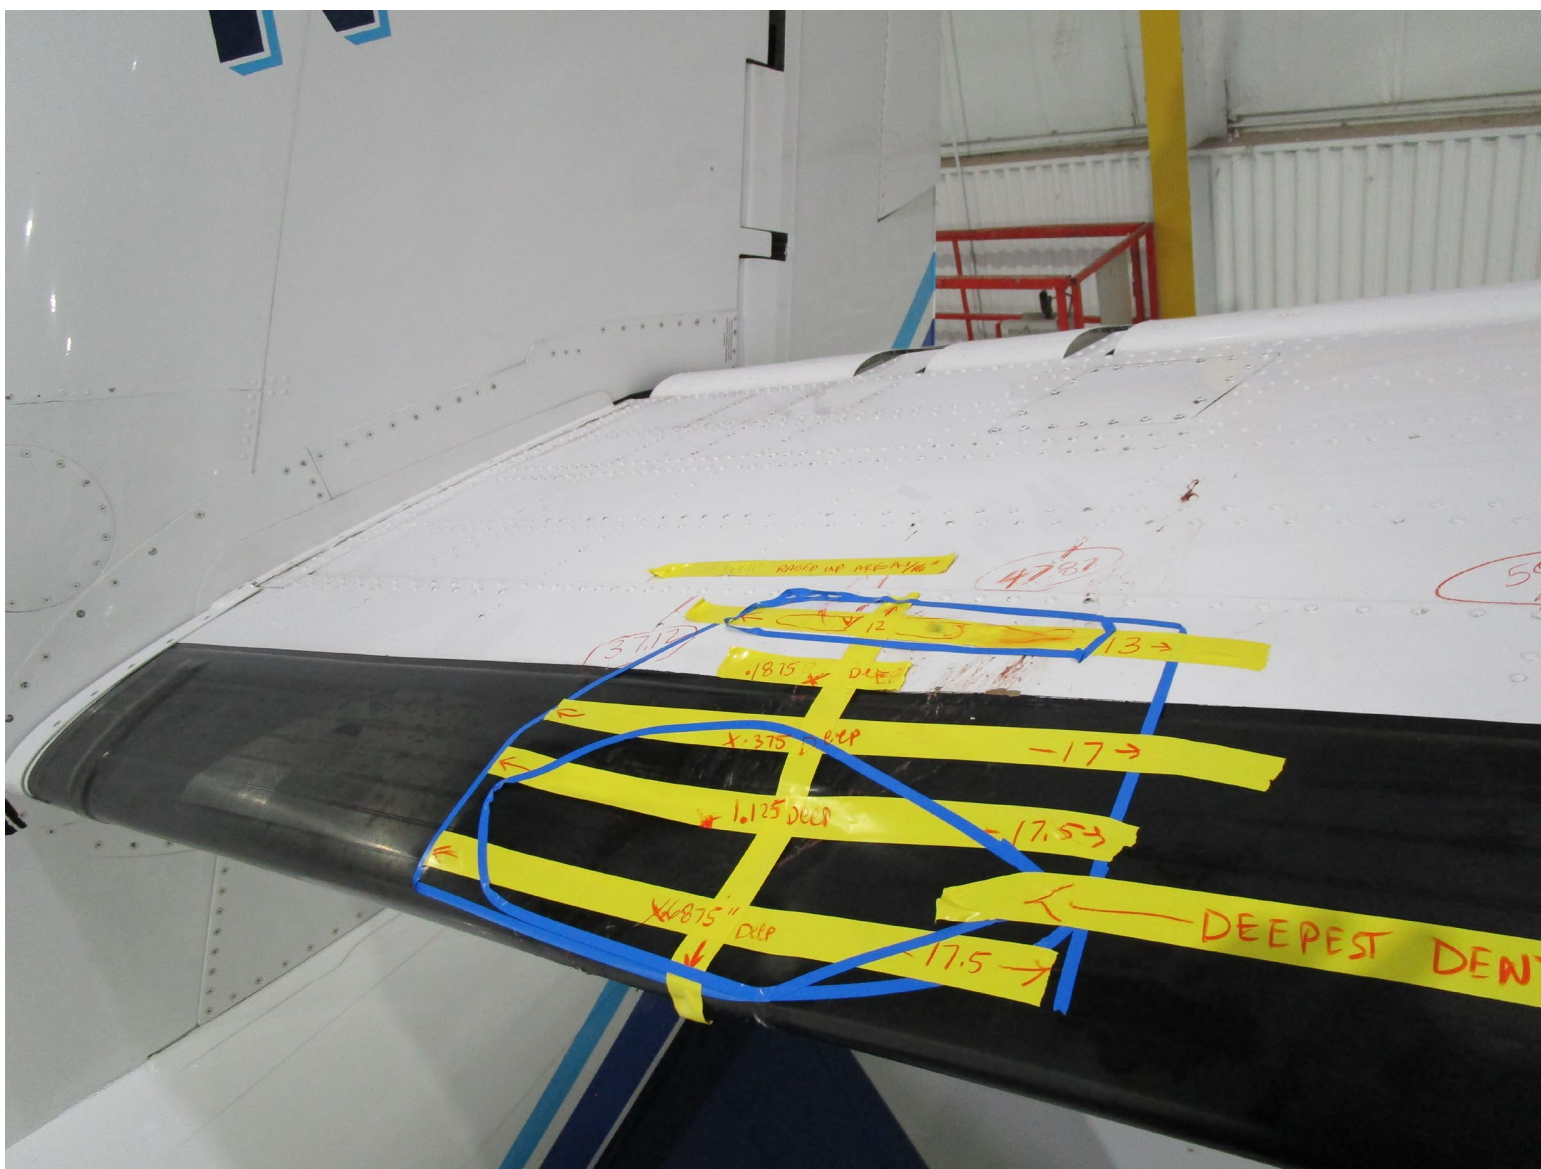
**Photograph 2 - Upper Surface Damage of Left Horizontal Stabilizer (Courtesy of Operator)**
