CEN24LA059

## INVESTIGATION PHOTOGRAPHS

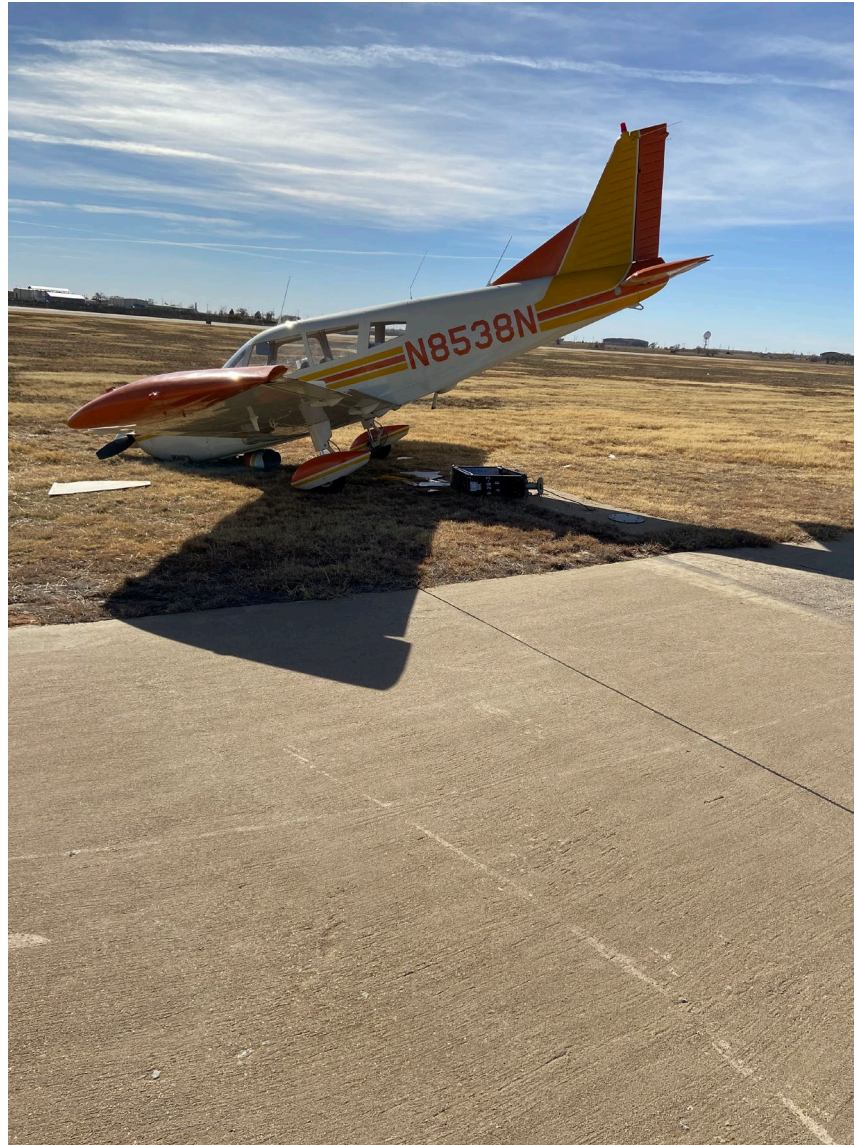
**Photograph 1 - View of the left side of the airplane (Courtesy of the Federal Aviation Administration)**

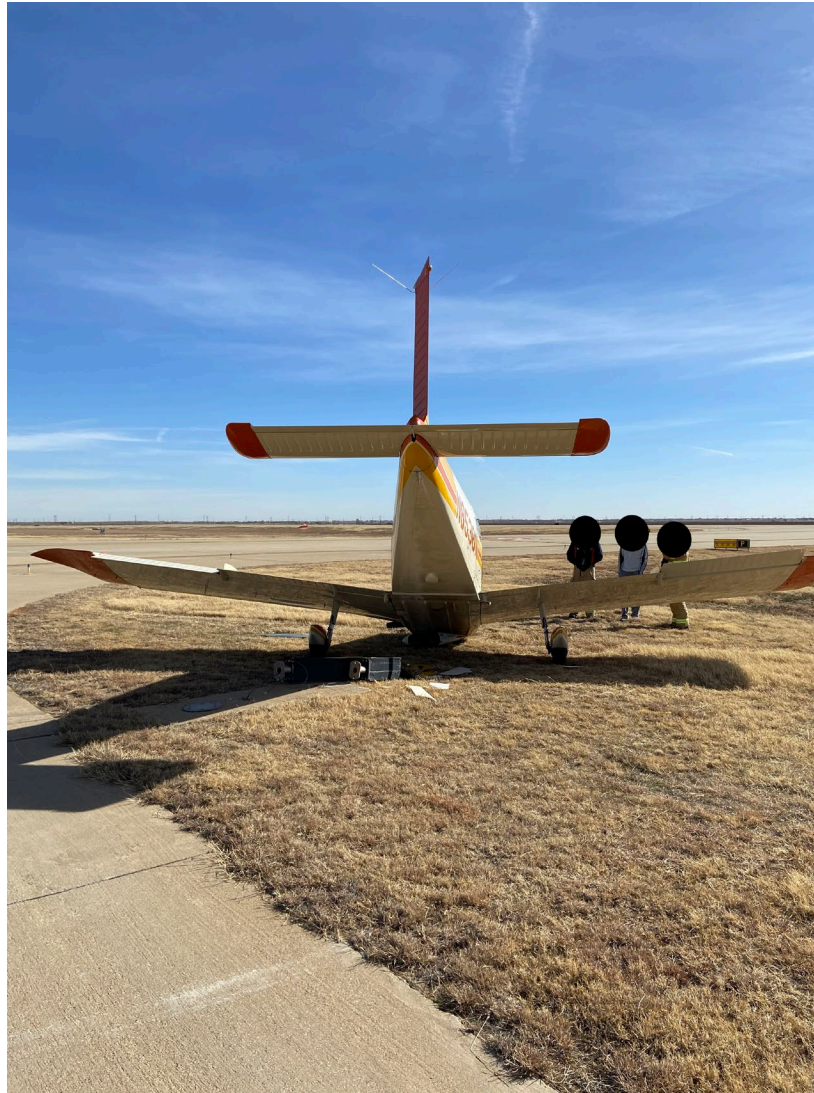
**Photograph 2 - View of the rear of the airplane (Courtesy of the Federal Aviation Administration)**

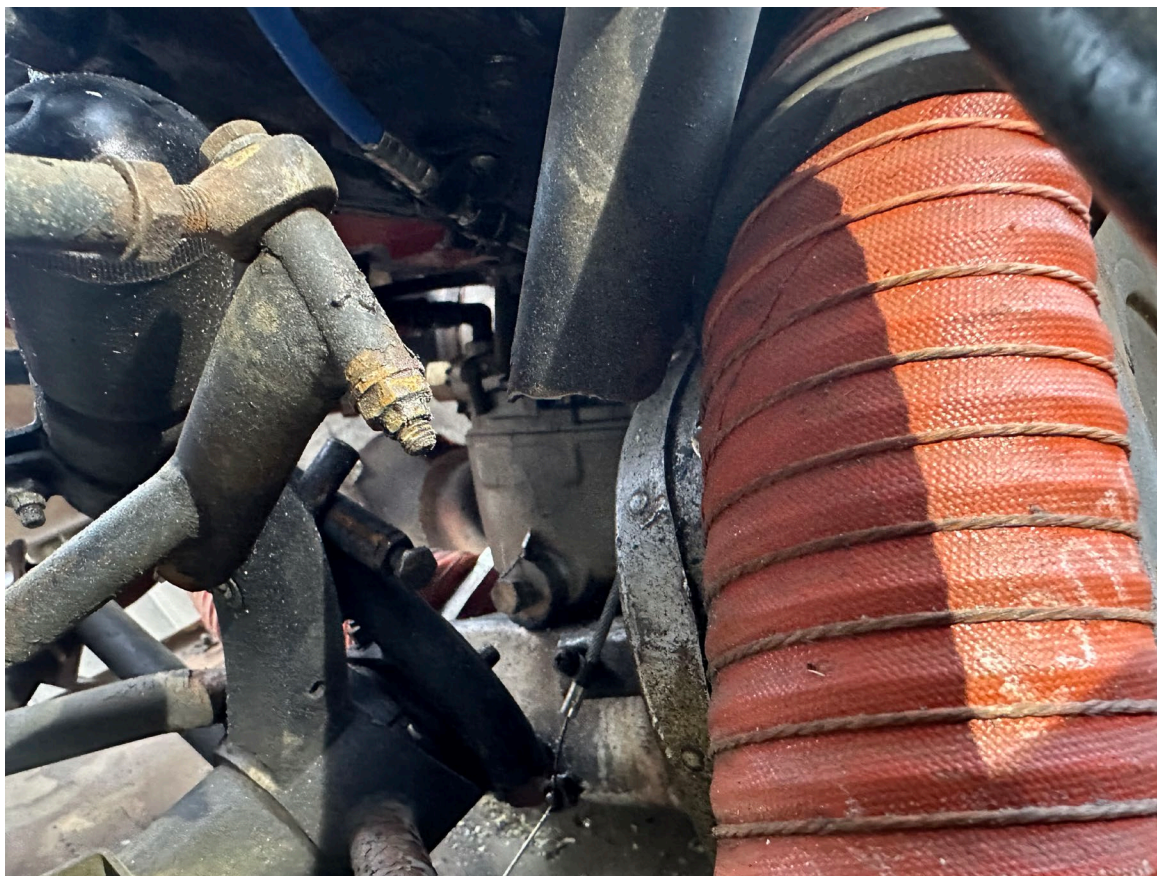
**Photograph 4 - View of the fractured engine mount (Courtesy of Lubbock Aero)**

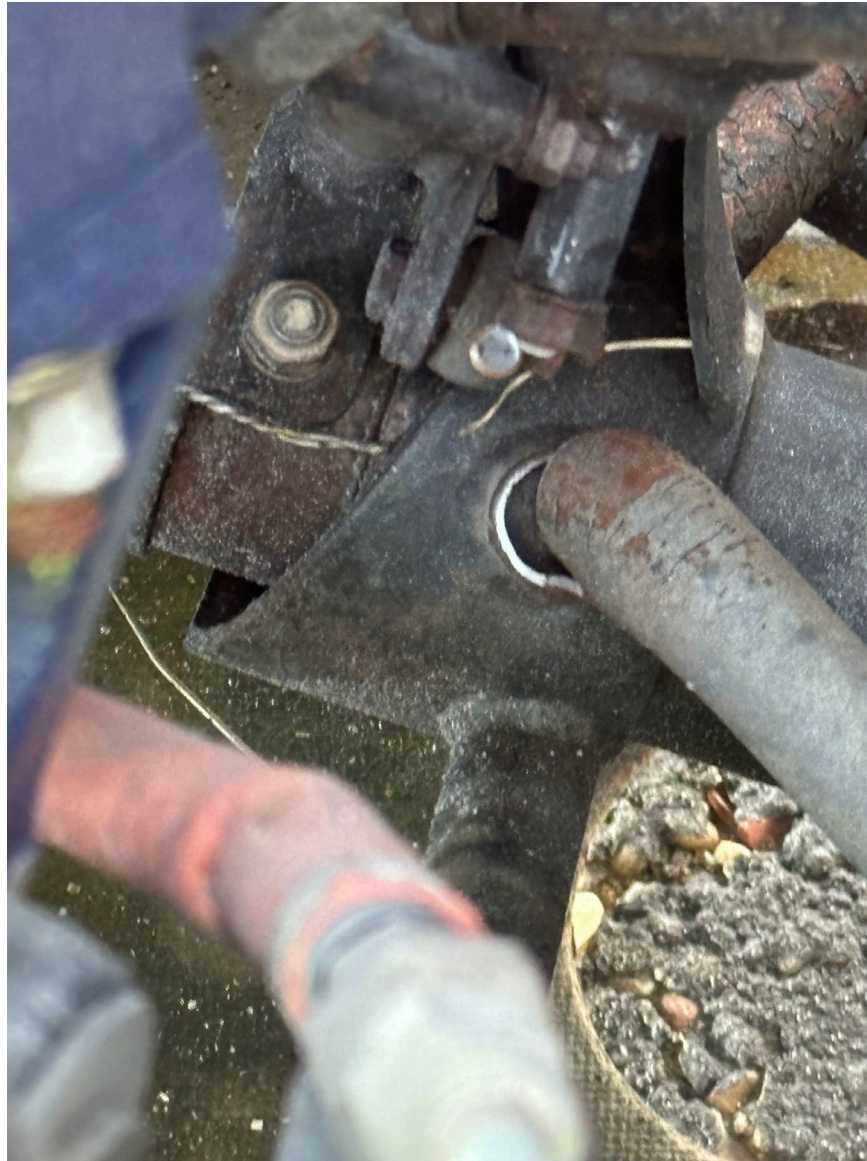
**Photograph 5 - View of the fractured engine mount (Courtesy of Lubbock Aero)**
