## Material & Process Engineering Report

**Report Title:** Examination of a Broken Spring Pin, P/N A-3150-18, McCauley Governor Assembly, Model 421C, NTSB Investigation CEN24LA061

**Report No.:** 24-359-183

**Date:** December 12, 2024

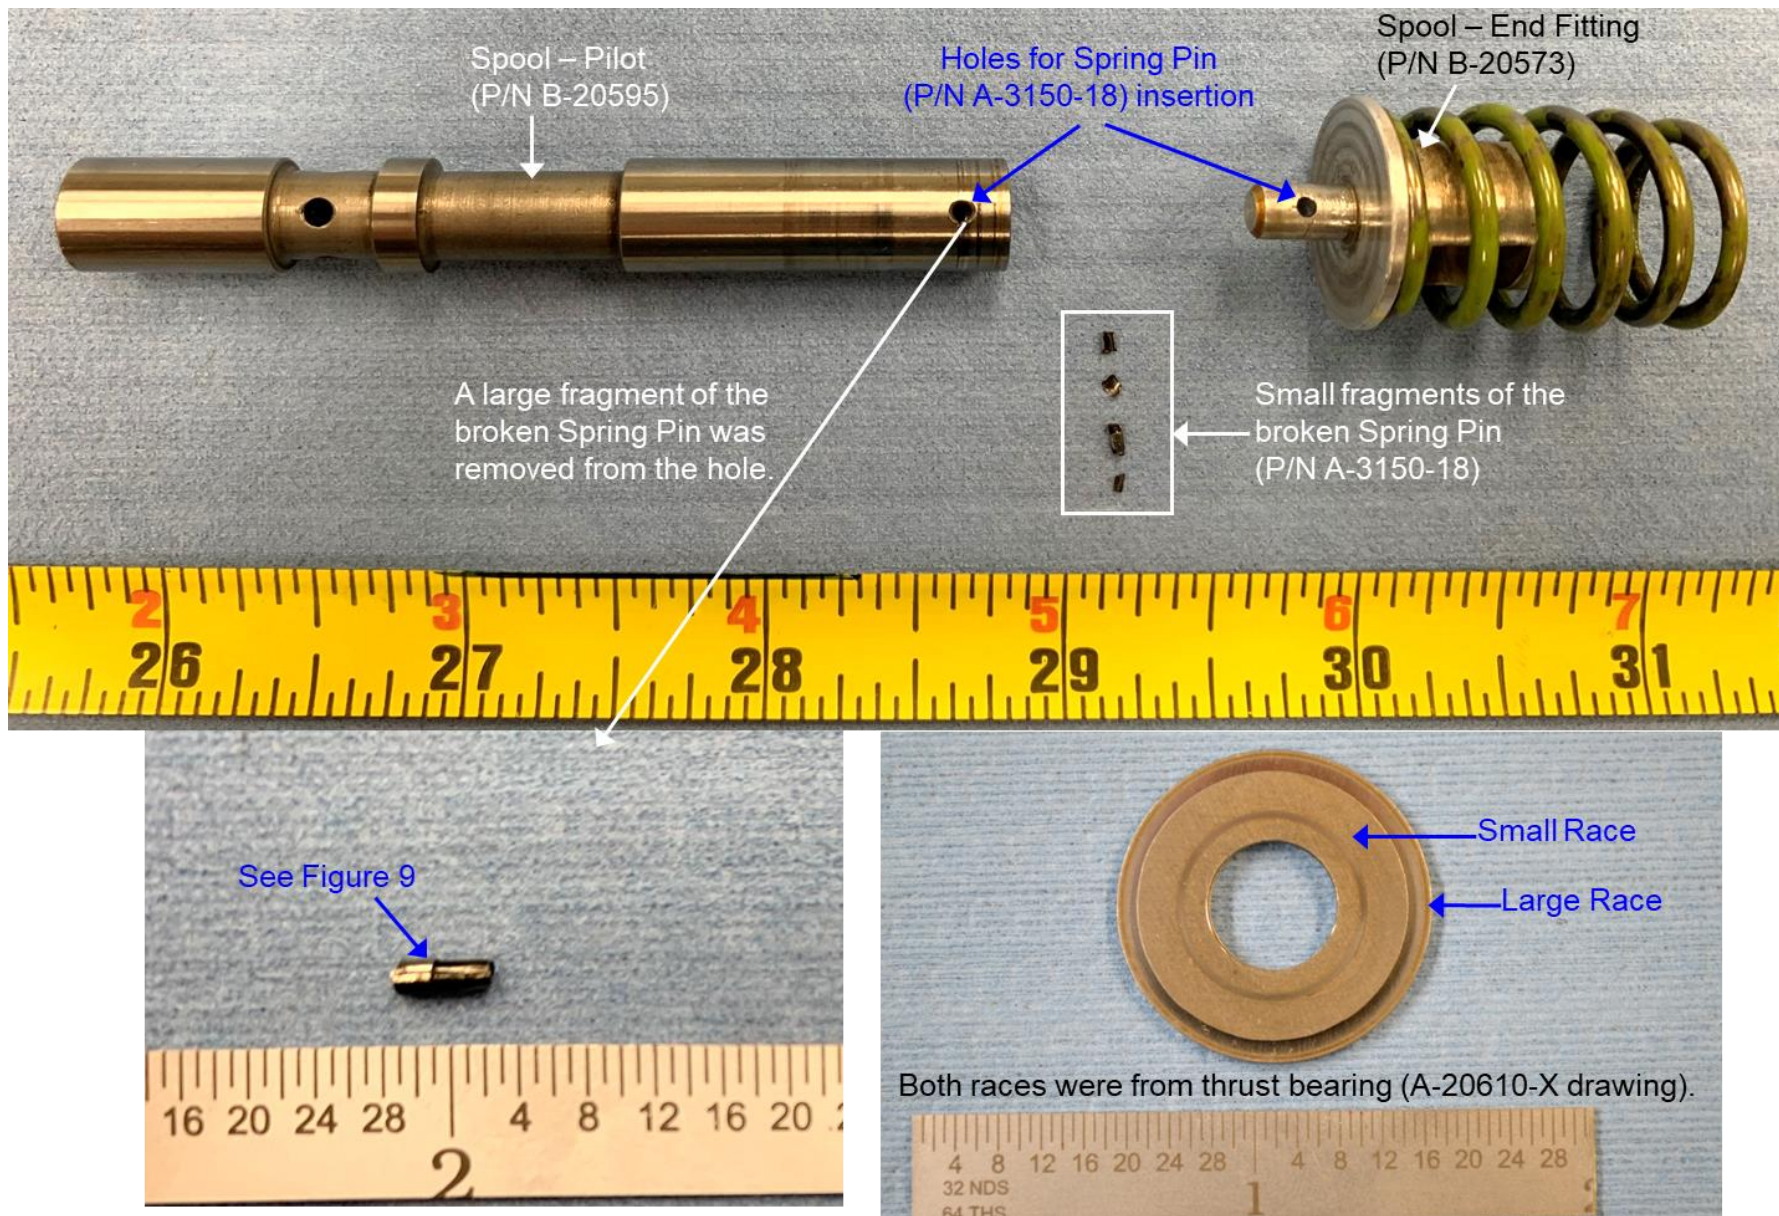
Figure 4 depicts images of the components from the Governor Assembly-DCFS (P/N D-20741) in the condition in which they were received by M&P. The A-3150-18 Spring Pin was broken into multiple fragments. The spring pin is used to pin B-20595 Spool – Pilot to B-20573 Spool – End Fitting. Optical and SEM images from the OD surface of the spool – pilot are shown in Figure 5. Shallow indentations and a gold-colored residue were observed near the hole for the spring pin insertion. EDS examination revealed that the gold-colored residue contained C, O, Pb, and Br (see Figure 6).

Figure 4. Images of the components from the Governor Assembly-DCFS (P/N D-20741) in the condition in which they were received by M&P. B-20595 Spool - Pilot and B-20573 Spool - End Fitting are cross-pinned with an A-3150-18 Spring Pin. Two races from the A-20610-X Thrust

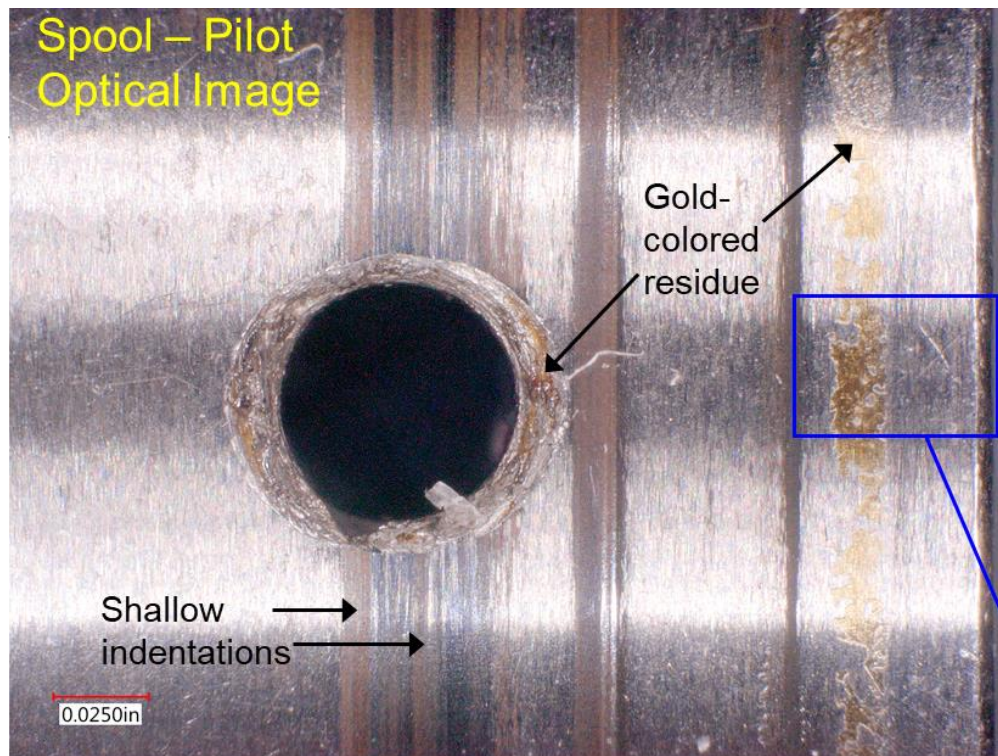
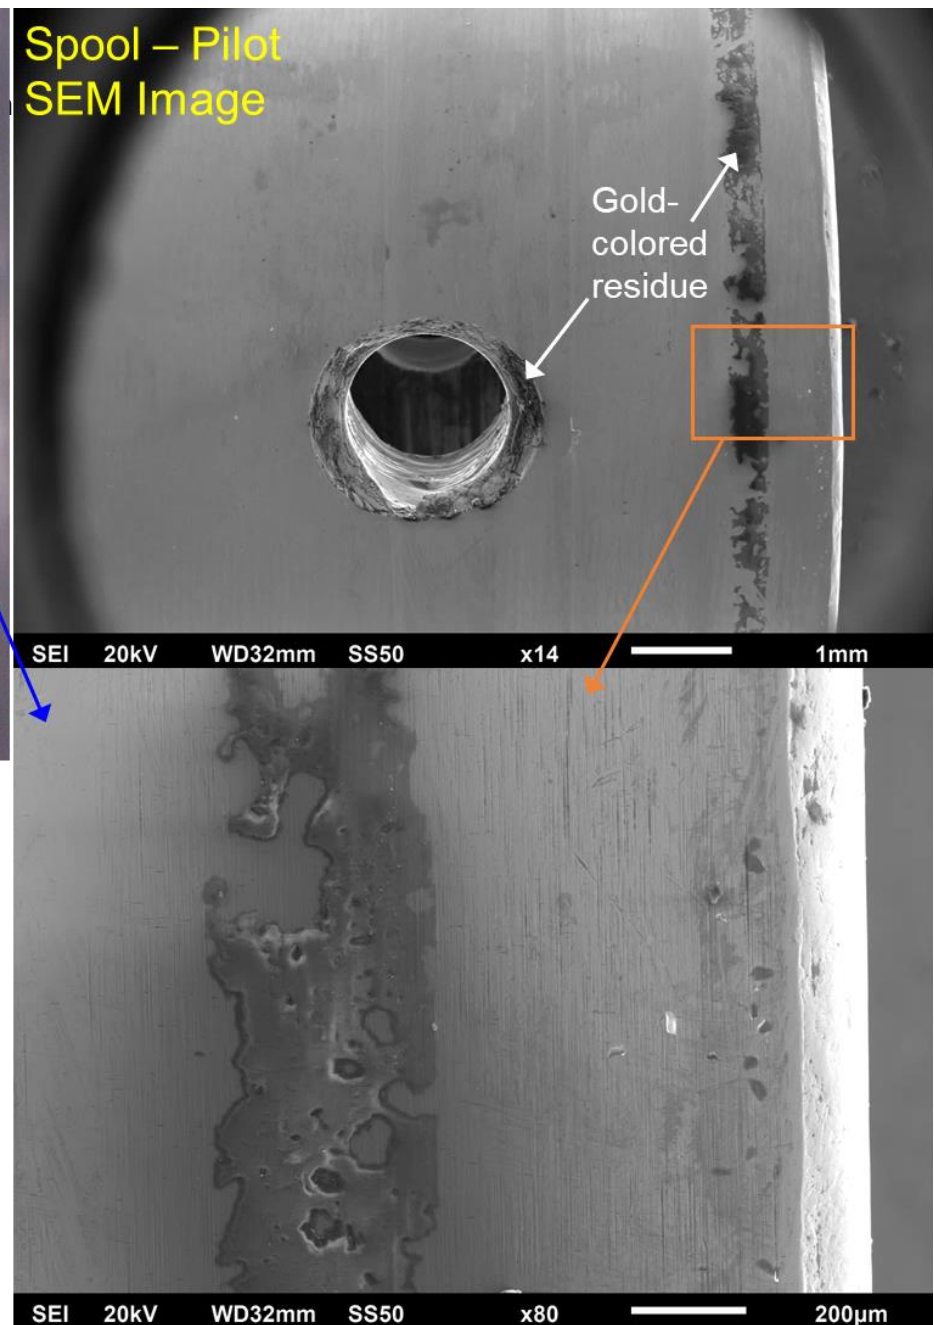
Figure 5. Optical and SEM images from the OD surface of the B-20595 Spool – Pilot. Shallow indentations and a gold-colored residue were observed near the hole for the Spring Pin insertion. Magnifications: x14, x20, and x80.

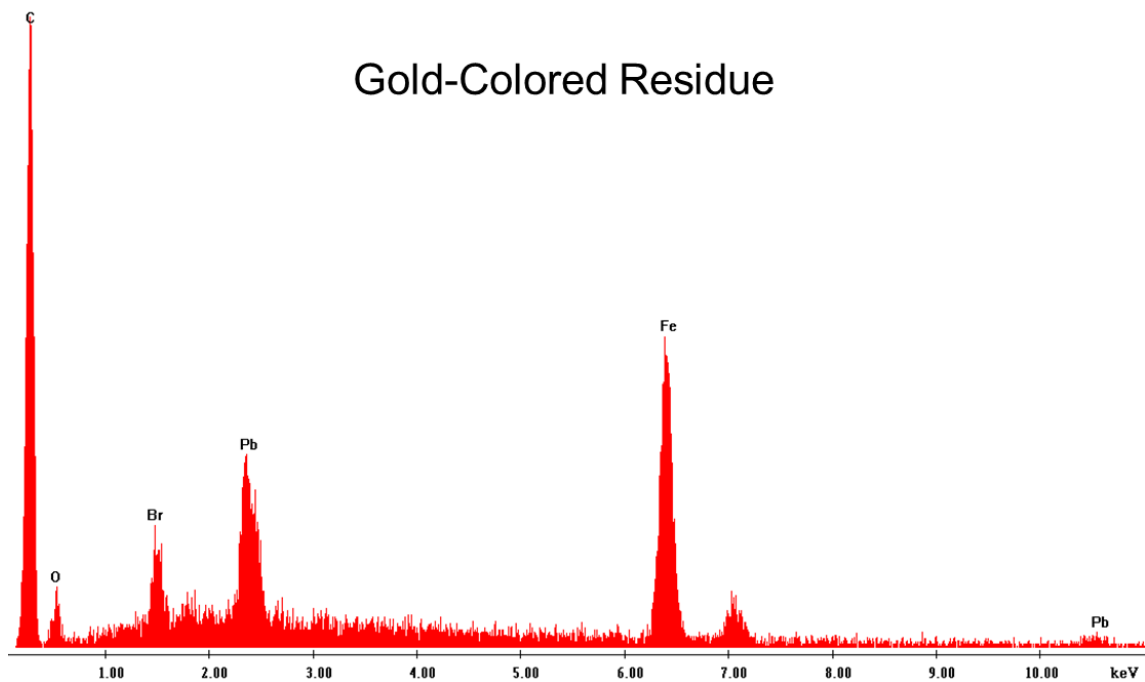
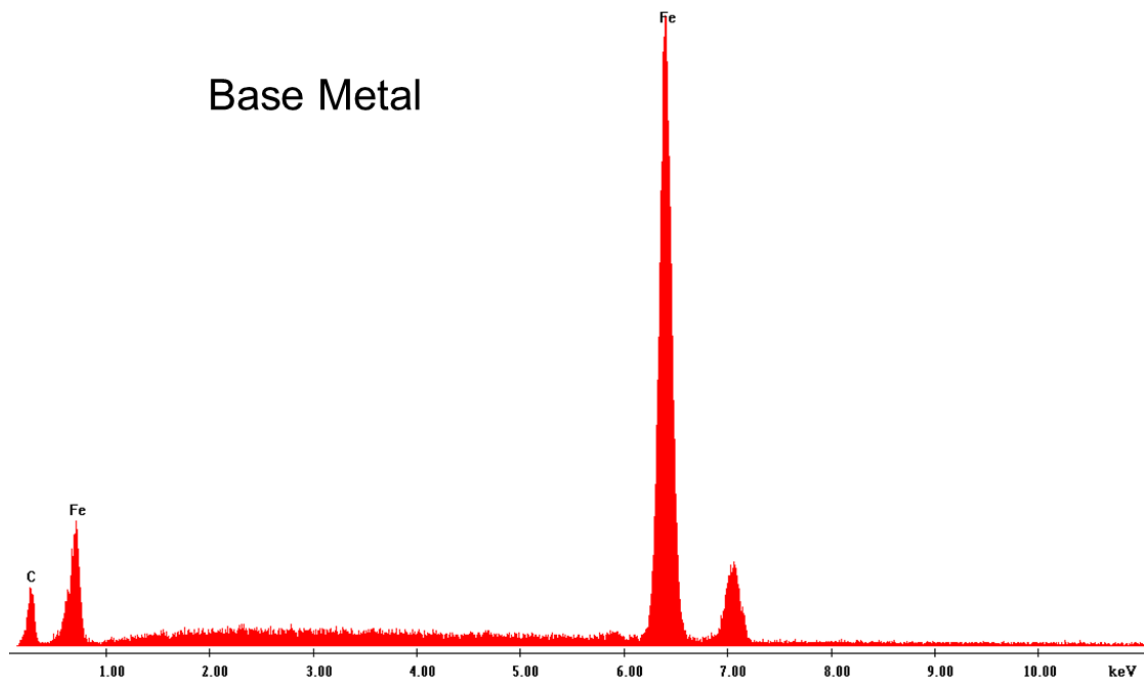
Figure 6. Typical EDS spectra from the gold-colored residue and base metal in Figure 4. The residue contained C, O, Pb, and Br.

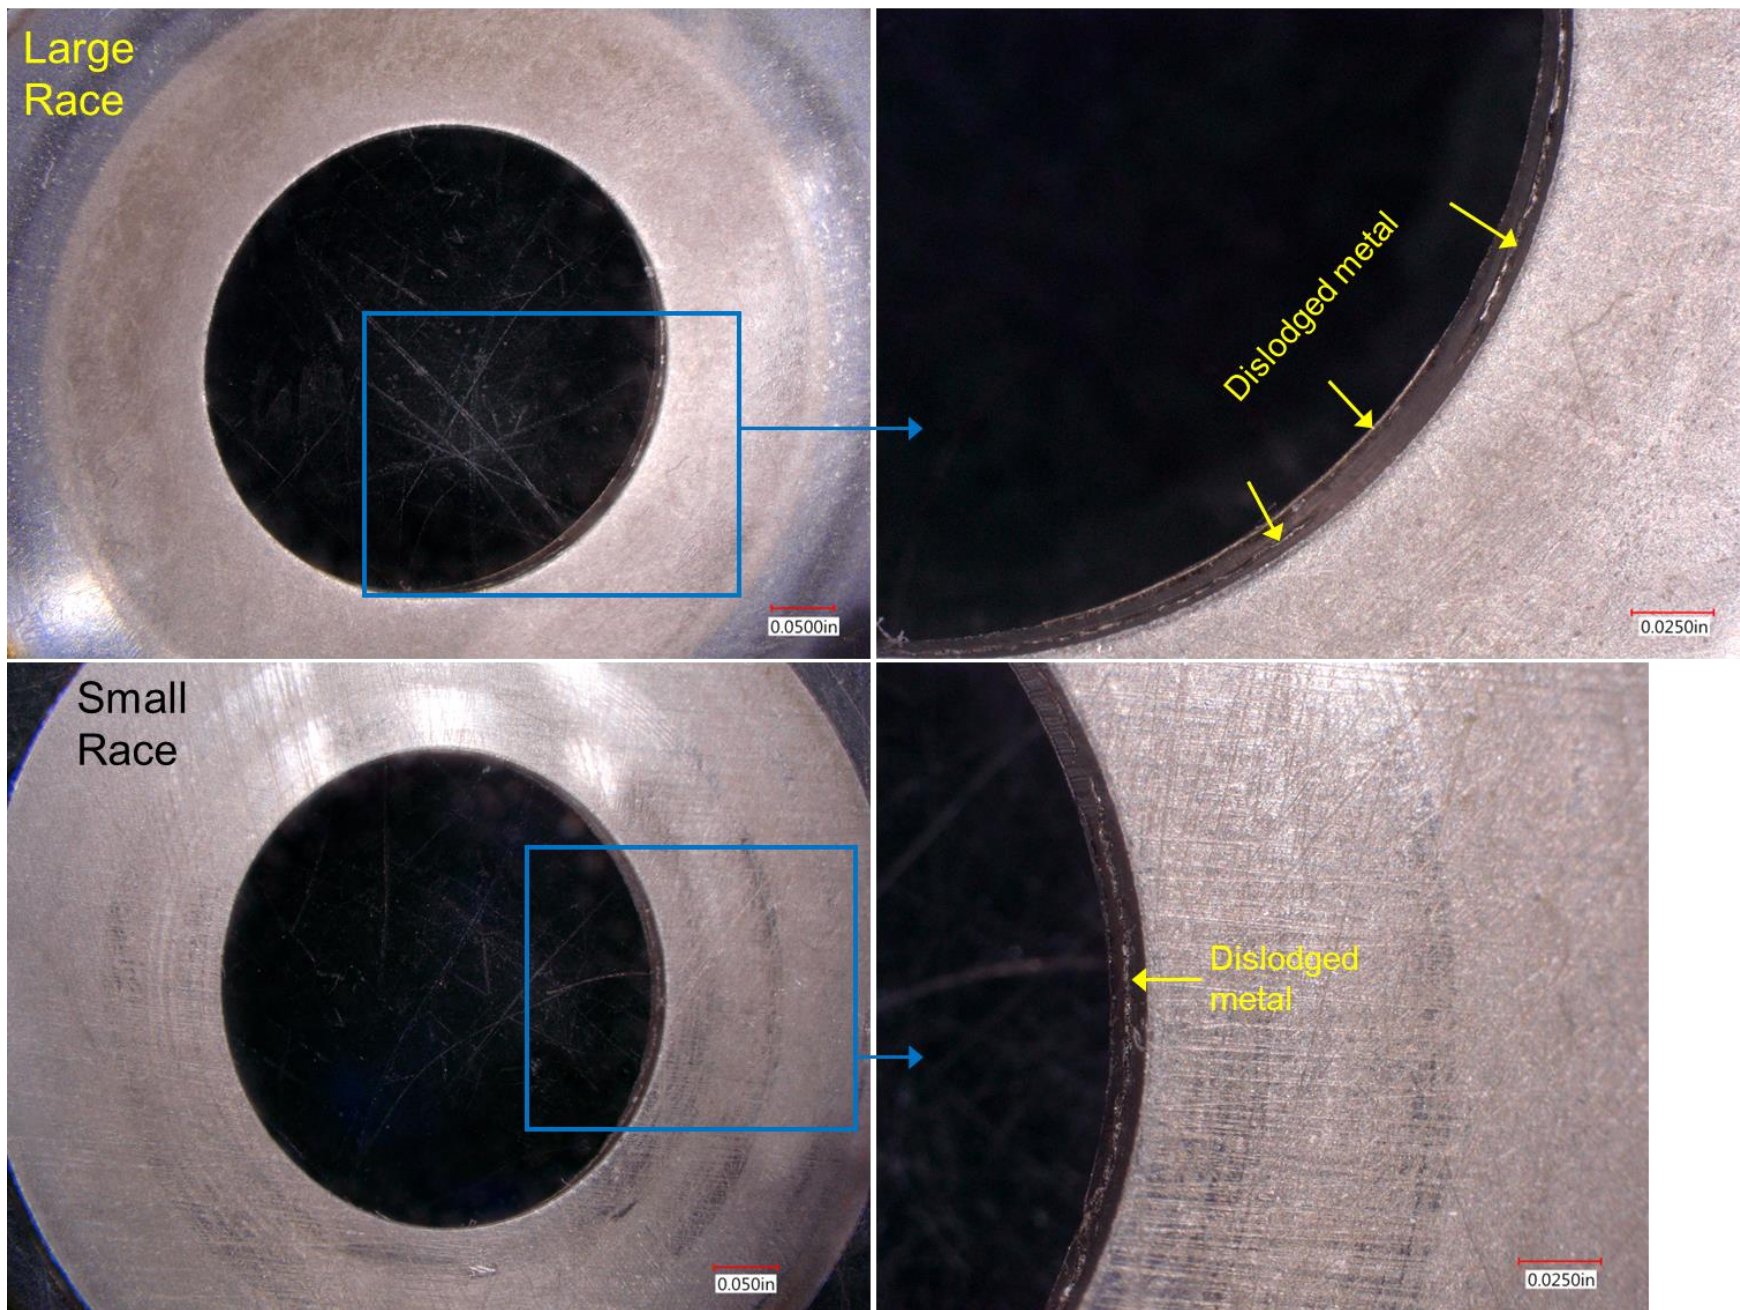
Figure 7 illustrates optical images from the two races in Figure 4. During operation, the ID surface of both the races was in contact with the OD surface of the spool – pilot. Metal dislodged from the OD surface of the spool – pilot (shallow indentations in Figure 5) was observed on the ID surface of both the races (Figure 7). Optical images from the OD surface of the B-20573 Spool – End Fitting are depicted in Figure 8. No foreign material was observed.

Figure 7. Optical images from the two races in Figure 5. Both the races were tilted before imaging. Metal dislodged from the OD surface of the B-20595 Spool – Pilot (shallow indentations in Figure 4) was observed on the ID surface of both the races. Magnifications: x7 and x17.

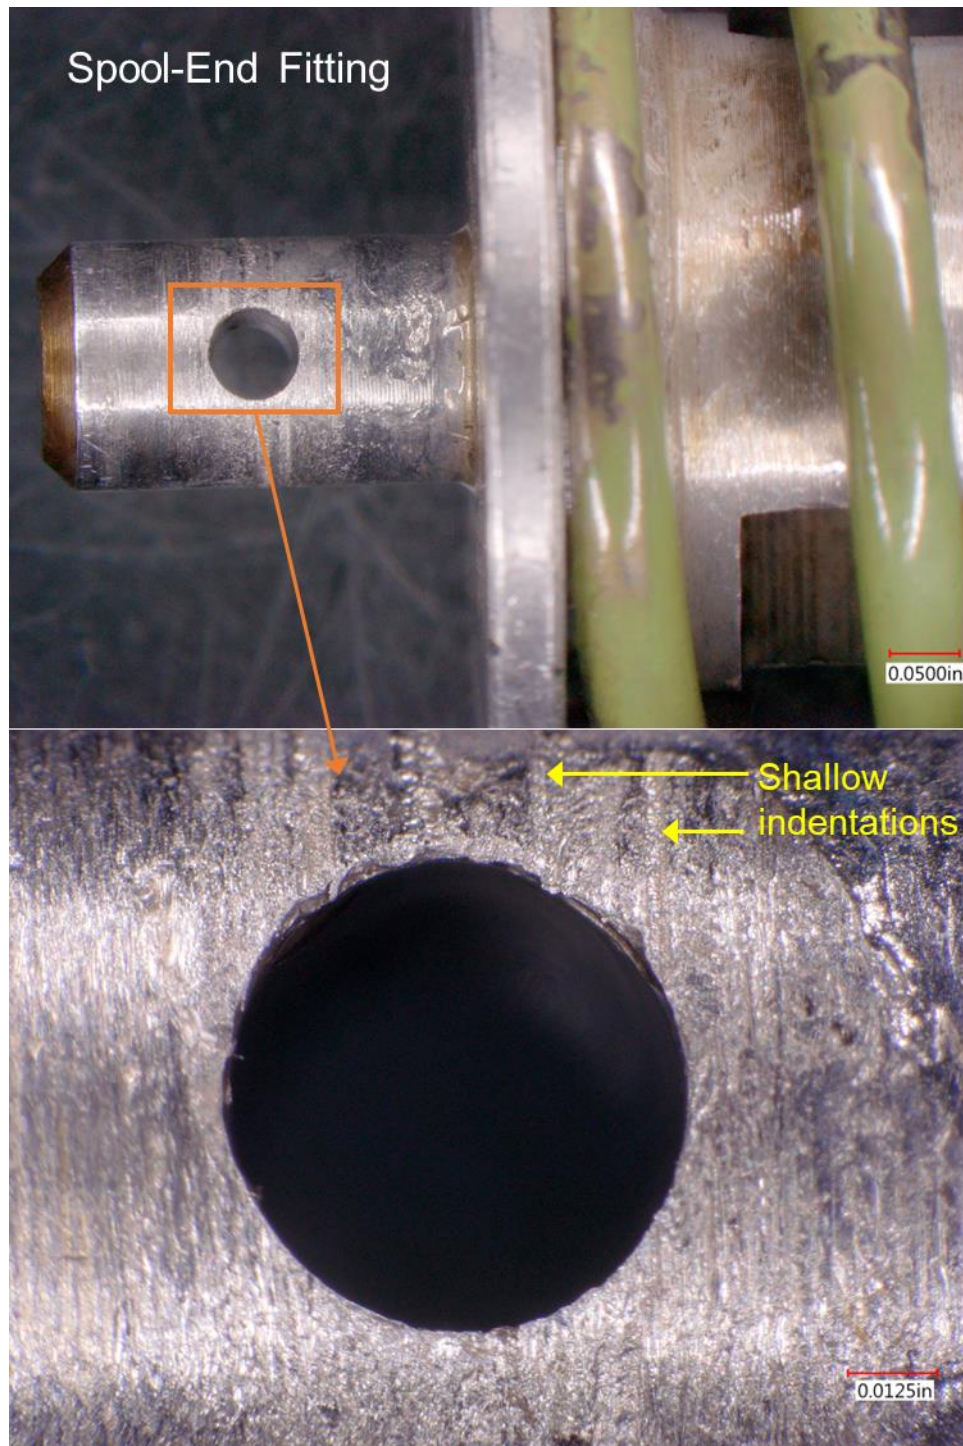
Figure 8. Optical images from the OD surface of the B-20573 Spool – End Fitting. Shallow indentations were observed near the hole for the spring pin insertion with no foreign material being present. Magnifications: x7 and x37.

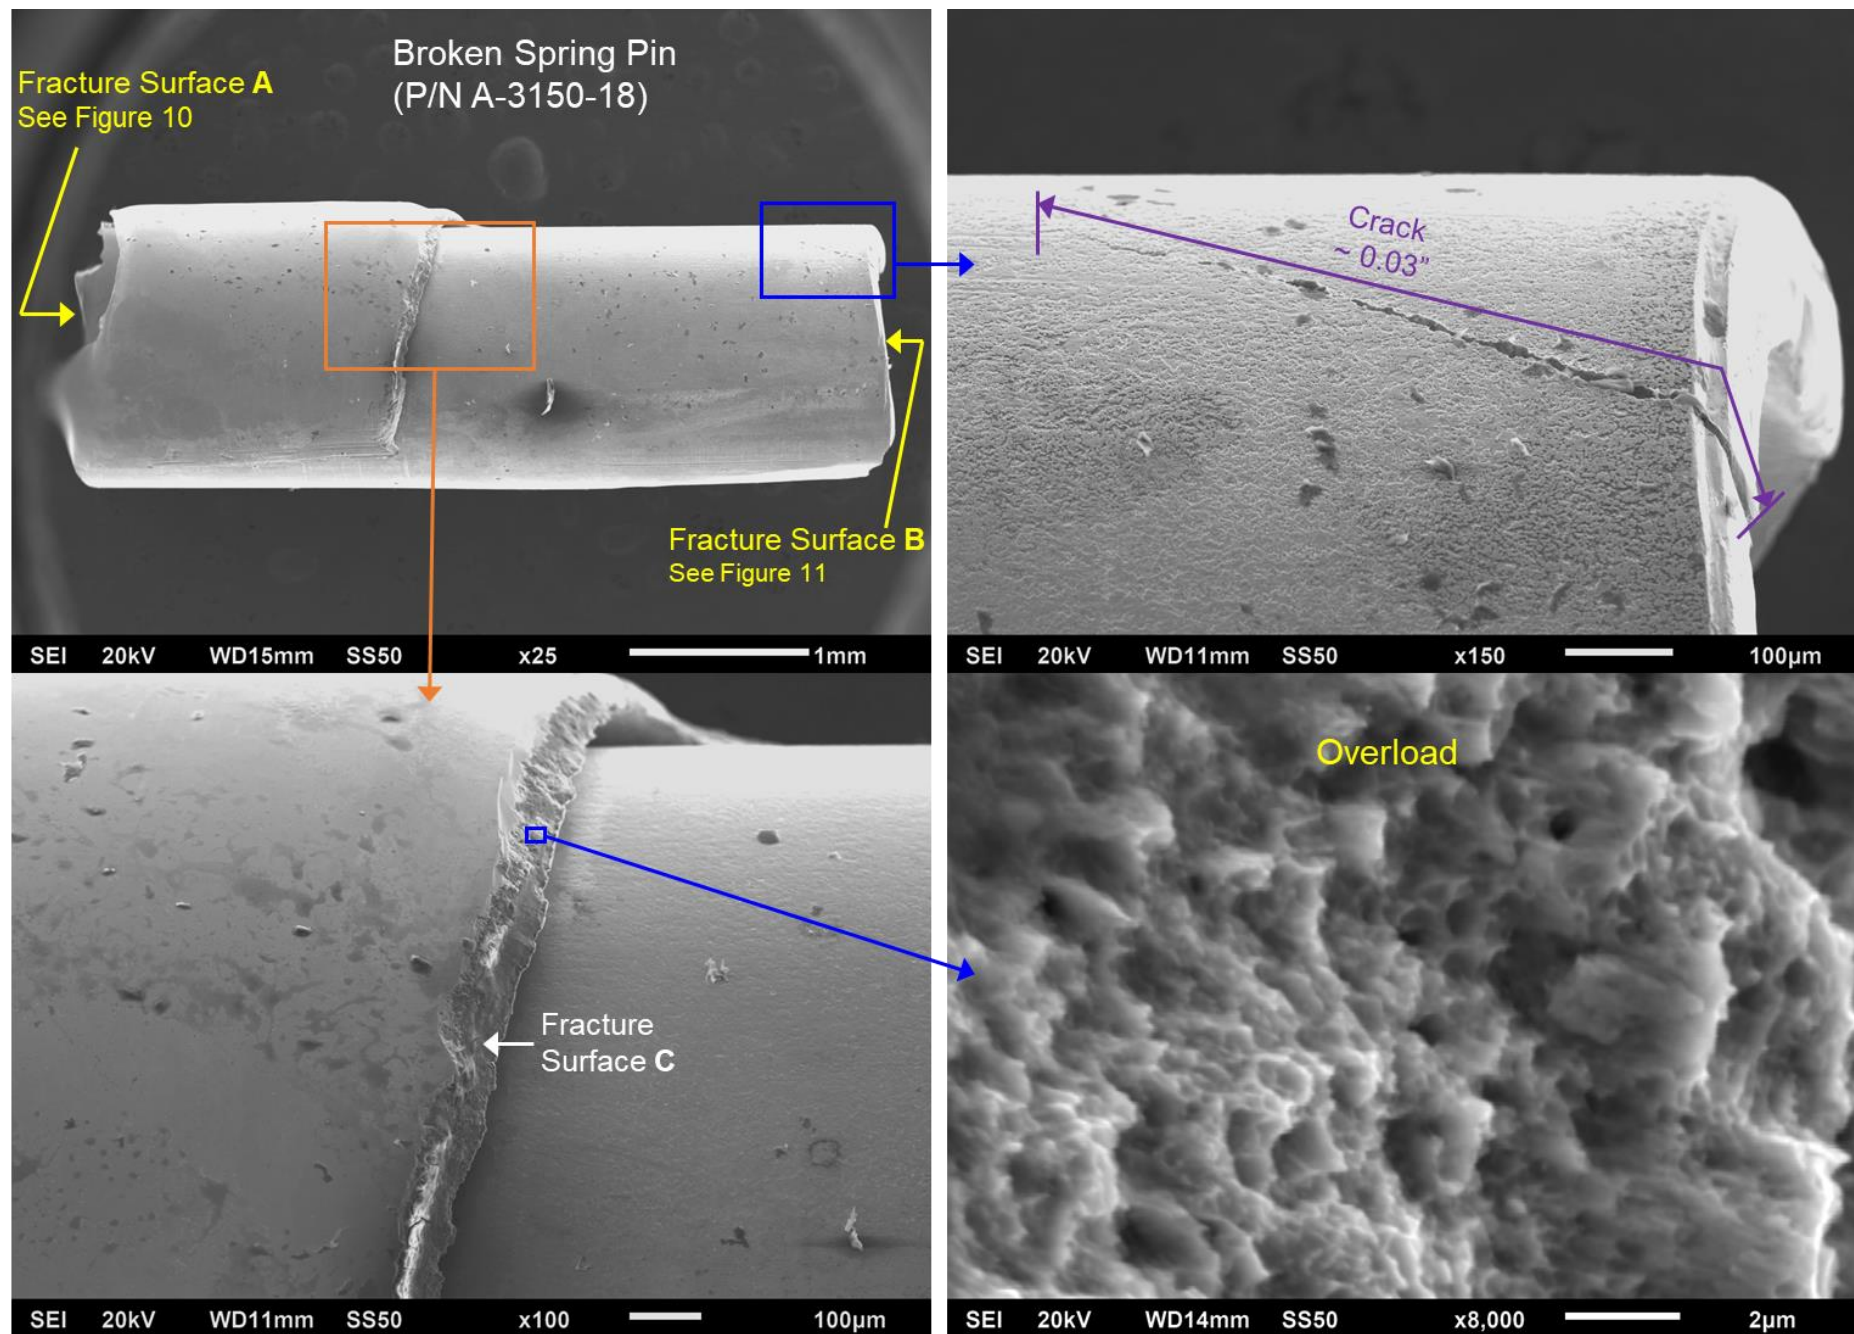
1. A-3150-18 Spring Pin was broken into multiple fragments. Representative fracture surfaces exhibited elongated dimples with no fatigue features. Thus, the mode of failure was determined to be shear overload.

Figure 9 illustrates SEM micrographs from the OD surface of the large fragment from the broken Spring Pin (P/N A-3150-18). Elongated dimples on Fracture Surface C suggested a shear overload failure mode. A crack with an approximate length of 0.03" was observed on the OD surface. Elongated dimples indicative of the shear overload were also observed on Fracture Surfaces A and B, as shown in Figures 10 and 11, respectively.

Figure 9. SEM images from the OD surface of the large fragment from the broken Spring Pin (P/N A-3150-18) in Figure 4. Elongated dimples on the Fracture Surface C suggested a shear overload failure mode. A crack with an approximate length of 0.03" was also observed.

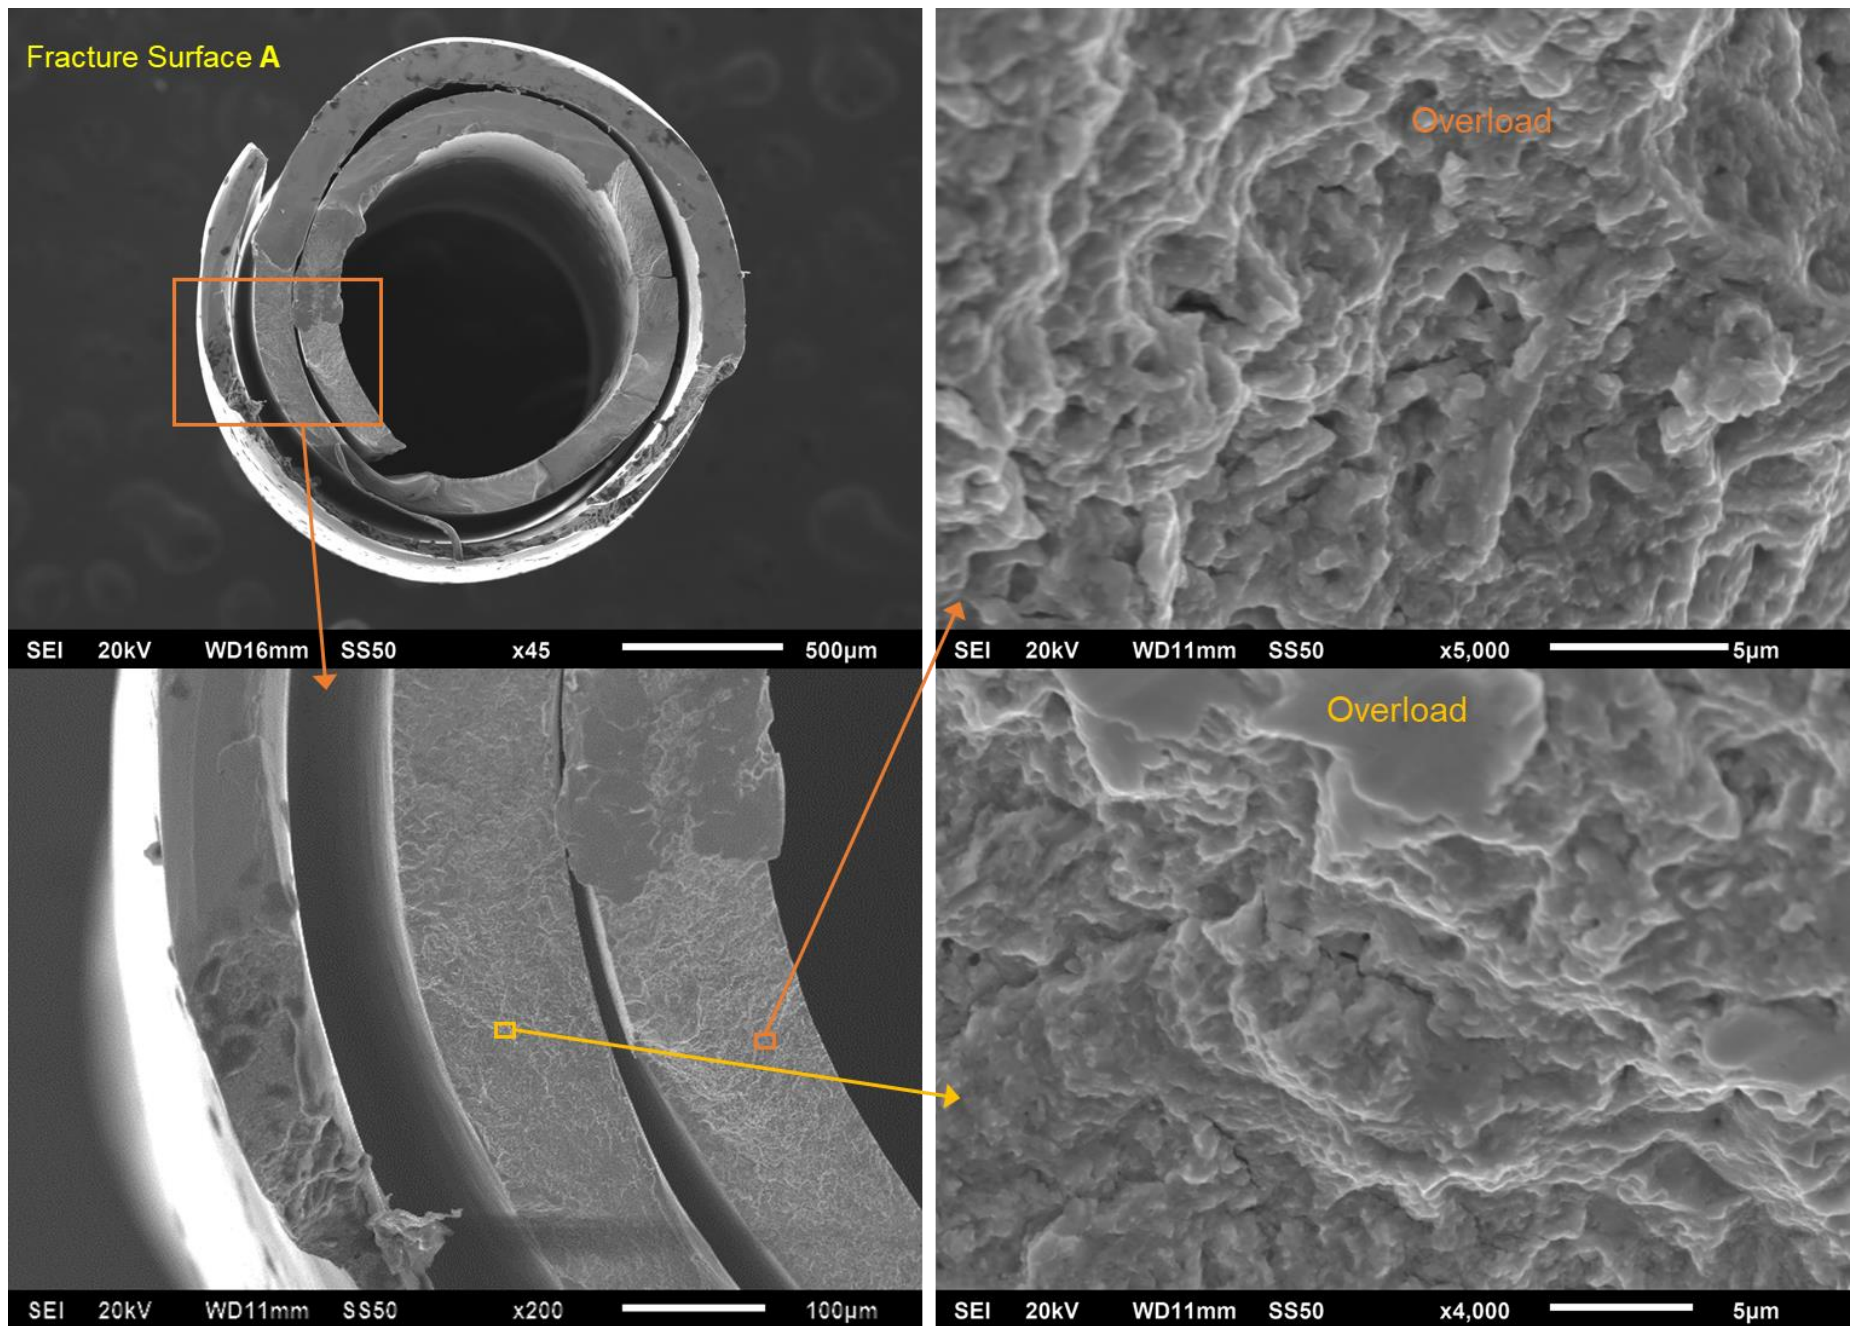
Figure 10. SEM micrographs from Fracture Surface A in Figure 9. Elongated dimples on the fracture surface suggested a shear overload failure mode.

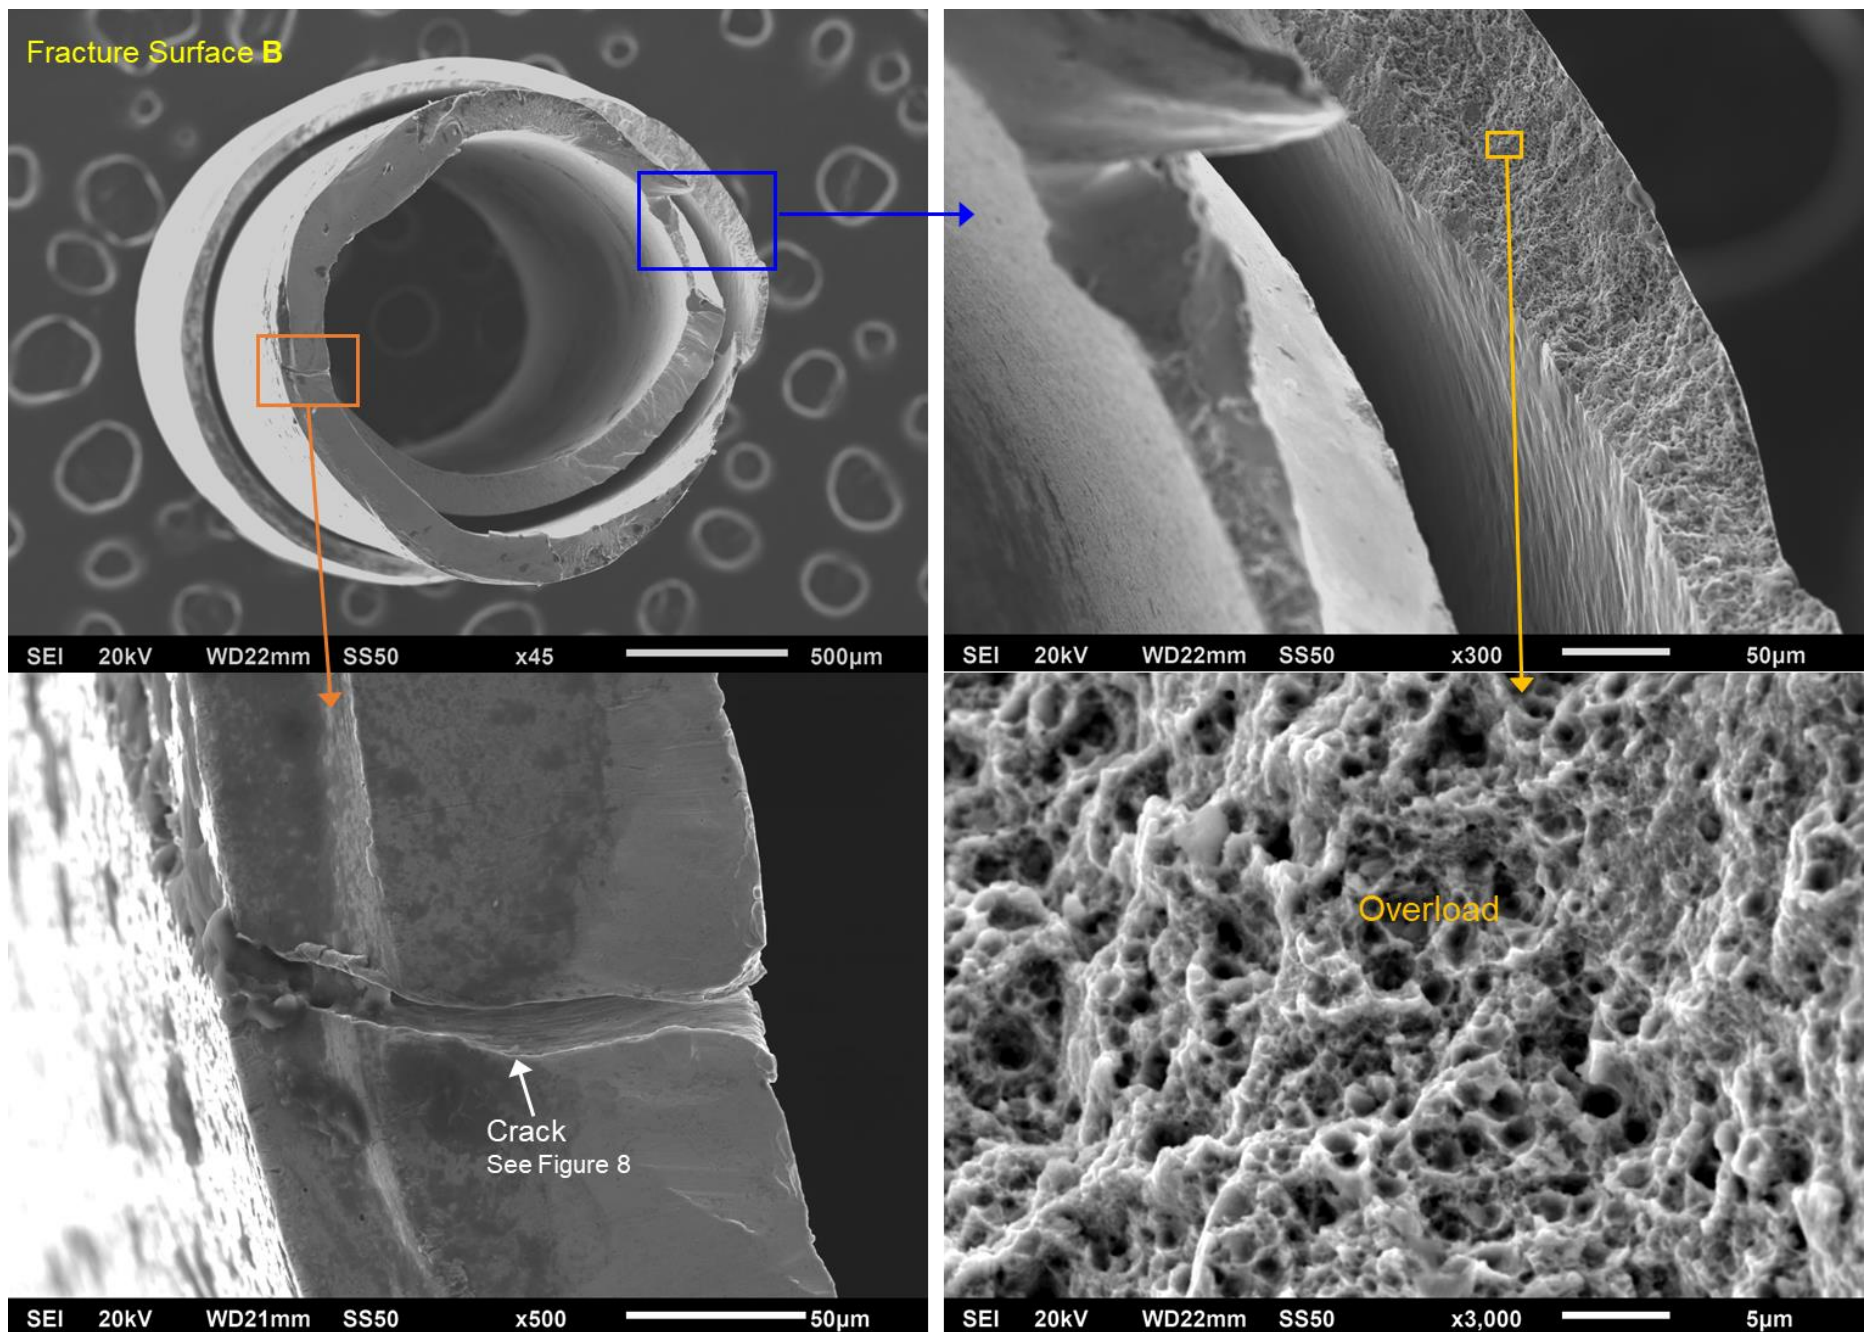
Figure 11. SEM micrographs from Fracture Surface B in Figure 9. Elongated dimples on the fracture surface suggested a shear overload failure mode.

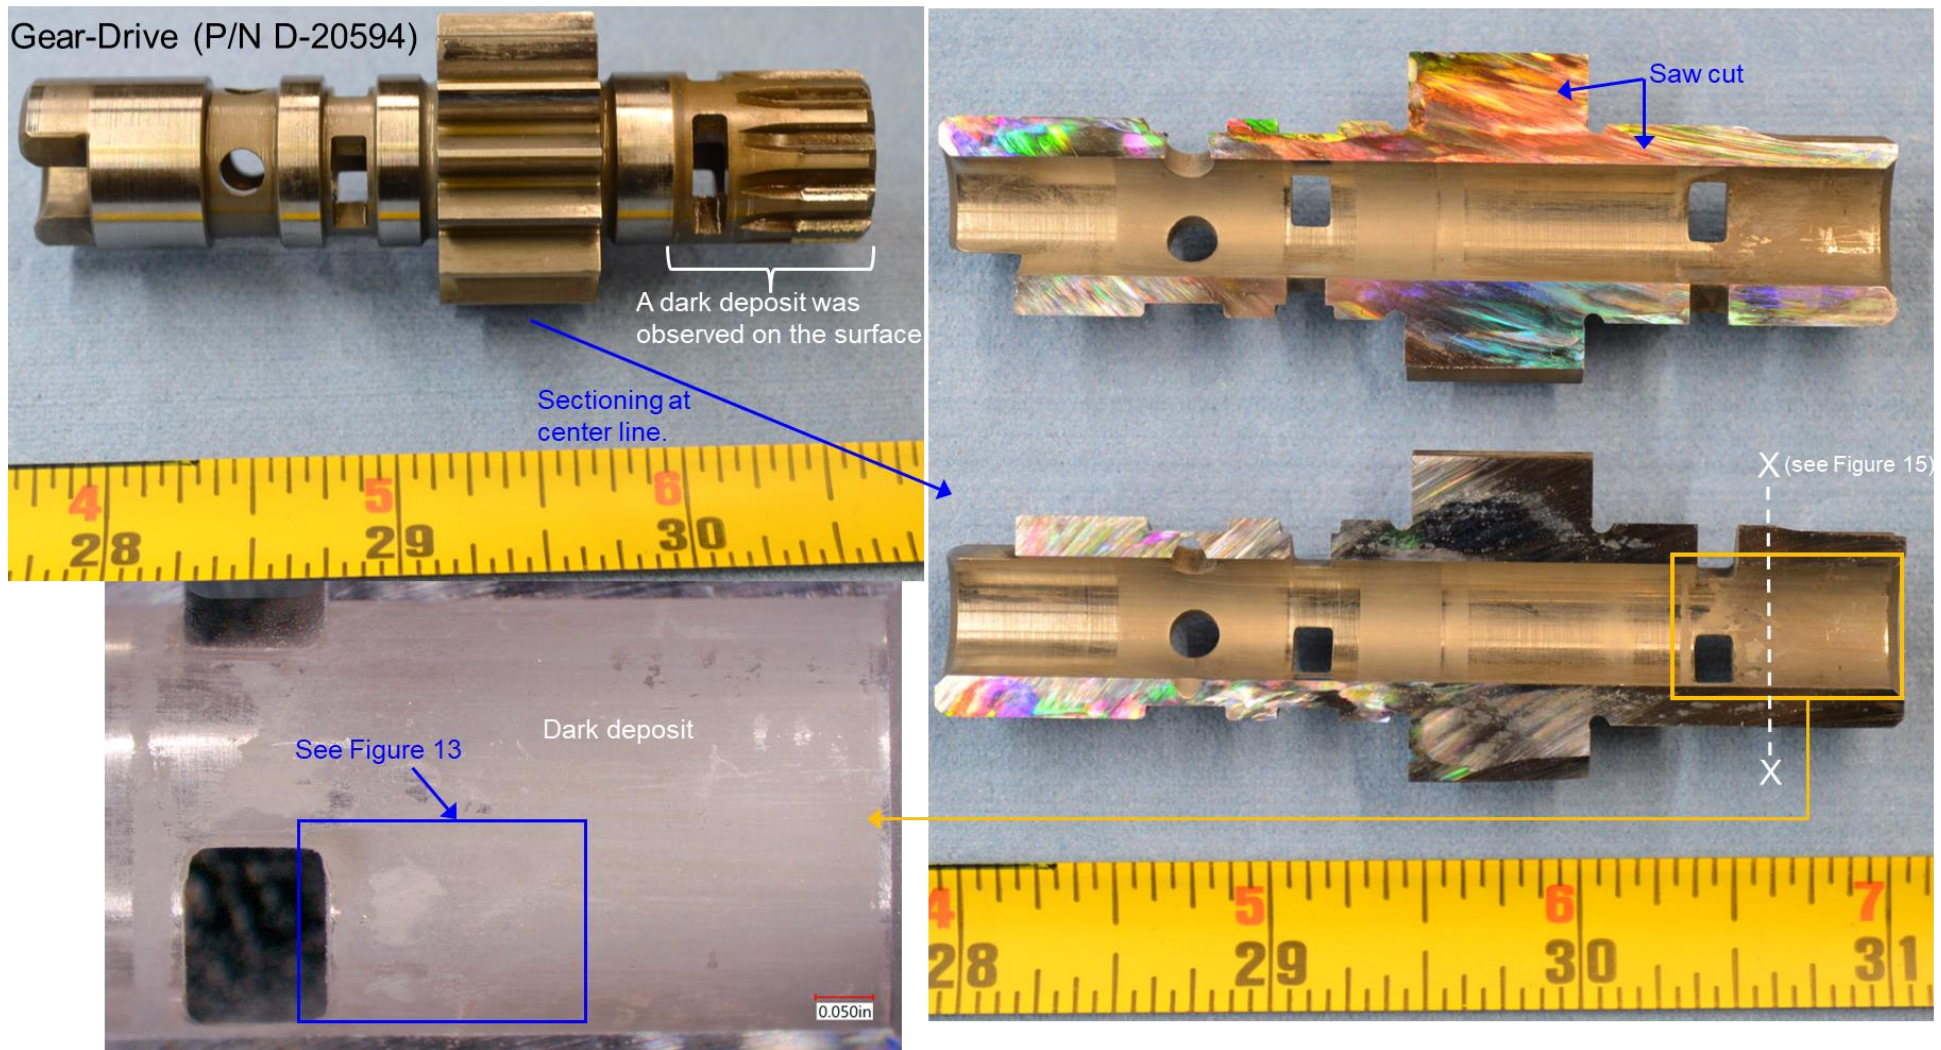
3. A Pb + Br deposit was observed on both OD and ID surface of the Gear – Drive (P/N D-20594) at its gear teeth end.
4. The gear teeth end of the gear – drive is not in contact with the Spool – Pilot (P/N B-20595) during operation. Thus, the deposit did not contribute to the fracture of the spring pin.

Figure 12 depicts images of the as-received Gear – Drive (P/N D-20594) from the Governor Assembly-DCFS (P/N D-20741) before and after sectioning. During operation, the non-rotating B-20595 Spool – Pilot in Figure 4 is housed inside the rotating D-20594 Gear – Drive. A dark deposit was observed on both OD and ID surface of the gear – drive at its gear teeth end. SEM micrographs from the dark deposit are shown in Figure 13. From EDS examination, the deposit was determined to mainly contain Pb and Br (see Figure 14).

Figure 12. Images of the as-received Gear – Drive (P/N D-20594) from the Governor Assembly-DCFS (P/N D-20741) before and after sectioning. In operation, the non-rotating B-20595 Spool – Pilot in Figure 4 is housed inside the rotating D-20594 Gear – Drive. A dark deposit was observed on both OD and ID surface of the gear – drive at its gear teeth end. Magnifications: x1.5 and x6.0.

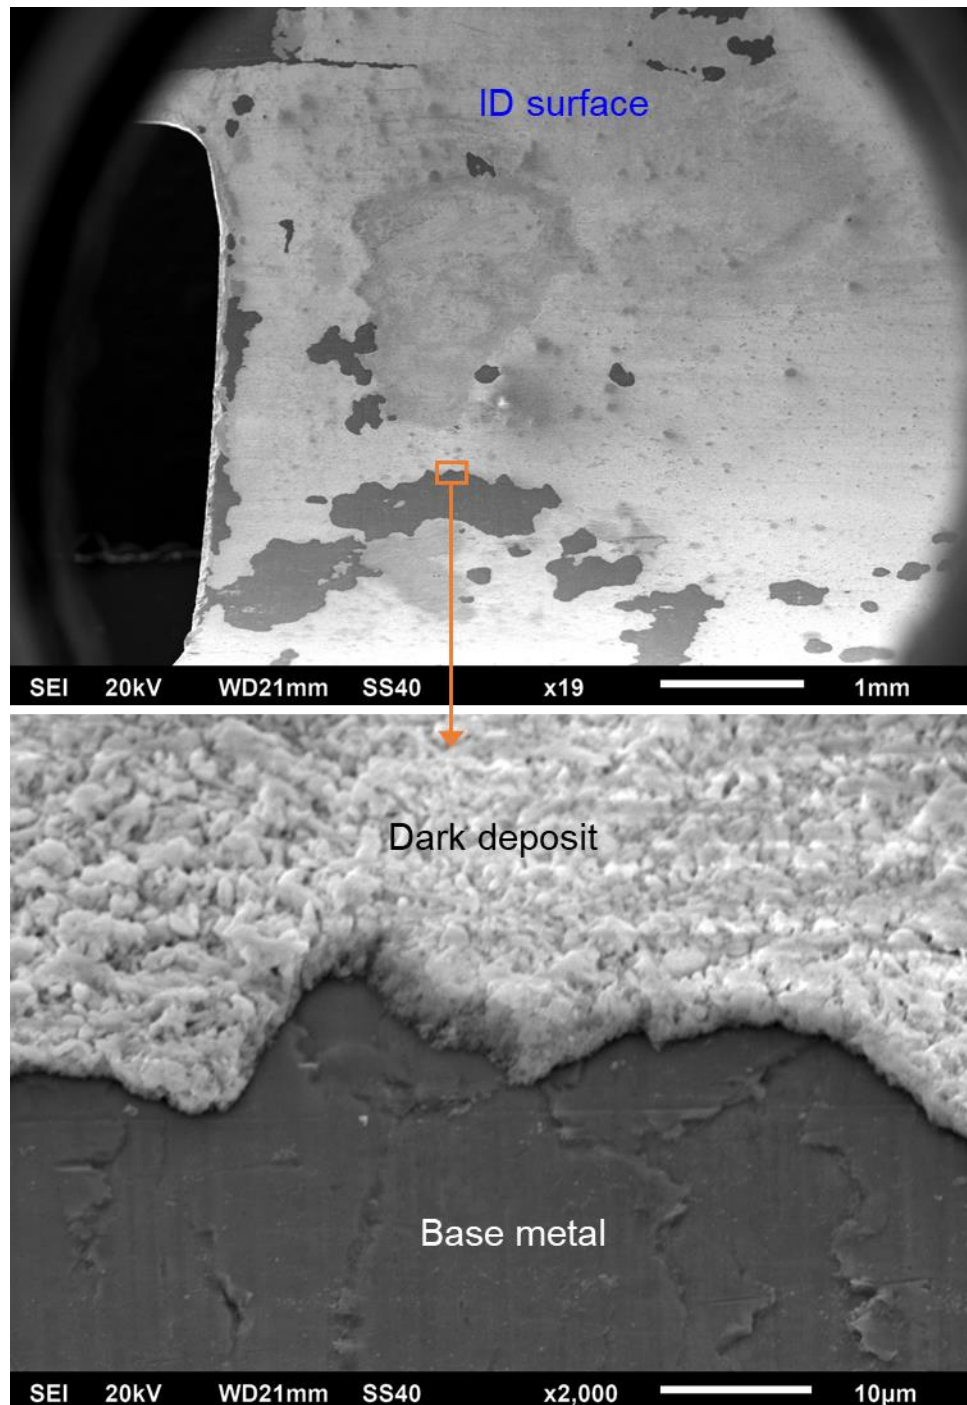
Figure 13. SEM micrographs from the ID surface of the D-20594 Gear – Drive (blue rectangle in Figure 12). Under electron microscopy, the dark deposit appeared lighter (in color) than the base metal.
