## Material & Process Engineering Report

**Report Title:** Examination of a Broken Spring Pin, P/N A-3150-18, McCauley Governor Assembly, Model 421C, NTSB Investigation CEN24LA061

**Report No.:** 24-359-183

**Date:** December 12, 2024

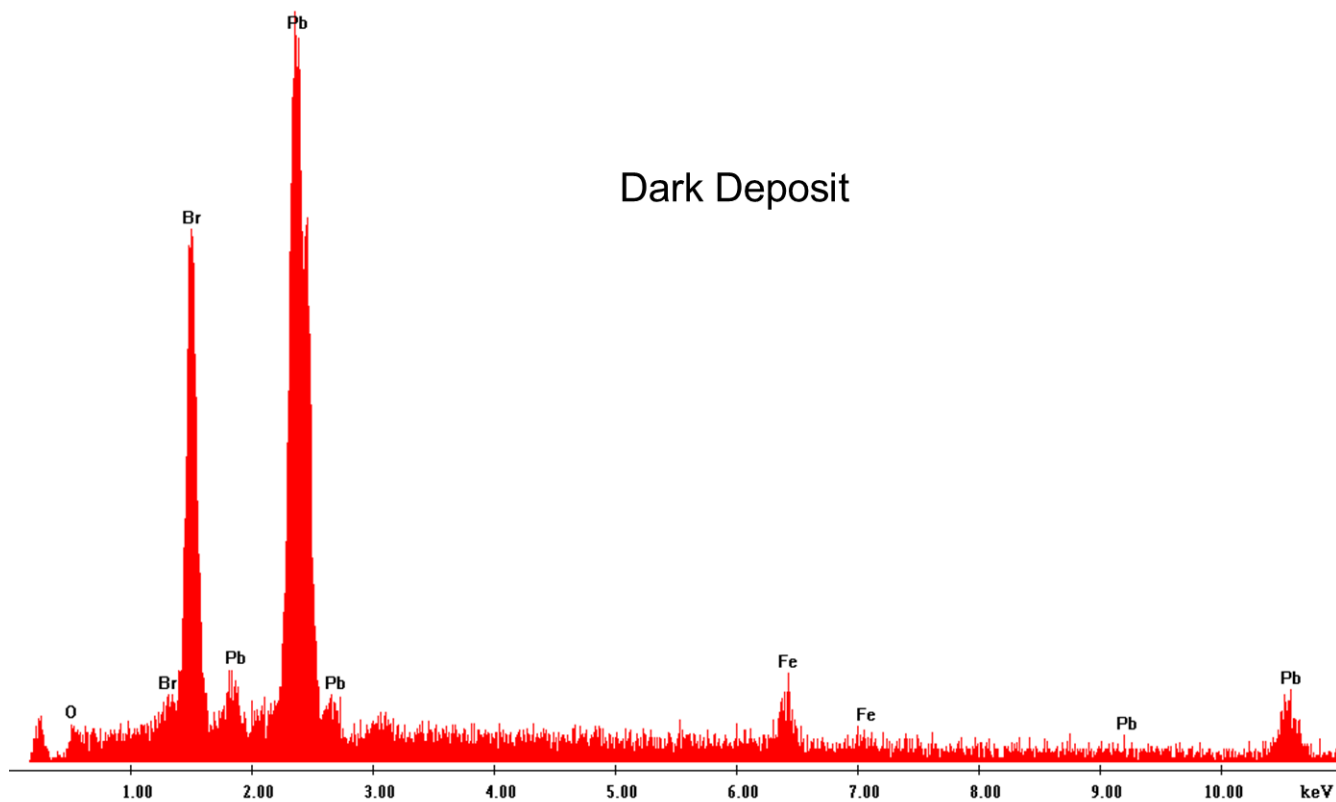
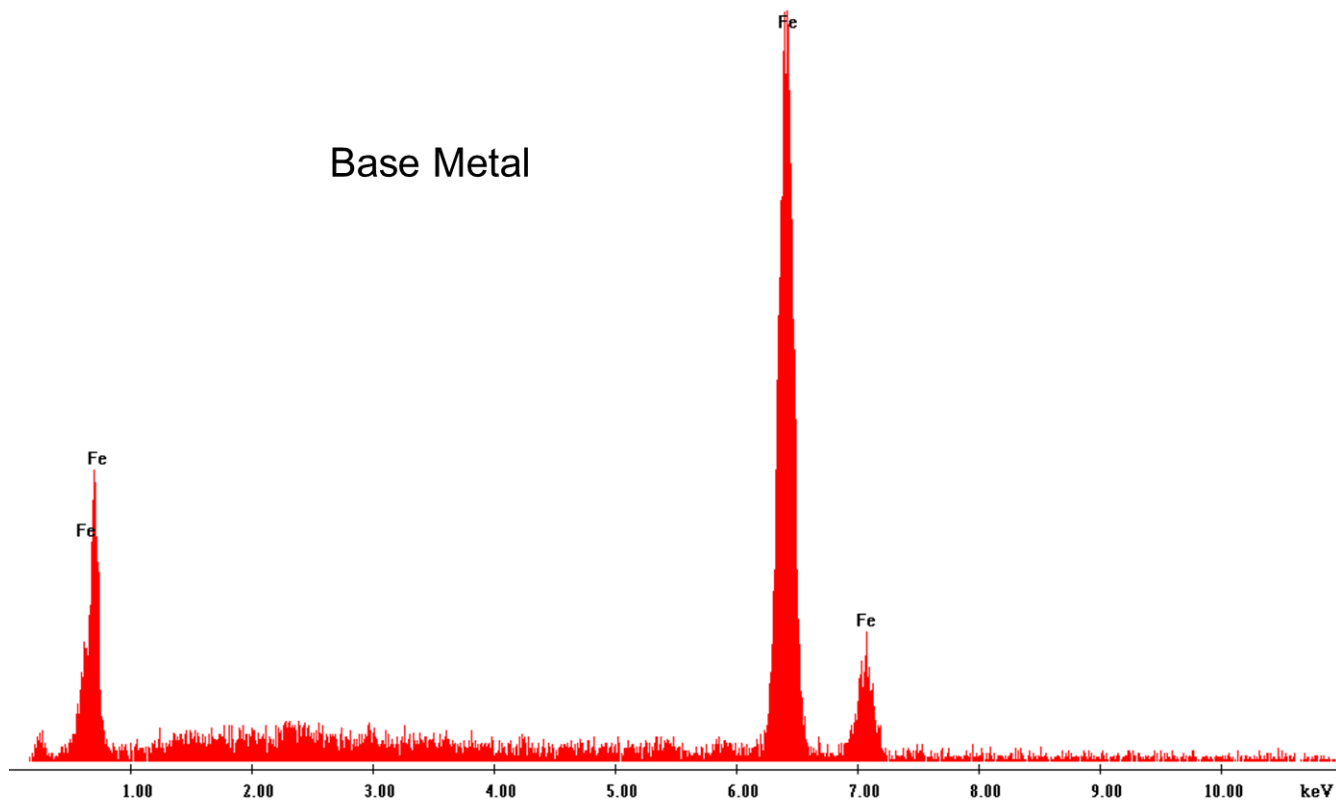
Figure 14. Typical EDS patterns from the dark deposit and base metal in Figure 13.

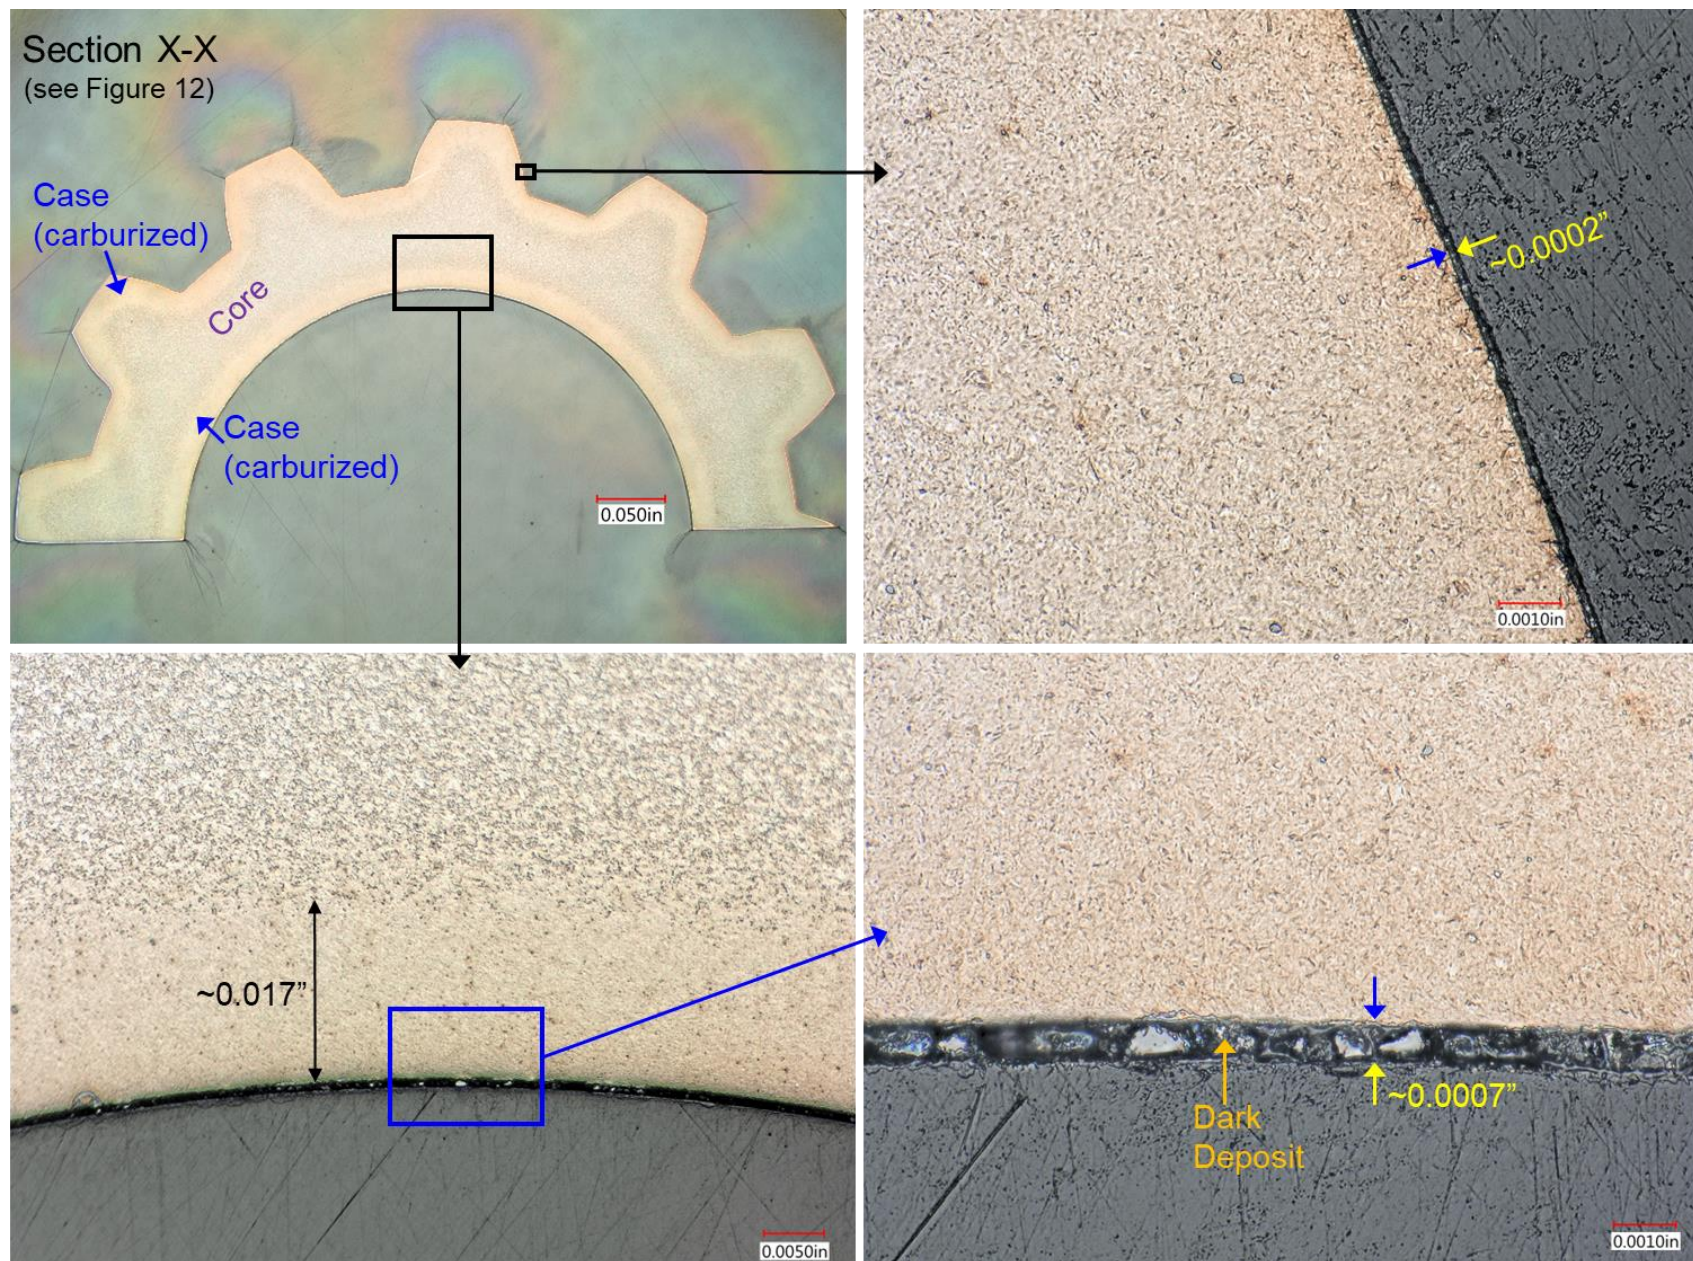
Optical images from cross-section of the gear – drive (Section X-X in Figure 12) after etching with 2 % Nital reagent are illustrated in Figure 15. The typical depth of the dark deposit on the OD and ID surface was measured to be approximately 0.0002” and 0.0007”, respectively.

The typical depth of the carburized layer (case) was measured to be approximately [REDACTED] for the gear – drive (see Figure 15), which was within [REDACTED] range specified in the engineering drawing. Microstructure of the case and core regions appeared to be tempered martensite and ferrite + pearlite, respectively, as shown in Figure 16. Both the microstructures are typical for the case and core regions of carburized low-alloy steels.

Figure 15. Optical images from the cross-section of the gear – drive (Section X-X in Figure 11) after etching with 2 % Nital reagent. The typical depth of the dark deposit on the OD and ID surface was measured to be approximately 0.0002" and 0.0007", respectively. The typical depth of the carburized layer (case) was measured to be approximately [REDACTED], which was within [REDACTED] range specified in the engineering drawing. Mount Index No. 4634. Magnifications: x7, x62, and x310.

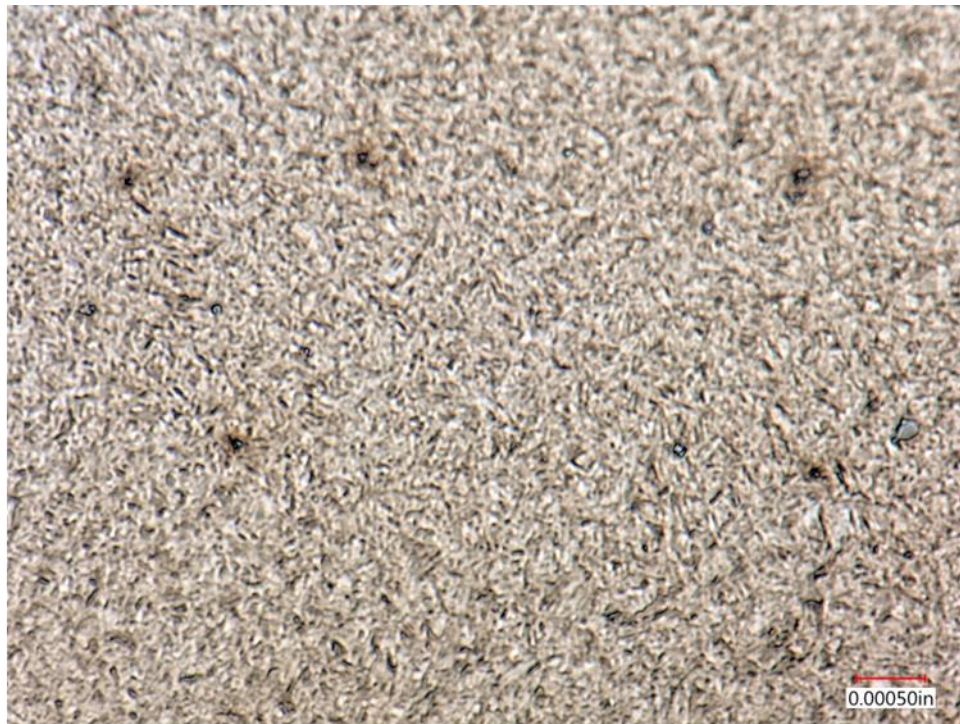
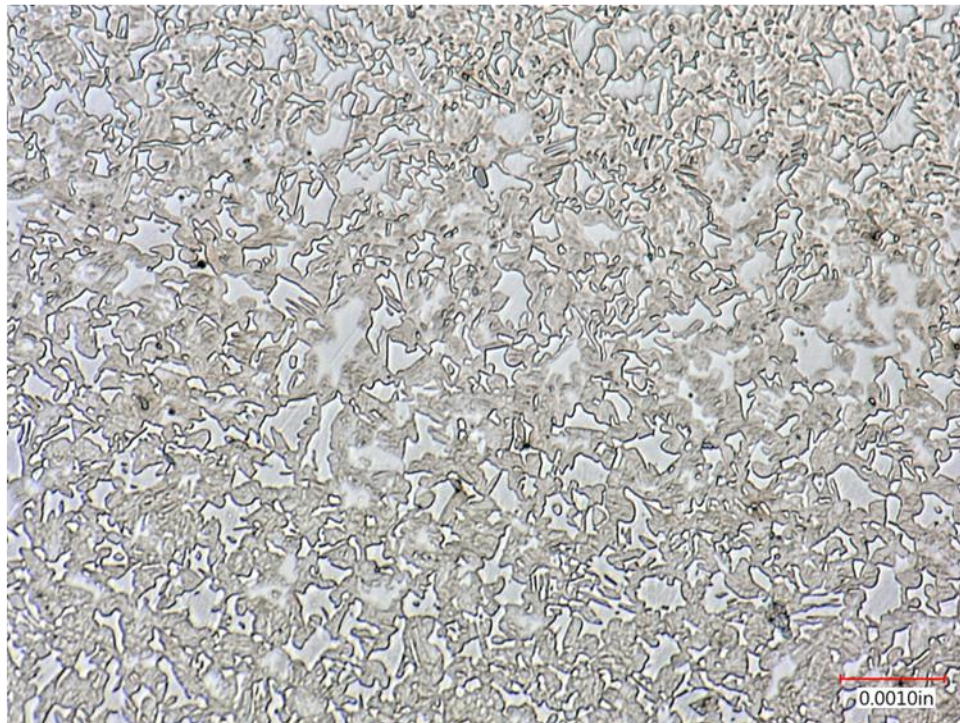
Figure 16. Typical optical images from the case and core regions in Figure 14. Microstructure of the case and core appeared to be tempered martensite and ferrite + pearlite, respectively. Both the microstructures are typical for the case and core of carburized low-alloy steels. Mount Index No. 4634. Magnifications: x700 and x540.

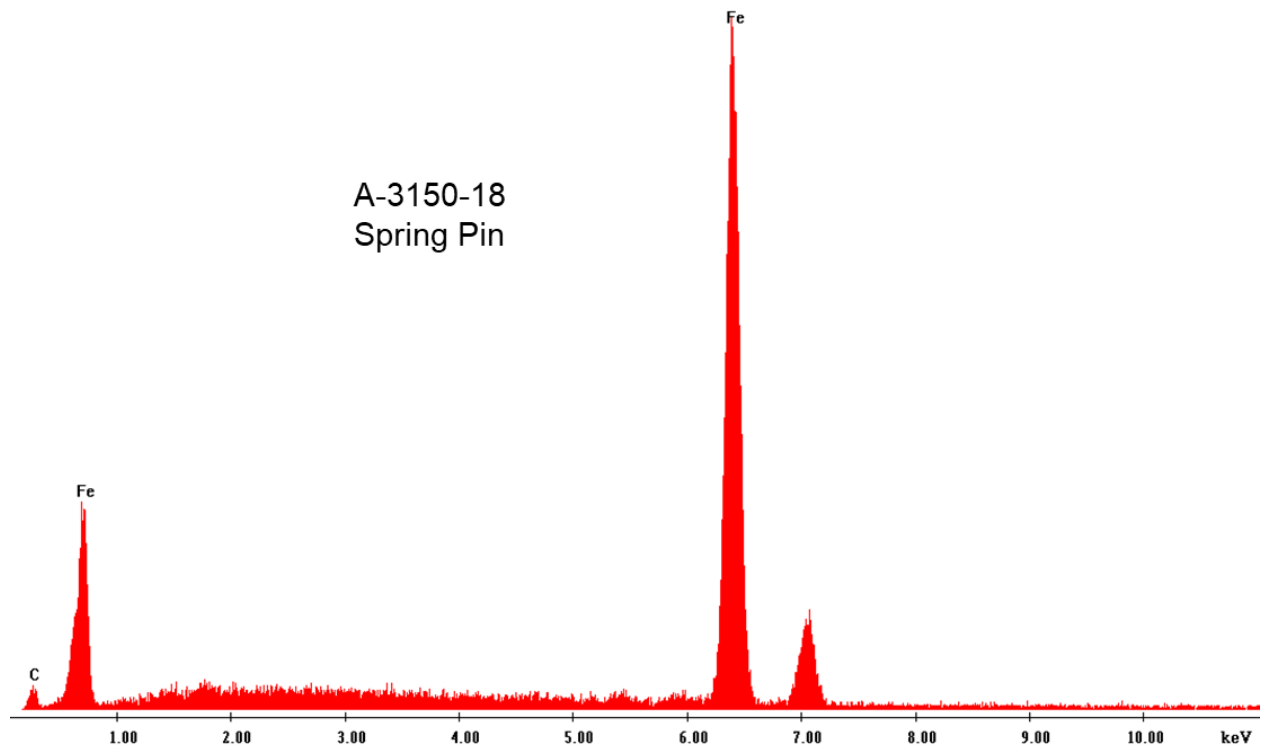
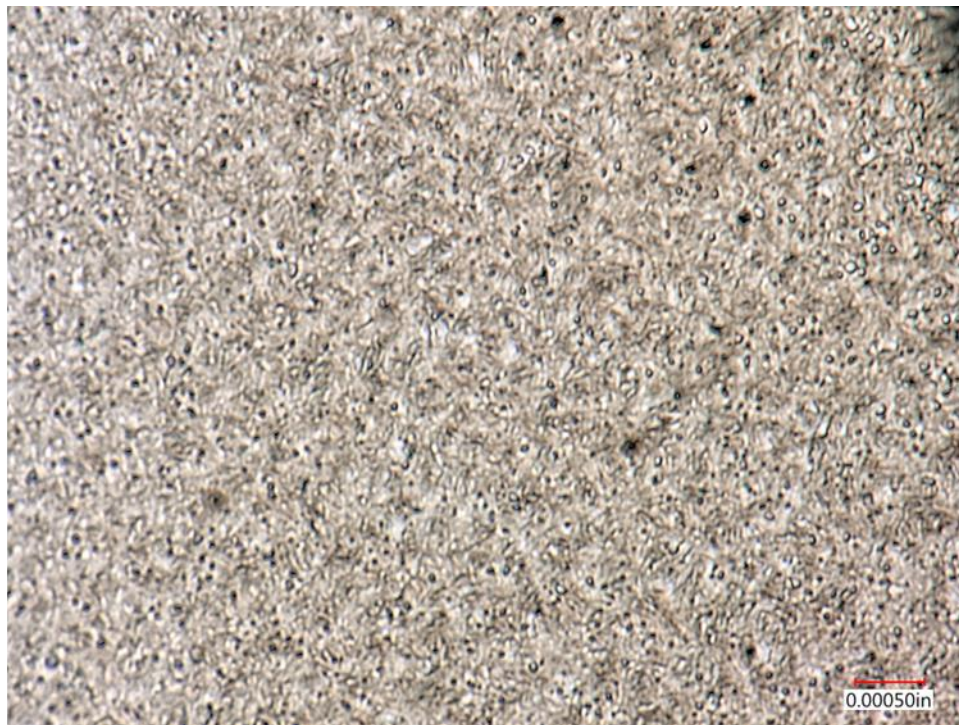
A-3150-18  
Spring Pin

2. Microstructure of the fractured spring pin appeared to be tempered martensite typical for plain carbon and low-alloy steels in the quenched + tempered condition.

Micro-hardness of the fractured spring pin (P/N A-3150-18) was measured to be 550-581 HK, which approximately corresponds to 50-52 HRC per ASTM E140. Figure 17 shows typical EDS spectrum and optical image from microstructure of the fractured spring pin. The EDS pattern is typical for plain carbon and low-alloy steels. Moreover, the observed microstructure appeared to be tempered martensite typical for plain carbon and low-alloy steels in the quenched + tempered condition. The required material and hardness for the spring pin were not provided.

Figure 17. Typical EDS spectrum (top) and optical image from microstructure (bottom) of the fractured spring pin (P/N A-3150-18). 2 % Nital reagent as used for etching. The EDS pattern is typical for plain carbon and low-alloy steels. Microstructure appeared to be tempered martensite typical for plain carbon and low-alloy steels in the quenched + tempered condition. Mount Index No. 4637. Magnification: x720.
