CEN24LA065

## INVESTIGATION PHOTOGRAPHS

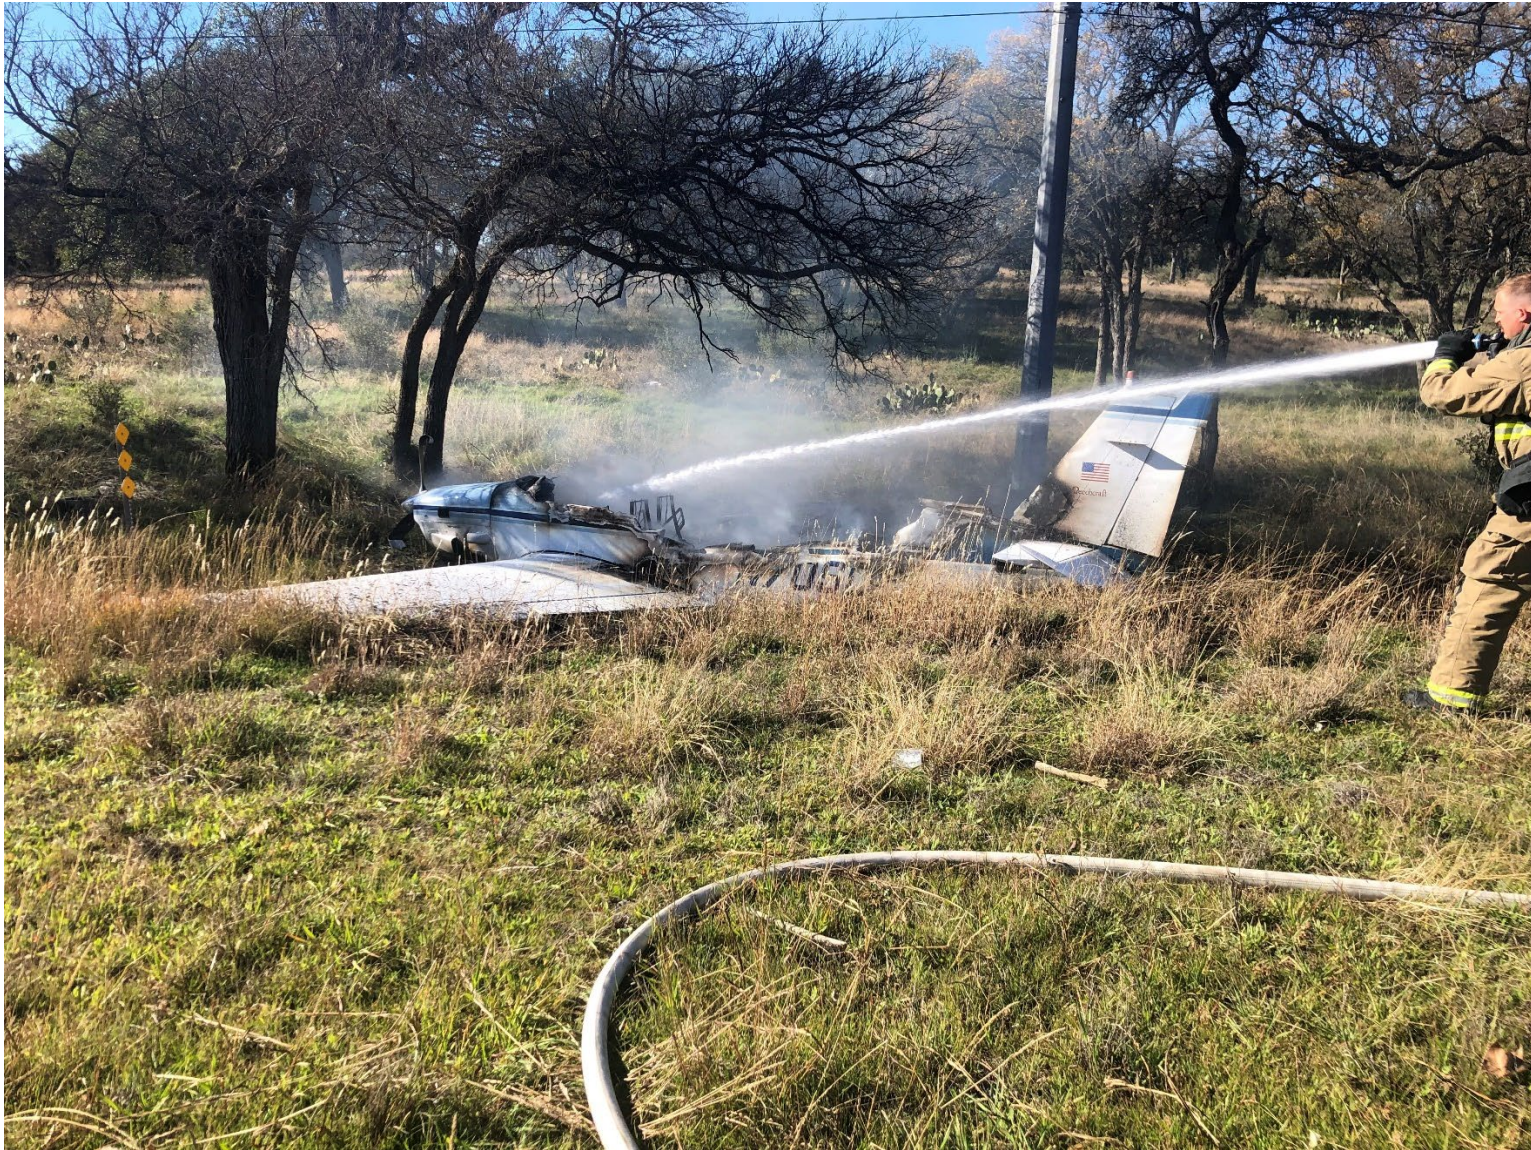
**Photograph 1 - Accident Site (Courtesy of Federal Aviation Administration)**

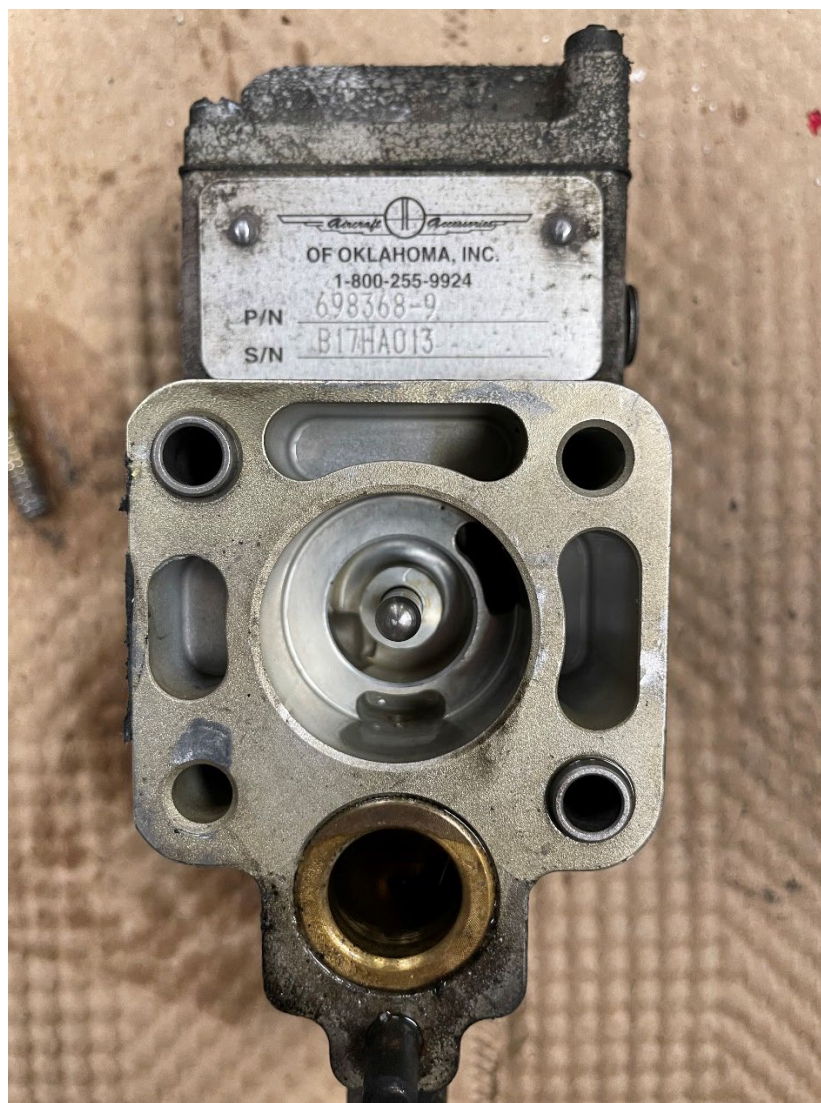
**Photograph 2 - Fuel Pump Assembly (Courtesy of NTSB)**

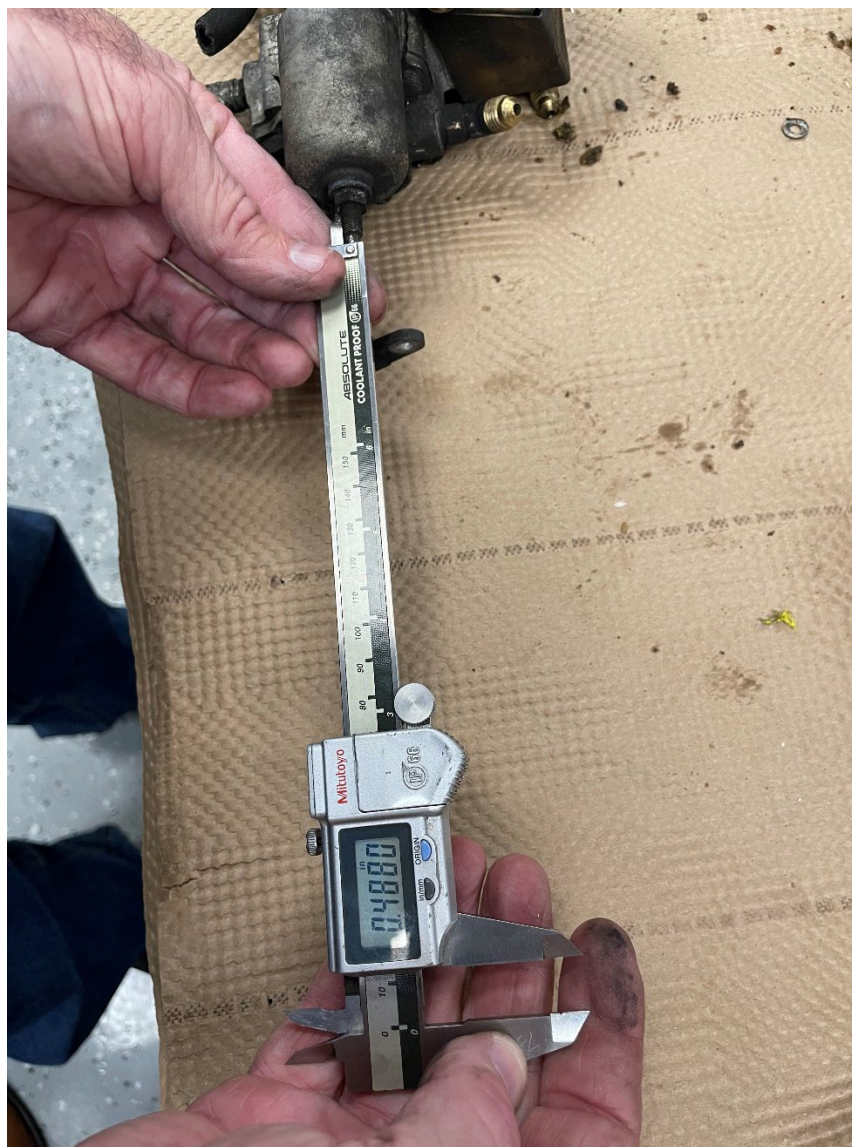
**Photograph 3 - Fuel Pump Assembly Screw Measurement (Courtesy of NTSB)**

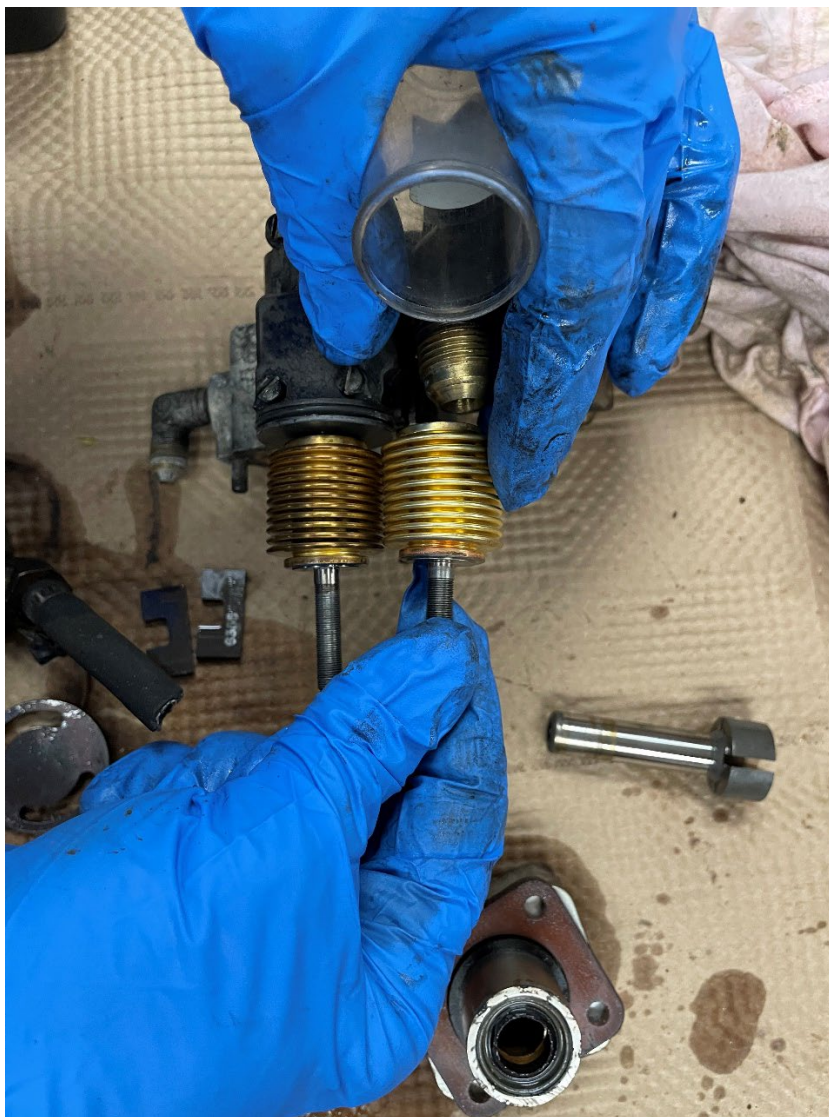
**Photograph 4 - Fuel Pump Assembly Internal Aneroid (Courtesy of NTSB)**
