## Incident Report

Incident Report #: 23-001

Nature of Incident: Airplane Veered off the Runway

Location of Incident: Runway 14-32

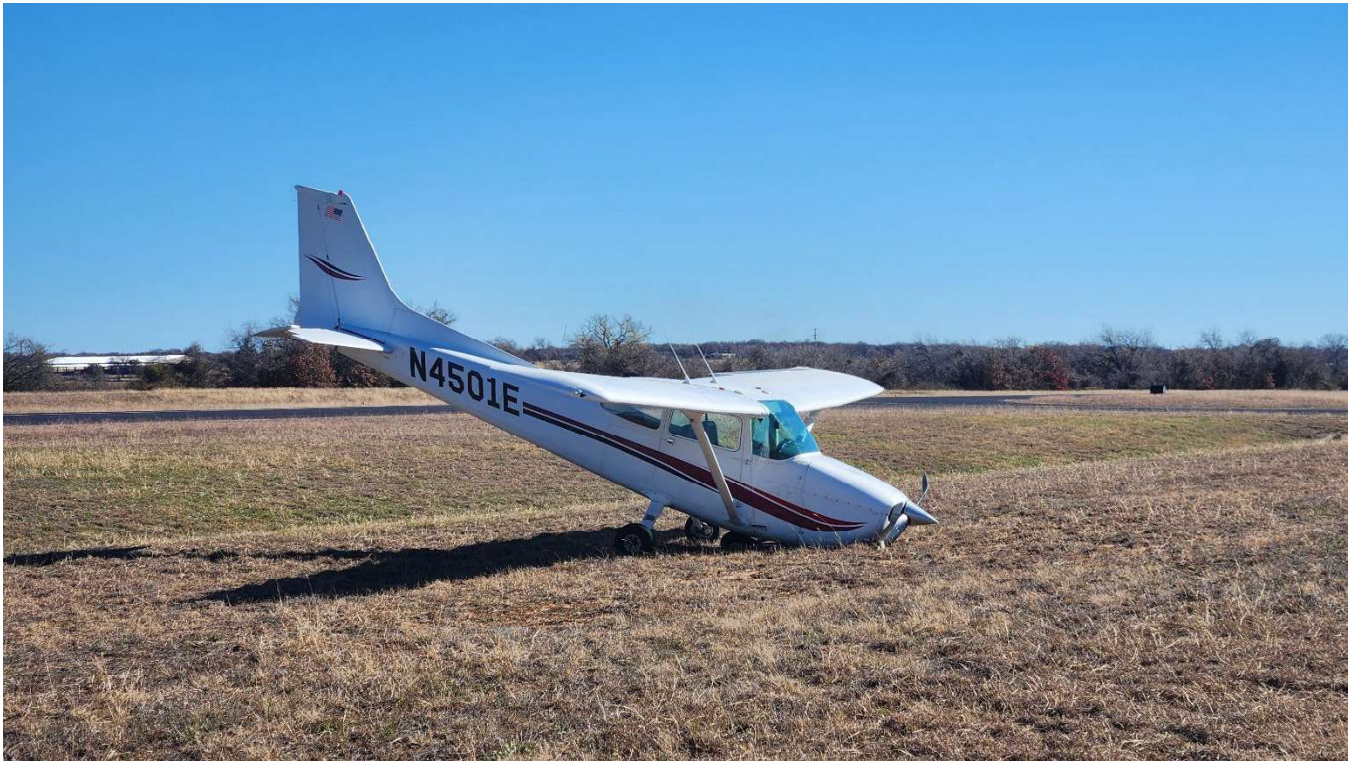
Wade Allan Jensen was on a flight from Northwest Regional Airport (52F) in Roanoke, Texas to Stephenville Clark Regional Airport (SEP). While landing on runway 14, Mr. Jensen encountered a southwest crosswind. The wind was skidding the airplane sideways so he tried correcting for it. He over-corrected the rudder to counter the wind and lost control of the airplane and veered to the right going southwest. The aircraft went down in the drainage ditch between the runway and taxiway then went up the other side. The left wingtip hit the ground in the lowest part of the ditch. As the aircraft went up the other side, the nose landing gear collapsed where it came to rest. Mr. Jensen was not hurt.

How the airplane came to rest.

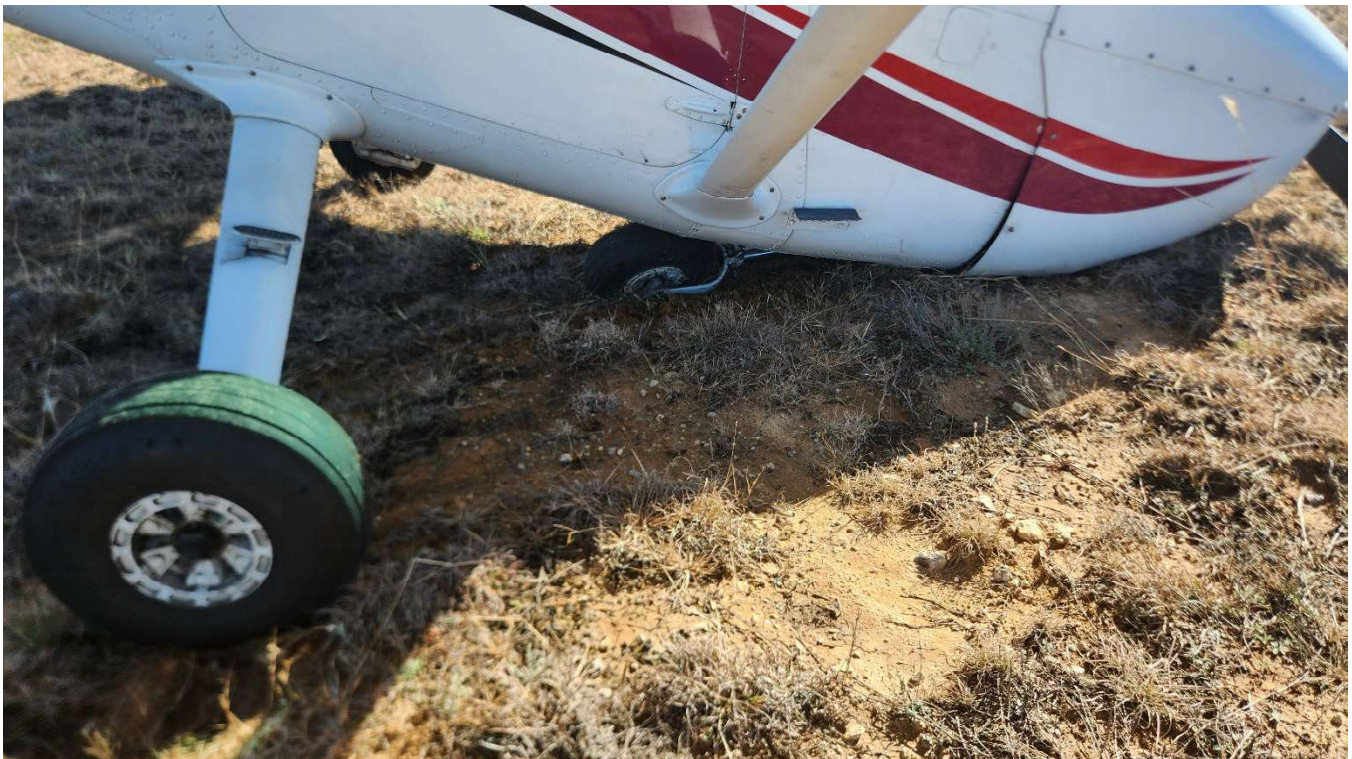
A closer look at the collapsed front landing gear.

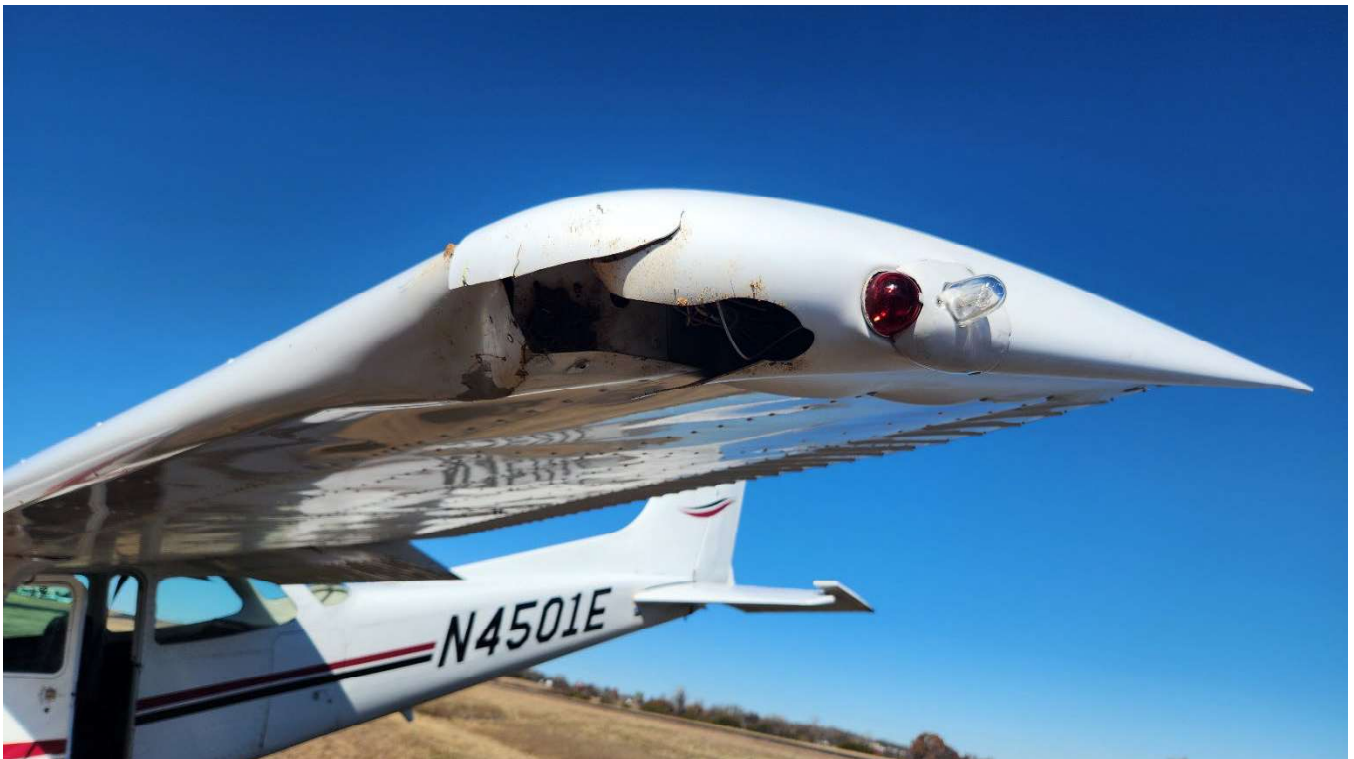
The broken left wingtip.

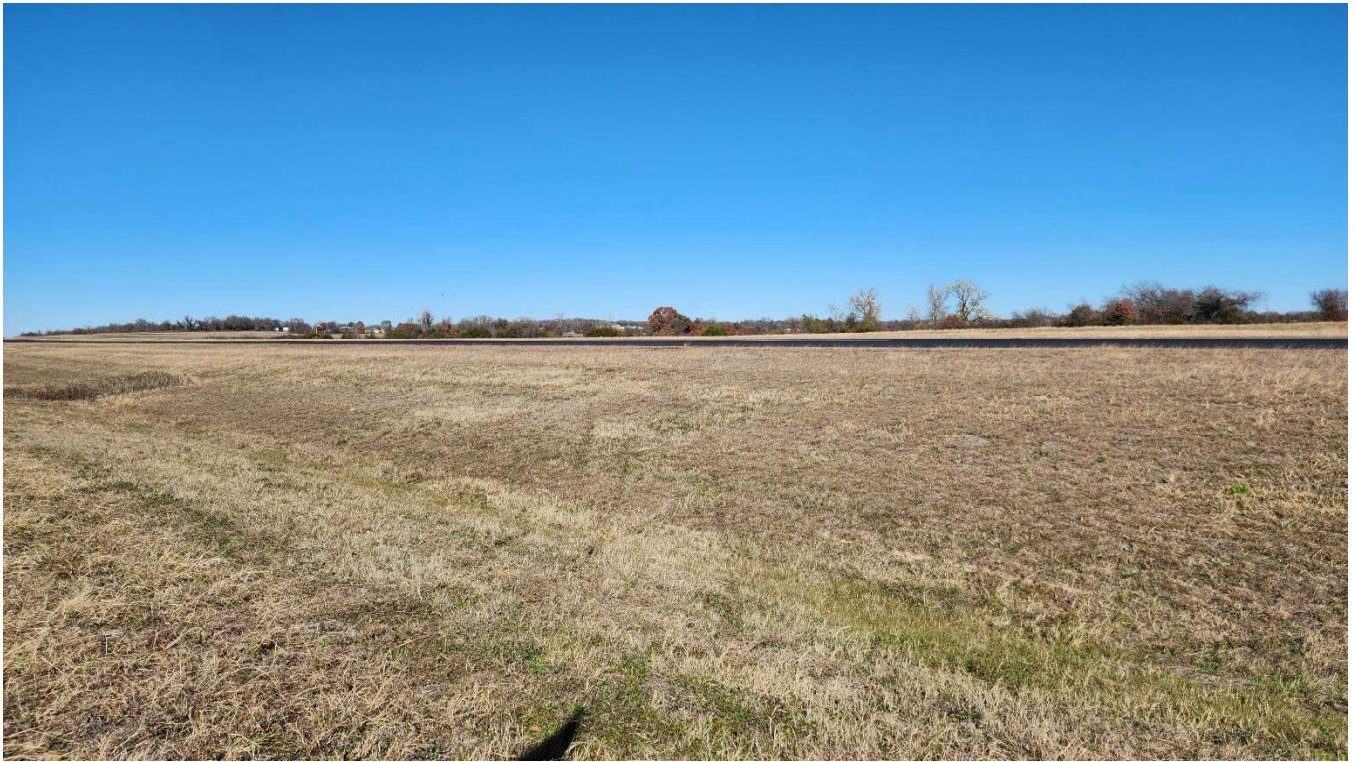
The tire marks in the grass looking North.

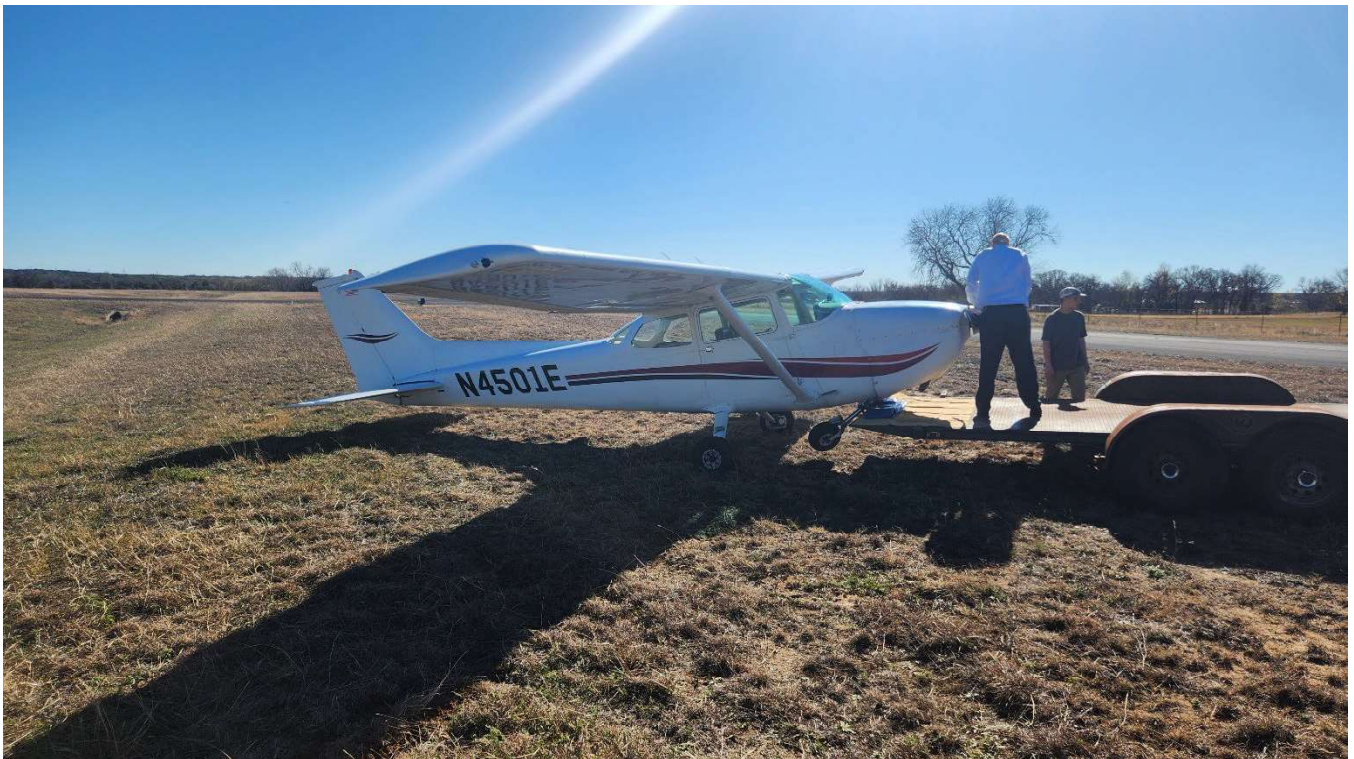
The front of the airplane sitting on Mr. Dickinson's trailer.

Mr. Dickinson and both Matt and Wade Jensen arrived back at the airport simultaneously and began to prepare the aircraft to be towed to the ramp. Mr. Dickinson instructed Matt Jensen, Wade Jensen, Mr. Clemmons, and Mr. Smith to maneuver the airplane so the front is pointed West. Mr. Dickinson then positioned his truck and trailer in front of the airplane. Mr. Smith and Mr. Clemmons pushed down on the tail at Matt Jensen's request to get the nose of the airplane up. Matt Jensen laid down the leather tarp he purchased on the end of the trailer before Mr. Dickinson backed it up toward the airplane. After backing up the trailer under the airplane. Mr. Clemmons and Mr. Smith lowered the airplane gently on the trailer. Mr. Dickinson and Matt Jensen then ratchet strapped the aircraft to the trailer to prevent it from sliding off. The airplane was then gently towed to the ramp where it was parked without incident. Part of the nose landing gear hardware was set to rest of a stack of pallets Mr. Smith brought. The aircraft was also chained down.

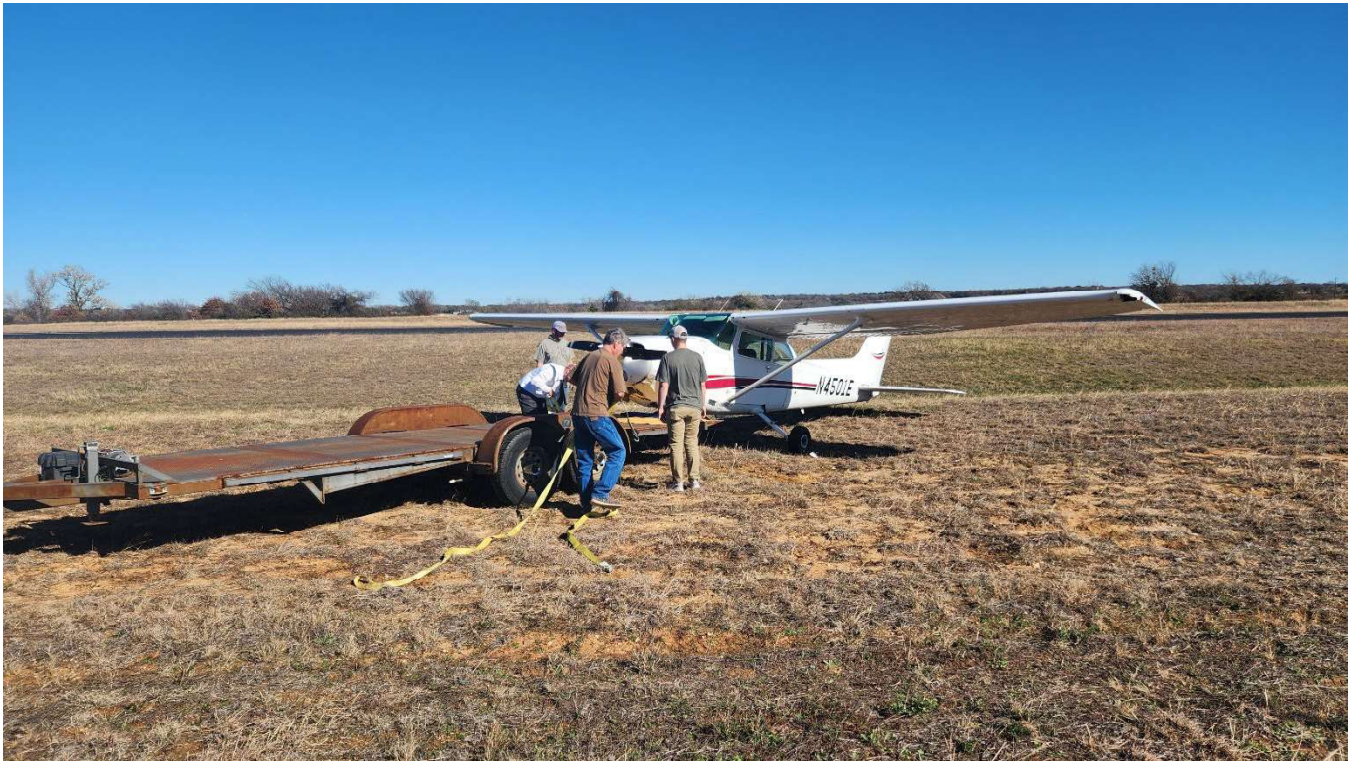
In the process of applying the ratchet straps.

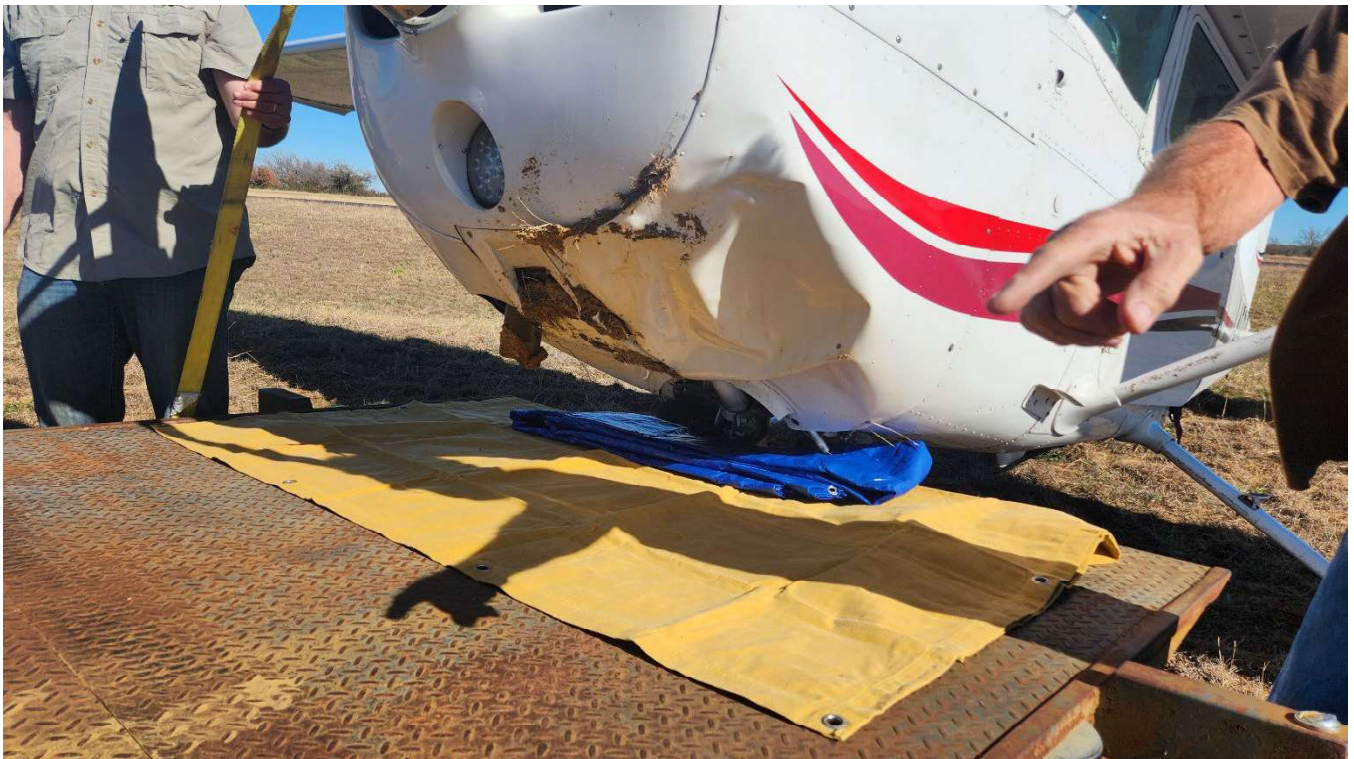
Damage to the front.

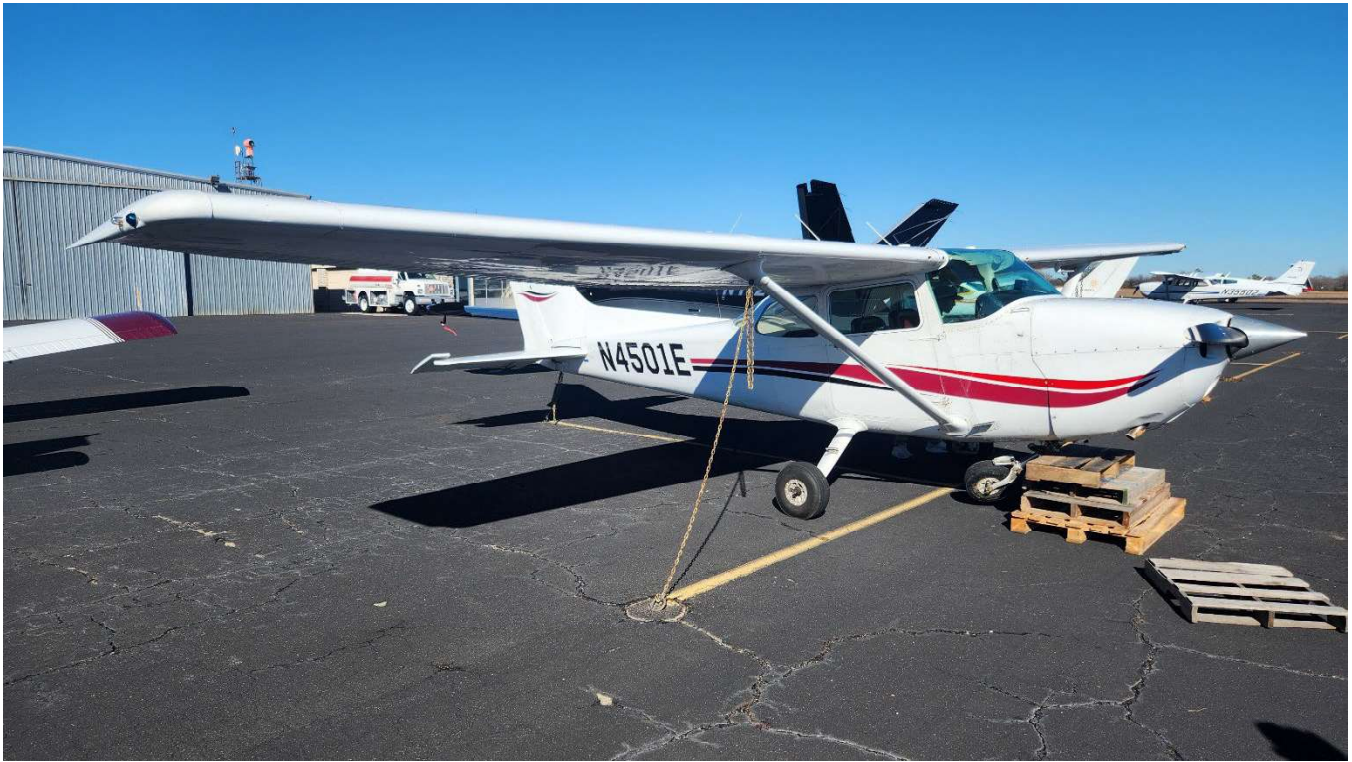
The airplane parked and chained down.
