# Carburetor Icing Probability Graph – CEN24LA076

Airplane: Piper PA-18A-150

Accident Date: 12/29/2023

Accident Location: Vermillion, SD

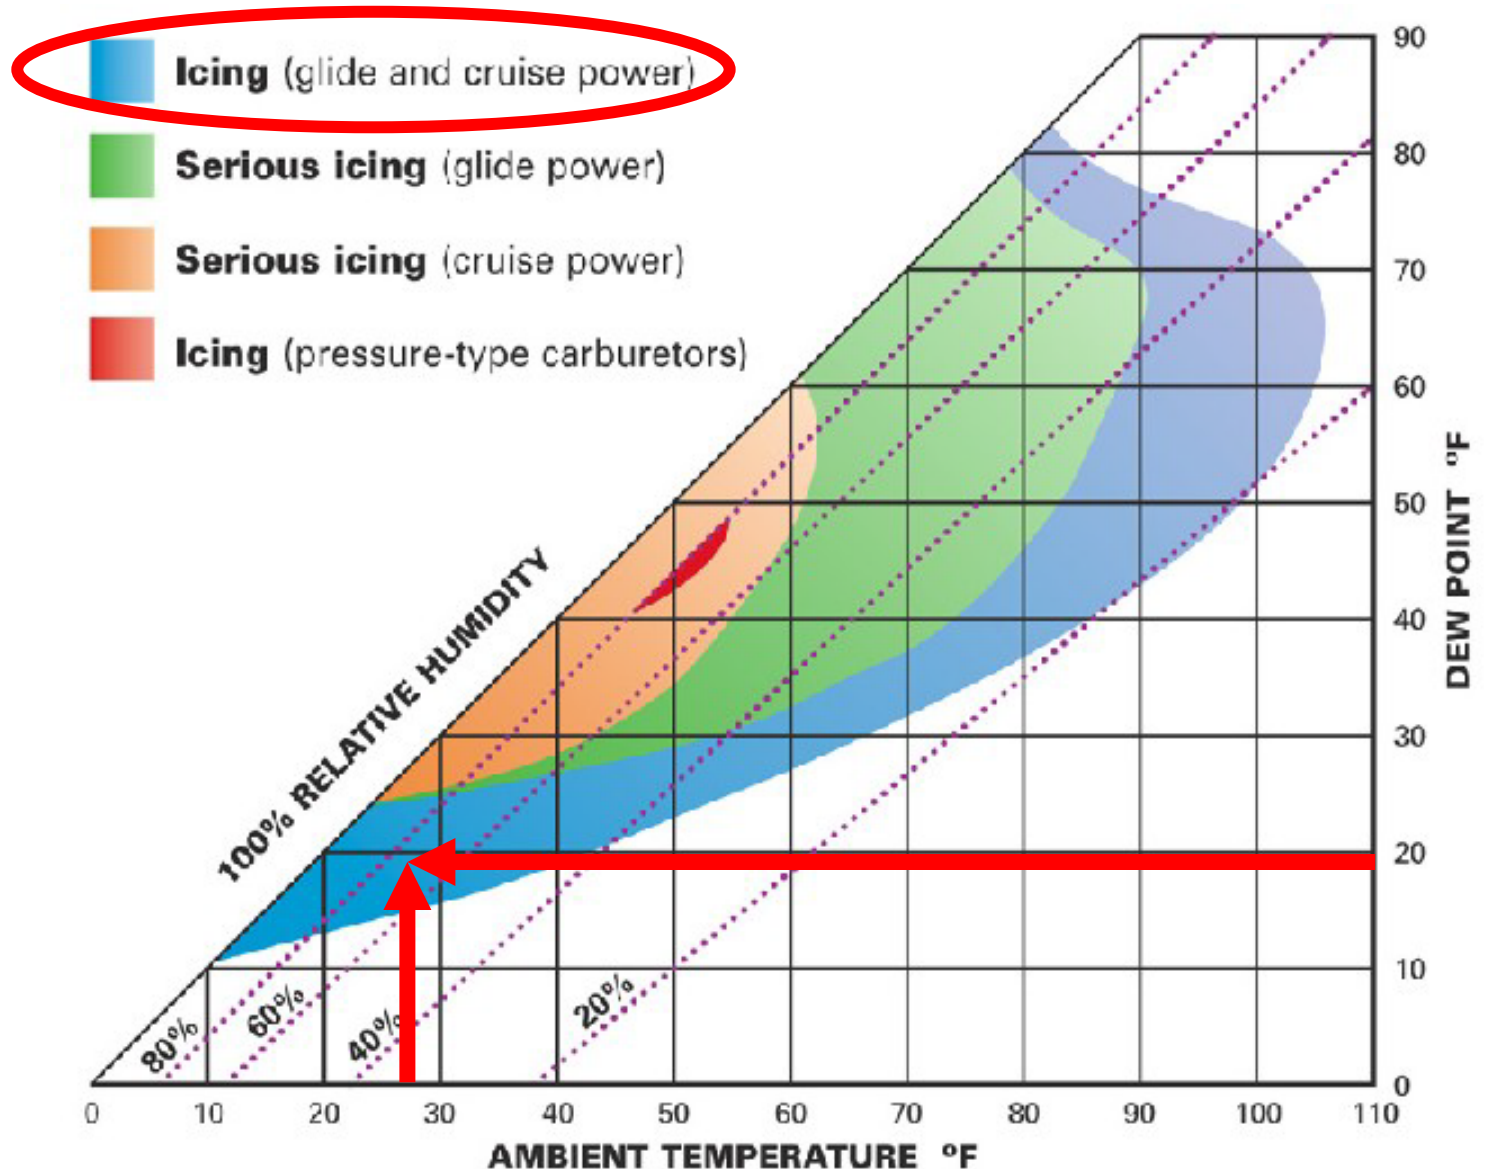
Weather: KSUX 291752Z 32007KT 10SM CLR M01/M06  
A3007 – Temp/Dew Point @ 1,200 MSL via HRRR NOAA  
Model was -2.6 °C / -6.9 °C.

Temperature, -2.6°C = 27.3°F

Dew Point, -6.9°C = 19.6°F
