# National Transportation Safety Board

CEN24LA077

## COMPONENT EXAMINATION SUMMARY

Location: Washington, MO  
Date: December 30, 2023  
Time: 1500 Central Standard Time  
Airplane: Bellanca 17-30A

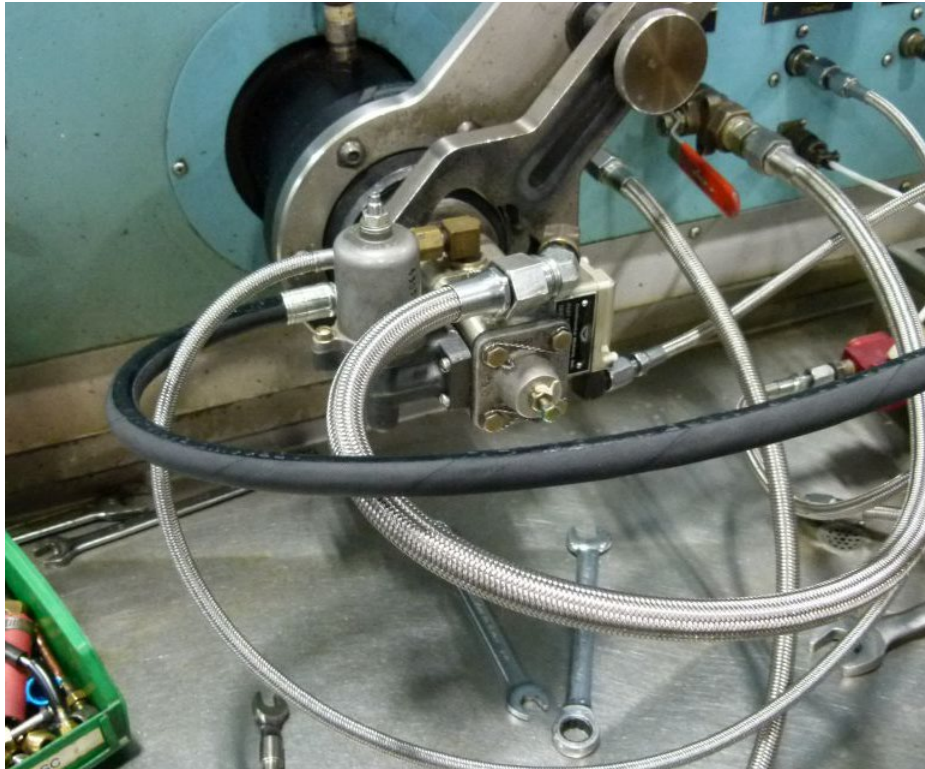
Figure 2 - Fuel Pump (installed on test bench)

The fuel pump was installed on a production test bench. The initial test flow rates did not meet the specification requirements. Partial disassembly revealed some debris within the vapor ejector cavity. The debris was removed, and the pump reassembled. The test procedure was completed again, and the pump performed to specification. Under 10x magnification, the debris appeared to be a small piece of rubber material.

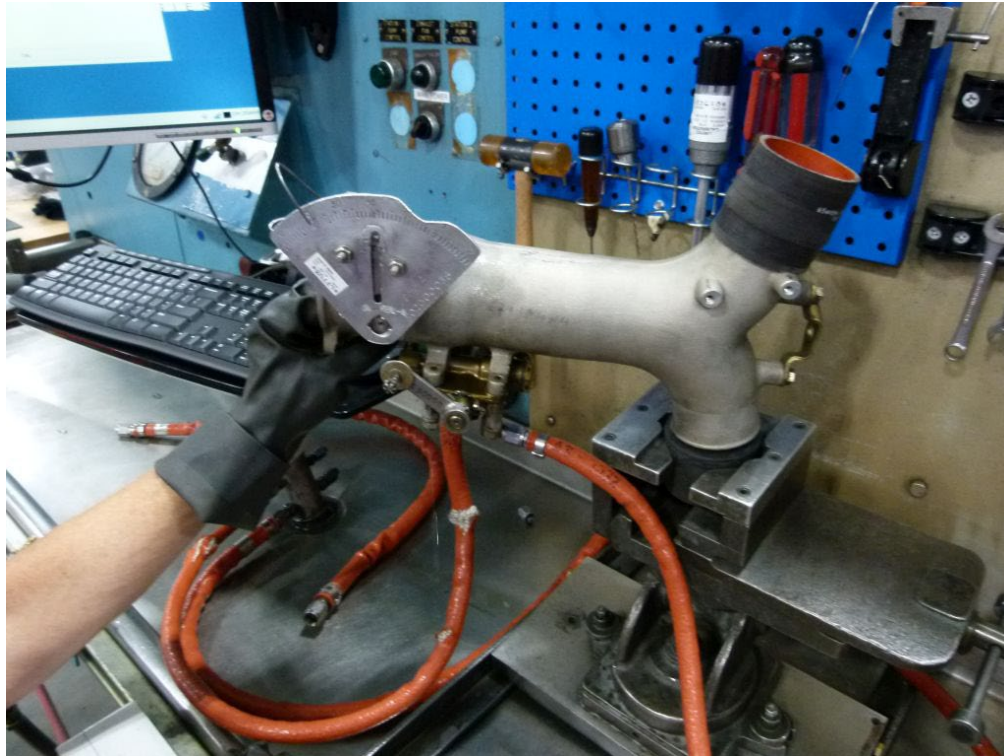
Figure 6 - Throttle Unit (installed on test bench)

The throttle and control unit was installed on a production test bench. The unit responded normally to throttle inputs. However, the measured test fuel flow rate at each test point exceeded the specification for a production unit.<sup>1</sup> Otherwise, the unit performed as expected and no anomalies were observed.

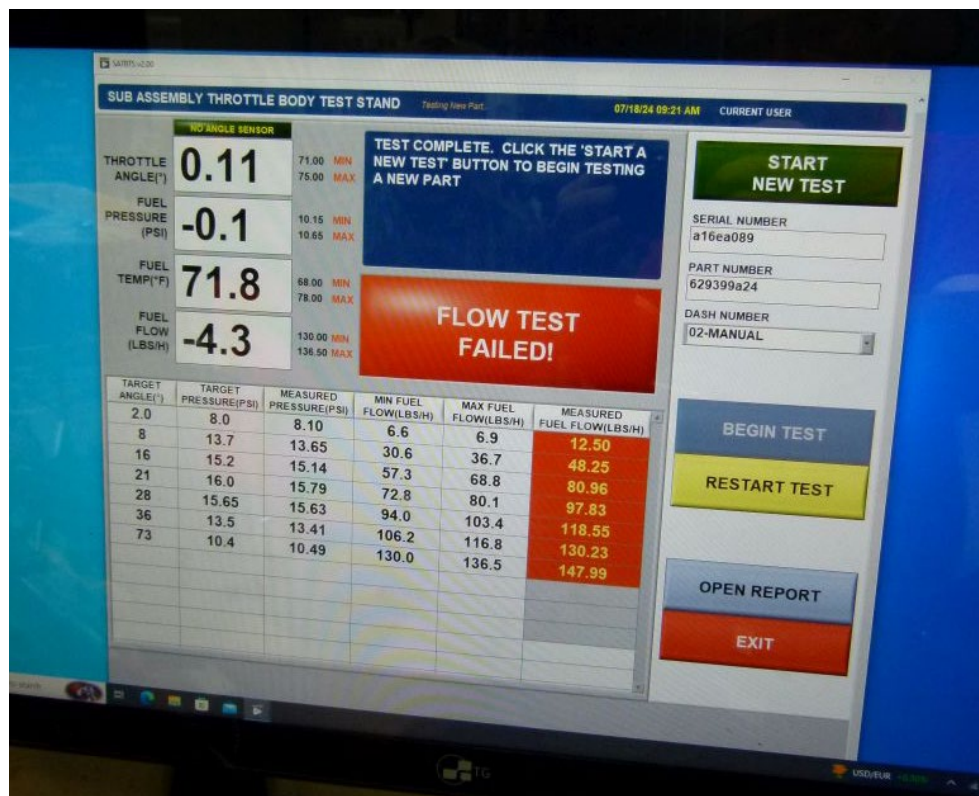
Figure 7 - Throttle Unit Test Results

<sup>1</sup> Fuel flow rates are adjustable on a particular airframe. According to the manufacturer, it is common for in-service units to be adjusted higher than production requirements, especially on low-wing airplanes.
