# National Transportation Safety Board

CEN24LA079

## **MATERIALS LABORATORY**

Factual Report 25-031

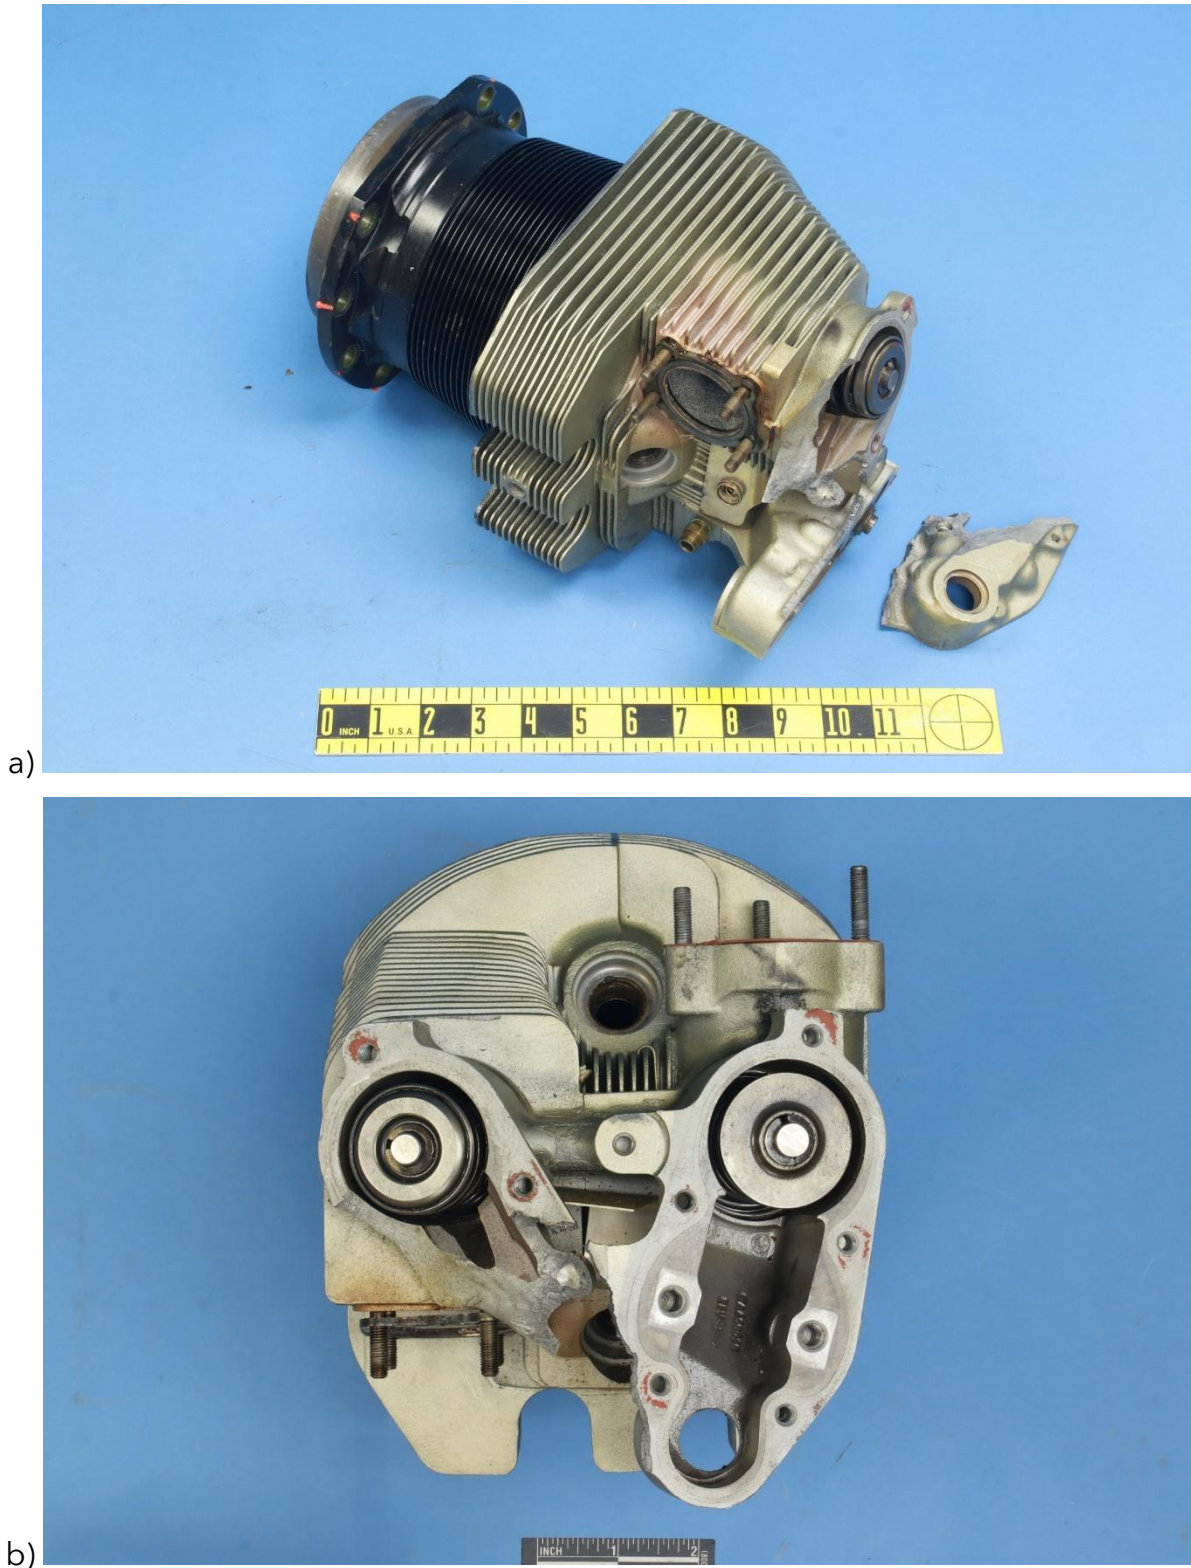
A cylinder assembly with a fractured exhaust rocker box ear from the accident aircraft was submitted to the NTSB Materials Laboratory for examination (figures 1a, 1b, and 2). The ear had fractured from the corner at the lower side of the rocker footing where the ear projects from the cylinder head. The corner lies at the intersection of three edges as illustrated below in figures 3a and 3b. Those edges, for the purpose of this report, are the external edge on the rocker box footing (outer edge), the internal edge beneath the ear, and an external edge on the ear itself. The cylinder is covered by Continental Aerospace Technologies Mandatory Service Bulletin MSB18-08C. The service bulletin requires covered cylinders to be inspected and modified to remove casting flash build-up or a sharp radius edge condition. Two other cylinders from different aircraft were also submitted. Those cylinders were the same part number as the cylinder from the accident aircraft and their serial numbers indicated that they were also covered by the service bulletin.

**Figure 1.** a) and b) Images of the as received cylinder from the accident aircraft, serial number AC17AB774.

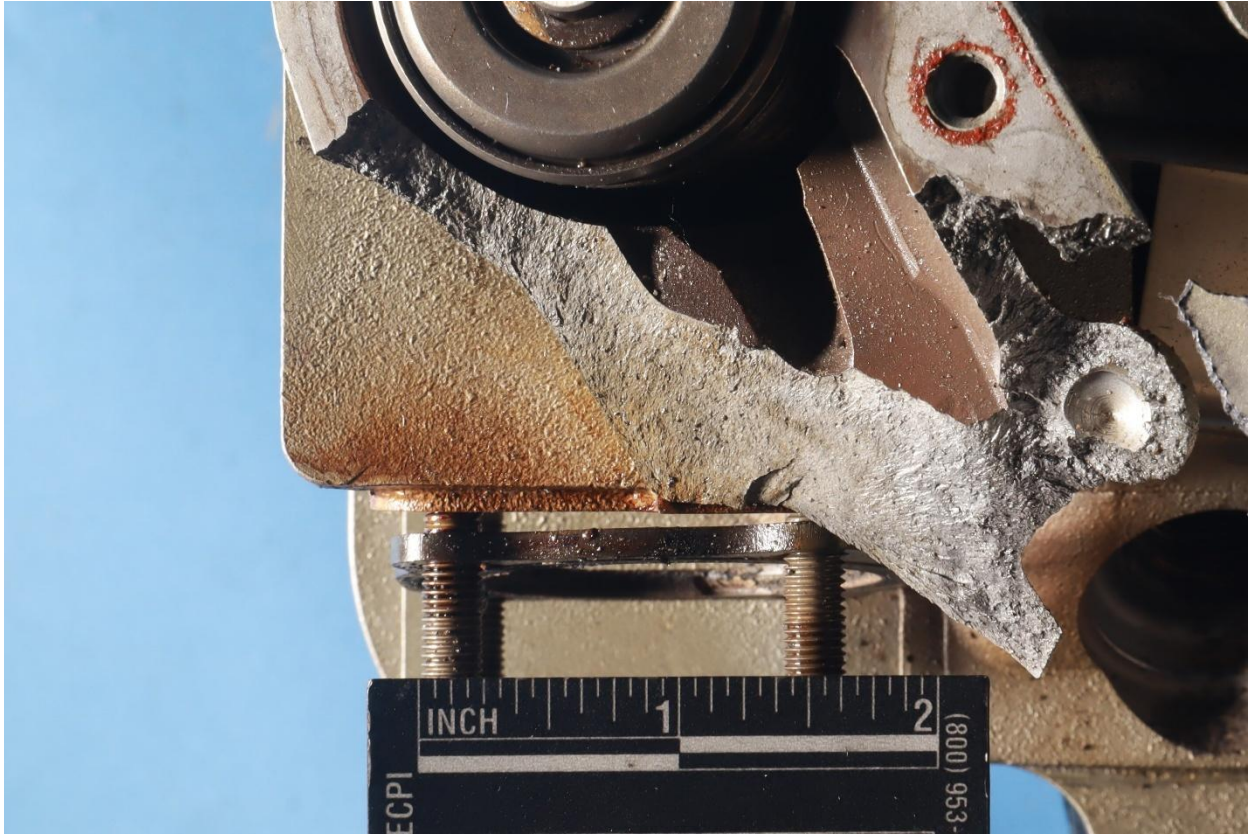
**Figure 2.** Fatigue fracture starting at the outer edge of the lower corner of the exhaust rocker box footing.

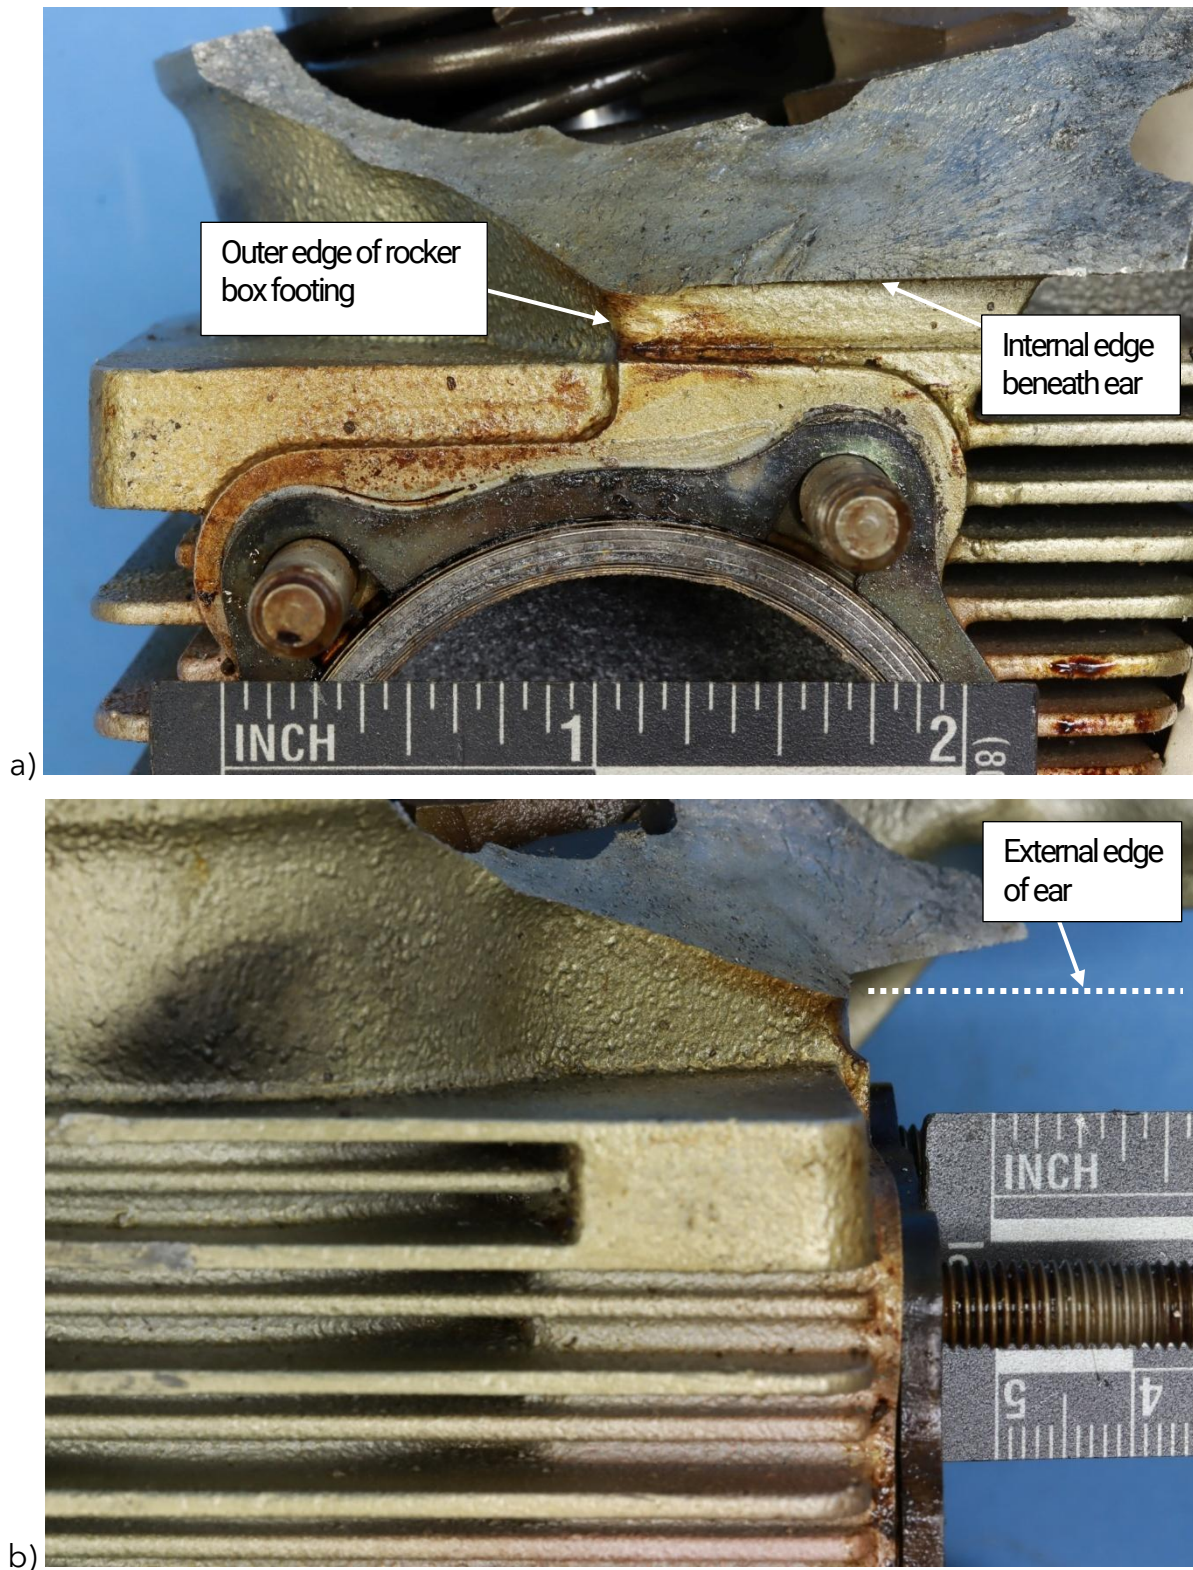
The outer edge of the footing beneath the exhaust rocker box exhibited features consistent with material removal and blending of the edge at the location specified for inspection and modification as described in the service bulletin. The blended region extended approximately 0.15 inches underneath the ear and 0.12 inches deep into the cylinder head rocker box footing.

**Figure 3.** Images showing blending of the outer edge: a) blending along the underside of the ear and b) blending into the footing.

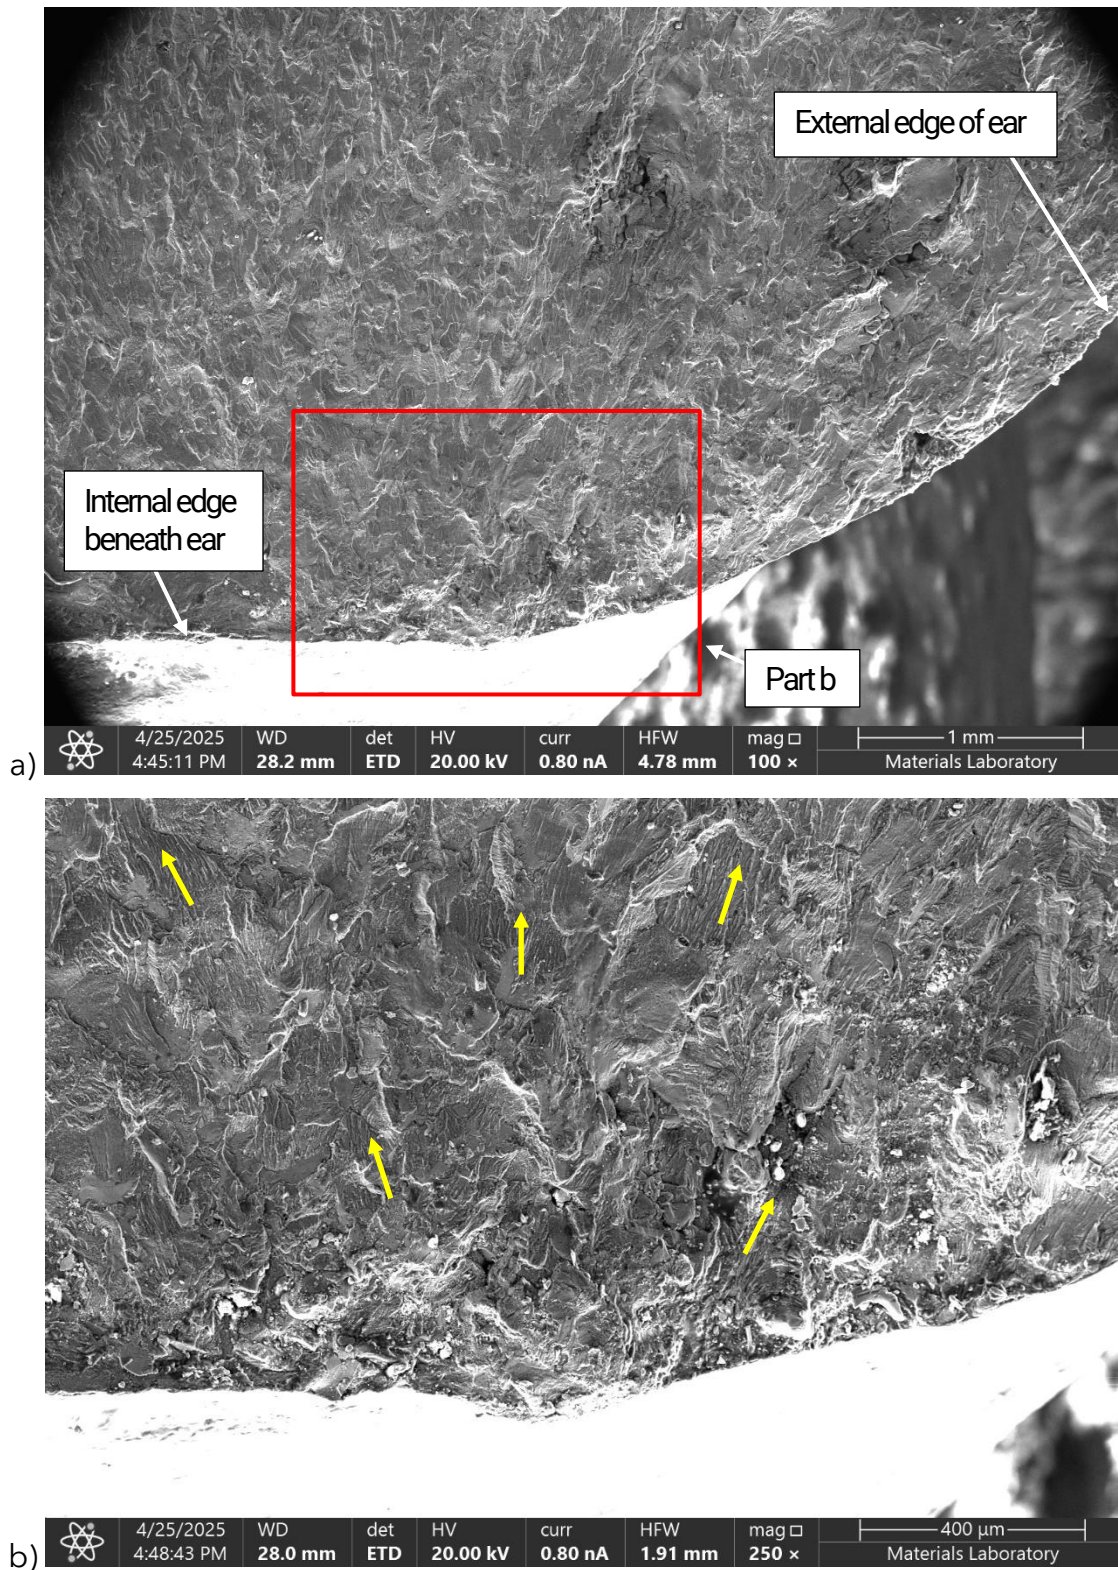
The fracture surface was cleaned with an alkaline detergent and soft-bristle brush, in accordance with standard laboratory protocols, and was examined using a scanning electron microscope (SEM). The fracture surface near the corner was comparatively flat and exhibited feathery features, consistent with high-cycle fatigue. The features were traced back to an origin area where the blended region transitioned to the internal edge beneath the ear (figures 4a and 4b).

**Figure 4.** Scanning electron microscope images of the fracture initiation area: a) overview image and b) higher magnification image showing crack initiation at the edge of the blended region.

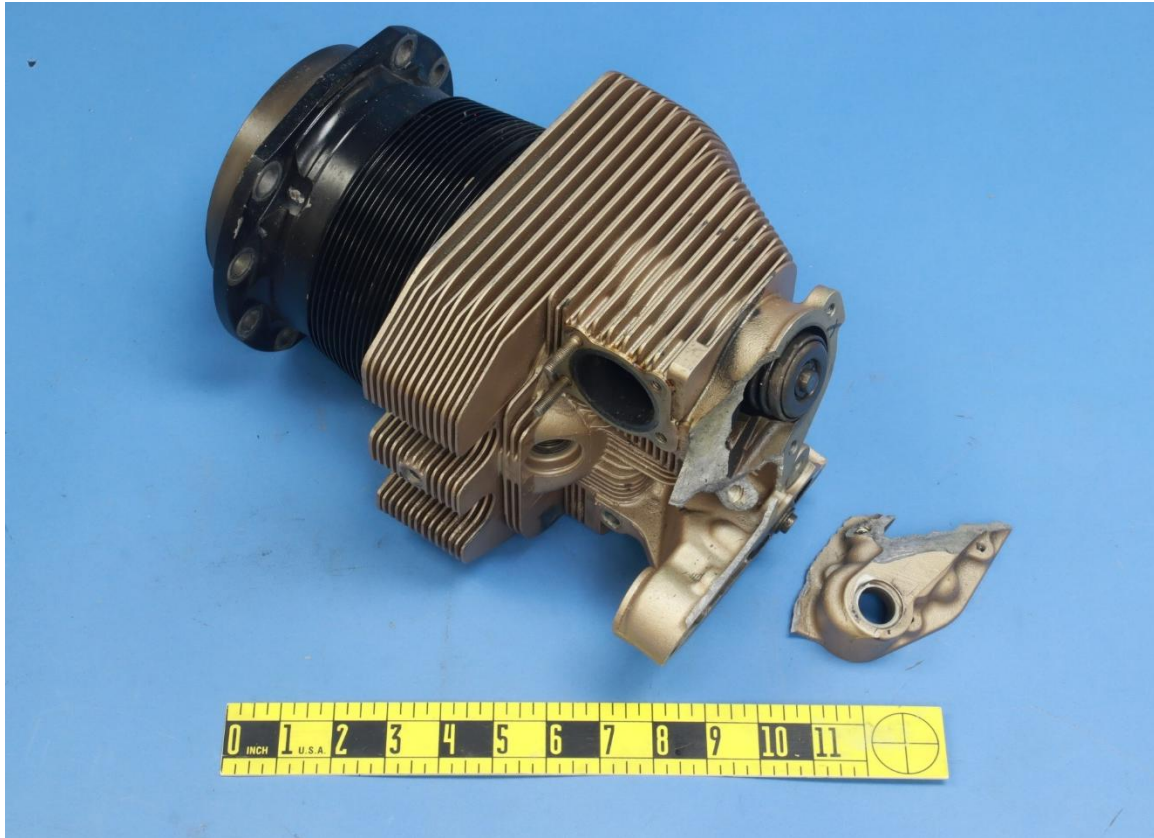
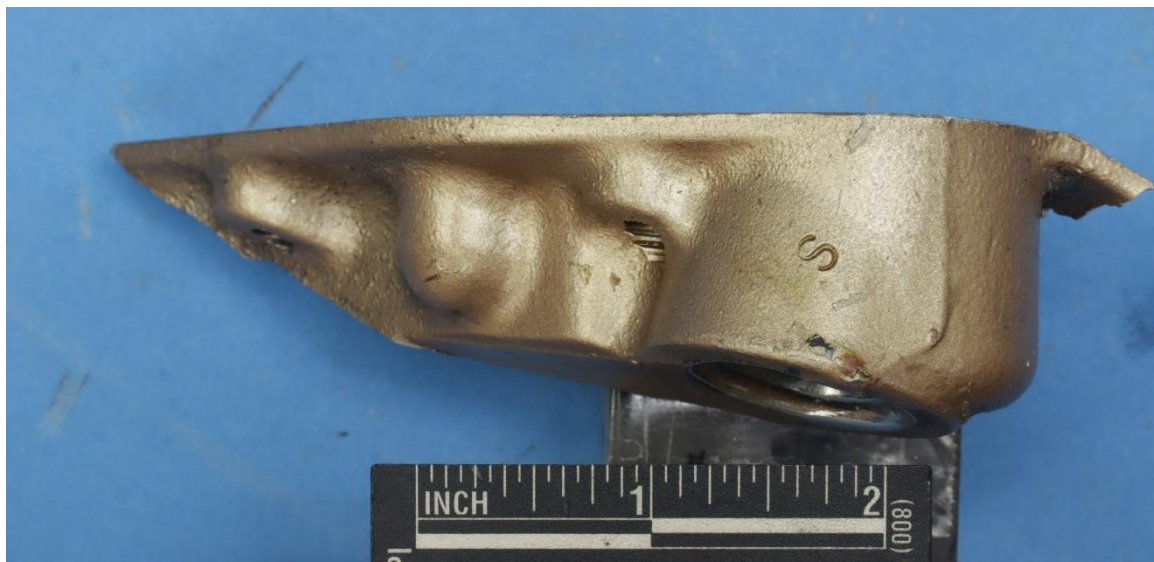
The exhaust rocker box ear had fractured from the cylinder head (figure 5a). The fracture features were similar to those seen on the accident cylinder, consistent with high-cycle fatigue fracture. The ear was stamped with an 'S', in accordance with the Continental service bulletin (figure 5b). Examination of the outer edge revealed material removal and blending along part of the edge. The blending did not extend up to the internal edge on the underside of the ear (figures 6a and 6b). Instead, a sharp outer edge was observed extending approximately 0.06 inches from the corner.

**Figure 5.** a) Overview image of cylinder, serial number AC16KA158, with fractured exhaust rocker box ear and b) image of fractured ear showing stamp mark.

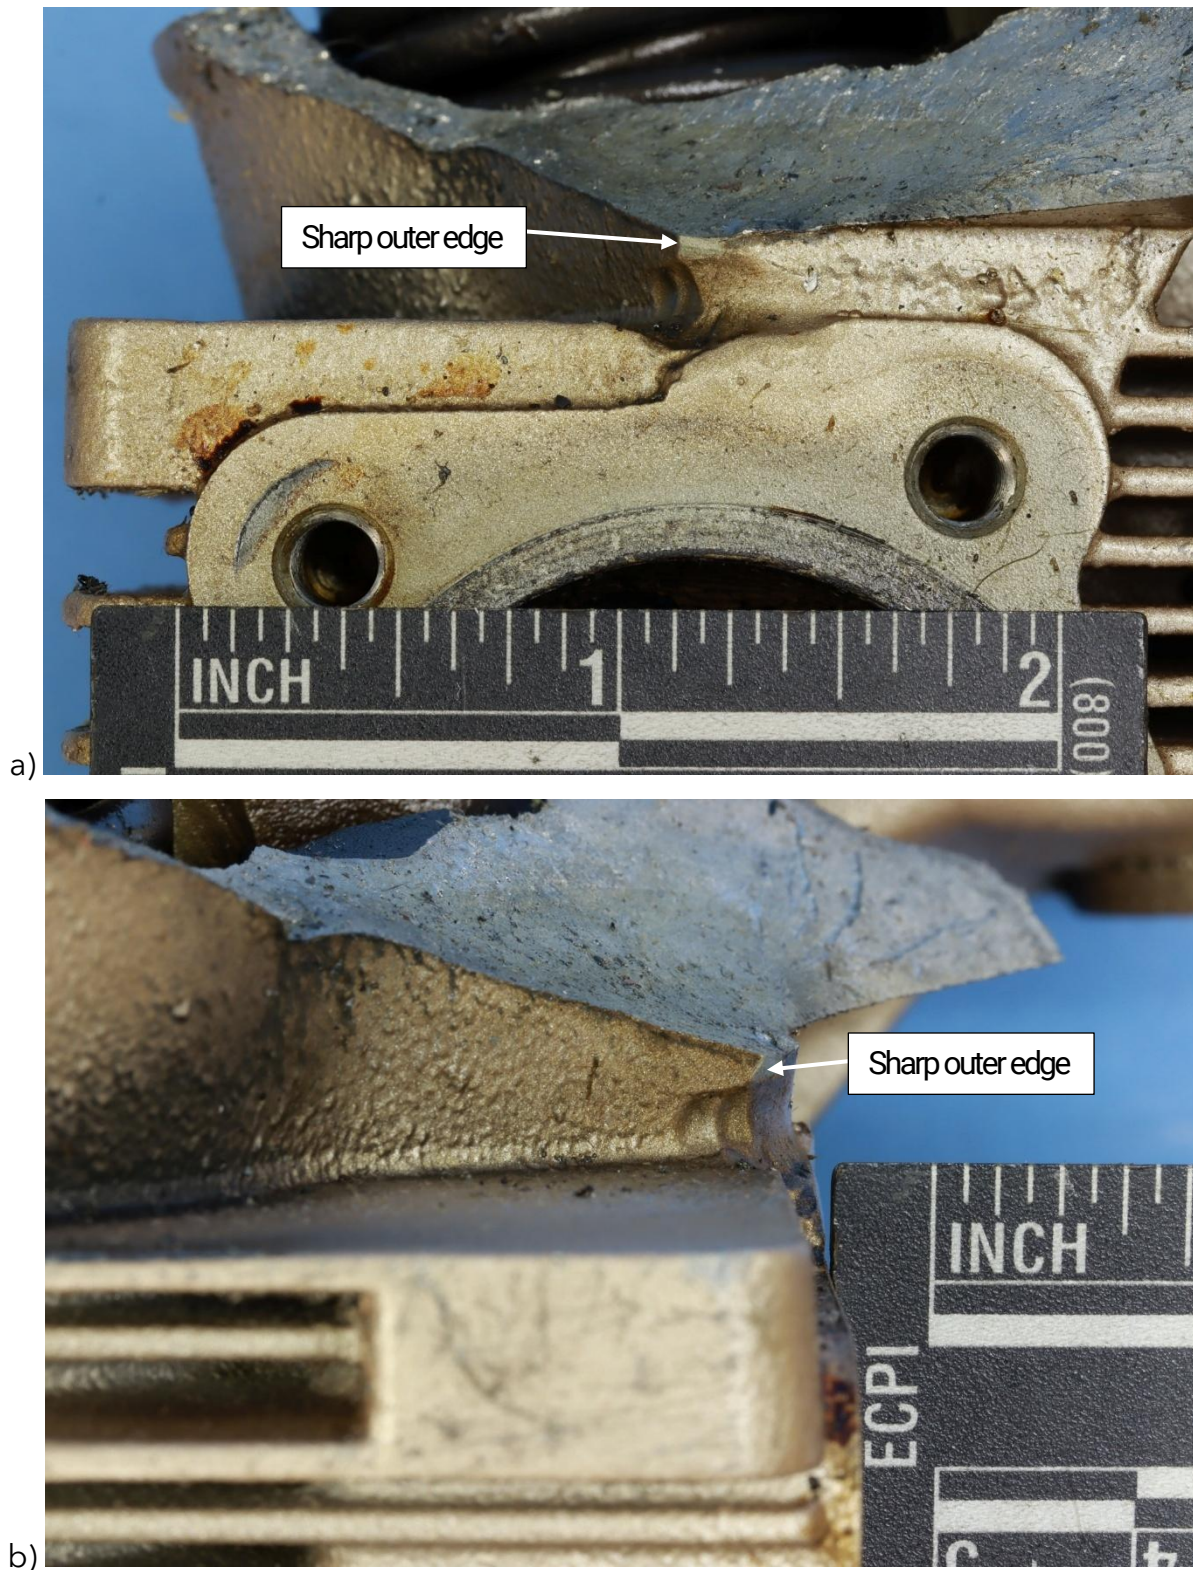
**Figure 6.** Images showing blending of the outer edge: a) blending along the underside of the ear and b) blending into the footing.

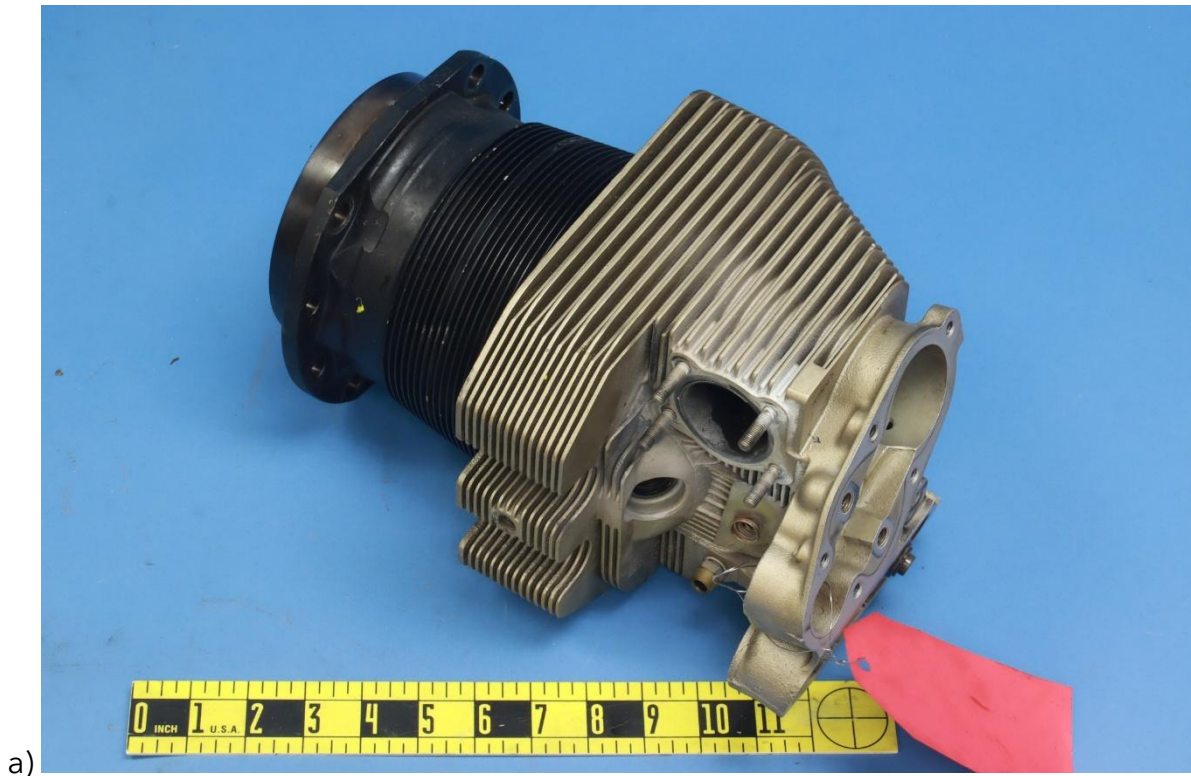
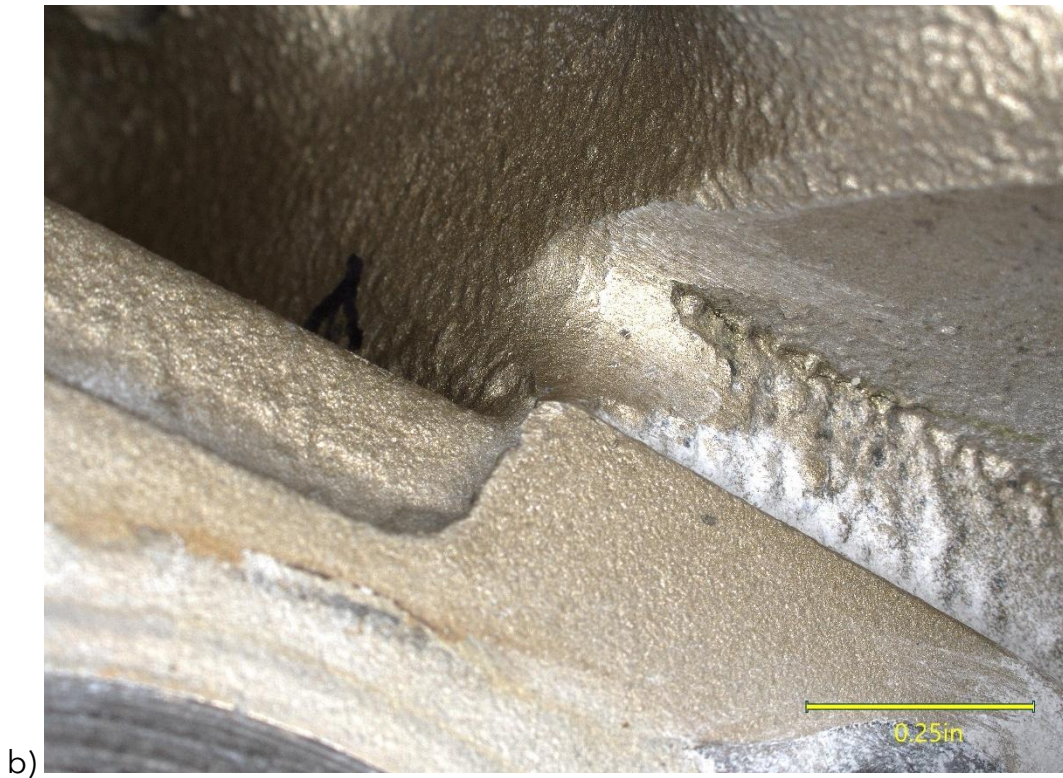
The as received cracked cylinder is shown in figure 7a. The intake rocker box ear was stamped with an 'S', in accordance with the Continental service bulletin and the outer edge was rounded, consistent with filing of the edge (figure 7b). At its greatest extent, the blending extended approximately 0.24 inches underneath the ear (figure 8a) and 0.10 inches deep into the footing (figure 9a). The internal edge underneath the ear was blended approximately 0.08 inches from the corner. The external edge of the ear was beveled but not blended (figure 7b). The cylinder had previously undergone a fluorescent penetrant inspection, and fluorescent dye was still present inside the crack (figures 8b and 9b). The dye was used to mark the ends of the crack.

**Figure 7.** a) Overview image of the as received cylinder with the cracked exhaust rocker box and b) image of the blended outer edge.

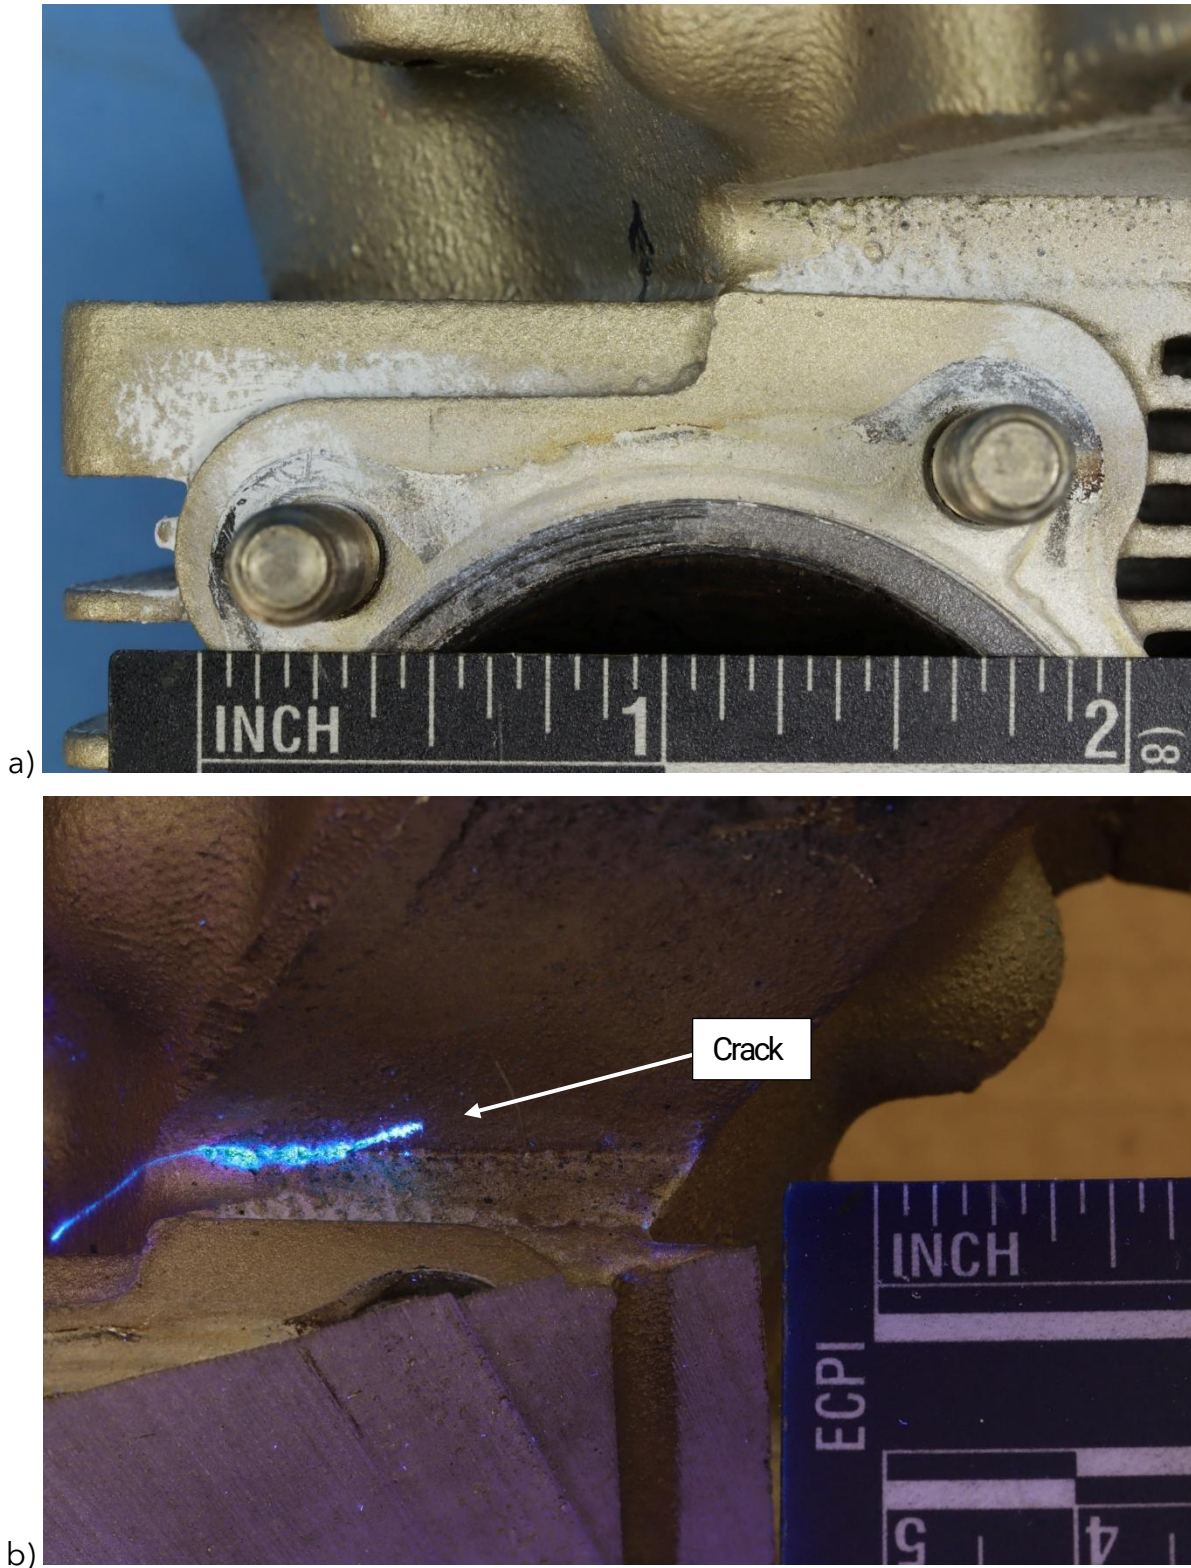
**Figure 8.** a) Image showing blending of the outer edge along the underside of the ear and b) black light image showing fluorescence of crack, initially running along the internal edge and the progressing into the ear.

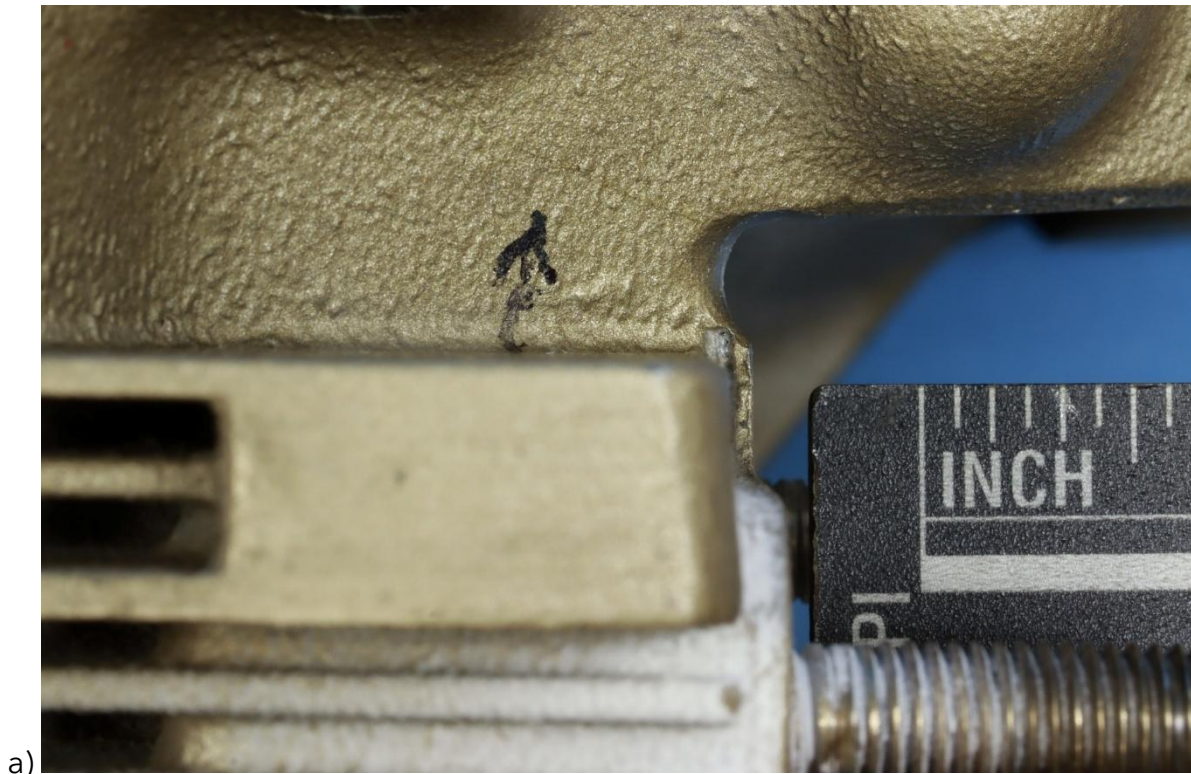
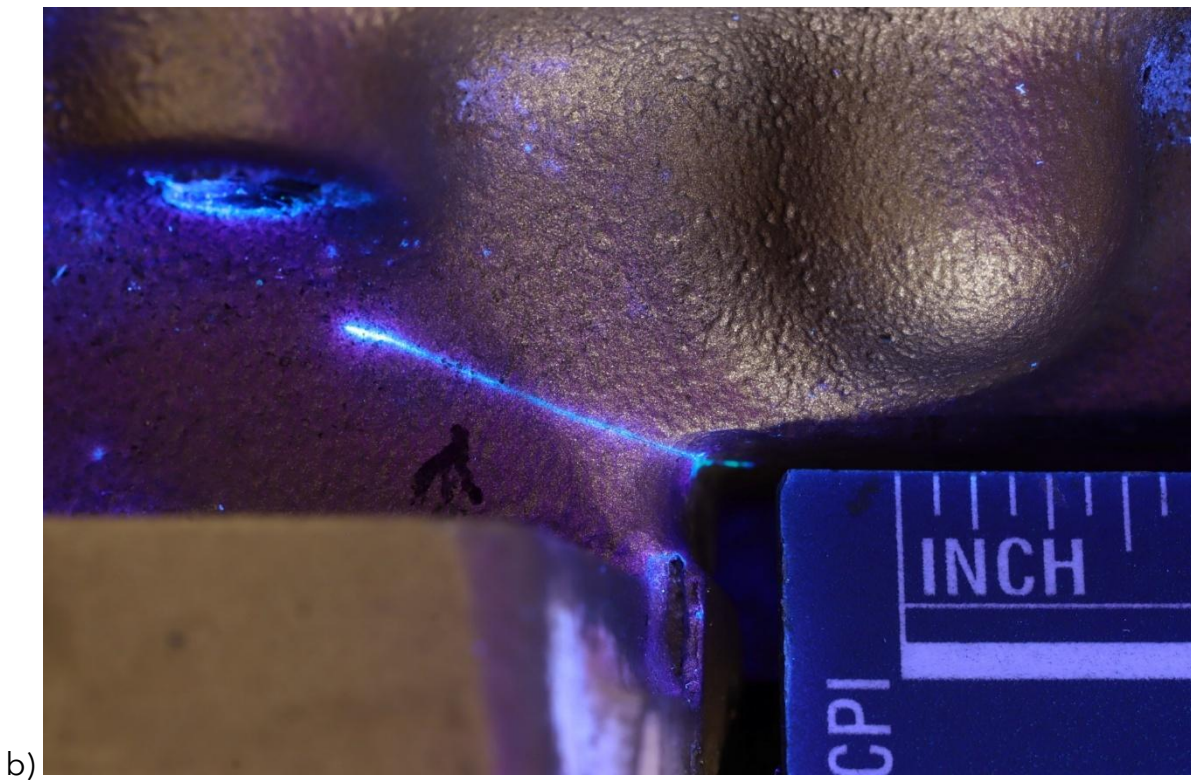
**Figure 9.** a) Image showing blending of the outer edge into the rocker box footing and b) black light image showing fluorescence of crack, progressing into the rocker box footing.

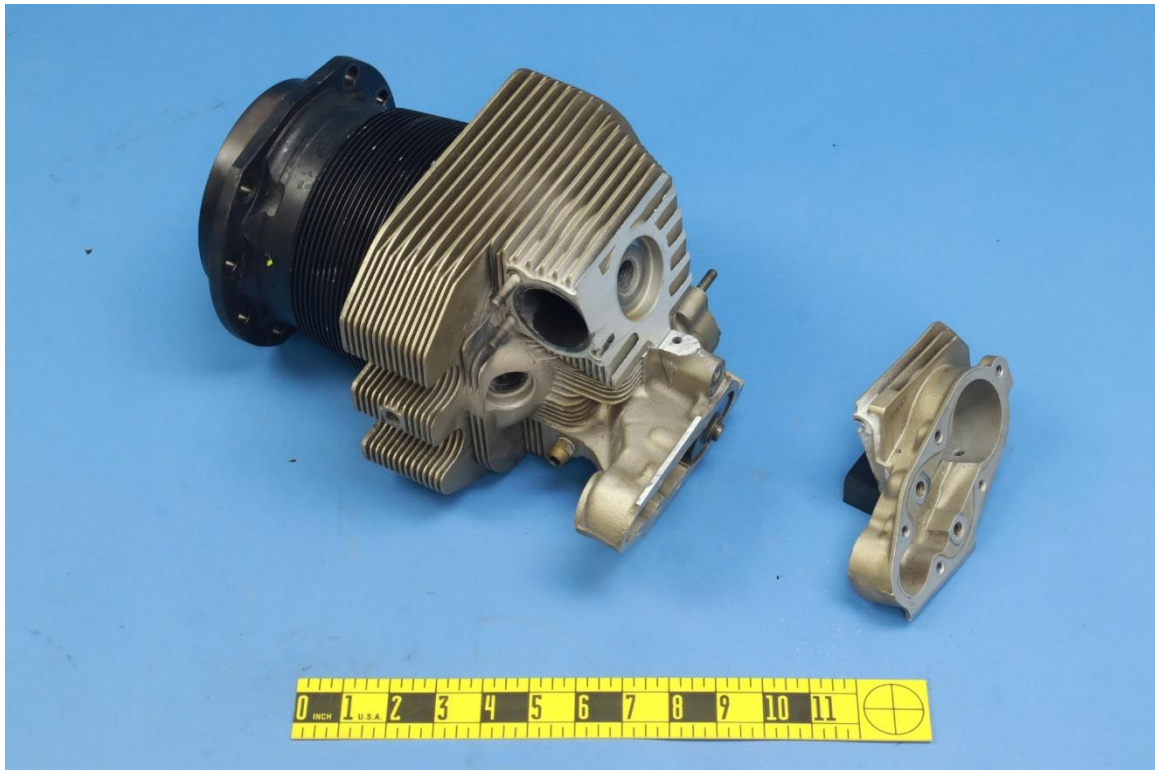
The portion of the cylinder with the crack was sectioned from the rest of the cylinder. Then, the crack was back-cut, and the piece was fractured, exposing the crack faces (figures 10a, 10b, and 11). The crack extended approximately 0.62 inches underneath the ear and 0.65 inches into the rocker box footing.

**Figure 10.** a) Exhaust valve rocker box region sectioned from the rest of the cylinder and b) further sectioning and exposure of the crack.

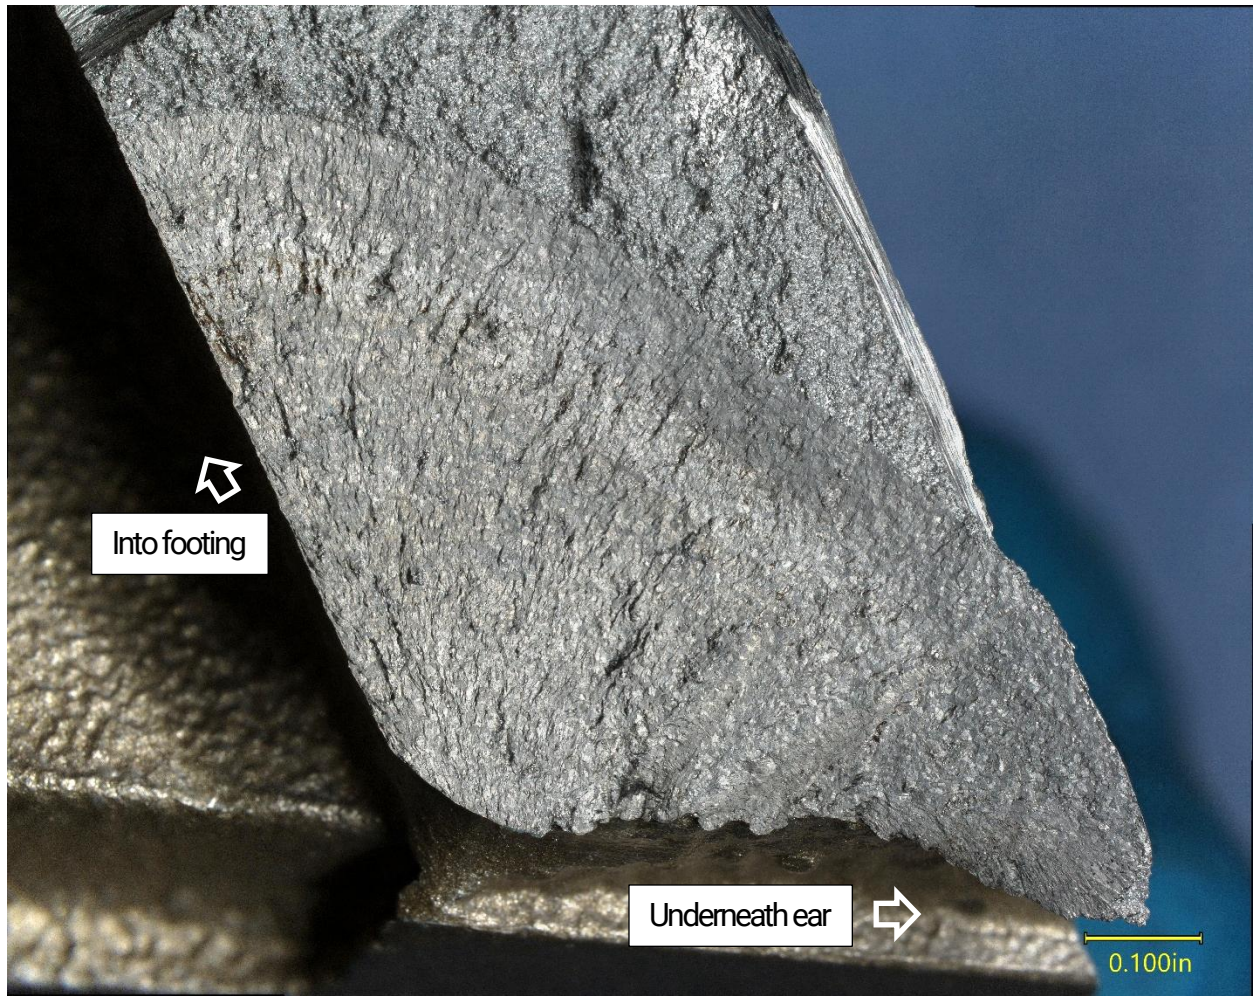
**Figure 11.** One of the crack surfaces after cleaning. The features were consistent with high-cycle fatigue.

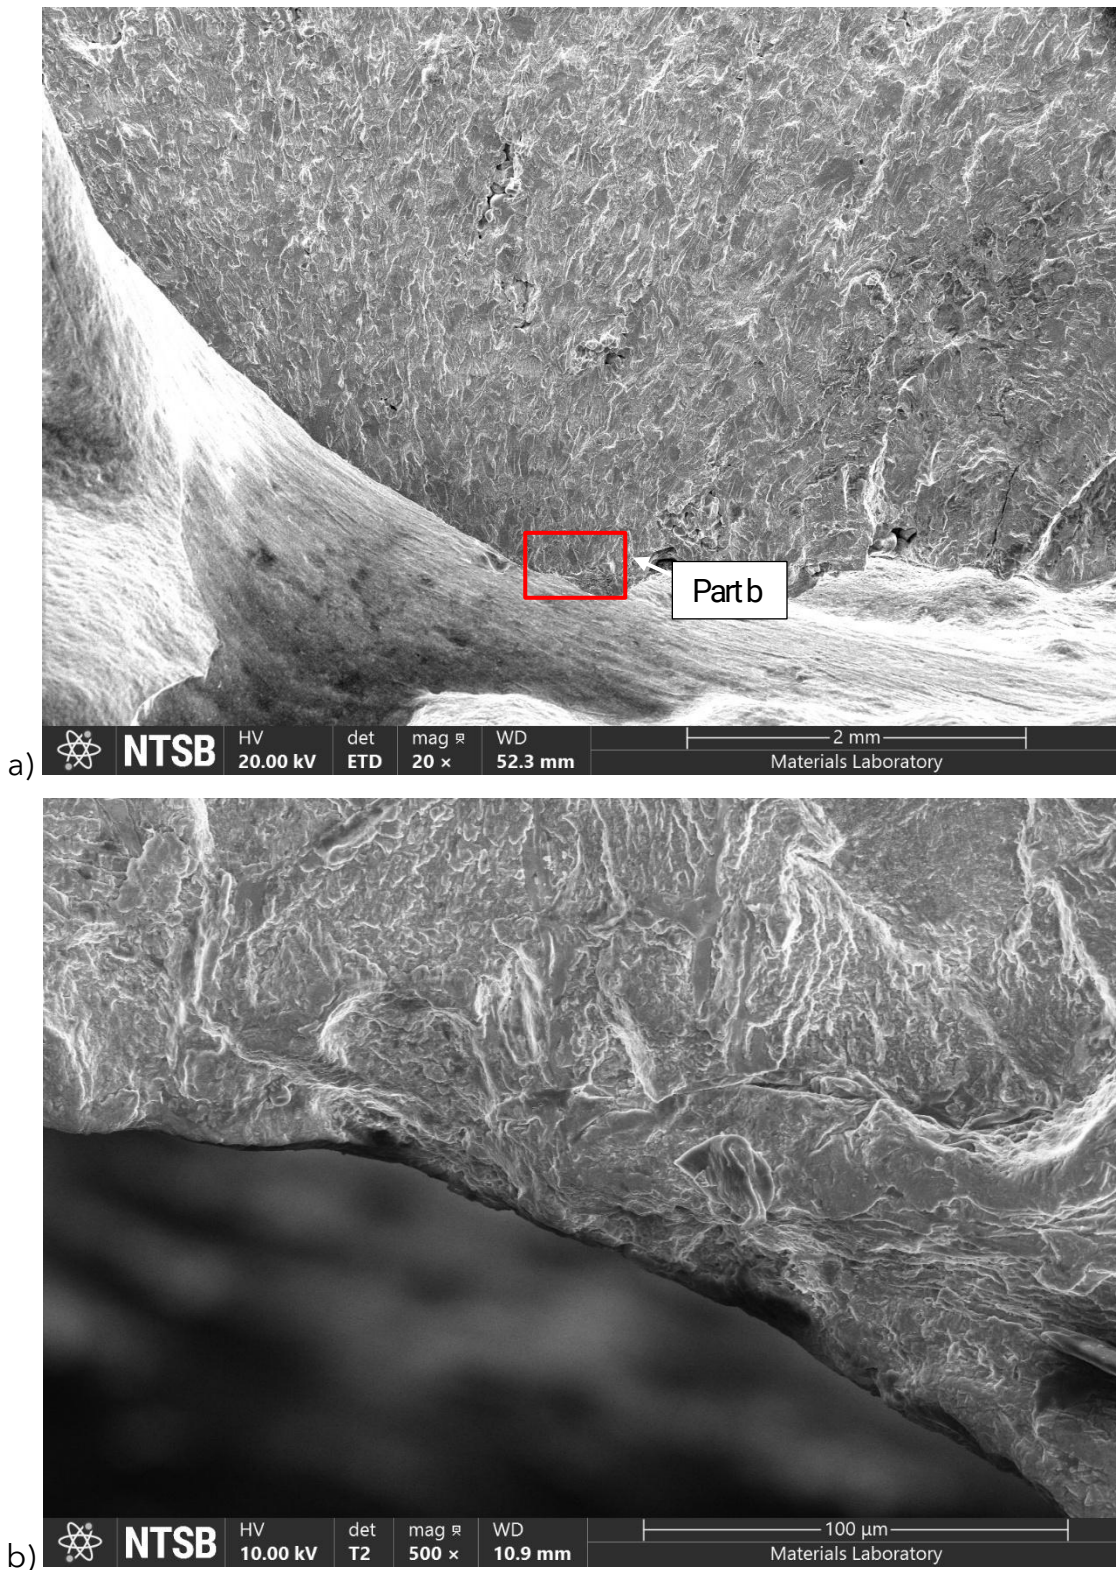
One of the crack faces was examined by SEM (figures 12a and 12b). The fracture surface exhibited feathery features consistent with high-cycle fatigue. Radial

lines and crack progression features were traced back to an origin near the end of the blended region along the internal edge beneath the ear.

**Figure 12.** Scanning electron microscope images of the crack surface: a) Overview image showing the transition from the blended region to the internal edge underneath the ear and b) higher magnification image showing the fracture origin at the edge of blended internal edge.
