# National Transportation Safety Board

CEN24LA079

## **ENGINE TEARDOWN EXAMINATION SUMMARY**

Location: Davenport, Iowa  
Date: December 31, 2023  
Time: 1540CST  
Airplane: N773GB, Cirrus SR22T

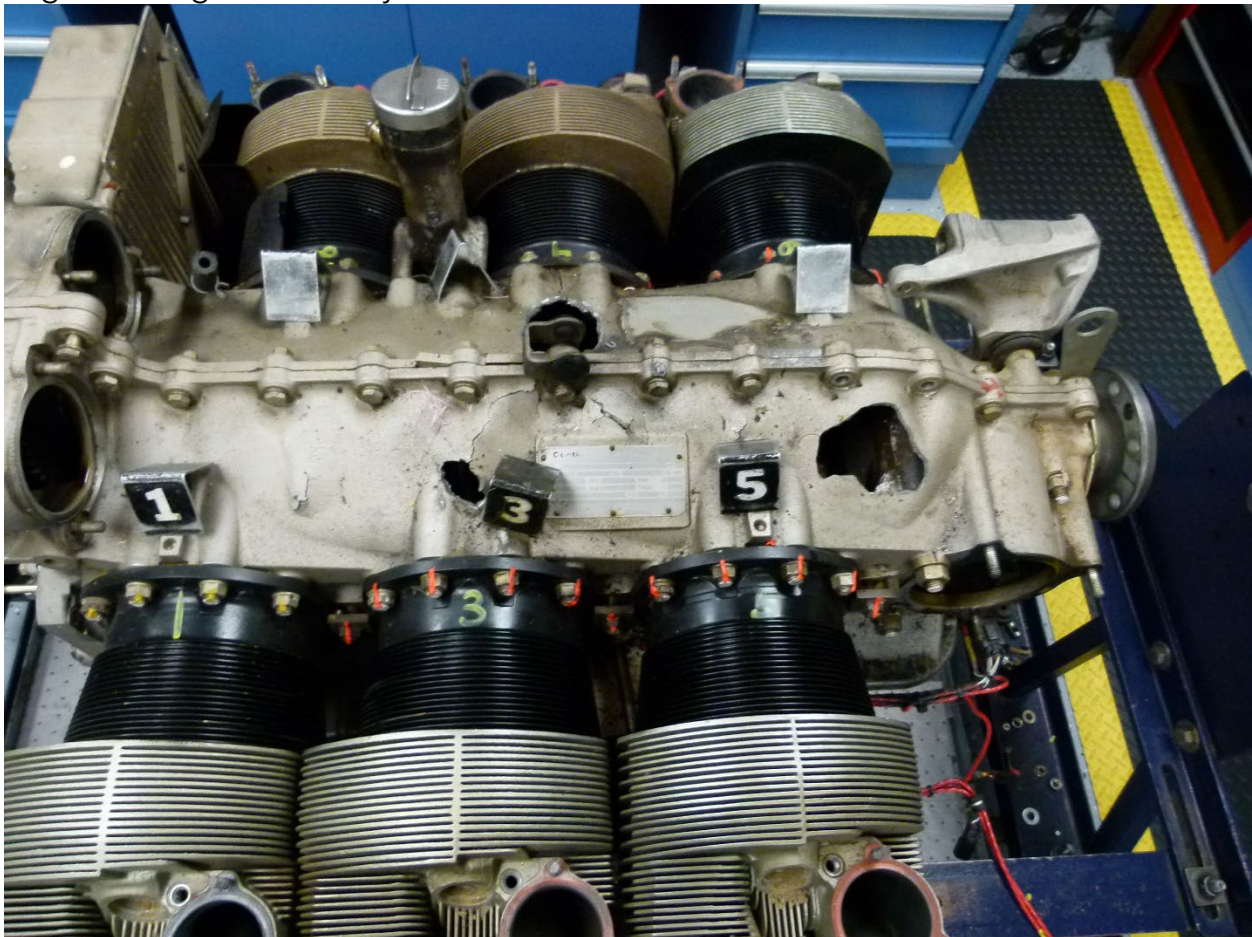
The engine was examined at the Continental Aerospace facilities in Mobile, Alabama, under the direct supervision of the NTSB IIC on January 13, 2025. The engine was removed from its shipping crate and mounted on an engine disassembly stand for the examination. Several holes in the top of the engine case were noted after removal of the intake tubes. The No.5 cylinder exhaust rocker arm area had separated from the rest of the cylinder head. About 1 quart of oil drained from the engine during disassembly.

Figure 1. Engine during examination disassembly.

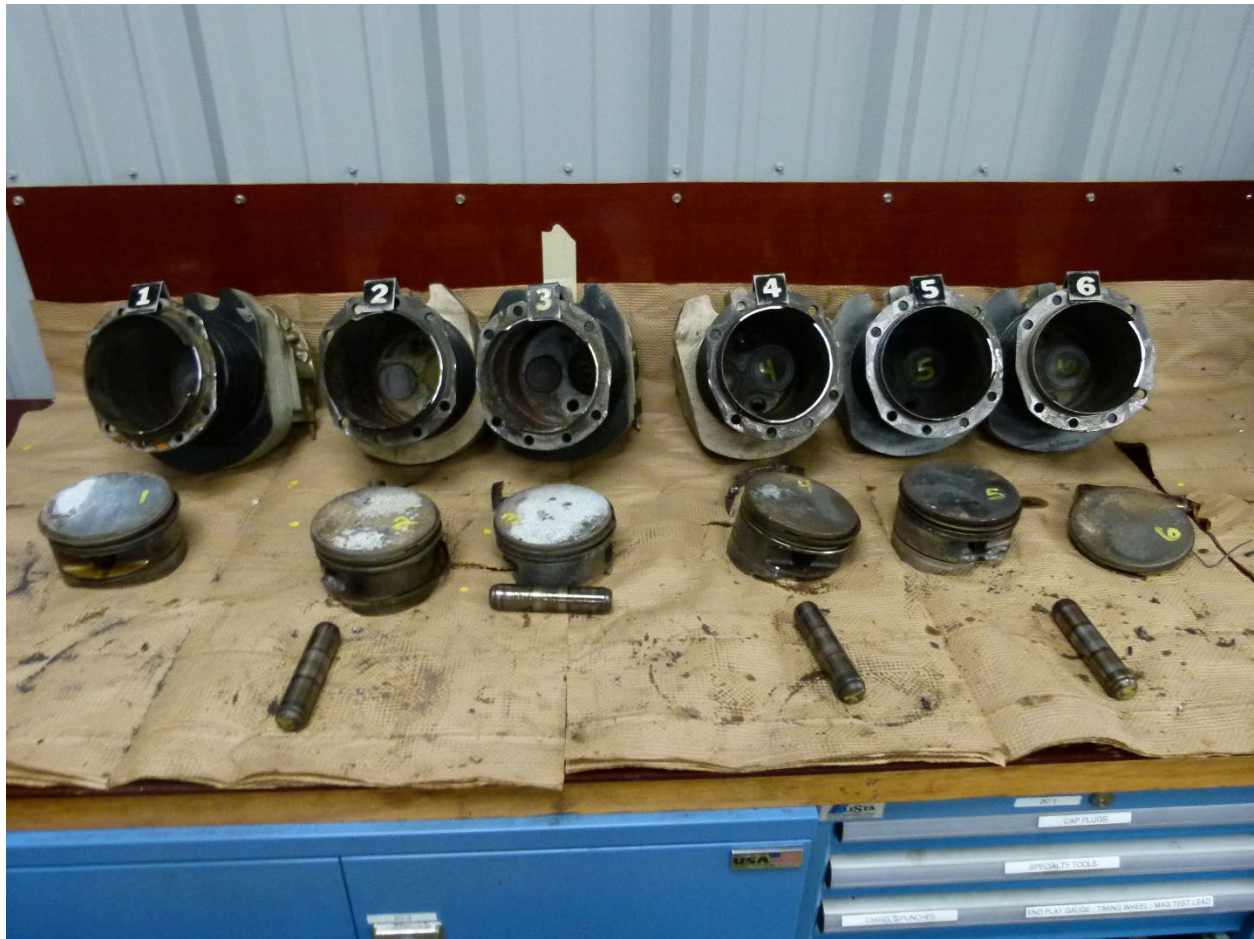
Figure 2. Engine pistons and cylinders.

The engine was completely disassembled. Connecting rods, No 3, and 4 separated at the large end. No 3 rod was twisted along its length. Pistons for cylinders No 5 and 6 were fractured, but the connecting rods were intact. The No. 3 and 4 connecting rod journals had evidence of heat distress consistent with lack of lubrication.

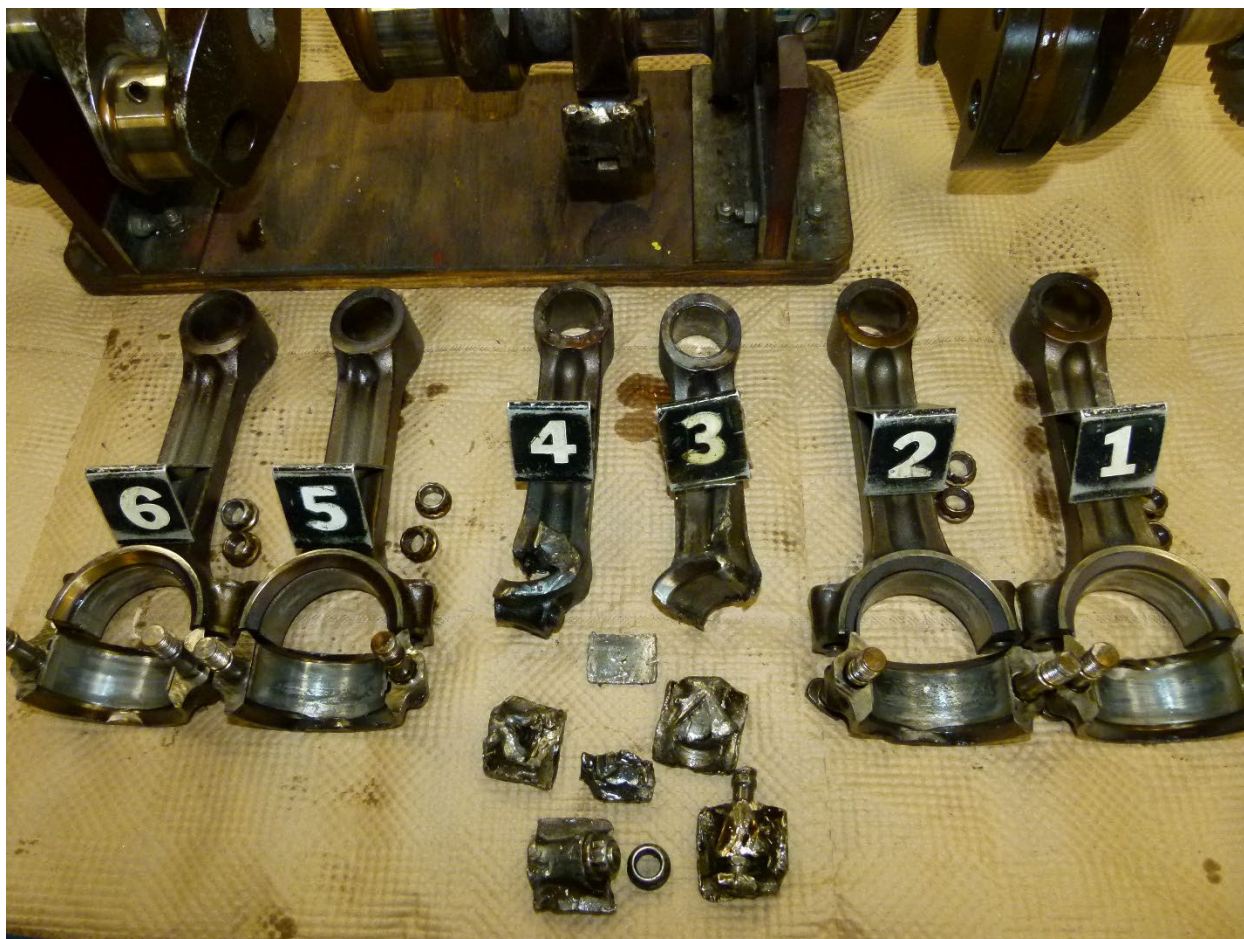
Figure 3. Engine connecting rods.

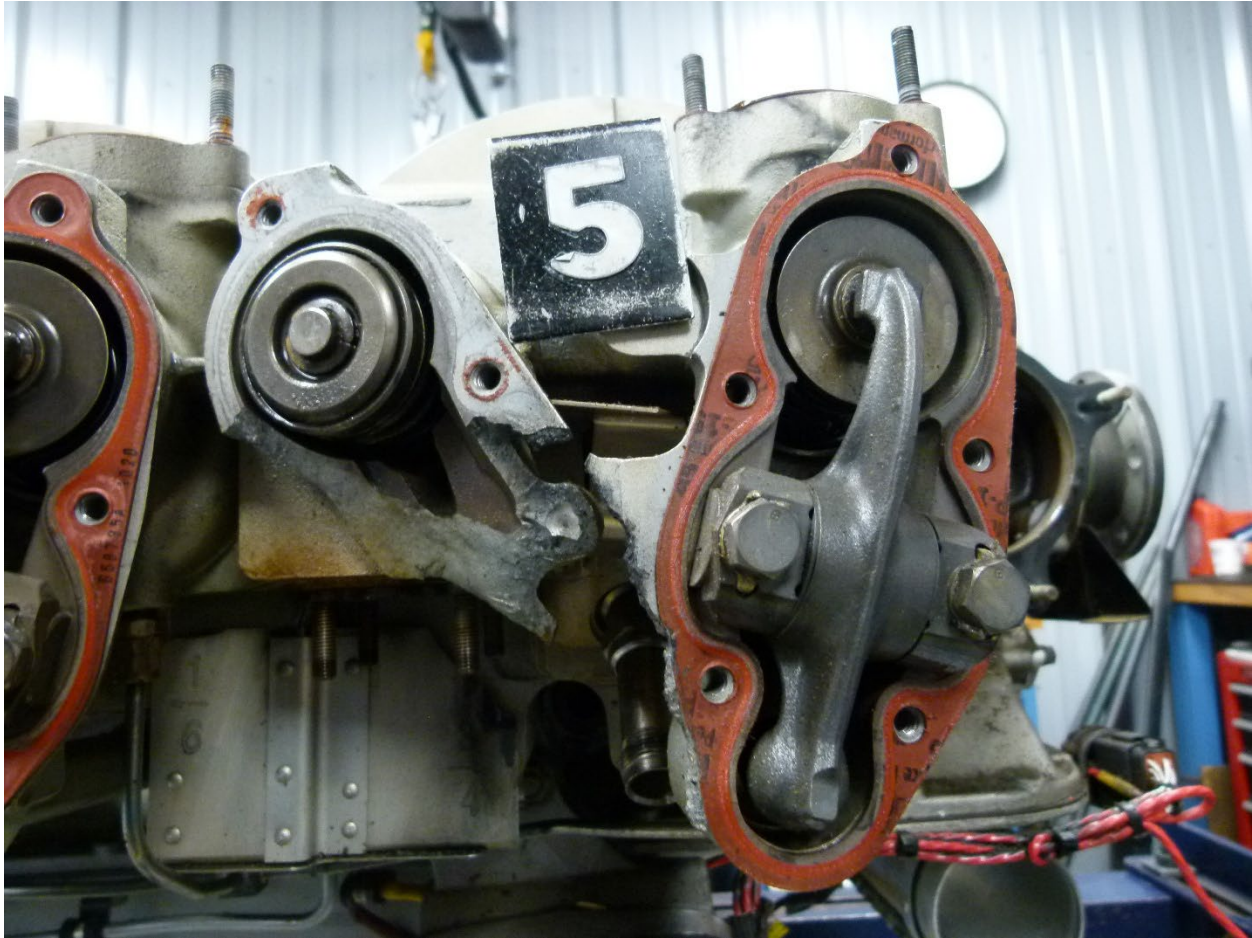
It was found that the broken rocker area of No.5 cylinder was subject to an Airworthiness Directive (AD), (2020-16-11), and manufacturer Service Bulletin (SB), (MSB 18-08 C). According to the details of the service bulletin, the No.5 cylinder was the only installed cylinder affected by the AD or SB. According to the serial number coding, the No.1, 2, 3, 4, and 6 cylinders were manufactured in 2013, the same year as the original date of manufacture of the engine. The No. 5 cylinder was manufactured in 2017. Maintenance records indicated that the No. 5 cylinder was replaced with the cylinder affected by the AD on April 21, 2017. The Airworthiness Directive Compliance sheet included with the aircraft maintenance records, and the Service tag from the FAA Approved Repair Station indicated that the No. 5 cylinder had AD 2020-16-11 complied with on February 26, 2021, when the cylinder had other maintenance performed on it.

Figure 4. Fractured rocker box ear on No.5 cylinder.

The AD and SB called for removing casting flashing and creating a smooth radius to a corner of the casting near the pushrod tube hole in the cylinder head. Once completed the SB called for stamping a "S" on a portion of the top of the cylinder to denote completion. The No.5 cylinder from the accident airplane had the "S" stamped. The No.5 cylinder was sent to the NTSB Materials Laboratory for further examination.

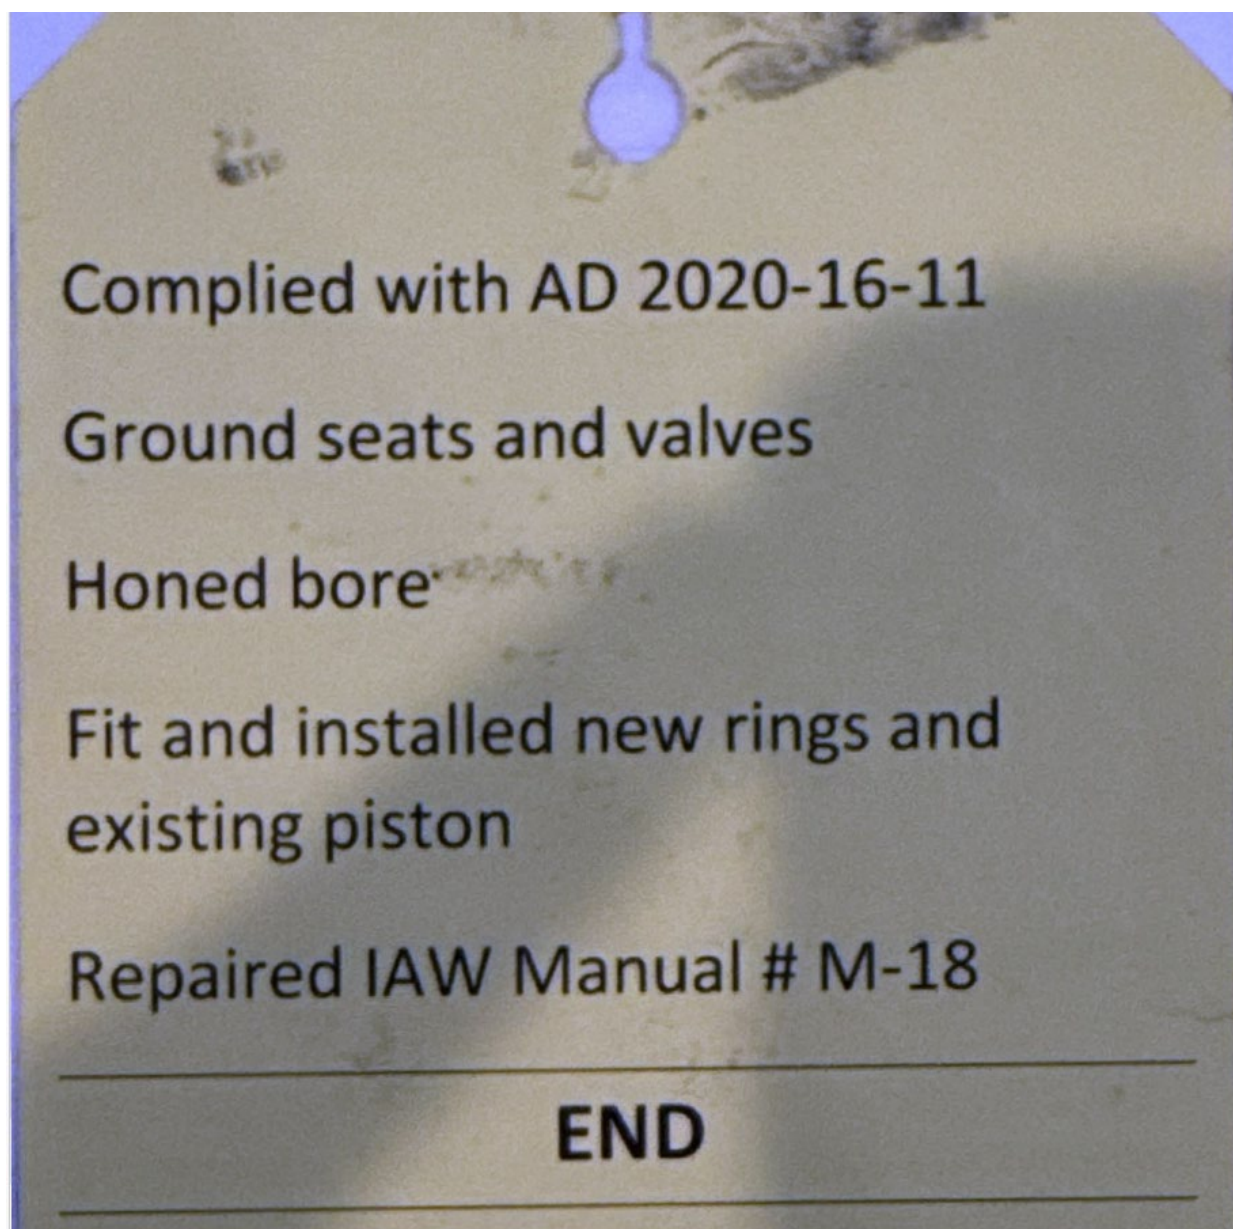
Figure 6. Image of repair tag for No. 5 cylinder showing AD 2020-16-11 compliance.
