CEN24LA082

## INVESTIGATION PHOTOGRAPHS

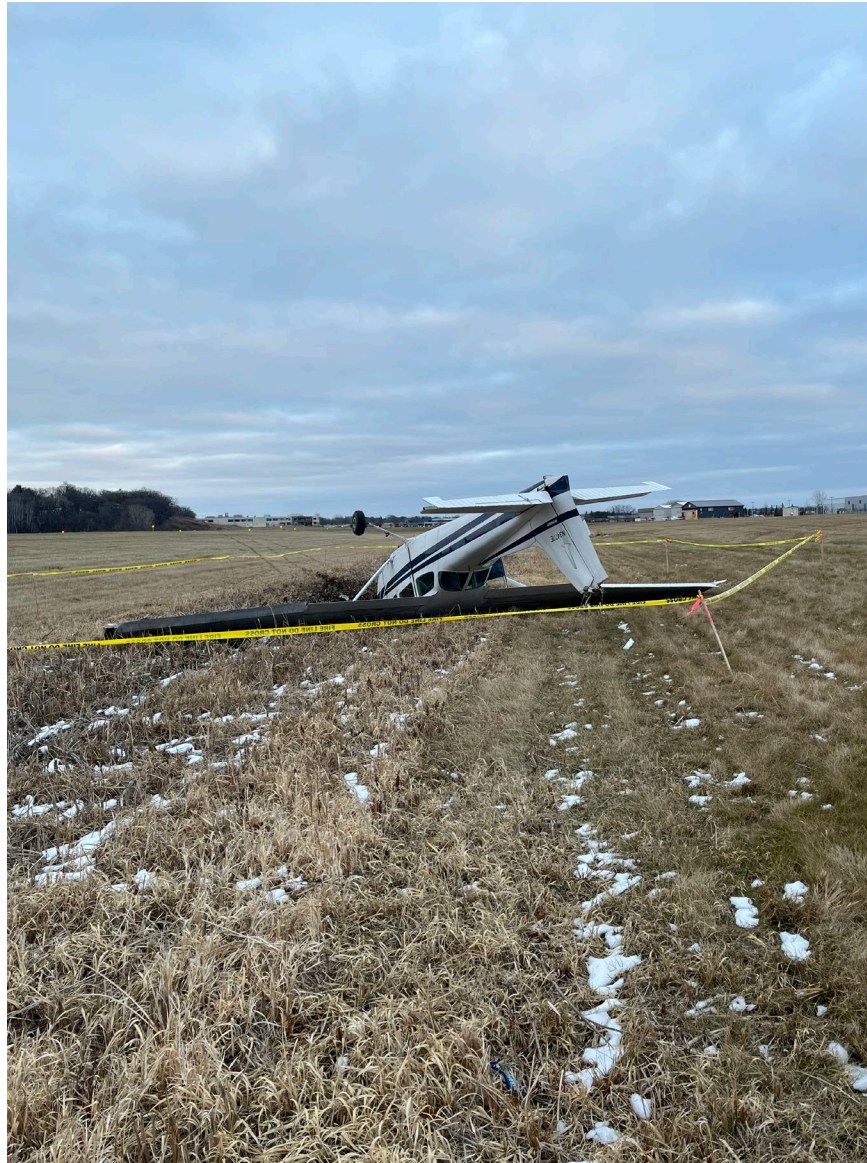
**Photograph 1 - Deformation noted to rudder (Courtesy of FAA)**

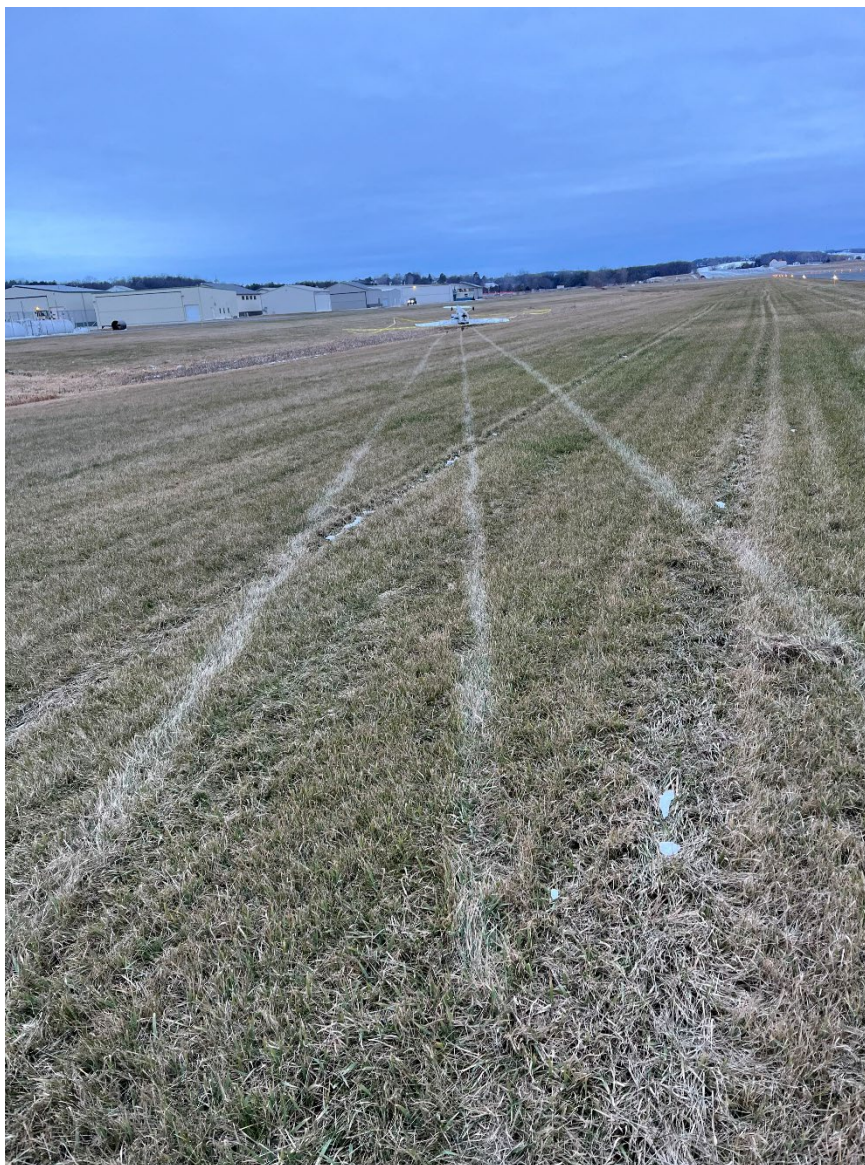
**Photograph 2 - Wheel impression noted from the runway to the wreckage (Courtesy of FAA)**

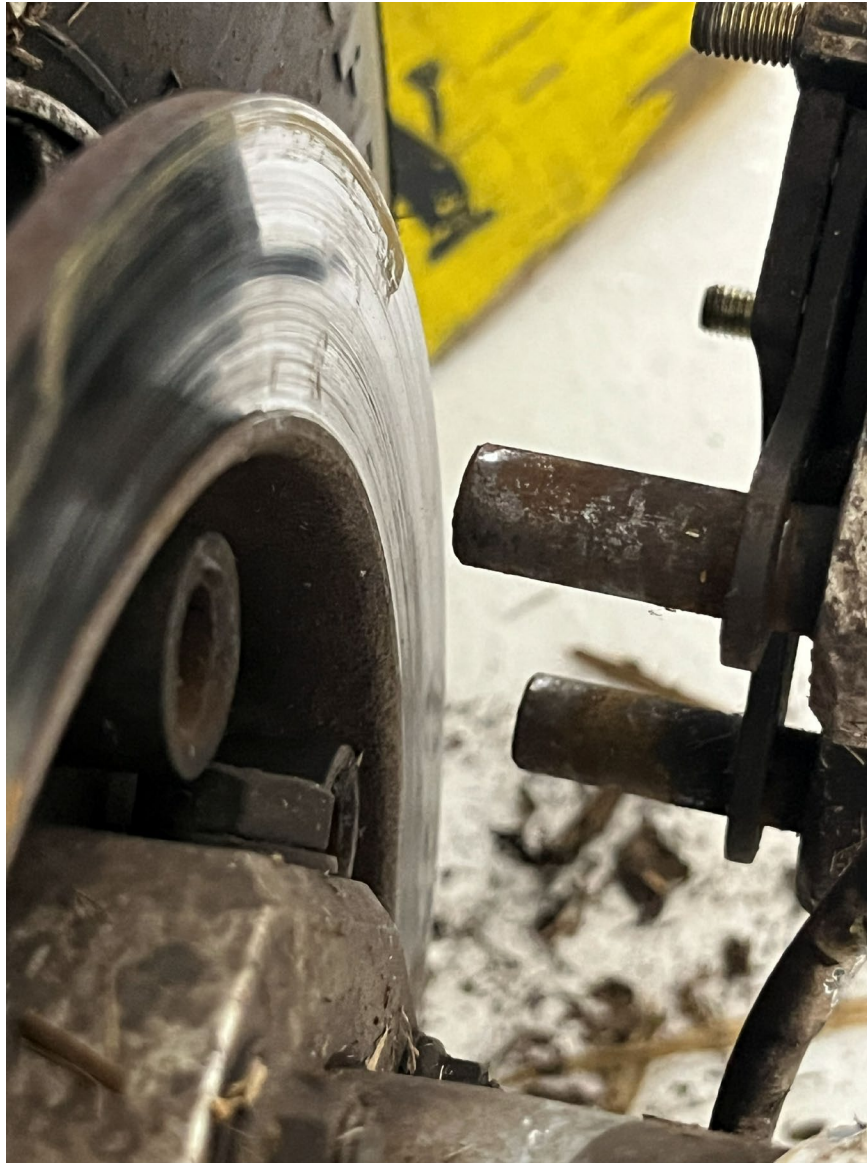
**Photograph 3 - Corrosion noted to the anchor bolts (Courtesy of FAA)**
