# National Transportation Safety Board

CEN24LA085

## **AIRPLANE PERFORMANCE STUDY**

Location: San Marcos, Texas  
Date: January 2, 2024  
Time: 1710 CST  
2310 GMT  
Airplane: LearJet 35A, N46MF

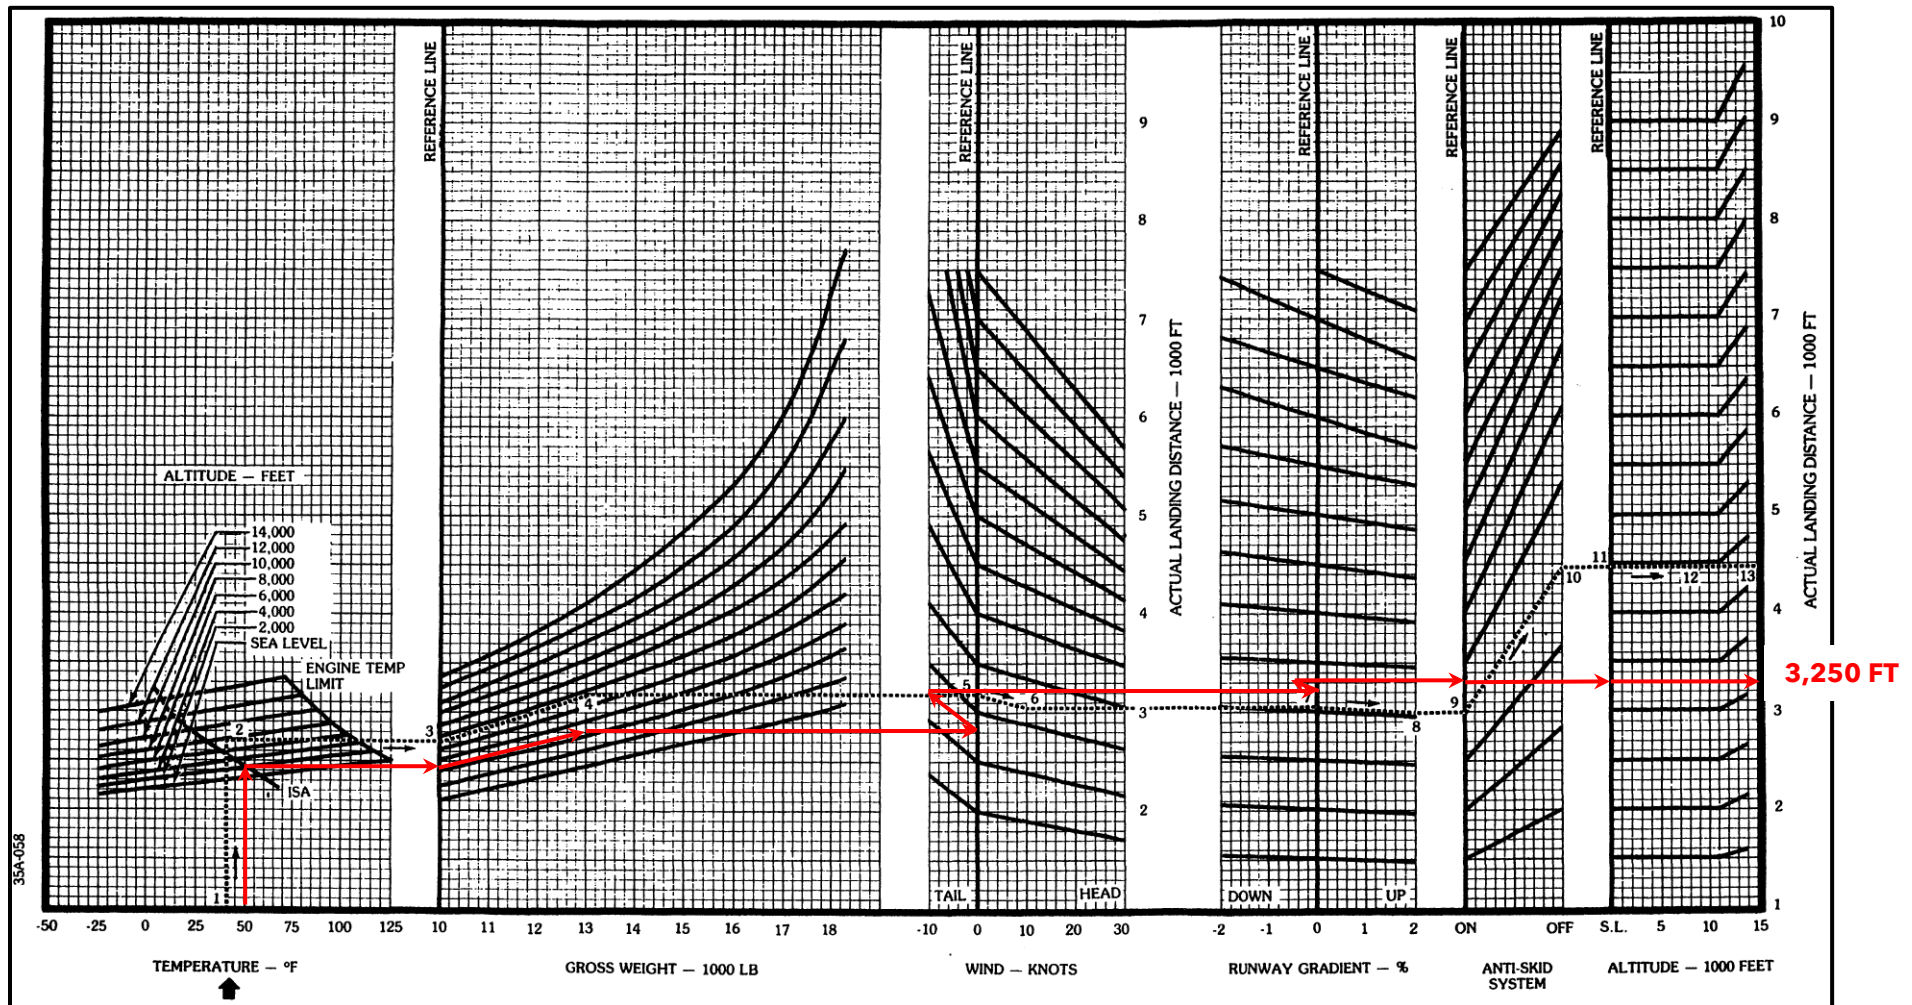
Figure 3: AFM Actual Landing Distance Calculation

Bombardier computed an unfactored dry landing distance of 3,250 ft for the following conditions using the FAA Approved Flight Manual (AFM) for the LearJet 35A. Figure 3 shows the calculation using the AFM "Actual Landing Distance" chart.

1. HYI Runway 13 (126° magnetic and 5,601 ft long)
2. Elevation of 593 ft
3. Temperature of 10°C
4. Landing weight of 12,862 lb
5. Winds 310° at 12 kt with gust 24 kt
6. 10 knot tailwind (This is the greatest tailwind listed in the AFM landing chart.)
7. Runway gradient of -0.36%
8. Anti-skid on
9. Flaps 40°

However, the AFM Supplement for a wet/contaminated runway (as was the case in the accident) specifies a factor of 1.4 to be applied to the unfactored dry landing distance. This results in a factored landing distance of 4,550 ft.

In addition to landing distance, the AFM lists the reference landing speed or the airspeed used for final approach,  $V_{ref}$ , as 119 kt indicated (KIAS) at the conditions above, not including the wind gust.  $V_{ref}$  increases to 125 kt when the recommended "half the gust factor" or 6 kt is added.

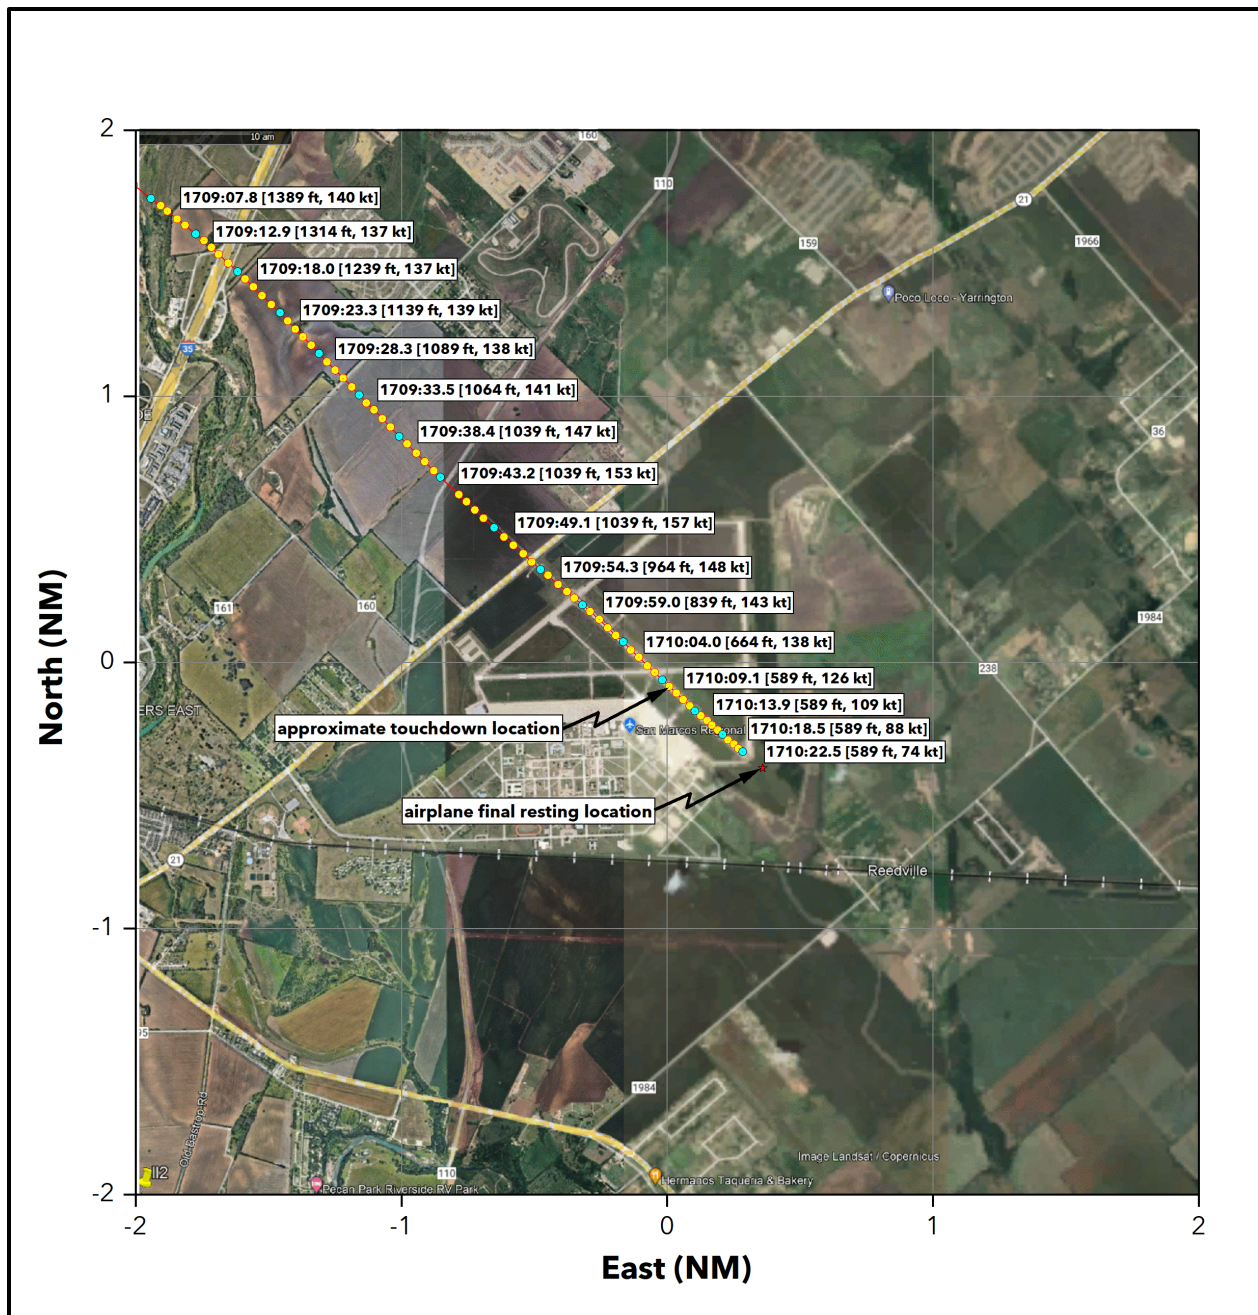
**Figure 5: Recorded ADS-B Ground Track with Altitude and Estimated Calibrated Airspeed for the Final Approach into HYI**

Figure 4 shows an over-head view of the recorded ADS-B ground track from Albuquerque to the wreckage location off the end of runway 13. Figure 5 is the same ground track but focuses on the last 3 NM of the approach and landing and includes altitude and estimated calibrated airspeed (KCAS). N46MF crossed the runway 13 threshold at approximately 144 KCAS and 300 ft agl. The optimal threshold crossing height (TCH) is between 40 and 60 feet<sup>3</sup>.

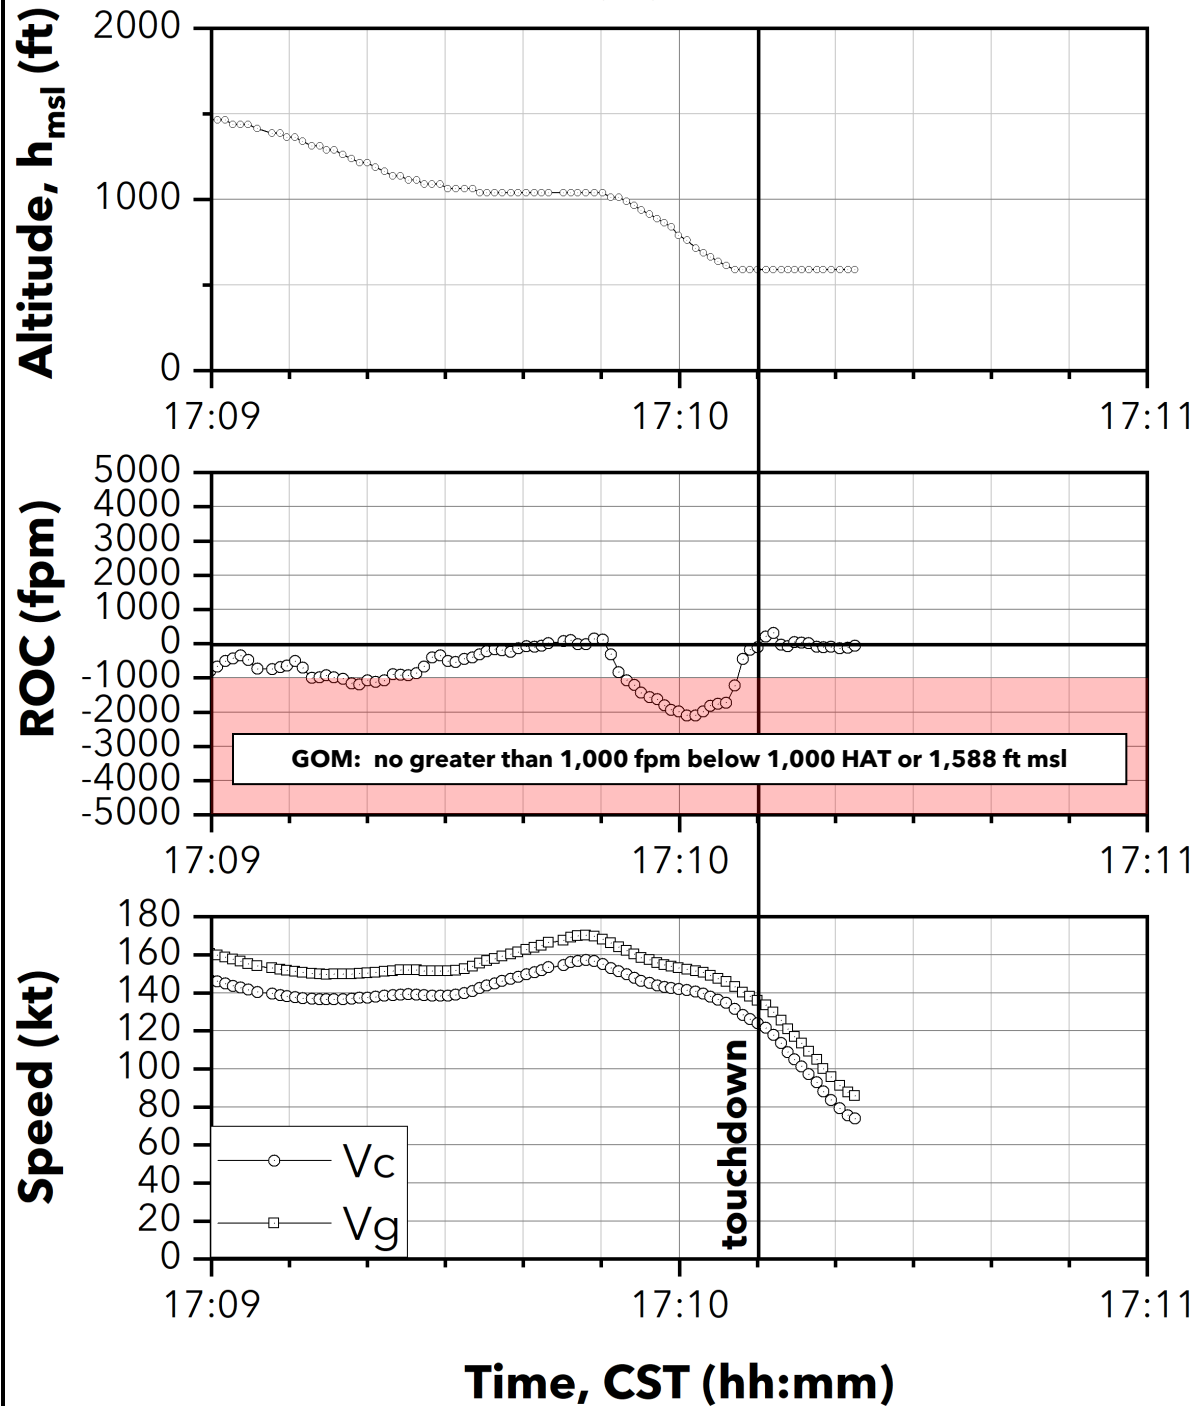
**Figure 7: ADS-B Altitude, Rate of Climb (ROC), and Ground Speed with Estimated Airspeed for Accident Flight during Final Approach**

Recorded data in Figure 7 indicate that N46MF had about a 15 kt tailwind and a descent rate that exceeded 2,000 ft/min approximately 10 sec before touchdown<sup>4</sup>. This was reduced to 1,000 ft/min about 3 sec before touchdown and 25 ft above the runway.

<sup>4</sup> The Med Flight Air Ambulance General Operations Manual notes that a stabilized approach is one of the key features of safe approaches and landings. The GOM lists one of the criteria for a stabilized approach as a rate of descent no greater than 1,000 fpm below 1,000 ft above the terrain.

The ILS approach to runway 13 was not stable as per the operator's stabilized approach criteria.

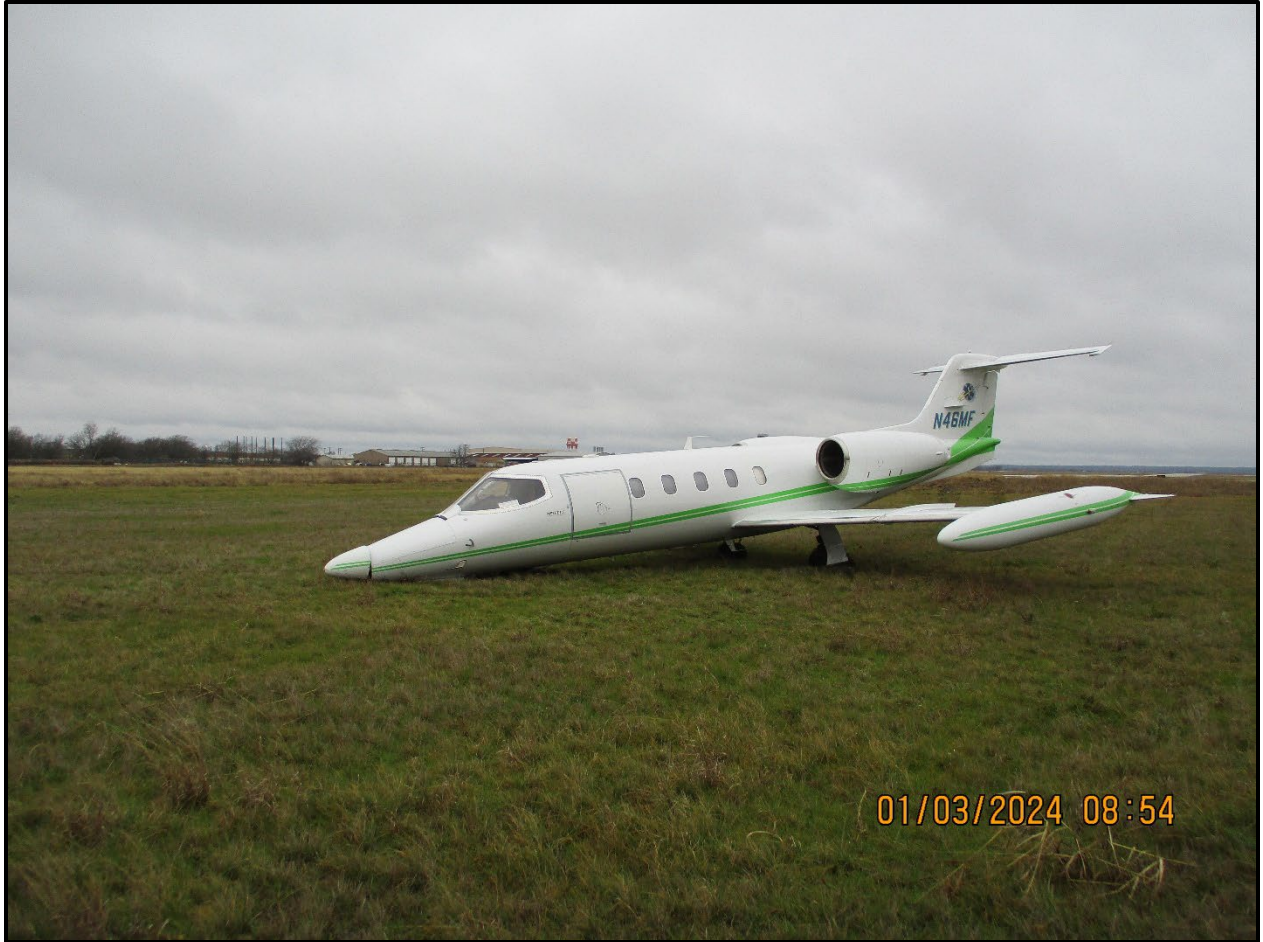
The airplane departed the end of runway and came to rest in the grass. The lower fuselage sustained substantial damage.

Recorded ADS-B data indicate that N46MF crossed the runway threshold about 250 ft high and landed about half-way down runway 13 at San Marcos Regional Airport. The airplane came to rest in the grass approximately 300 ft off the end of the runway as shown in Figure 8. In addition to the runway being wet, a 15 kt tailwind existed around the time of the landing. ATC did not advise the flight crew of the tailwind<sup>5</sup>.

**Figure 8: N46MF Came to Rest about 300 ft off of Runway 13**
