Jason Aguilera  
Senior Air Safety Investigator  
Aviation Safety - Central Region

**Date:** January 30, 2024  
**Subject:** CEN24LA085 Weather Information  
**Contact:** Don Eick, NTSB Meteorologist

The following information was collected in reference to CEN24LA085:

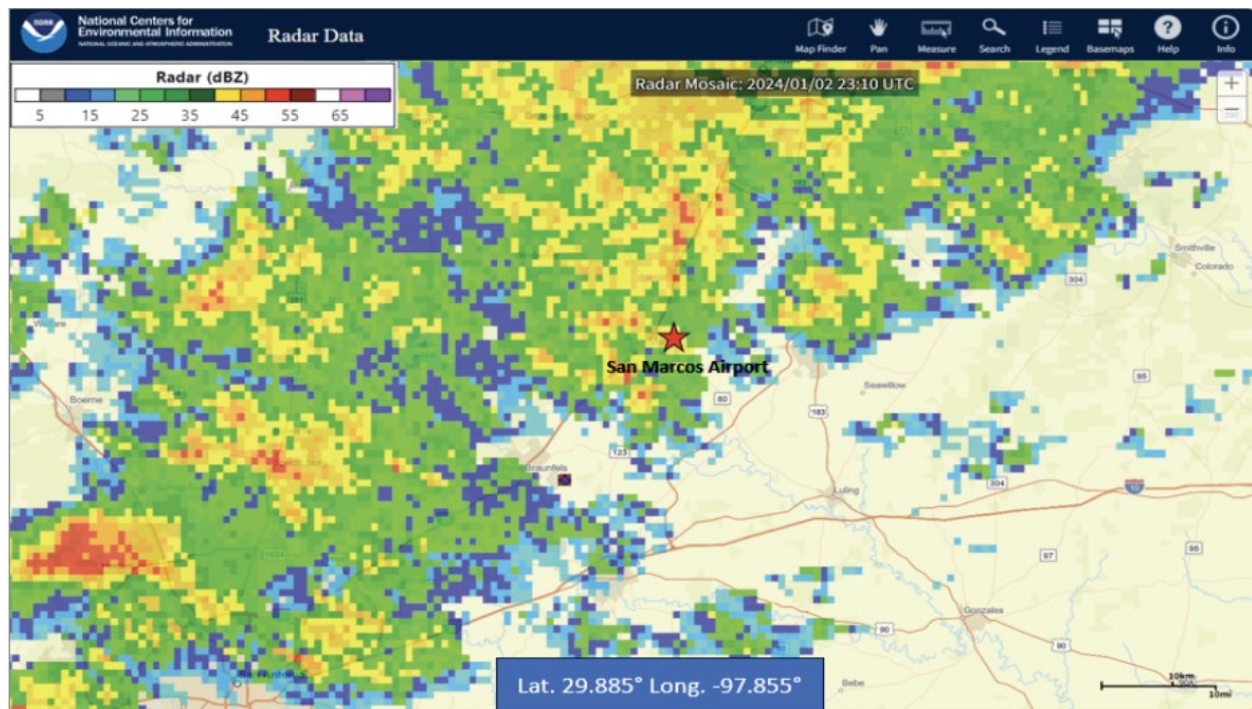
Figure 1. NWS Regional Composite Radar Mosaic

A review of the NWS Regional Composite radar Mosaic for 1710 CST (figure 1) depicted a large area of echoes with over central Texas with echoes of 40 to 50 dBZ over the accident site. No cloud-to-ground lightning was detected within 15 miles of the accident site at the time of the image.

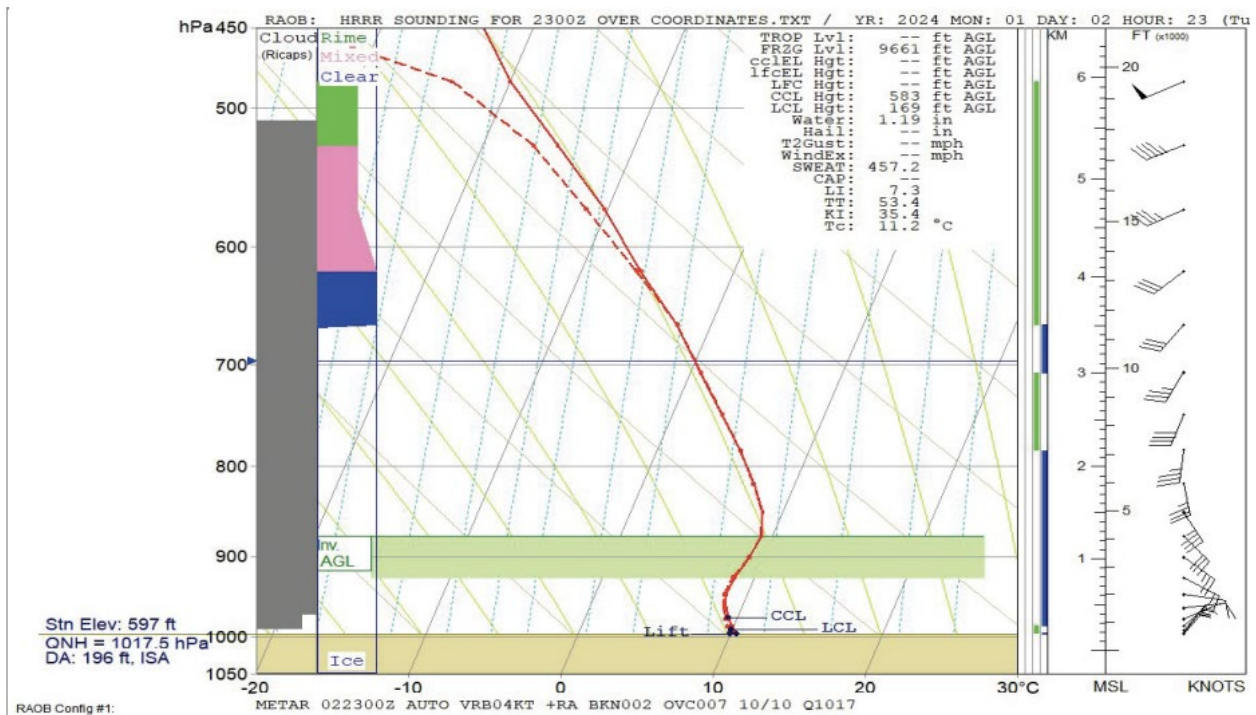
Figure 2. High Resolution Rapid Refresh

A High Resolution Rapid Refresh (HRRR) numerical model data were obtained from the NOAA Air Resource Laboratory for the grid sight closest to the accident site for 1700 CST. The data was then plotted on a standard Skew T log P diagram using the RAOB Analysis software. Figure 2.

The sounding depicted an elevation of 597 ft over the grid point with a near surface temperature of 10.4°C (50.7°F), a dew point temperature of 10.0°C (50.0°F), with a relative humidity of 97%. The lifted condensation level (LCL) was identified at 168 ft agl, with the convective condensation level (CCL) at 583 ft agl. A temperature inversion was noted above the CCL through about 4,000 ft. The sounding was saturated from the LCL through 17,500 ft and with the Lifted Index of 7.3 and no significant Convective Available Potential Energy (CAPE), supported nimbostratus type clouds with heavy rain. The precipitable water content was 1.19 inches. The freezing level was identified at 10,258 ft and supported icing in clouds above that level. The HRRR sounding wind profile indicated a surface wind from the northeast or from 040° at 4 knots, with winds less than 10 knots below the inversion, and then veering rapidly to the south above the inversion and then to the west-southwest with increasing wind speeds with height. The mean 0 to 6 kilometer (or 18,000 ft steering wind was from 215° at 28 knots. A low level jet streak was identified near 5,000 ft or above the inversion with winds from 155° at 34 knots.
