CEN24LA086

## INVESTIGATION PHOTOGRAPHS

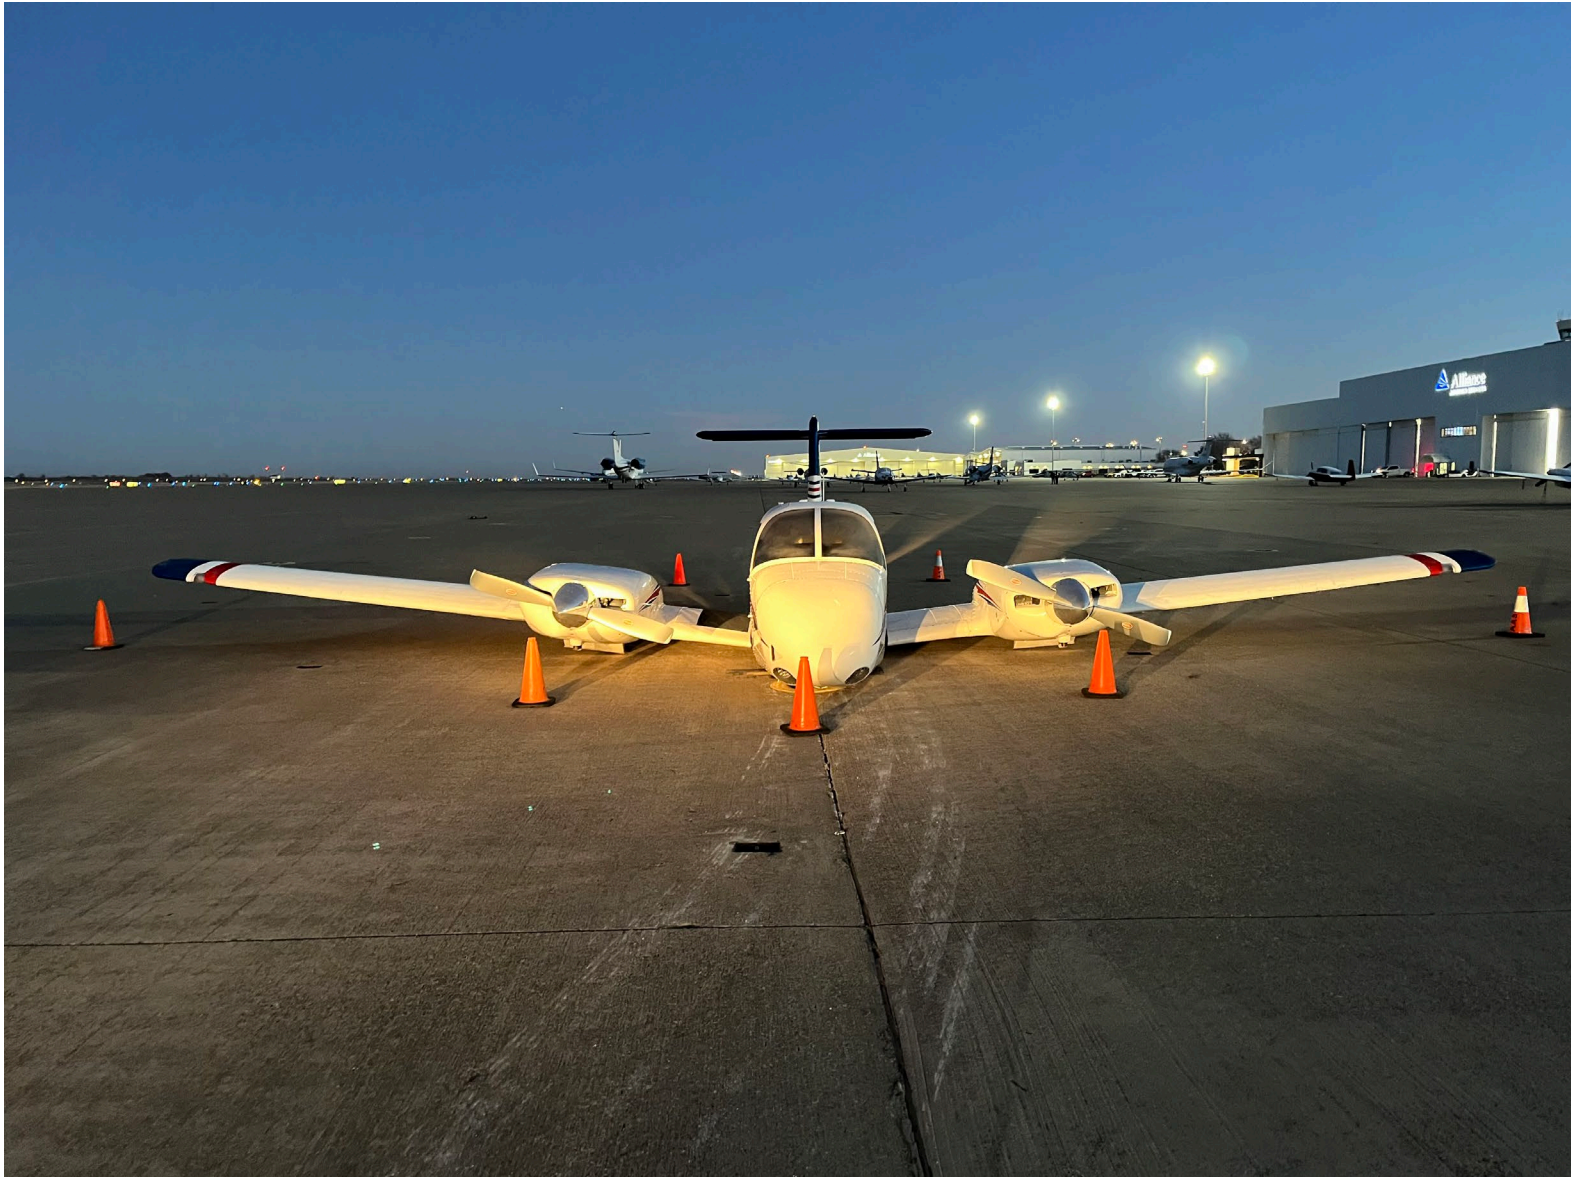
**Photograph 1 - Airplane on ramp (Courtesy of FAA)**

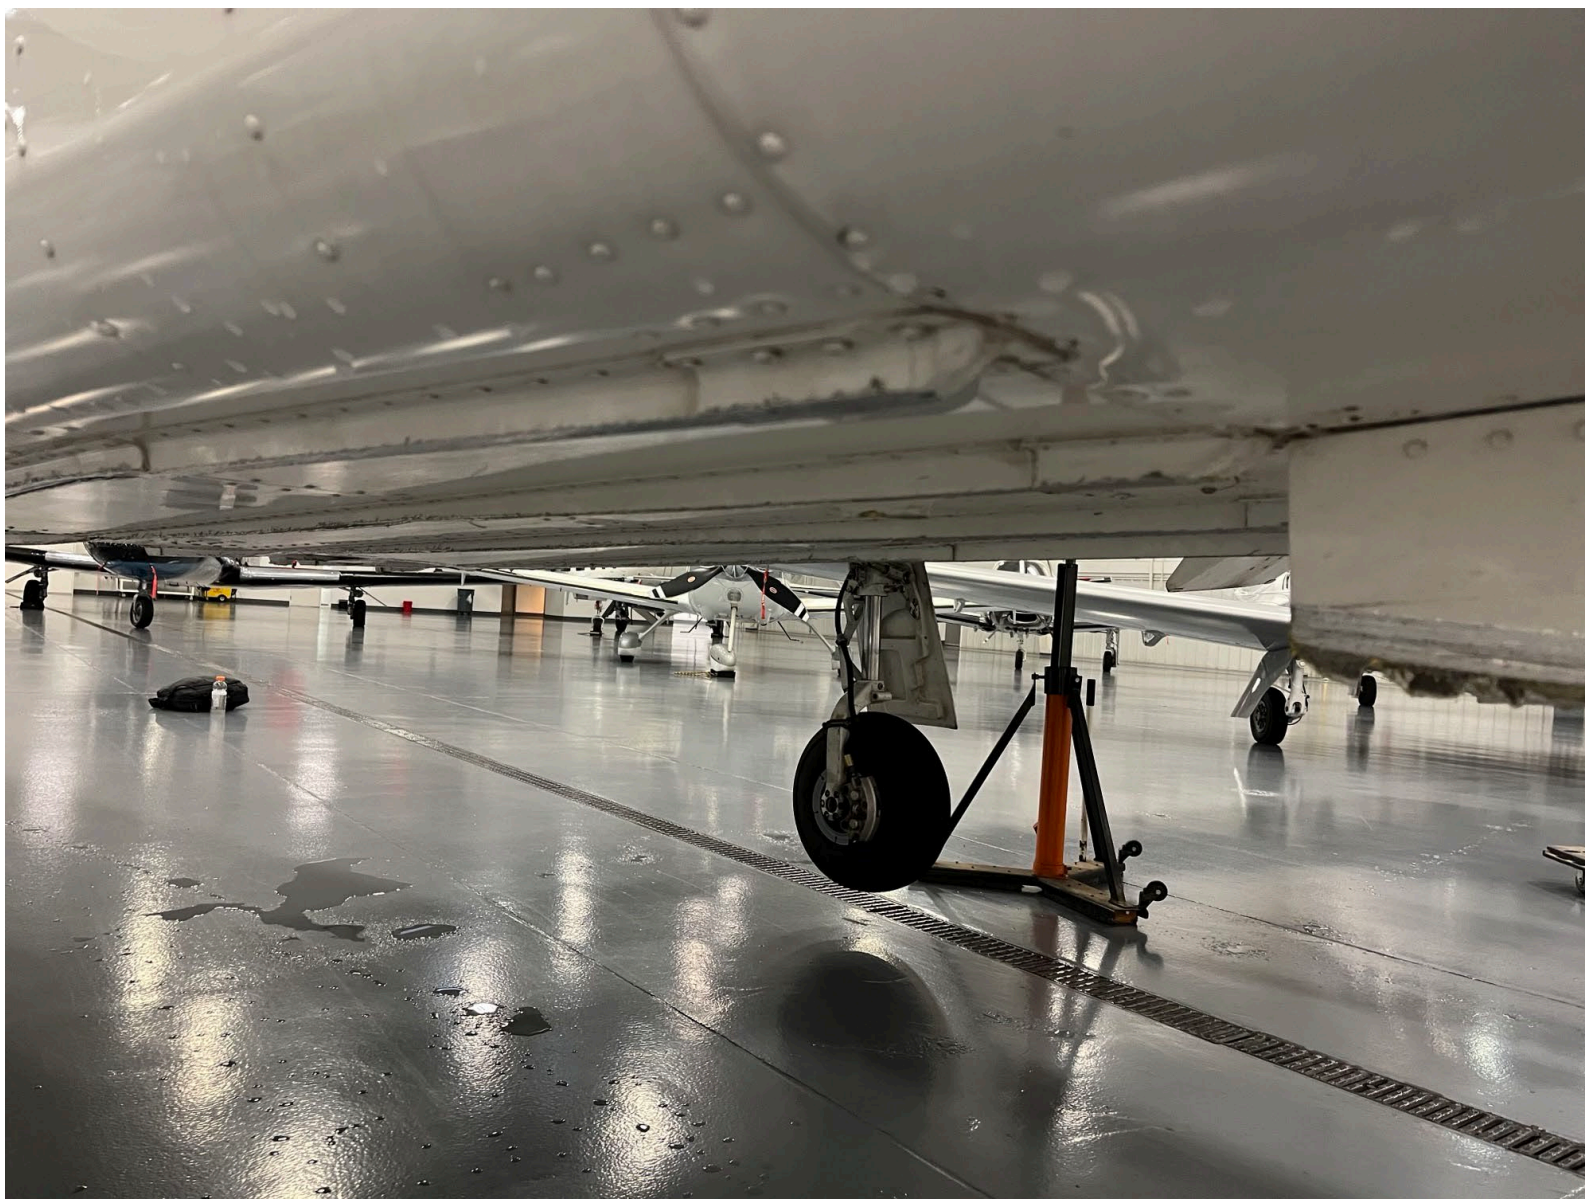
**Photograph 2 - Lower fuselage and gear door damage (Courtesy of FAA)**

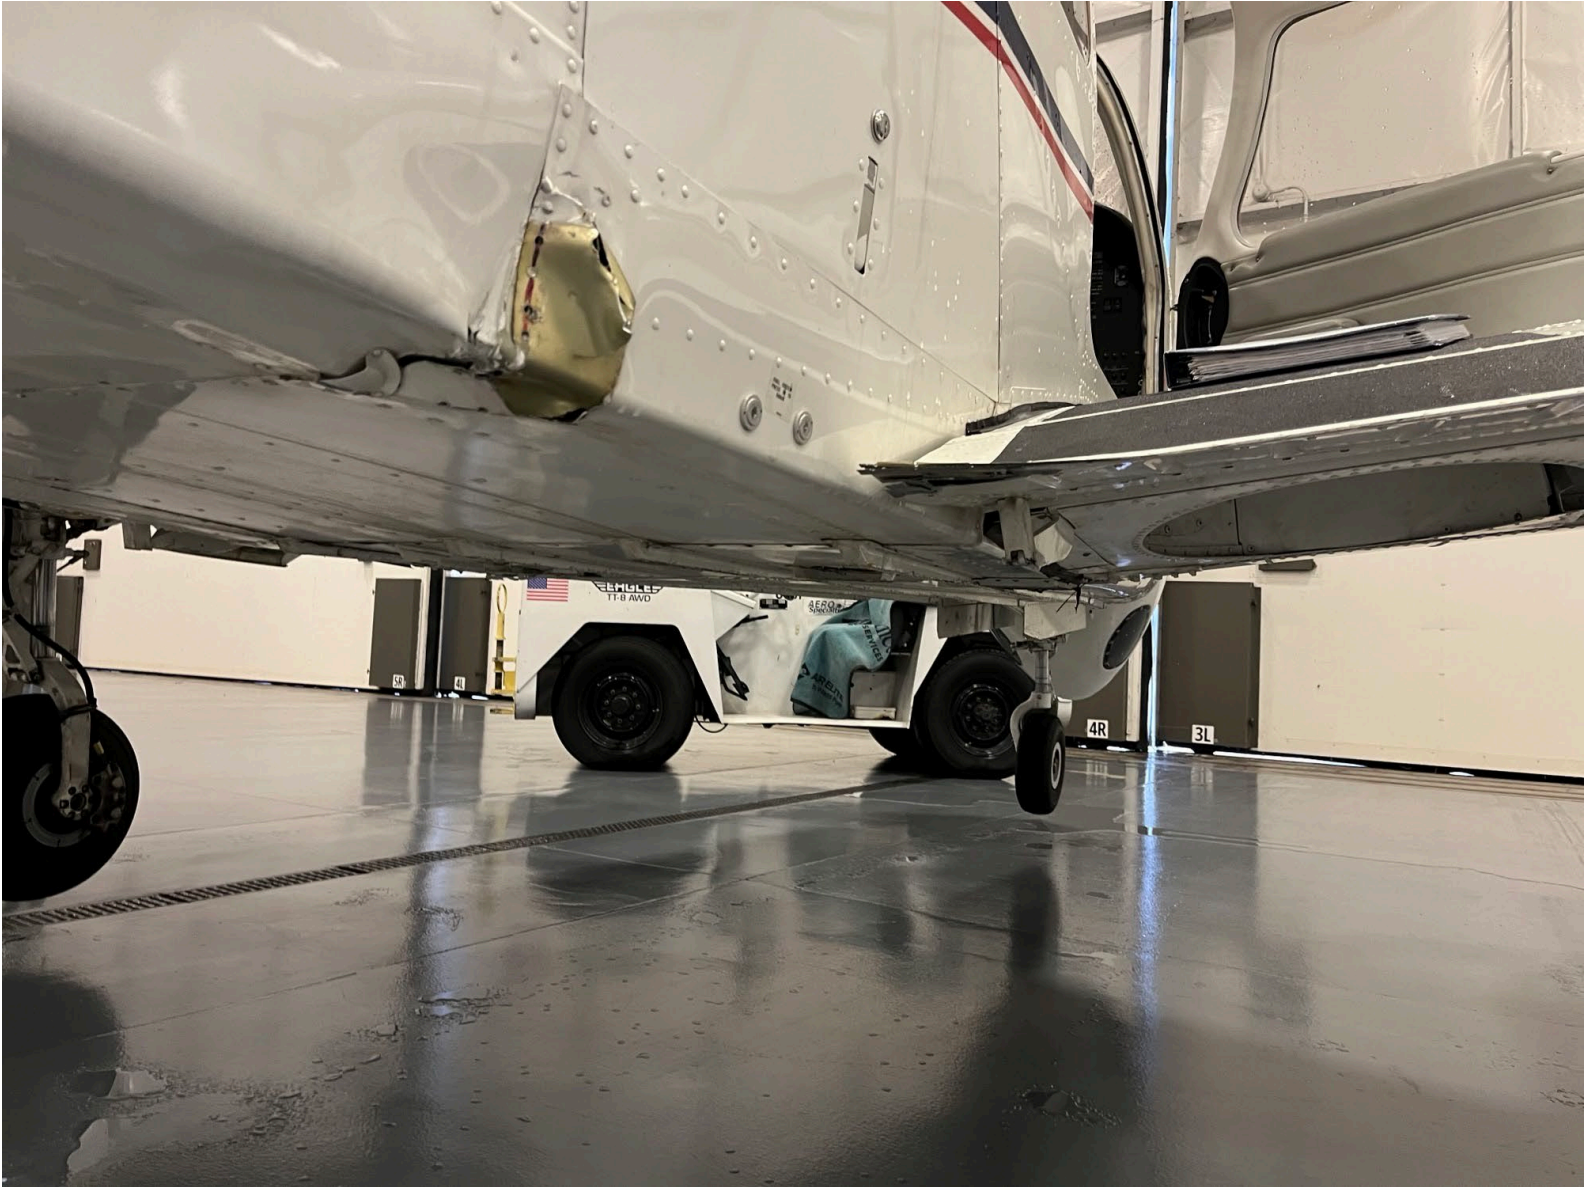
**Photograph 3 - Lower fuselage and flap damage (Courtesy of FAA)**

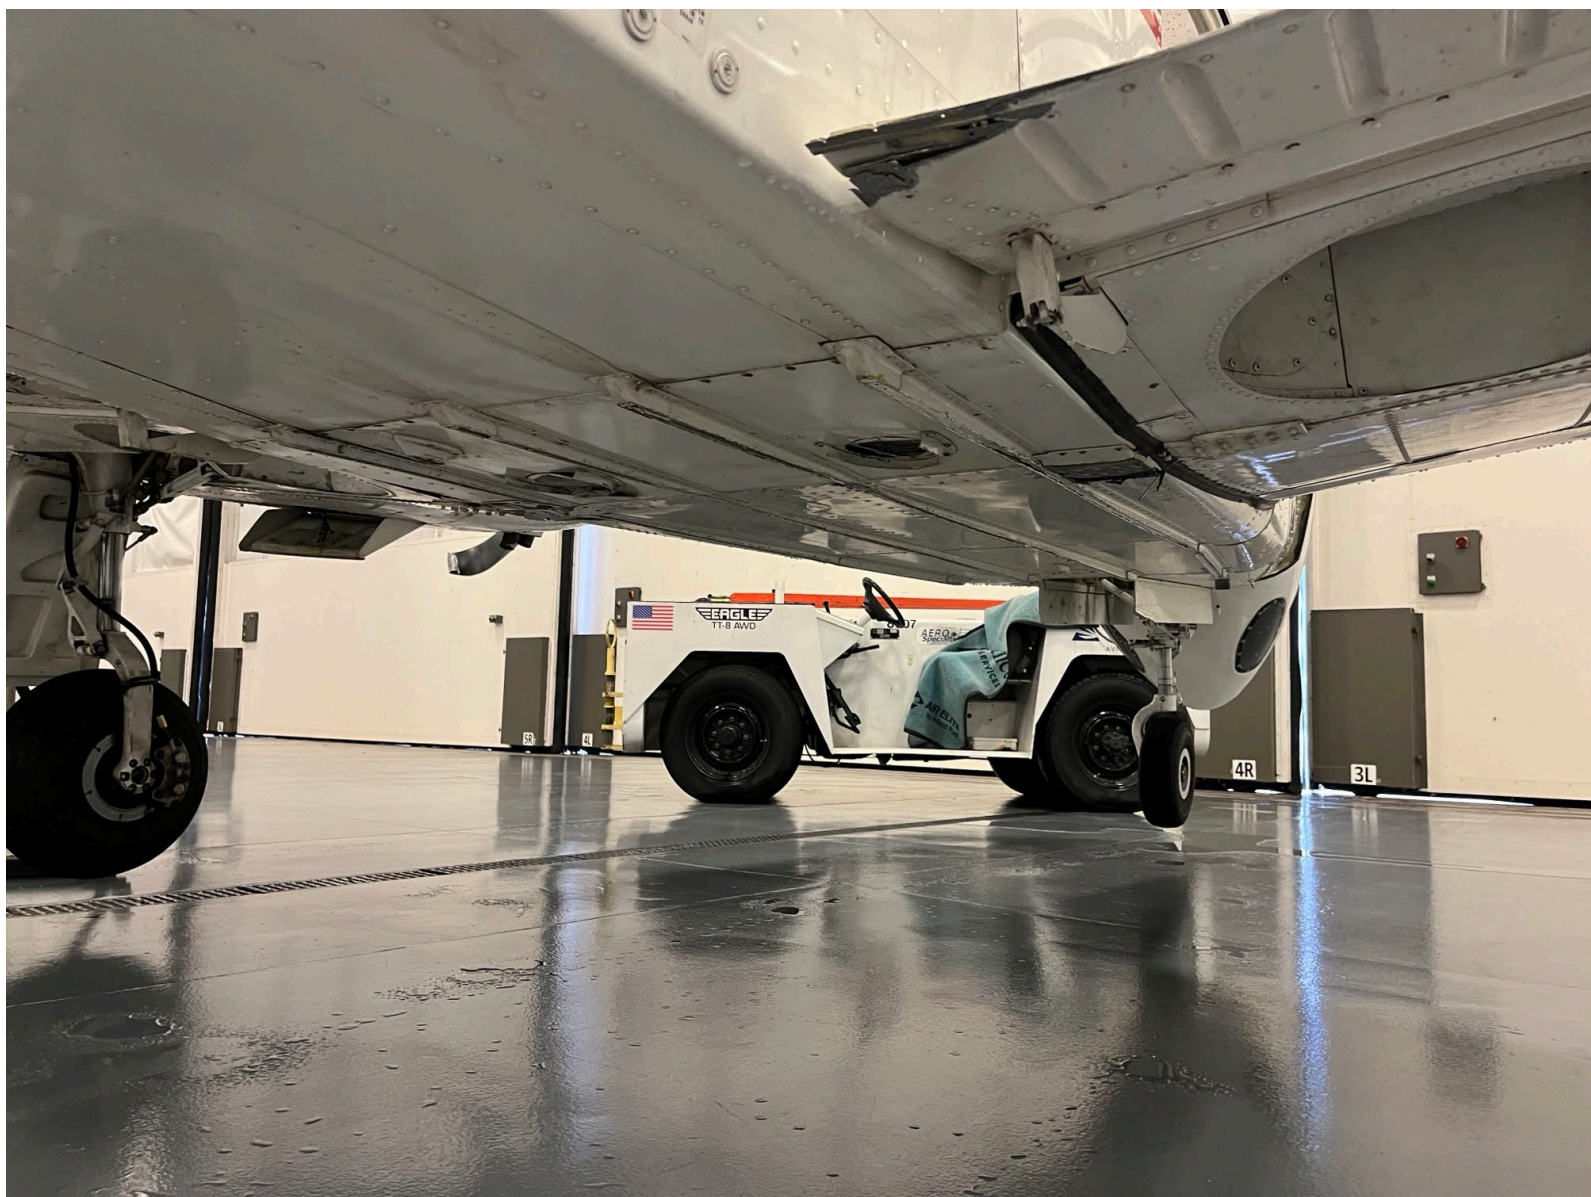
**Photograph 4 - Lower fuselage and flap damage (Courtesy of FAA)**
