# National Transportation Safety Board

CEN24LA088

## **MATERIALS LABORATORY**

Factual Report 24-021

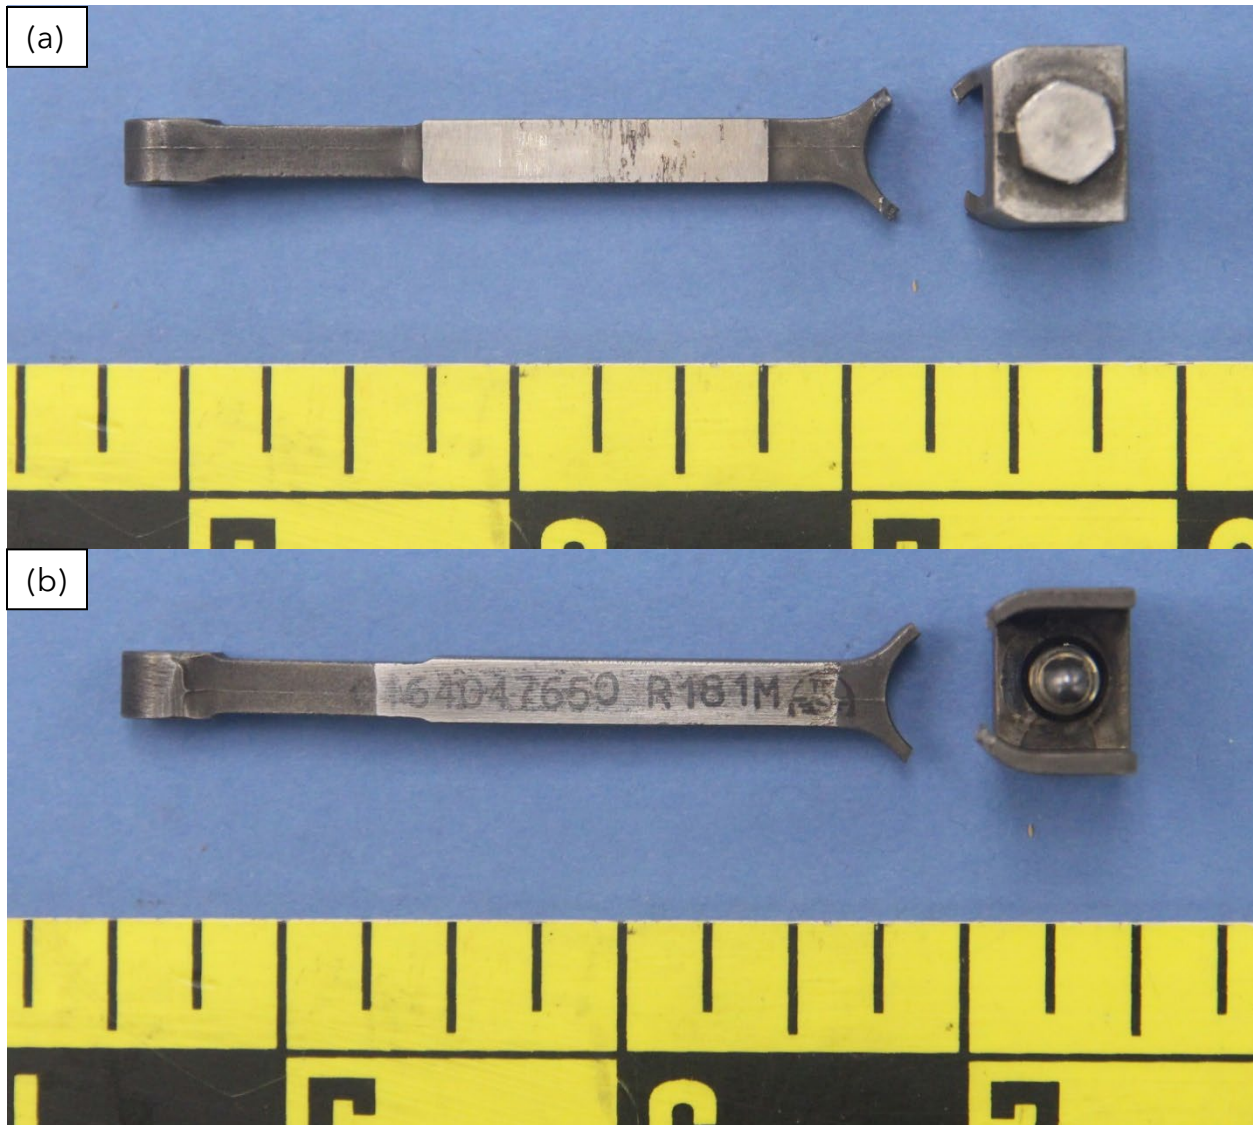
The fuel control unit examination focused on the actuated arm, shown in Figure 1. This part had fractured along the two sides of the yoke as it transitioned from the arm to the post. The part exhibited ferromagnetic properties when placed near a permanent magnet. The arm body exhibited two sets of markings, one electroetched and one manually vibroetched. The markings stated:

**Figure 1.** Opposite sides of the arm from (a) the upward facing sides and (b) the downward facing sides.

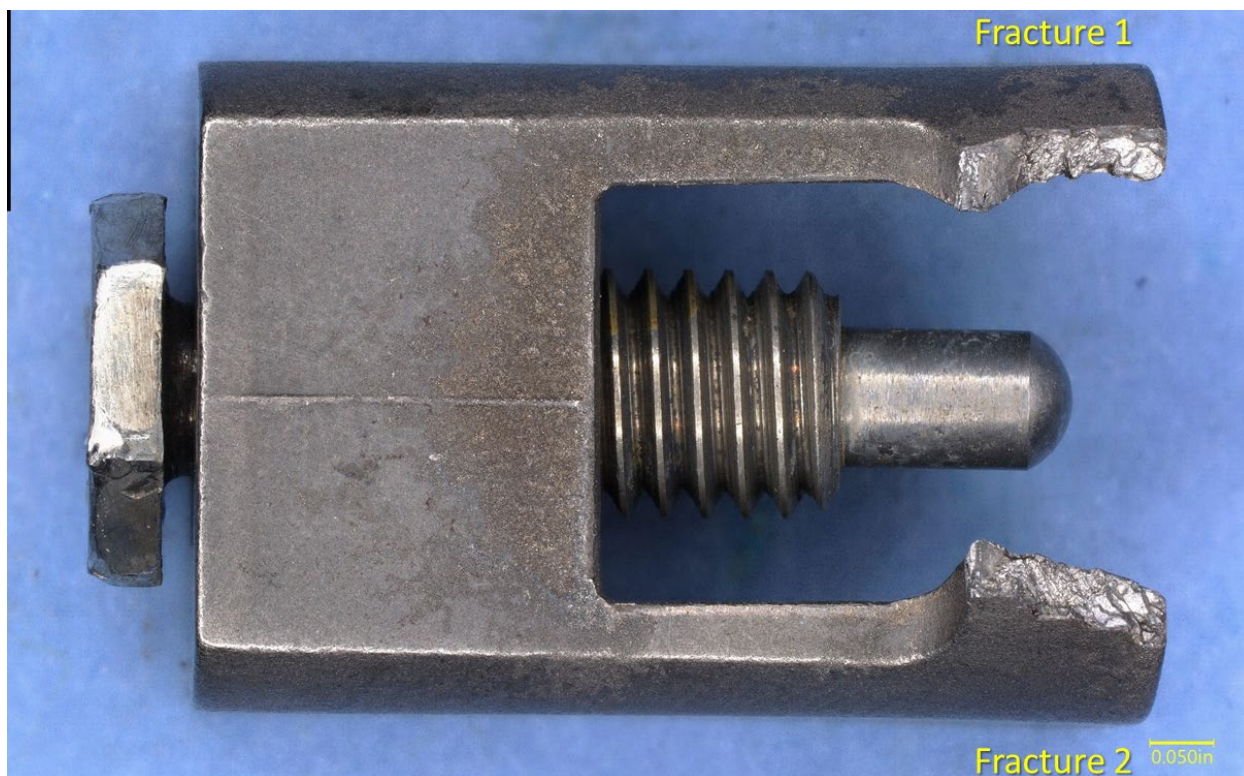
Figures 2 and 3 show the mating fracture surfaces from the post and the actuating arm, respectively. Each fracture surface exhibited a general rough surface texture with a reflective luster, though each also exhibited an area of 20-35% that was flatter and smoother in shape. The bore of the actuating arm, shown in Figure 3, exhibited circumferential marks, consistent with machining marks, along with areas of divots or depressions.

The adjustment bolt in the post shown in Figure 2 exhibited some localized plastic deformation on the edges of the hexagonal head. There were no corresponding witness marks on the face of the post. After removal of the bolt, the mating threads were examined. These areas bore no indications of severe wear, gouging, or corrosion.

**Figure 2.** The fractured side of the post, showing the two fractures and the nomenclature used in this report.

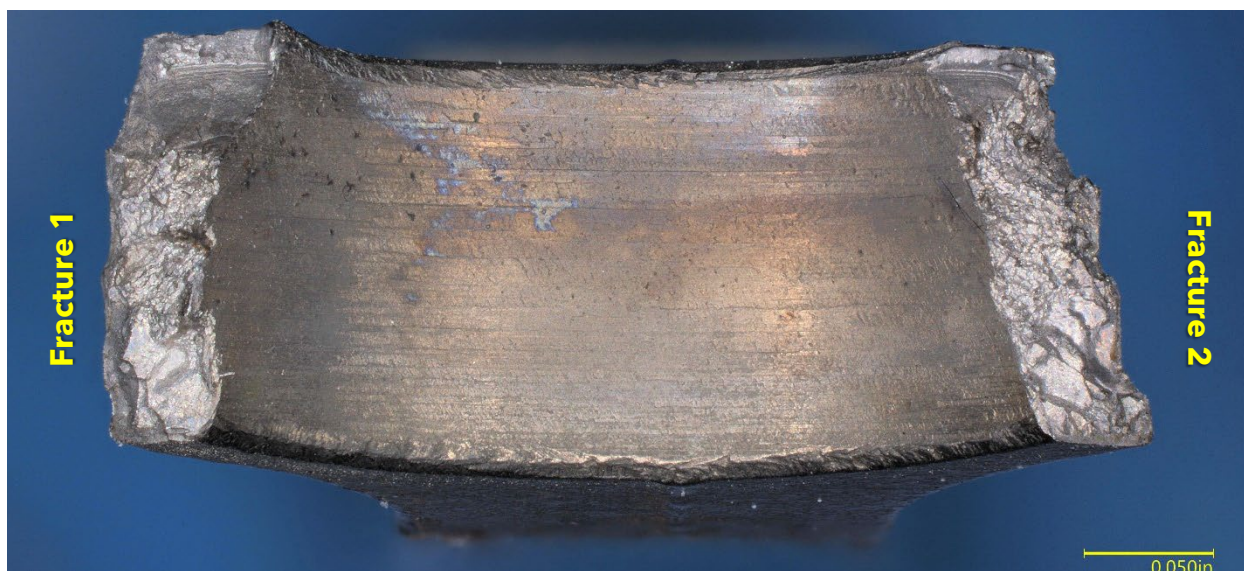
**Figure 3.** Mating fractures of the arms side, showing the bore of the actuating arm.

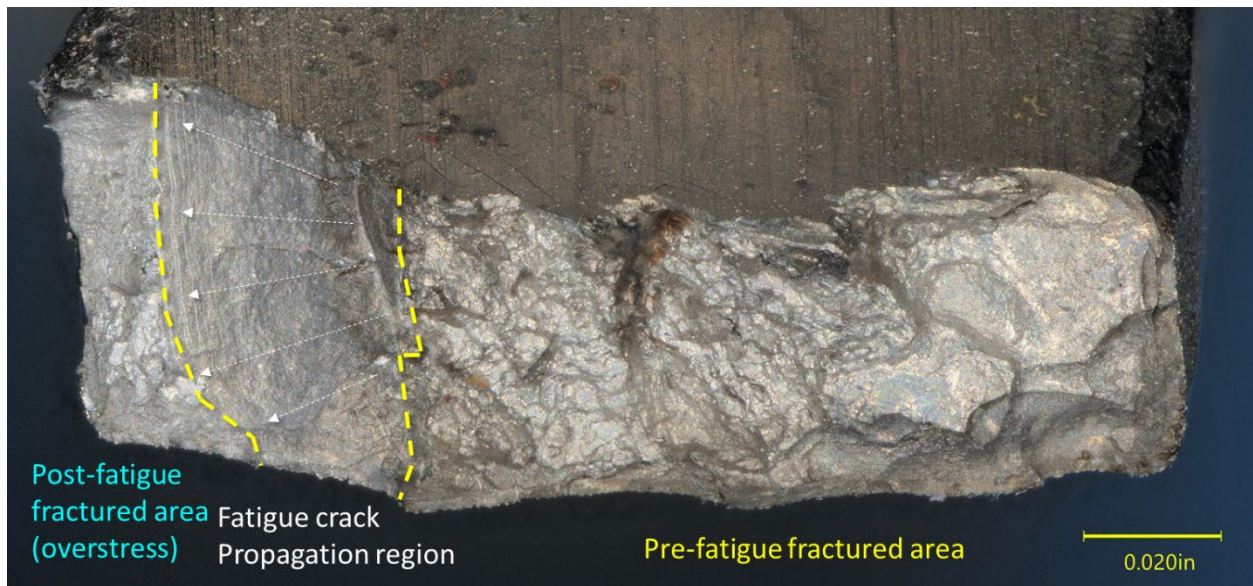
For this report, the fracture surfaces were labeled 1 and 2. Figure 4 shows an annotated view of Fracture 1, which exhibited a larger flatter area than Fracture 2. This flatter area exhibited crack arrest marks, consistent with crack propagation under cyclic loading, and ratchet marks, consistent with crack initiation at multiple sites. This initiation area was located to the left of the larger reflective, rough area, shown on the right in Figure 4.

with crack propagation from the rougher fracture area (right in Figure 4) inward (to the left in Figure 4).

**Figure 4.** View of Fracture 1, with the three main fracture/cracking regions demarcated.

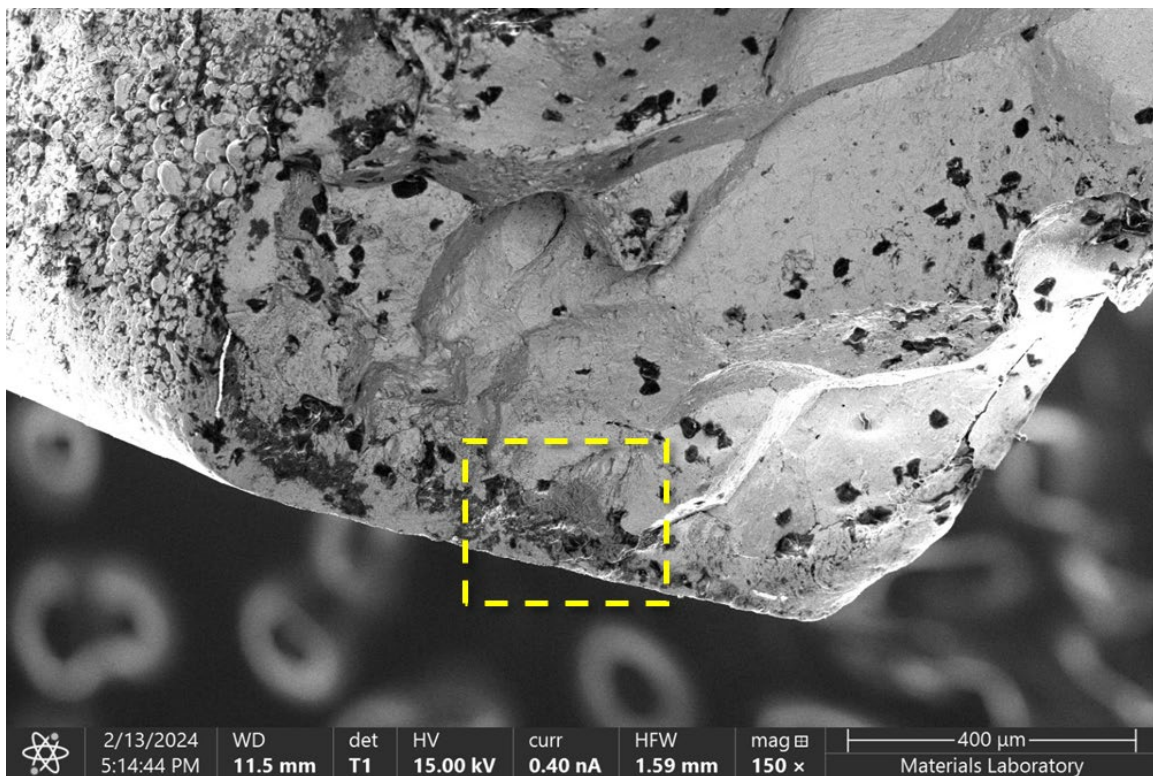
The rightmost edge of Fracture 1 is shown in Figure 5. The edge exhibited an area with a compound that exhibited a darker contrast in backscattered mode.<sup>1</sup> This area is highlighted in Figure 6. This figure shows that the material exhibited charging effects, consistent with its nonmetallic (nonconductive) properties. The chemical composition of the compound was examined using energy-dispersive X-ray spectroscopy (EDS), which was consistent with iron oxide.

**Figure 5.** Backscattered electron (BE) micrograph of the right edge of Fracture 1 in Figure 4, with the boxed area shown in Figure 6.

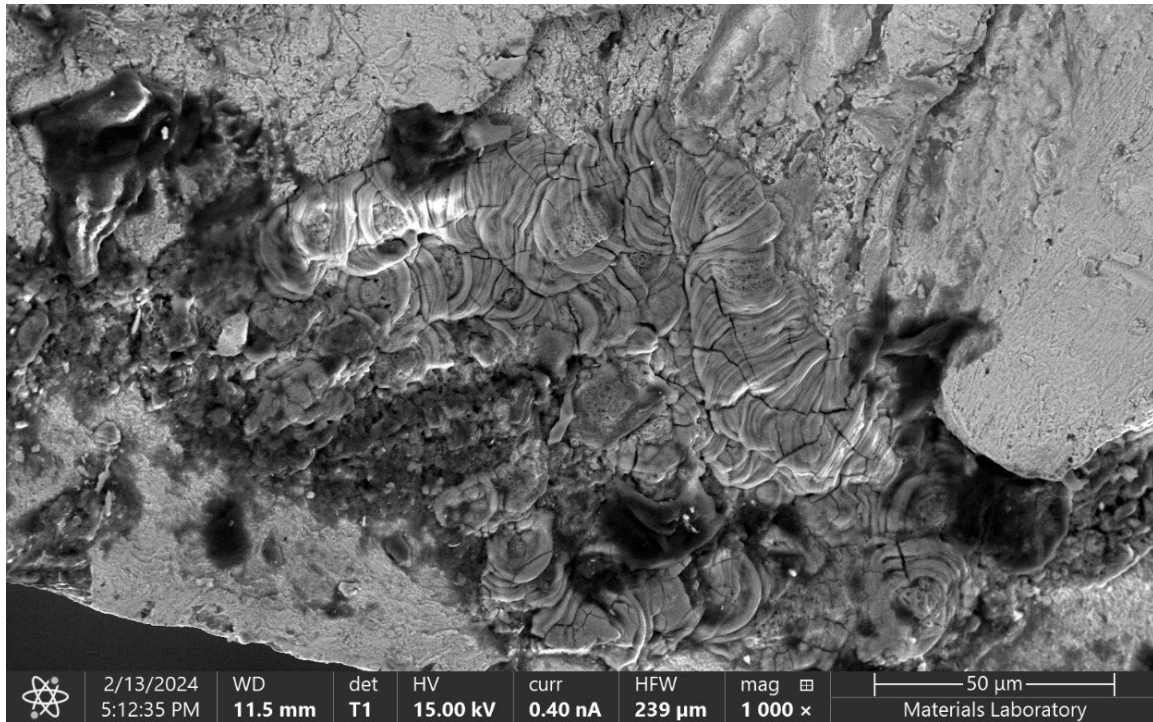
This iron oxide exhibited a wrinkled and undulating surface morphology. The oxide had also cracked in multiple locations. This oxide adhered to the fracture surface, even after cleaning in an ultrasonic bath with acetone.

**Figure 6.** BE micrograph of wrinkled oxide in the boxed area of Figure 5.

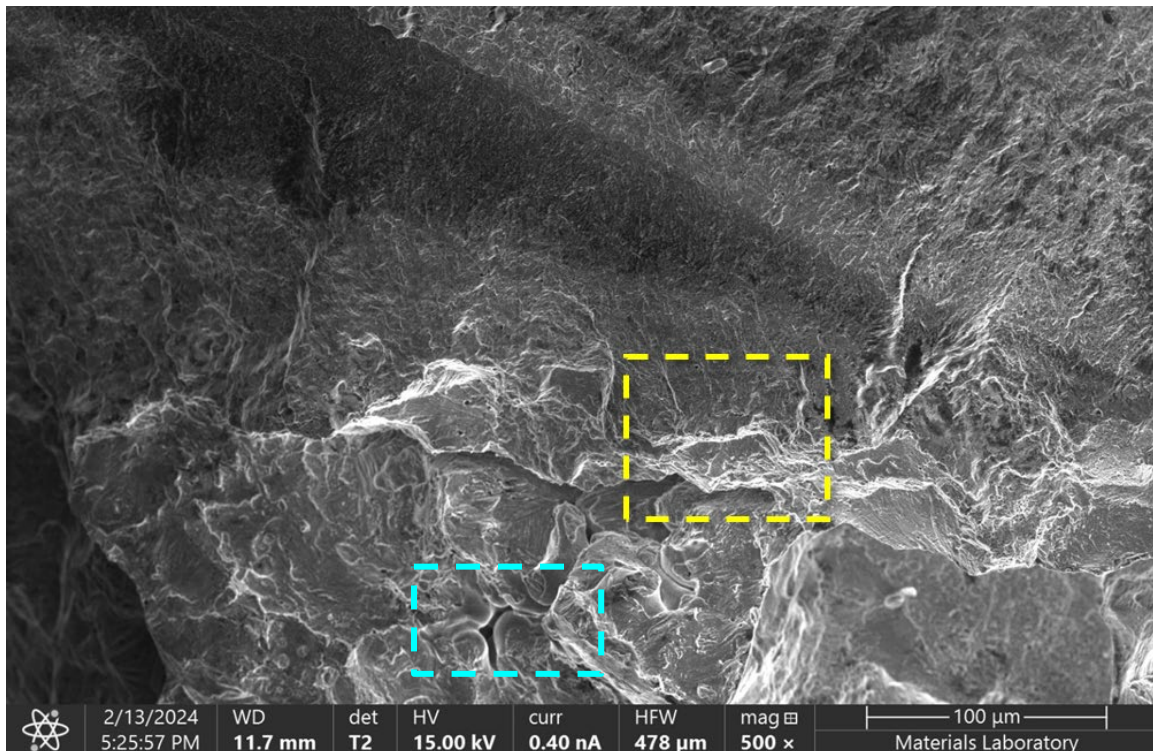
Figure 7 shows a closer view of the crack initiation area of the flatter region of Fracture 1. This area showed ratchet marks consistent with initiation along the rougher, reflective portion of the fracture surface. One of the crack initiation sites is highlighted in Figure 8. This region shows vertical ratchet marks bounding the site and horizontally oriented parallel striations, consistent with fatigue crack propagation after the crack initiates. As demonstrated in Figure 9, the striations were consistent

**Figure 7.** Secondary electron (SE) micrograph of the initiation of the fatigue crack propagation in the middle of Figure 4. The yellow boxed area is shown in Figure 8, and the cyan boxed area is shown in Figure 10.

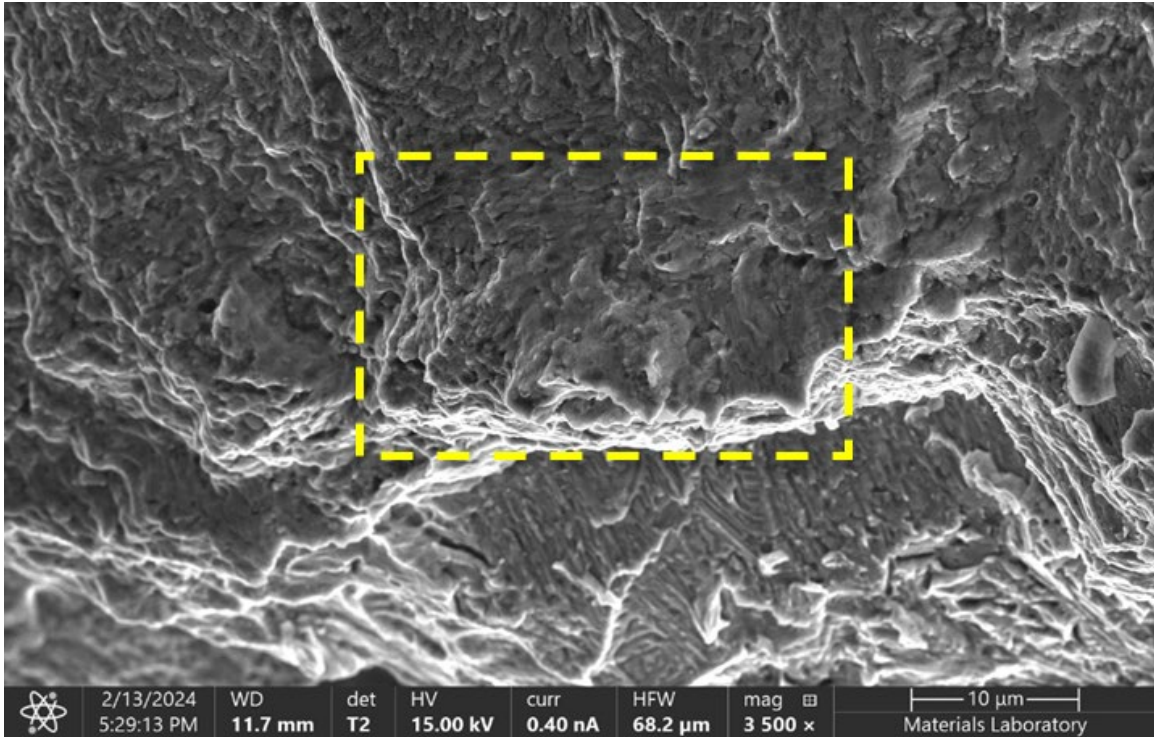
**Figure 8.** SE micrograph of an initiation site of the fatigue crack in Fracture 1 (boxed area in Figure 7).

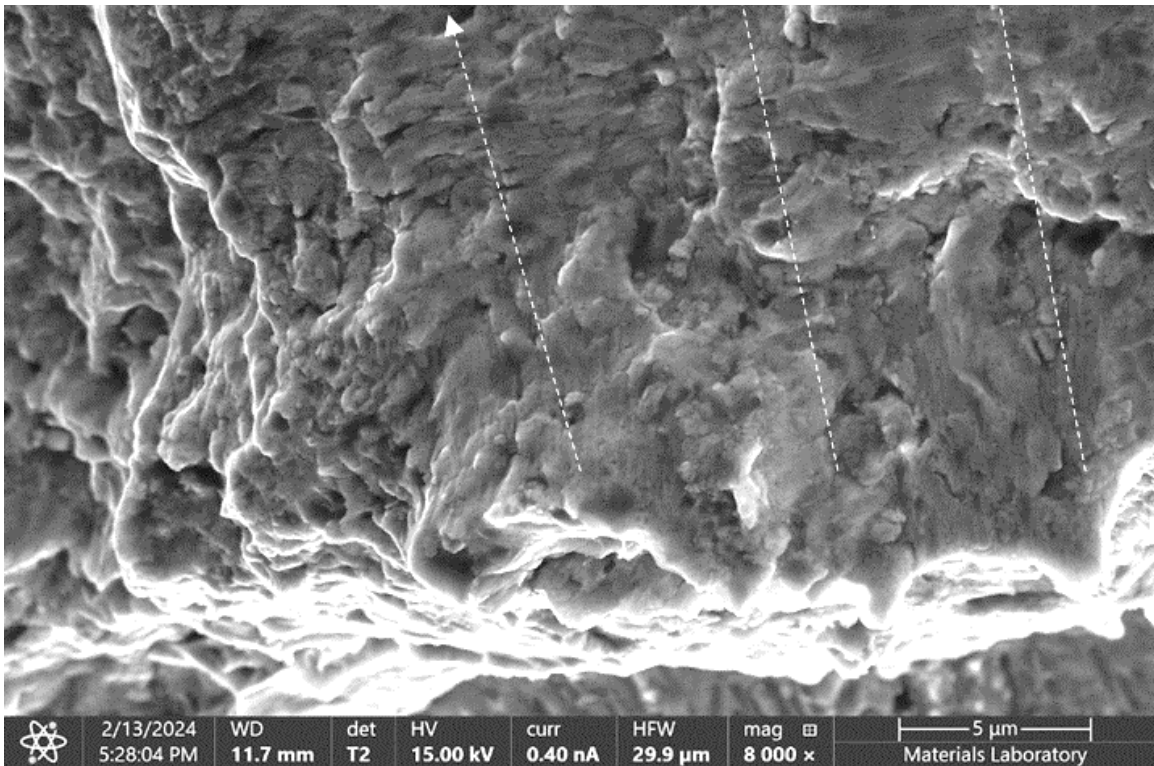
**Figure 9.** SE micrograph of striations at the initiation site in Figure 8, with crack growth direction indicated by the white arrows.

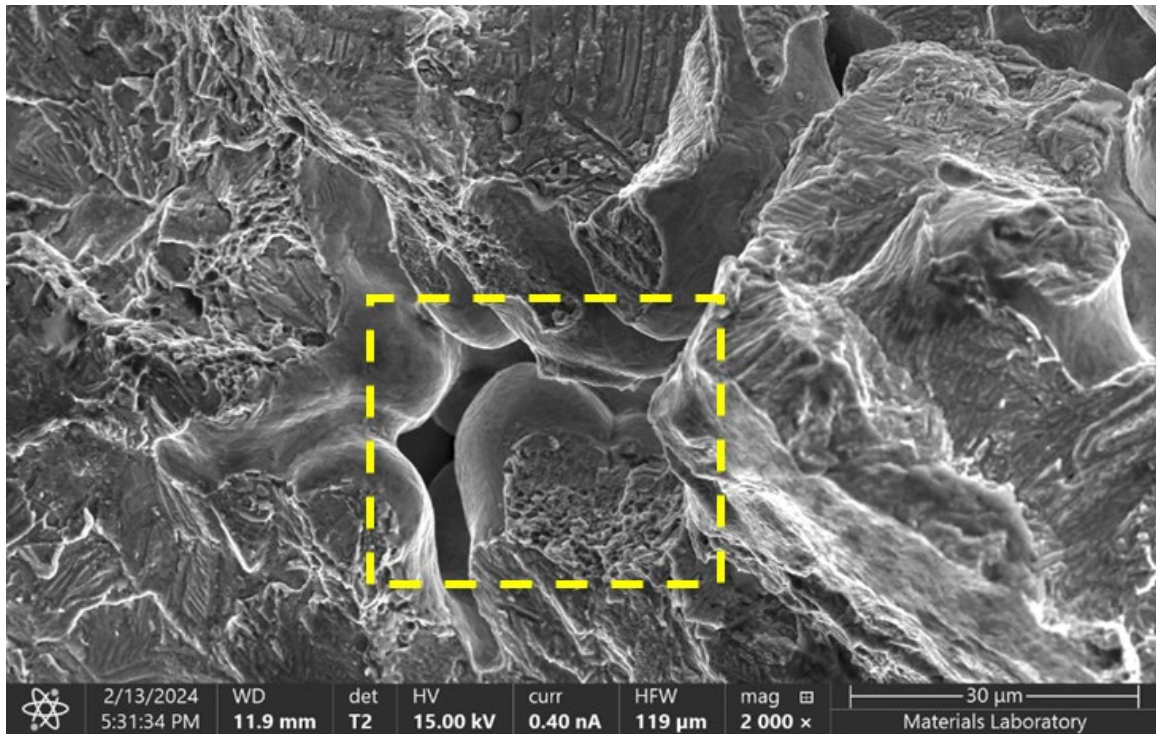
A void was observed below the initiation region in Figure 4, which is annotated by the cyan box and highlighted in Figure 10. The area, shown closer in Figure 11, exhibited smooth surface areas, consistent with internal surfaces typical of solidification voids between the dendrites that form during the casting process. These regions would not have been attached and bore no applied stresses before fracture. In contrast, the rougher areas at the bottom of Figure 11 were consistent with dimpled rupture from overstress fracture. These regions would have been intact before the fracture, breaking under stresses exceeding the local fracture strength.

**Figure 10.** SE micrograph of a void in Figure 4 (cyan box) below the fatigue initiation.

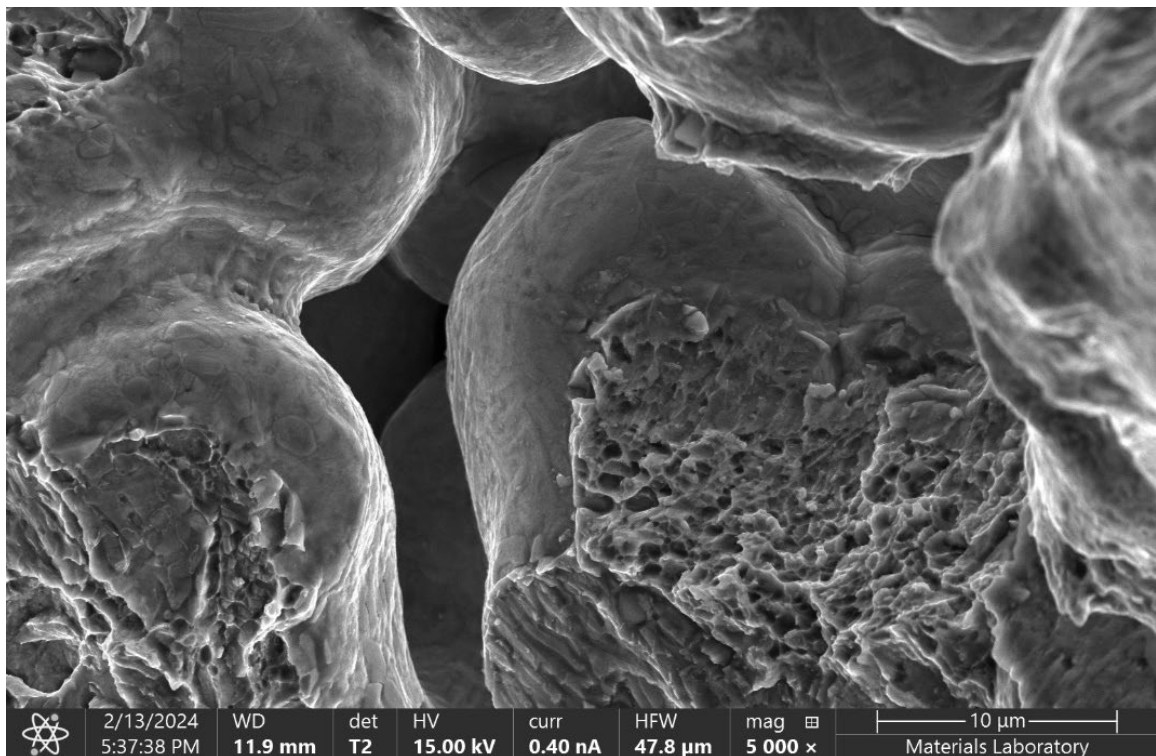
**Figure 11.** SE micrograph of the void boxed area in Figure 10, showing smooth areas with limited areas of dimpled rupture.

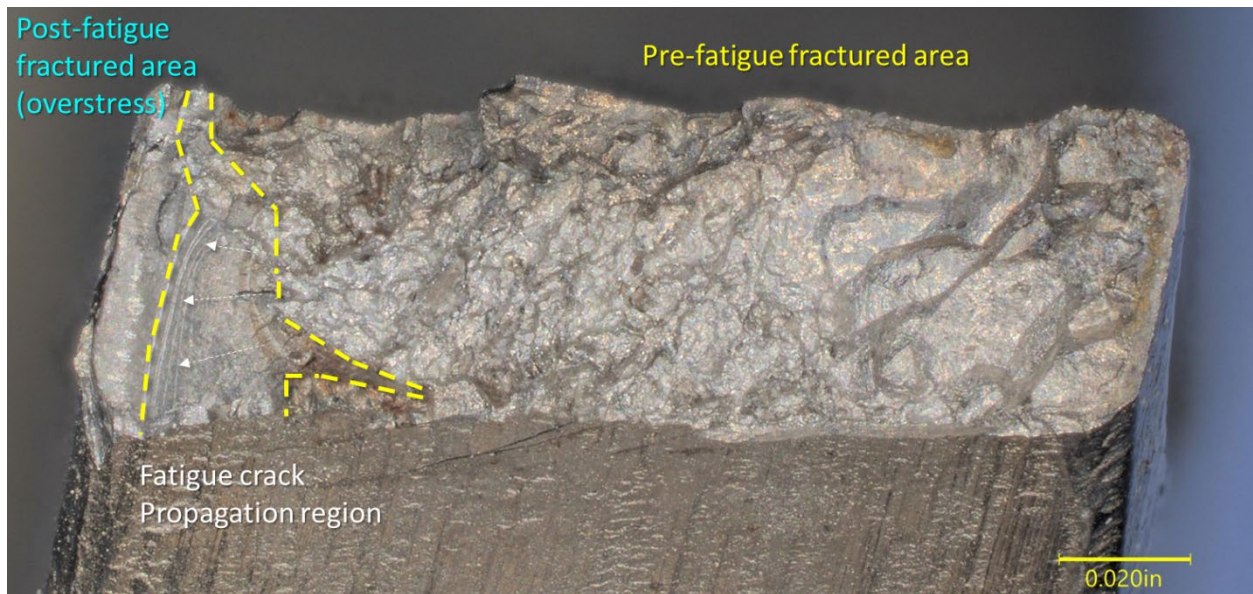
Figure 12 shows an annotated view of the Fracture 2 surface. This surface exhibited similar fracture feature patterns to Fracture 1, except that the fatigue crack propagation region was smaller. Figure 13 shows the edge of the fracture surface, which was the rightmost edge as oriented in Figure 12. Overall, this surface exhibited large faceted features, also observed in Fracture 1. A closer view of these areas of the fracture surface revealed faceted fracture features with gaps and separation between grains. These features were most prevalent at triple points between grains, illustrated in Figure 14.

**Figure 12.** View of Fracture 2, with the three main fracture/cracking regions demarcated.

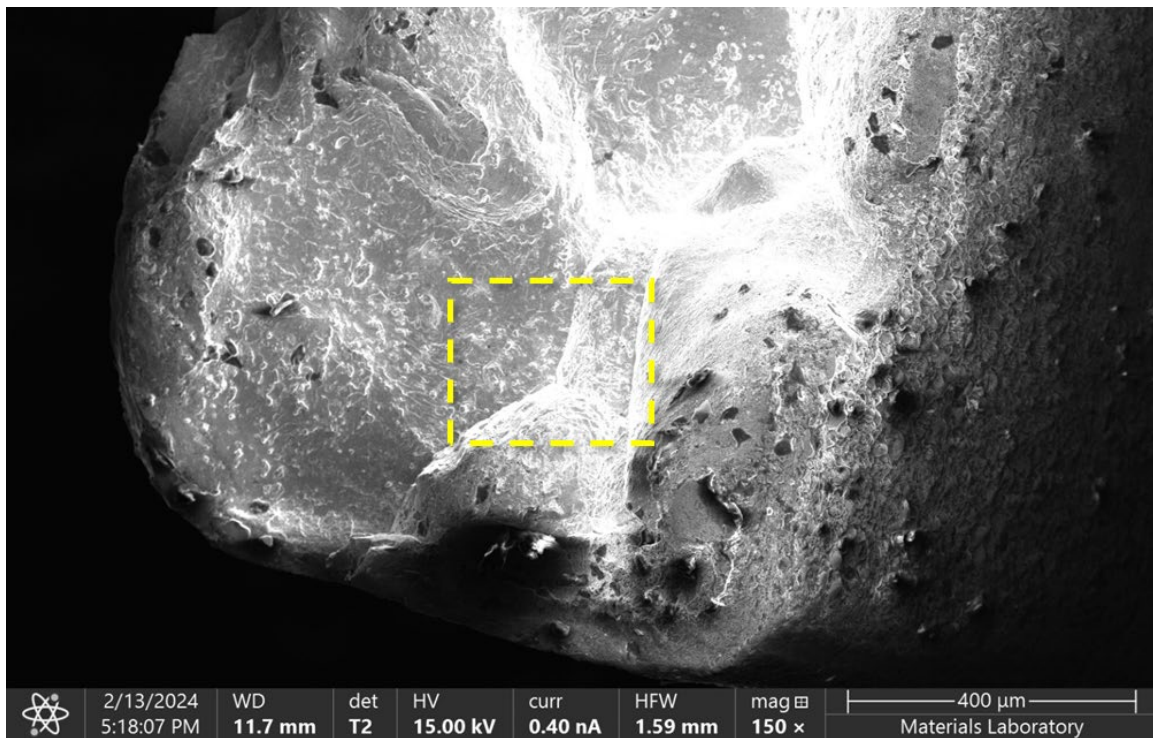
**Figure 13.** SE micrograph of rightmost edge of Fracture 2 as shown in Figure 12.

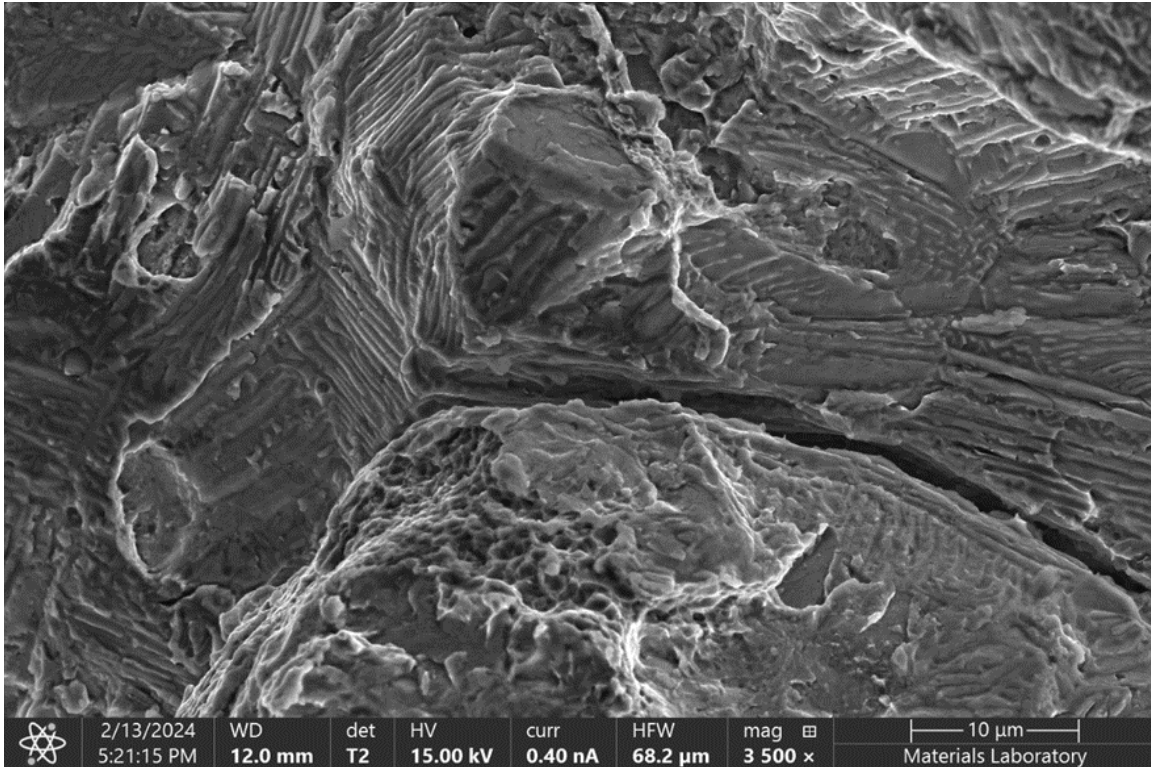
These grain facets exhibited parallel features, which were not consistently oriented over the entire fracture. These features also intersected other linear features, consistent with the microstructure morphology of dendrites from cast components. Figure 15 shows a closer view of the interdendritic fracture features. These faceted features were interspersed with areas of dimpled rupture, as illustrated in the middle of Figure 14. These features were consistent with mixed intergranular and overstress fracture over part of the arm yoke cross sections.

**Figure 14.** SE micrograph of the boxed area in Figure 13 showing a triple point intergranular fracture, exhibiting parallel features and limited dimpled rupture.

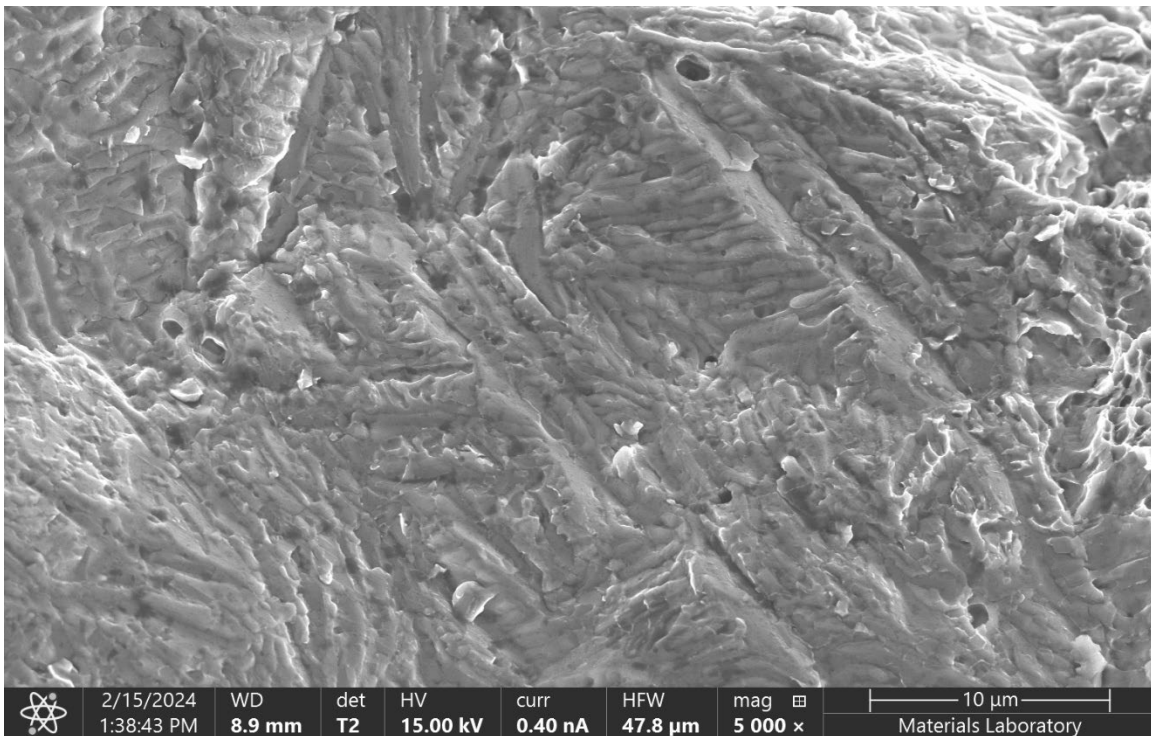
**Figure 15.** SE micrograph of a closer view of the area in Figure 13, showing cross-shaped parallel features consistent with dendrite arms.

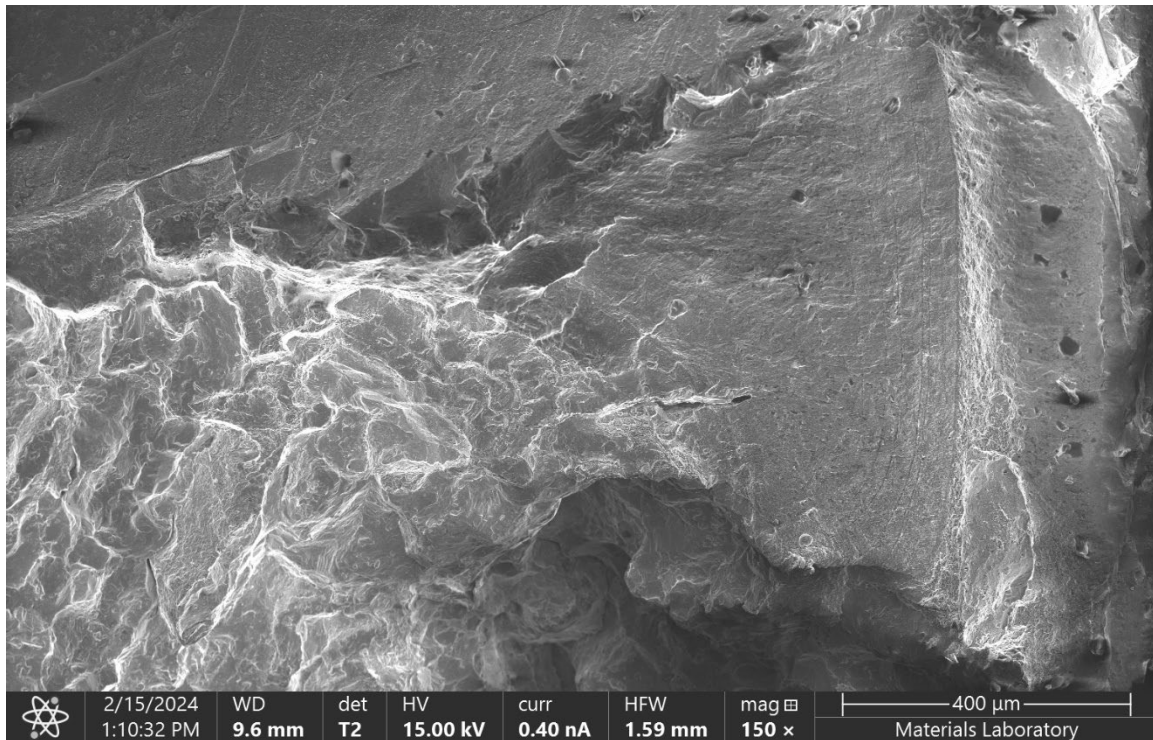
Figure 16 shows the fatigue crack region of Fracture 2. Like in Fracture 1, this region exhibited crack arrest marks and ratchet marks consistent with fatigue crack propagation from multiple initiation sites consistent with the faceted features of the initial fracture region. Figure 17 shows the end of this fatigue crack, demonstrating the crack arrest marks. A closer view of this crack portion shows the fine fatigue striations, typical of high-cycle or low-load fatigue (see Figures 17 and 18).

**Figure 16.** SE micrograph of the fatigue crack of Fracture 2.

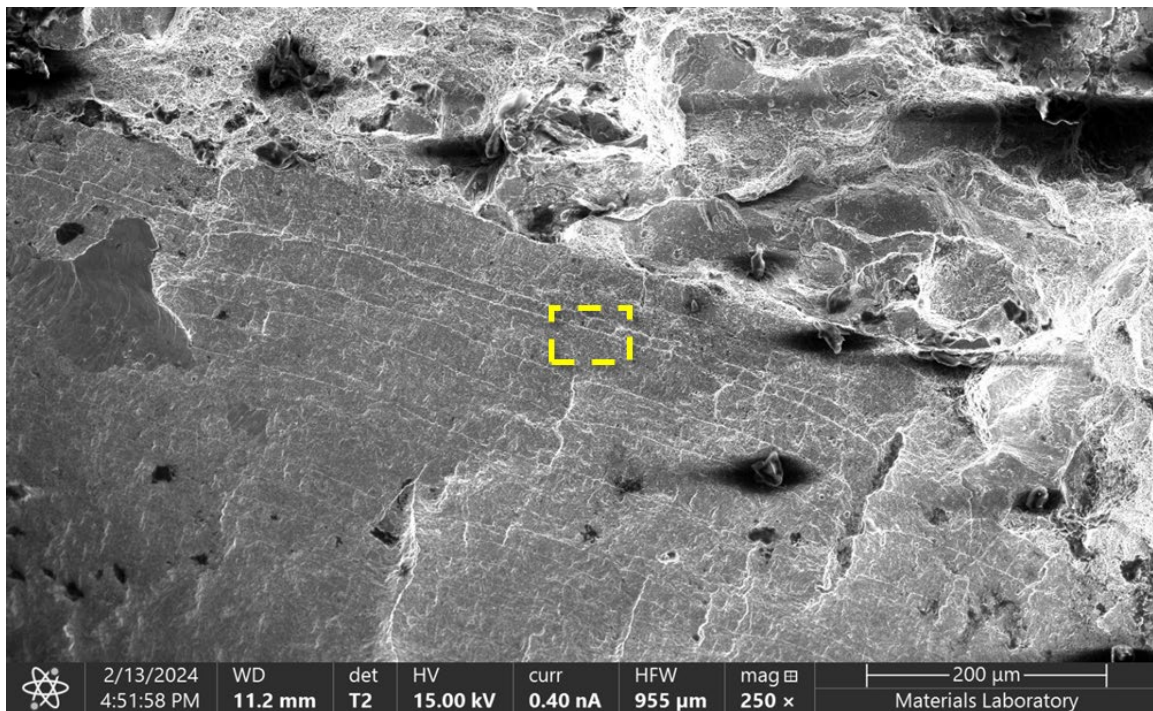
**Figure 17.** SE micrograph of the end of the fatigue crack in Fracture 2, showing parallel crack arrest marks, rotated 90° from Figure 16. The boxed area is shown in Figure 18.

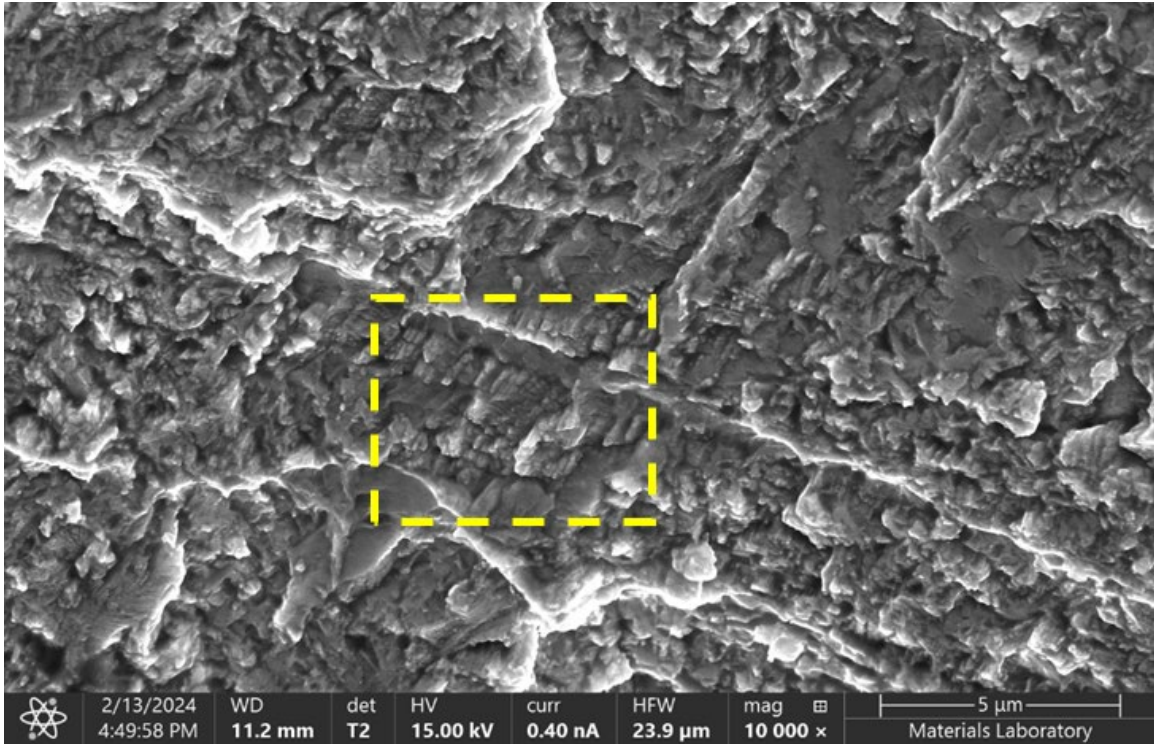
**Figure 18.** SE micrograph of the boxed area in Figure 17 showing arrest marks and striations.

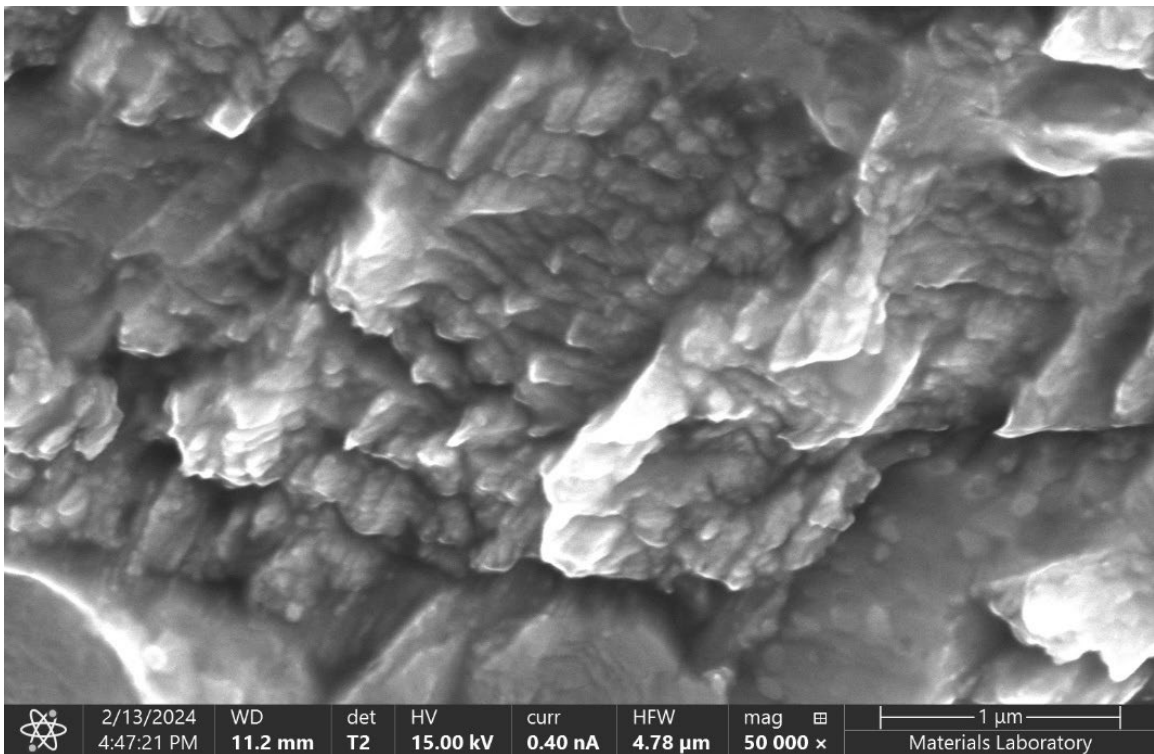
**Figure 19.** SE micrograph of a closer view of the boxed area in Figure 18, showing fatigue striations.

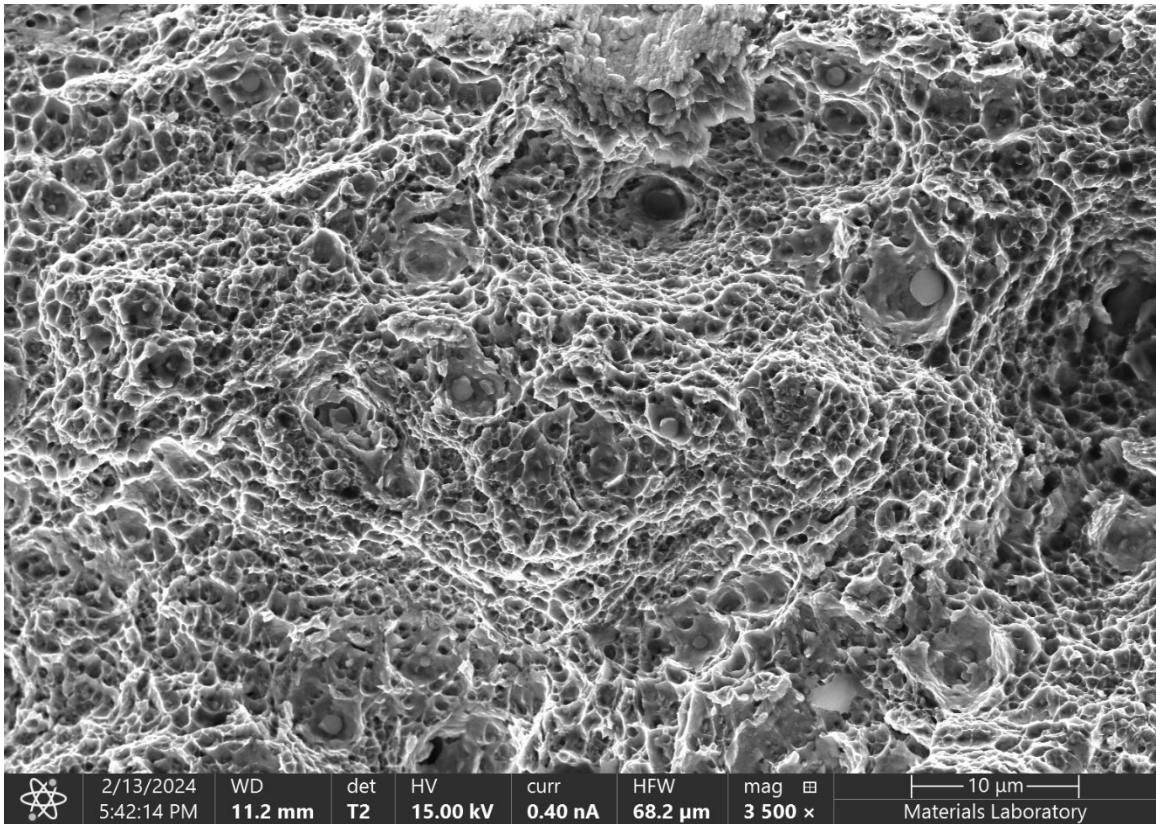
Outside of this crack, the fracture surface exhibited dimpled rupture, consistent with subsequent overstress fracture of the remaining yoke ligaments (Figure 20). In contrast to the fracture surface before the fatigue crack initiation, this area of subsequent overstress fracture was not faceted and consistently exhibited dimpled rupture rather than interdendritic fracture features.

**Figure 20.** SE micrograph of dimpled rupture on the area of Fracture 2 outside of the fatigue crack propagation region.
