# National Transportation Safety Board

CEN24LA096

## EXAMINATION SUMMARY

Location: Liberty Hill, Texas  
Date: January 21, 2024  
Time: 1320 CDT  
Airplane: AirCam, N1230R

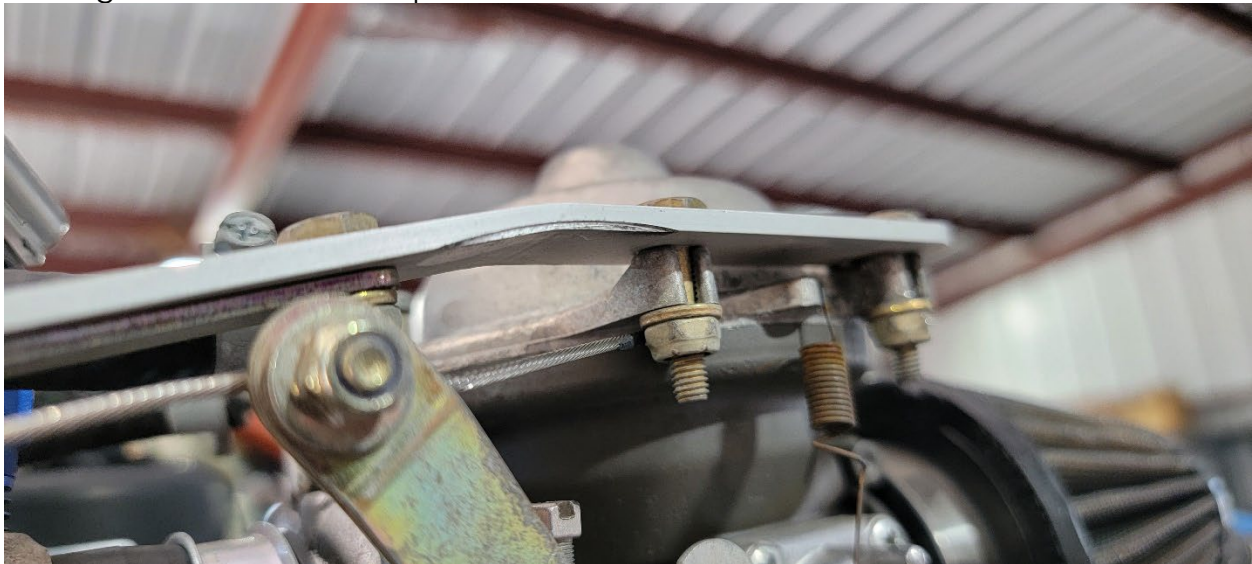
The right engine throttle levers exhibited full range of simultaneous travel on both carburetors, however the outboard lever exhibited wear and rubbing (Figure 1.) The inboard lever would intermittently become momentarily stuck slightly open as the throttle was moved to idle. The lever was assisted to the idle position by spring tension after about two seconds. The throttle lever did not inhibit normal operation of the engine while in its stuck position.

Figure 1: Right engine outboard throttle lever and rubbing.
