CEN24LA097

## INVESTIGATION PHOTOGRAPHS

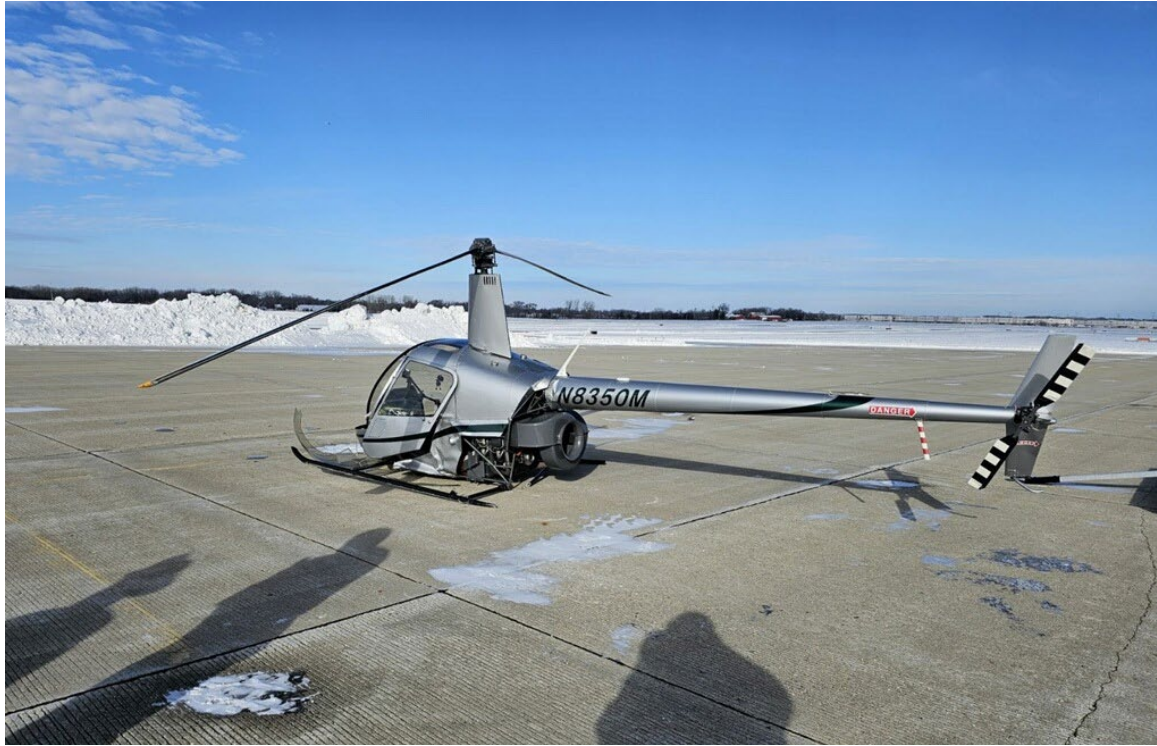
**Photograph 1 - Deformation noted to the fuselage (Courtesy of Airport Manager)**

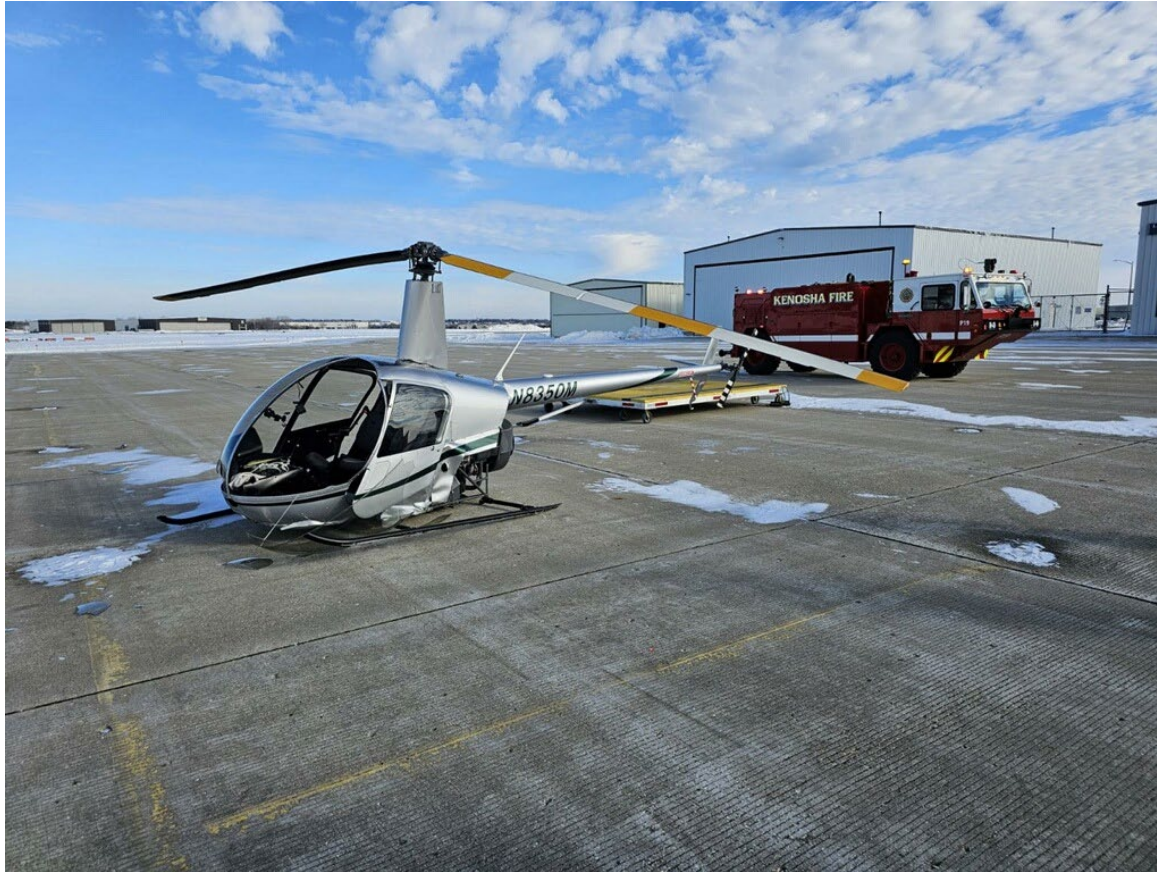
**Photograph 2 - Deformation noted to main rotor blade (Courtesy of Airport Manager)**
