N2184T evaluation

09 February 2024

Performed by Twining Aviation Maintenance of Carlisle, AR

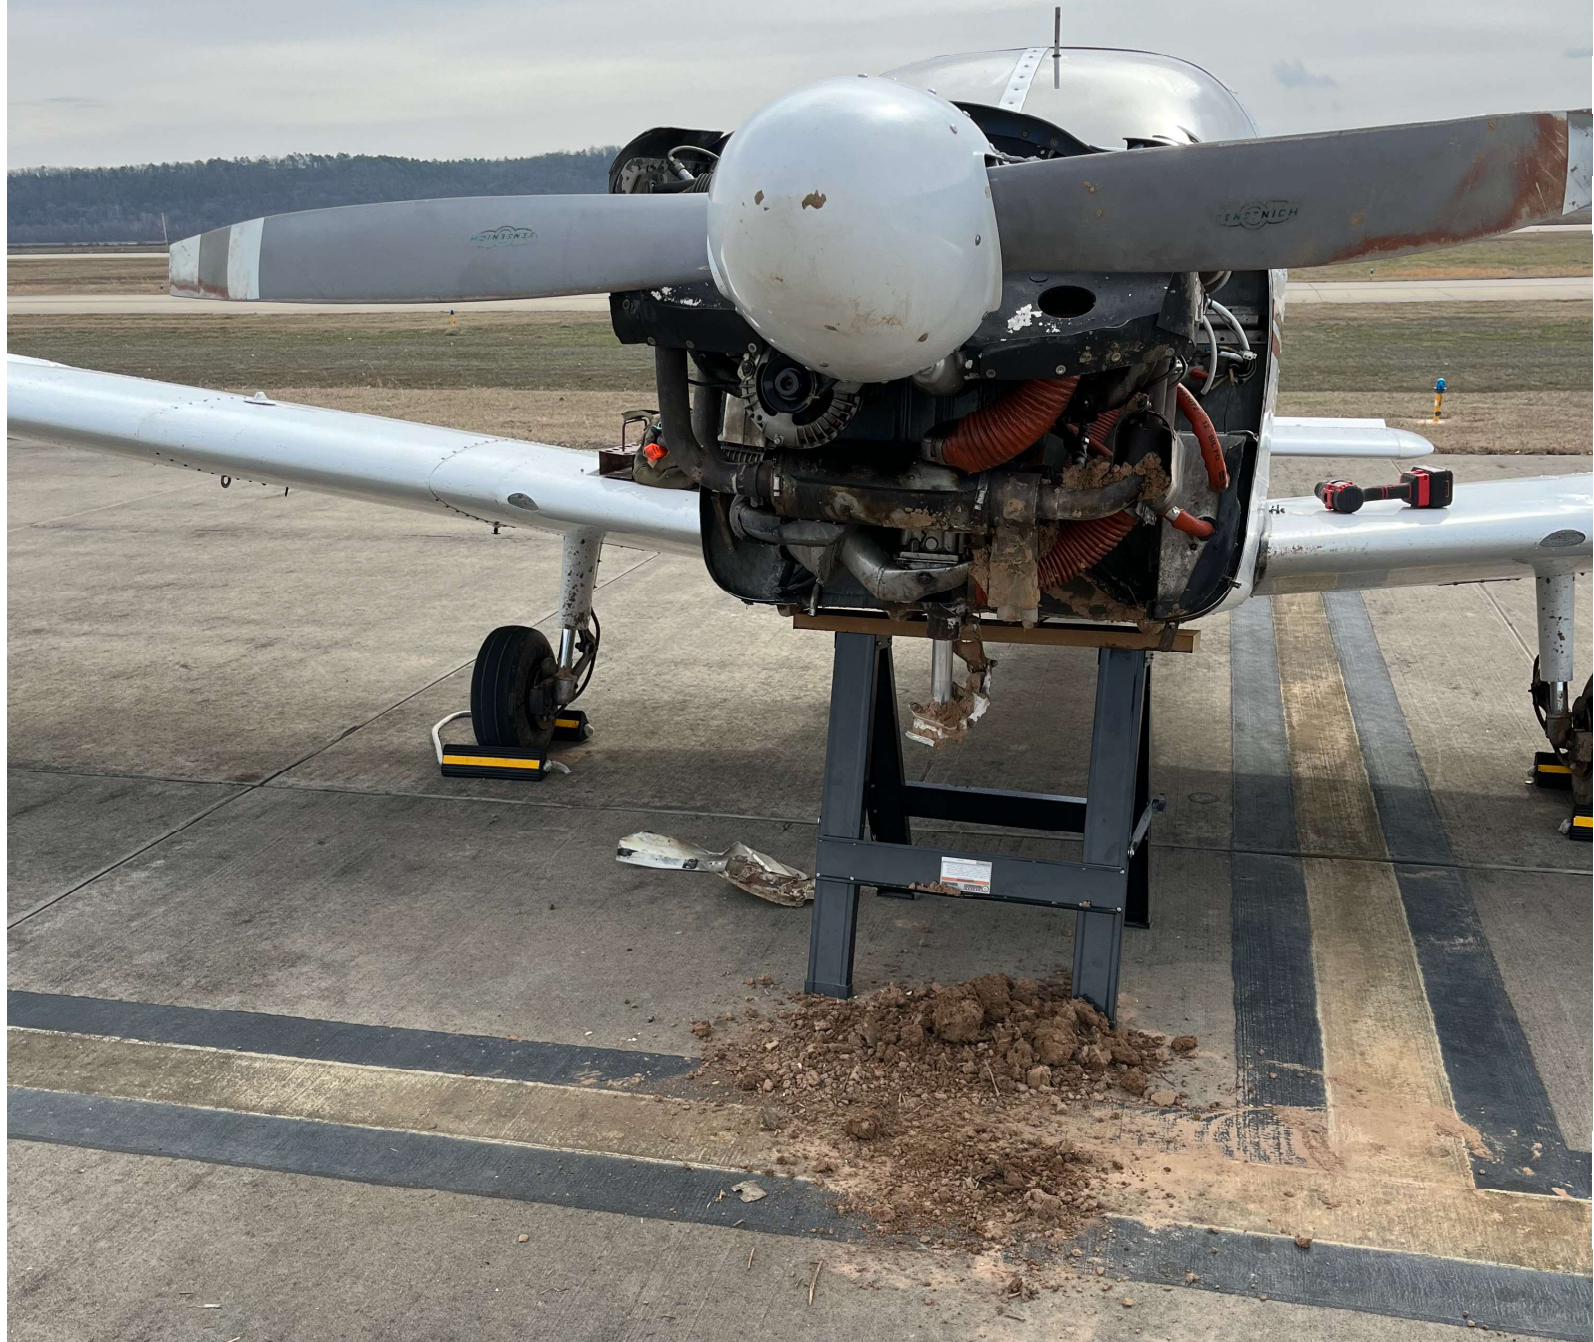
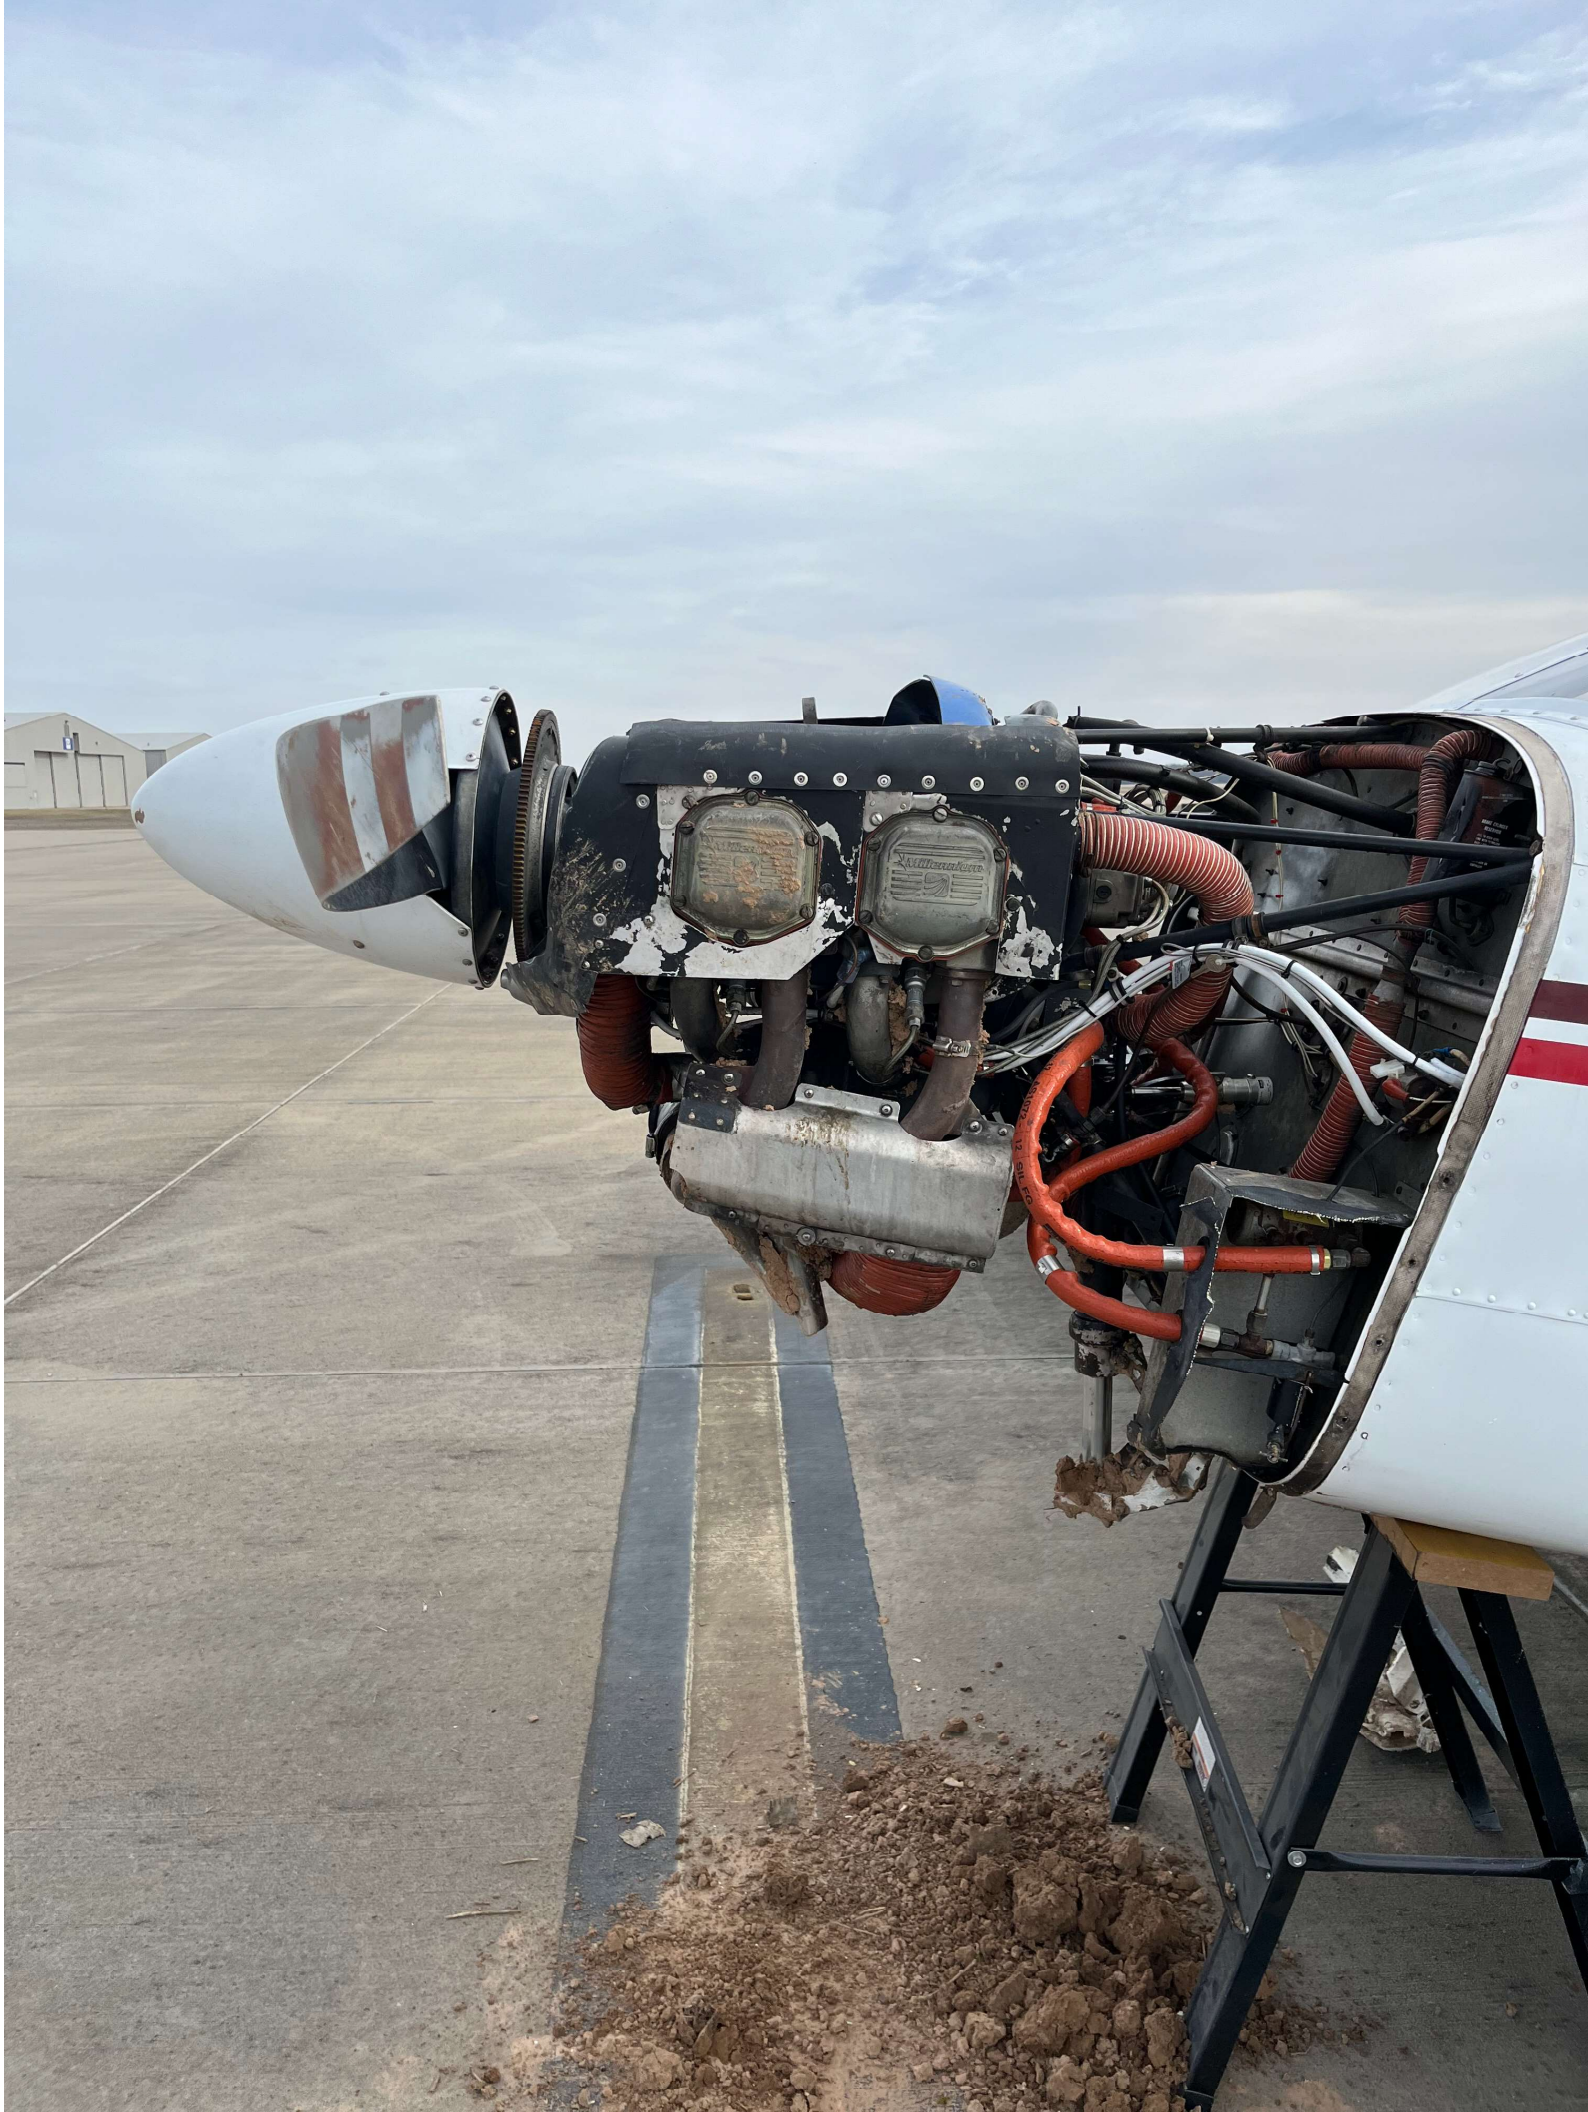
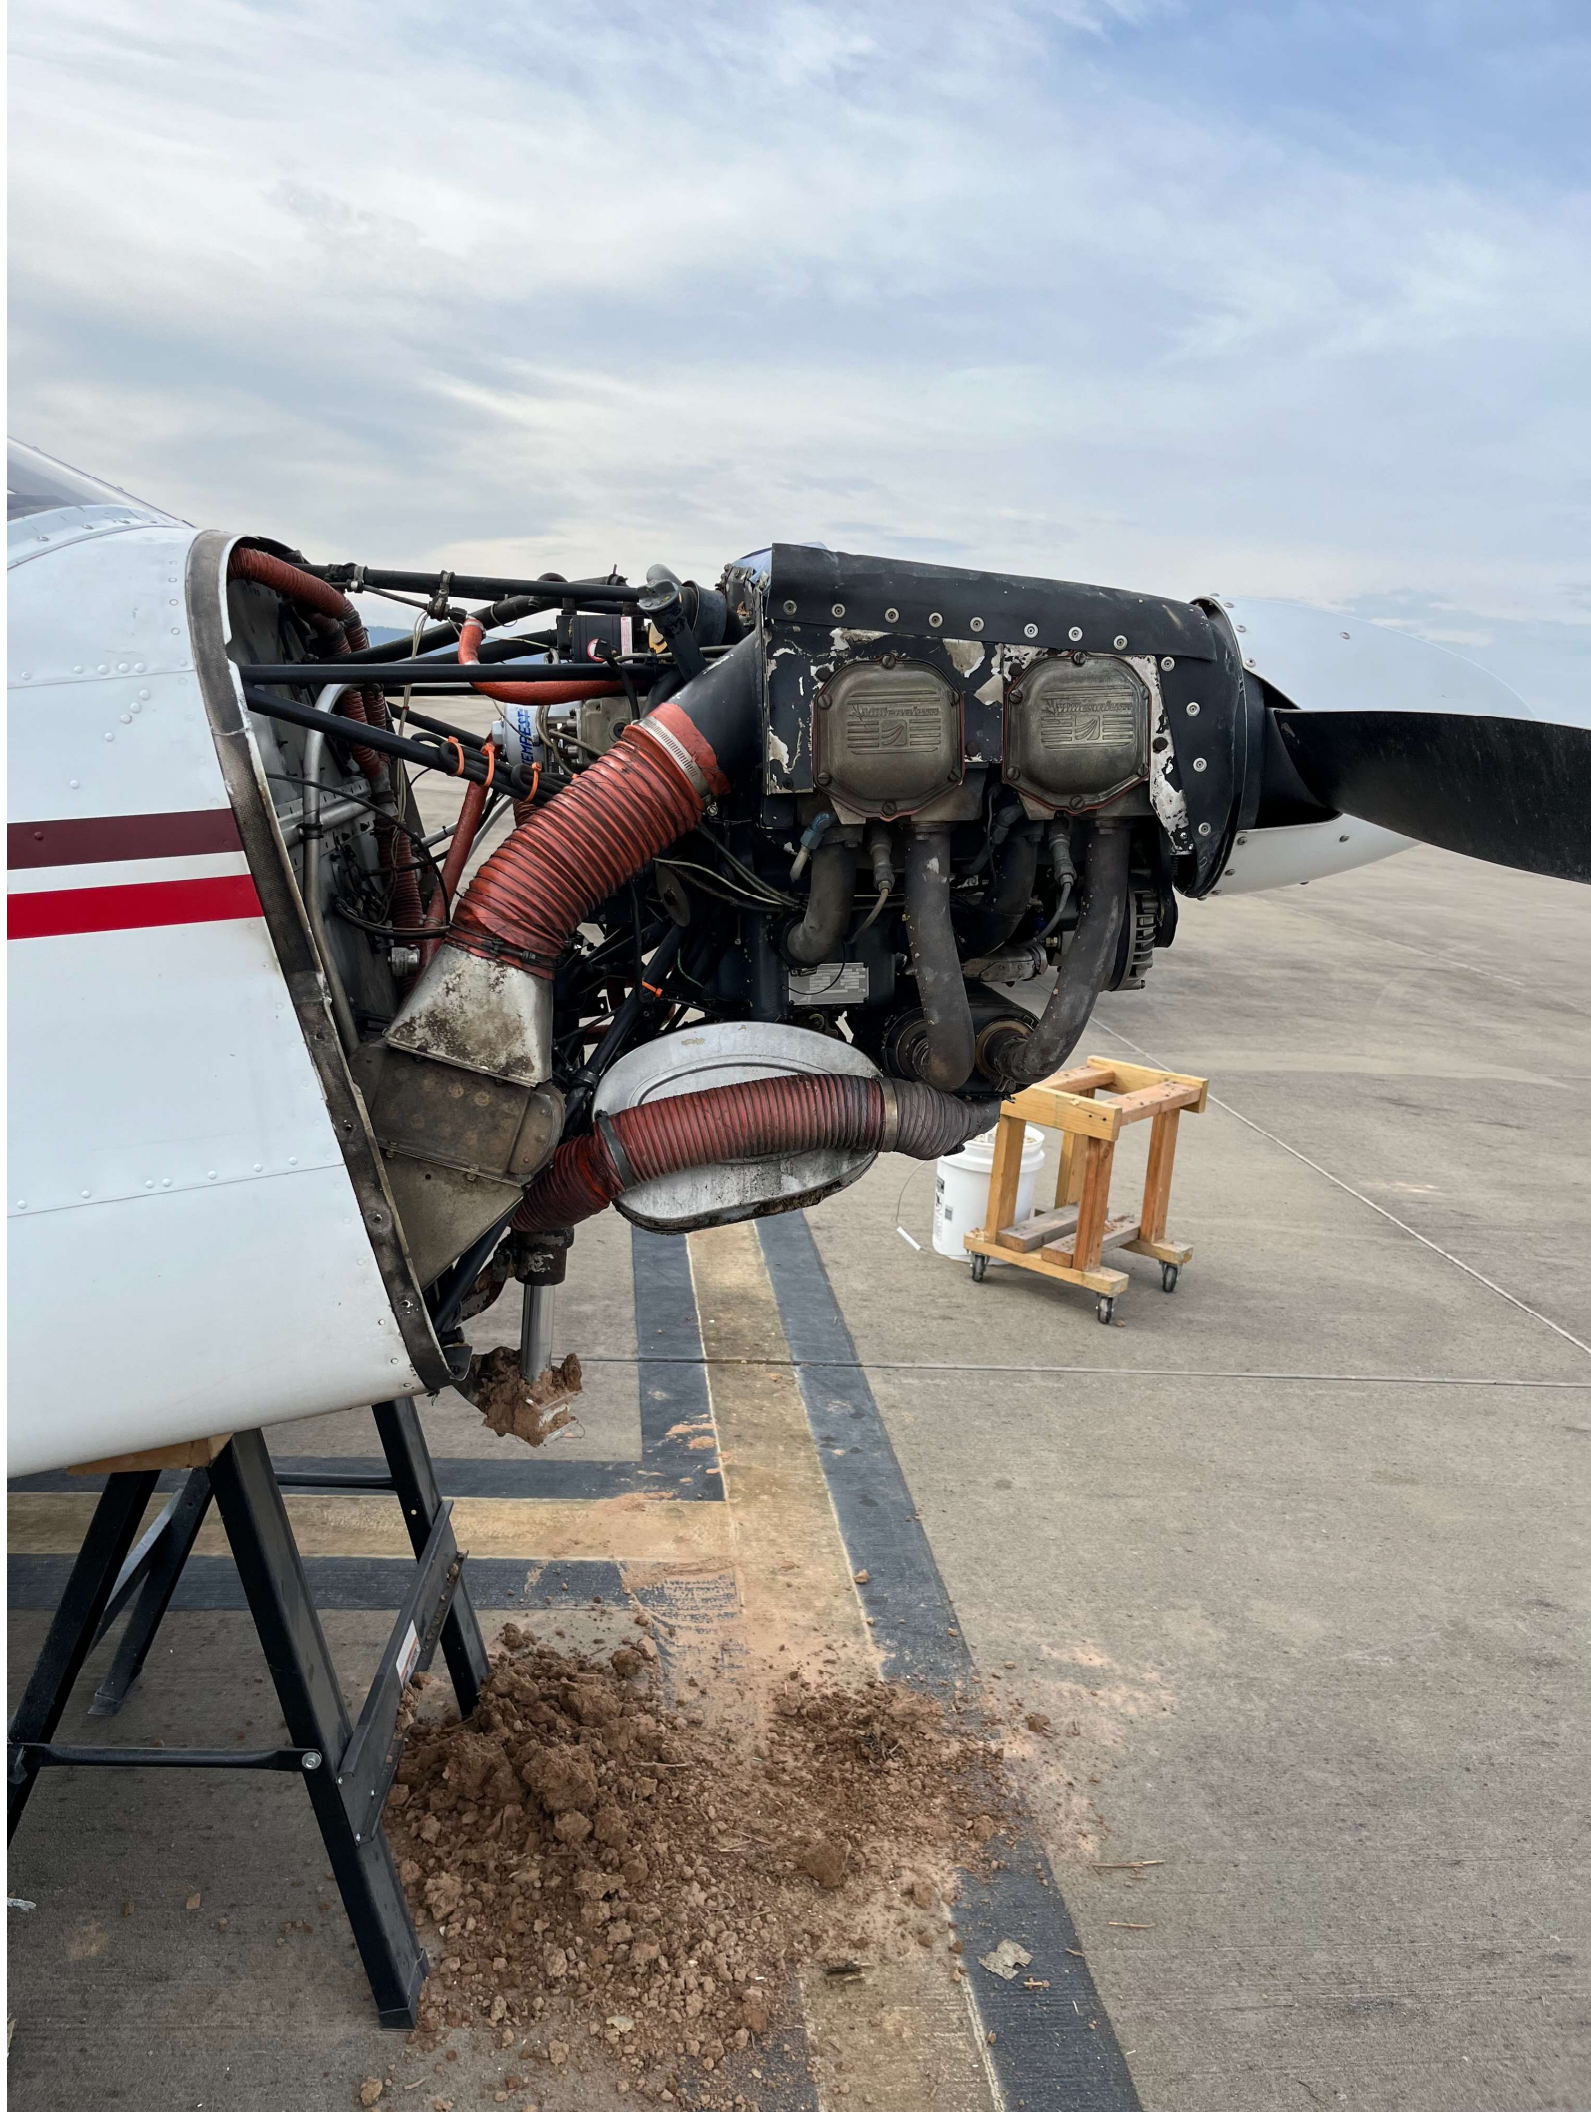
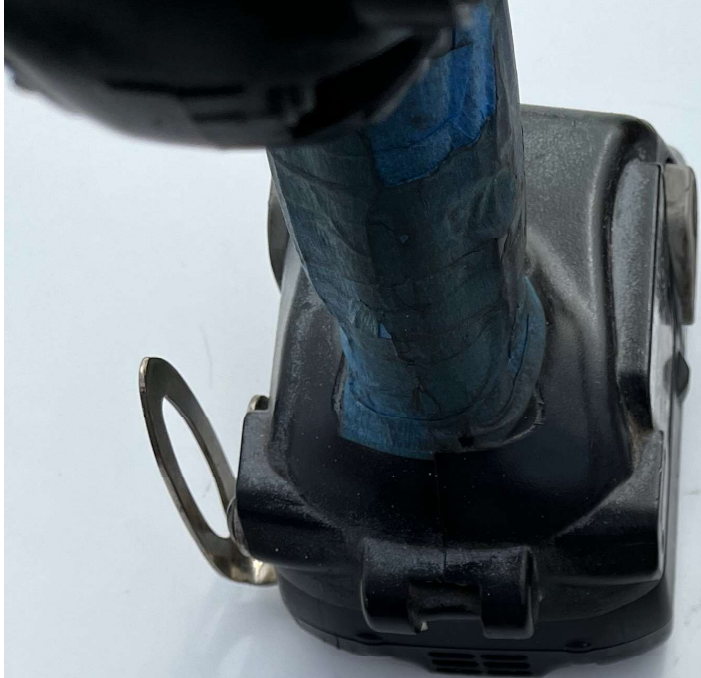
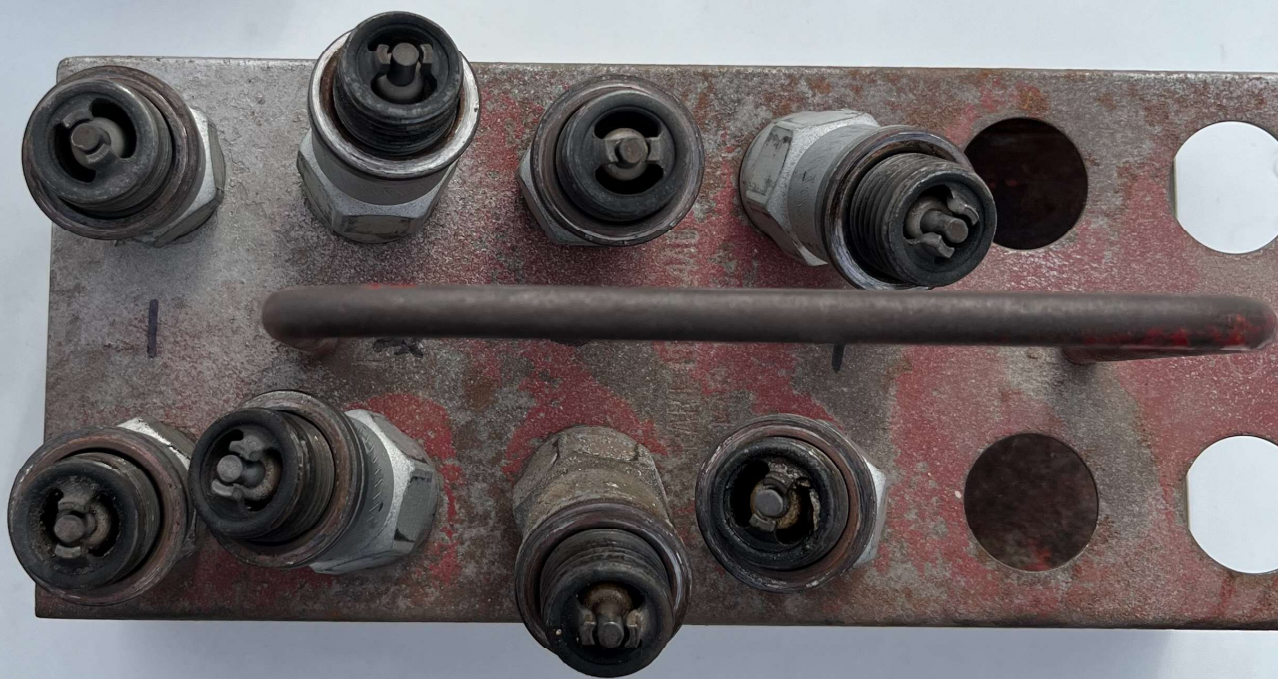
The evaluation was performed on the ramp area at Conway Municipal Airport (CXW) in Conway, AR. Mr. Twining and assistant shored the aircraft (the nose gear is broken off at the yoke and the strut is folded under the aircraft) as level as possible with the equipment available. The upper and lower engine cowlings were removed. An initial inspection of the engine showed a broken engine mount, crushed air inlet box and muffler and engine controls with binding due to the broken mount. The lower spark plugs were removed, and a compression test was performed. #1 73 #2 75 #3 70 and #4 72. The remaining spark plugs were removed, and all had normal coloration with no wear or fouling. The valve covers were removed. The engine was rotated through multiple revolutions with normal crankshaft, piston, and cam shaft movement, indicated by movement of rocker arms at each port on all cylinders (each had proper oiling also). The impulse coupling on the magnetos were "clicking" and there was intake vacuum at the vacuum pump. This indicated normal accessory gear movement. Spark was present at each ignition lead. All fuel and oil line connections were tested for tightness, and none were loose. The fuel had been removed from the aircraft for movement from the crash site, so several gallons of that fuel was put in each tank. The output line from the fuel boost pump was disconnected. With the boost pump on there was a steady flow of fuel when the selector was placed in right tank and left tank position. There was no fuel when placed in the off position. When the selector was placed in the position it was in when I photographed it at the scene, there was a slight stream of fuel that would not be sufficient to keep the engine producing power. Equipment to measure fuel flow and psi was not available at the time of the evaluation.

In summary, the engine appeared to operate mechanically as it should. It produced sufficient compression and spark. The fuel pump produced a strong fuel flow and the fuel selector operated as it should. Damage to the engine mount and airbox prevented full movement of the throttle, mixture and carburetor heat. These things along with the bent propeller prevented any attempts at running the engine.
