CEN24LA108

## INVESTIGATION PHOTOGRAPHS

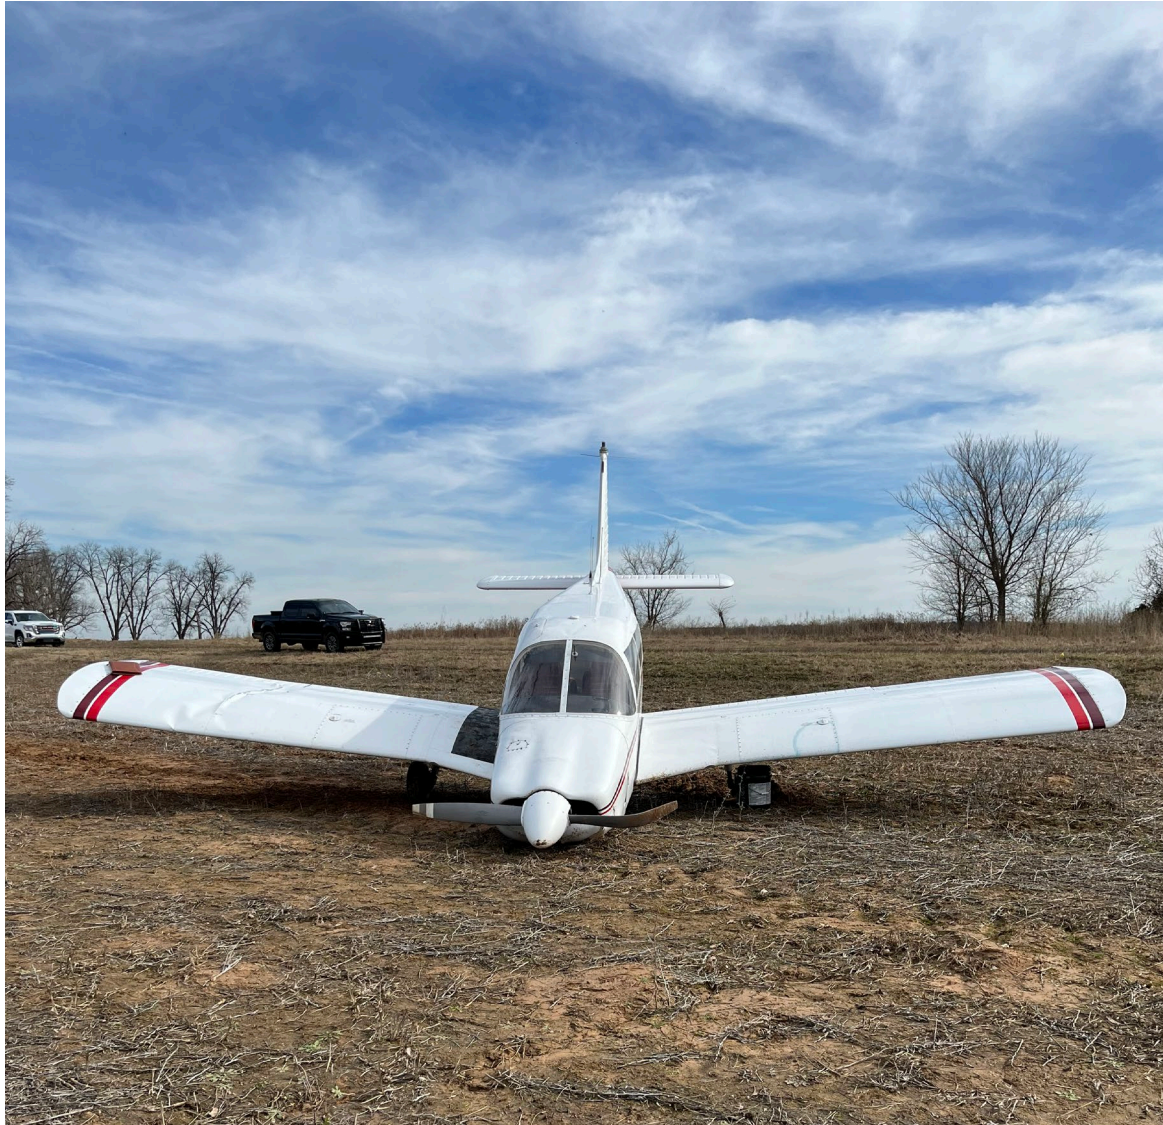
**Photograph 1 - Front of airplane (Courtesy of FAA)**

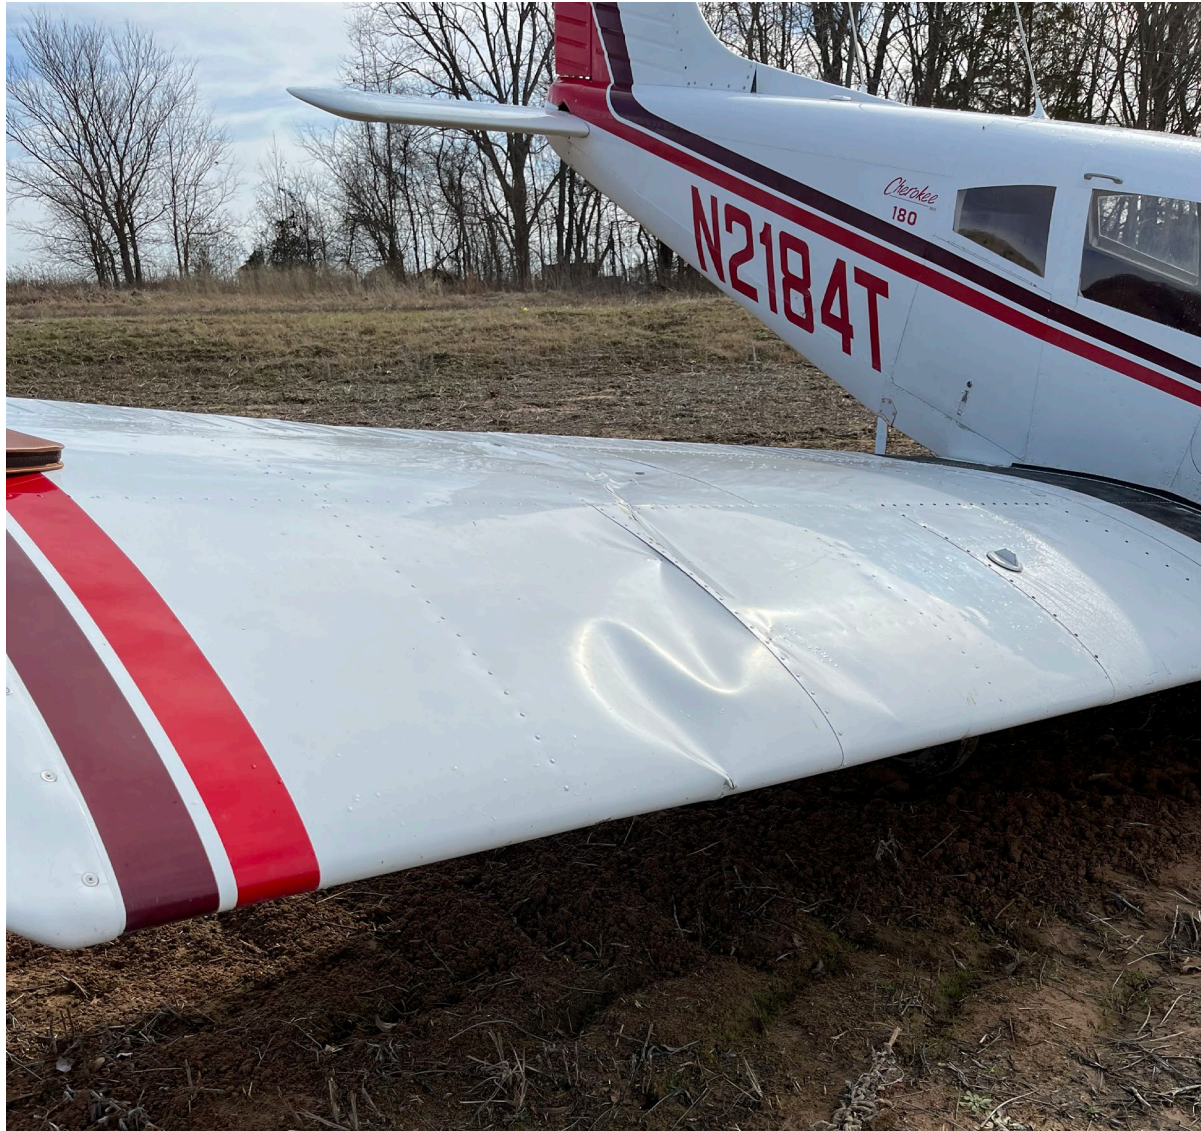
**Photograph 2 - Right wing damage (Courtesy of FAA)**

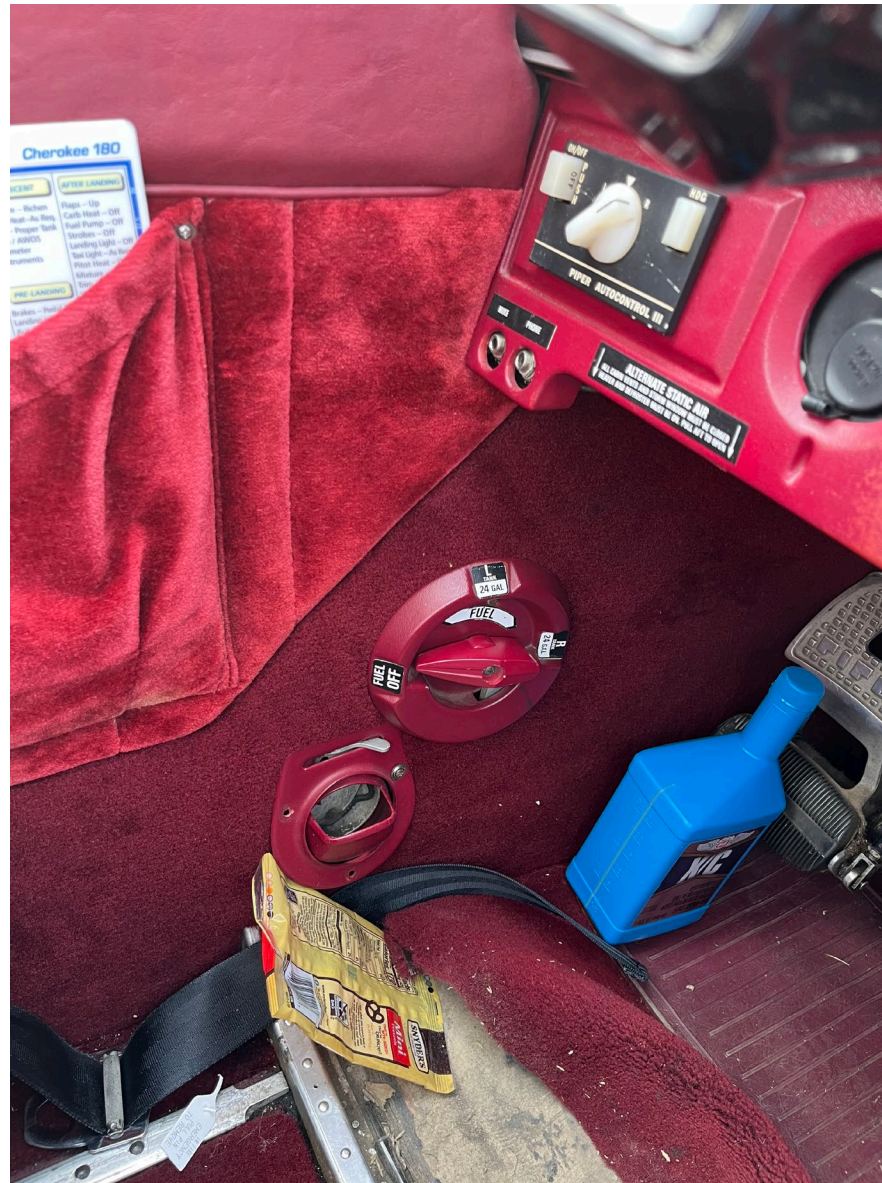
**Photograph 3 - Fuel selector handle OFF (Courtesy of FAA)**
