CEN24LA118

## INVESTIGATION PHOTOGRAPHS

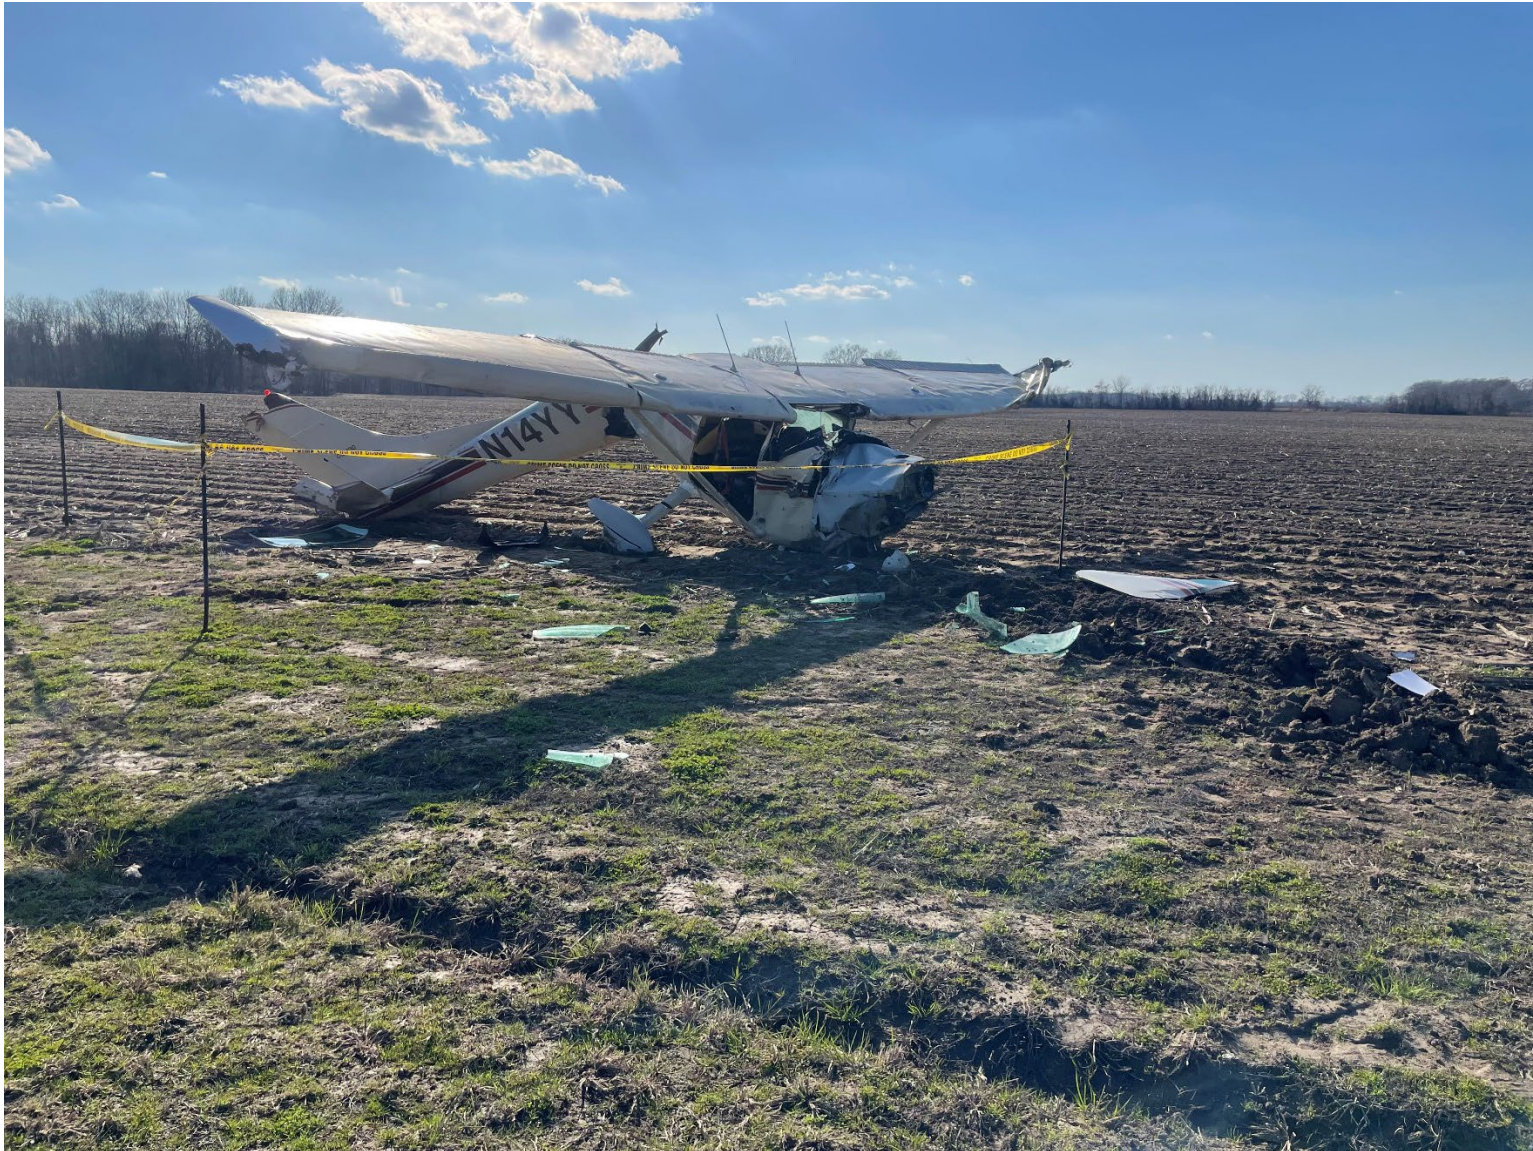
**Photograph 1 - Accident Site of N14YY (Courtesy of the Federal Aviation Administration)**

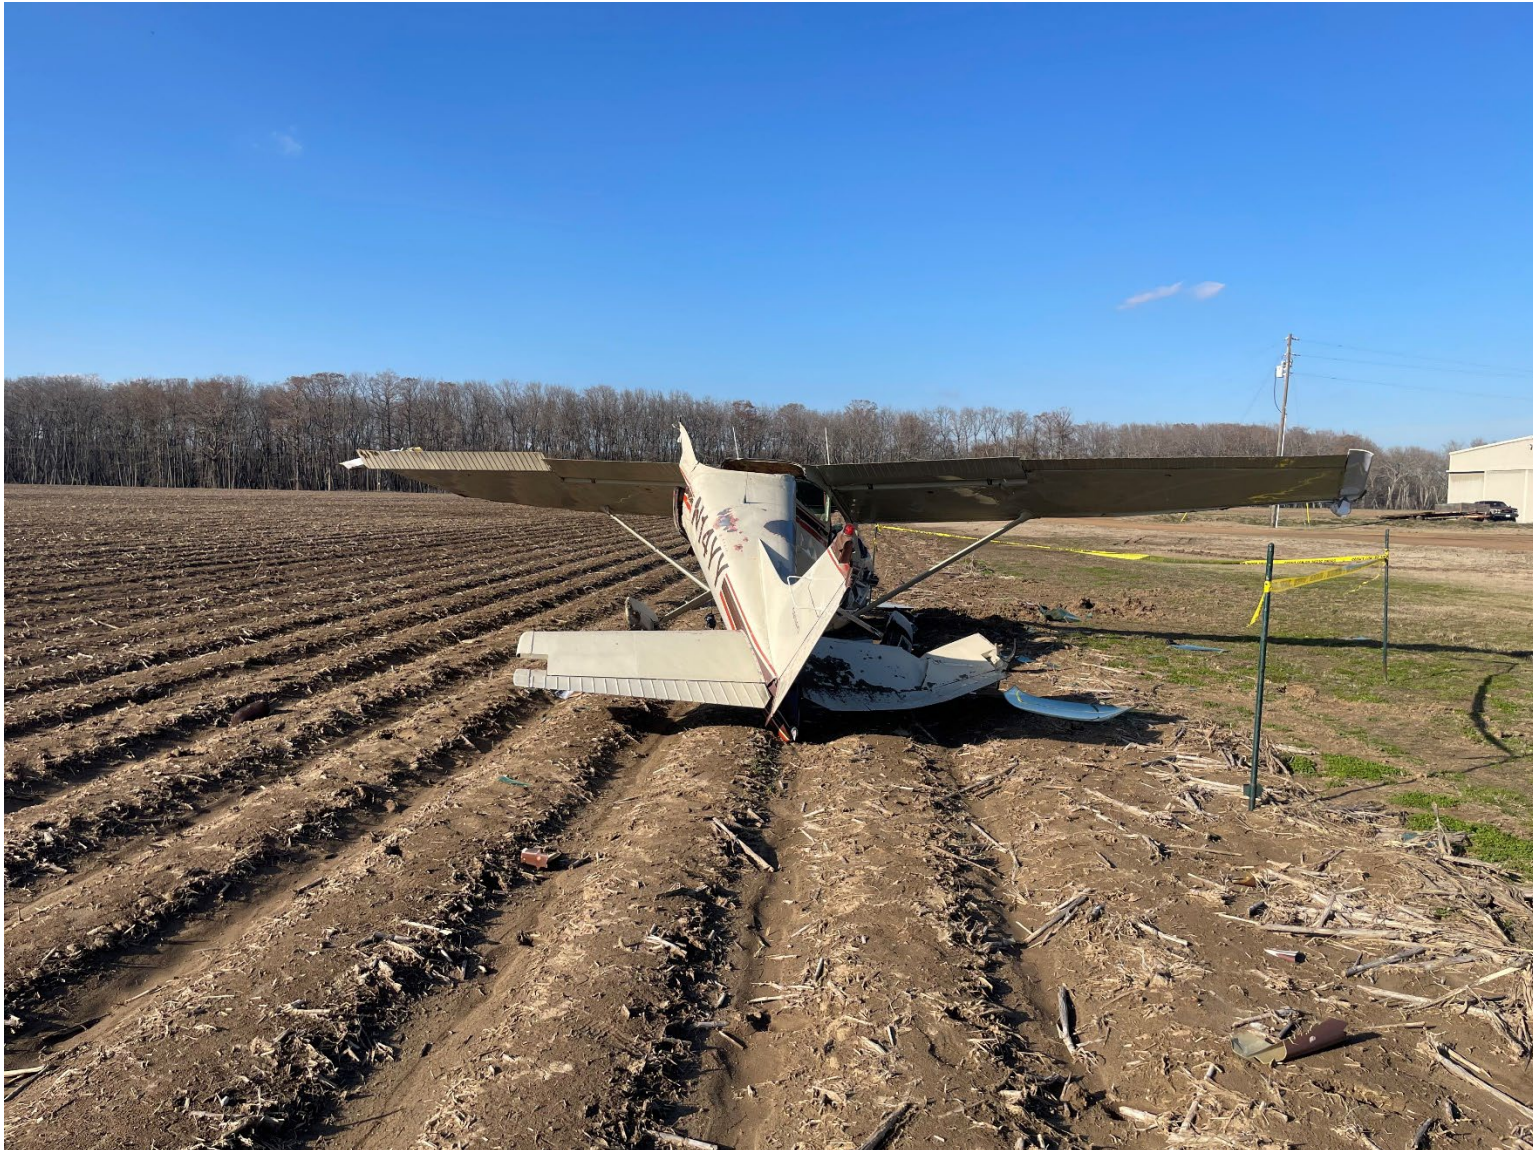
**Photograph 2 - Accident Site of N14YY (Courtesy of the Federal Aviation Administration)**

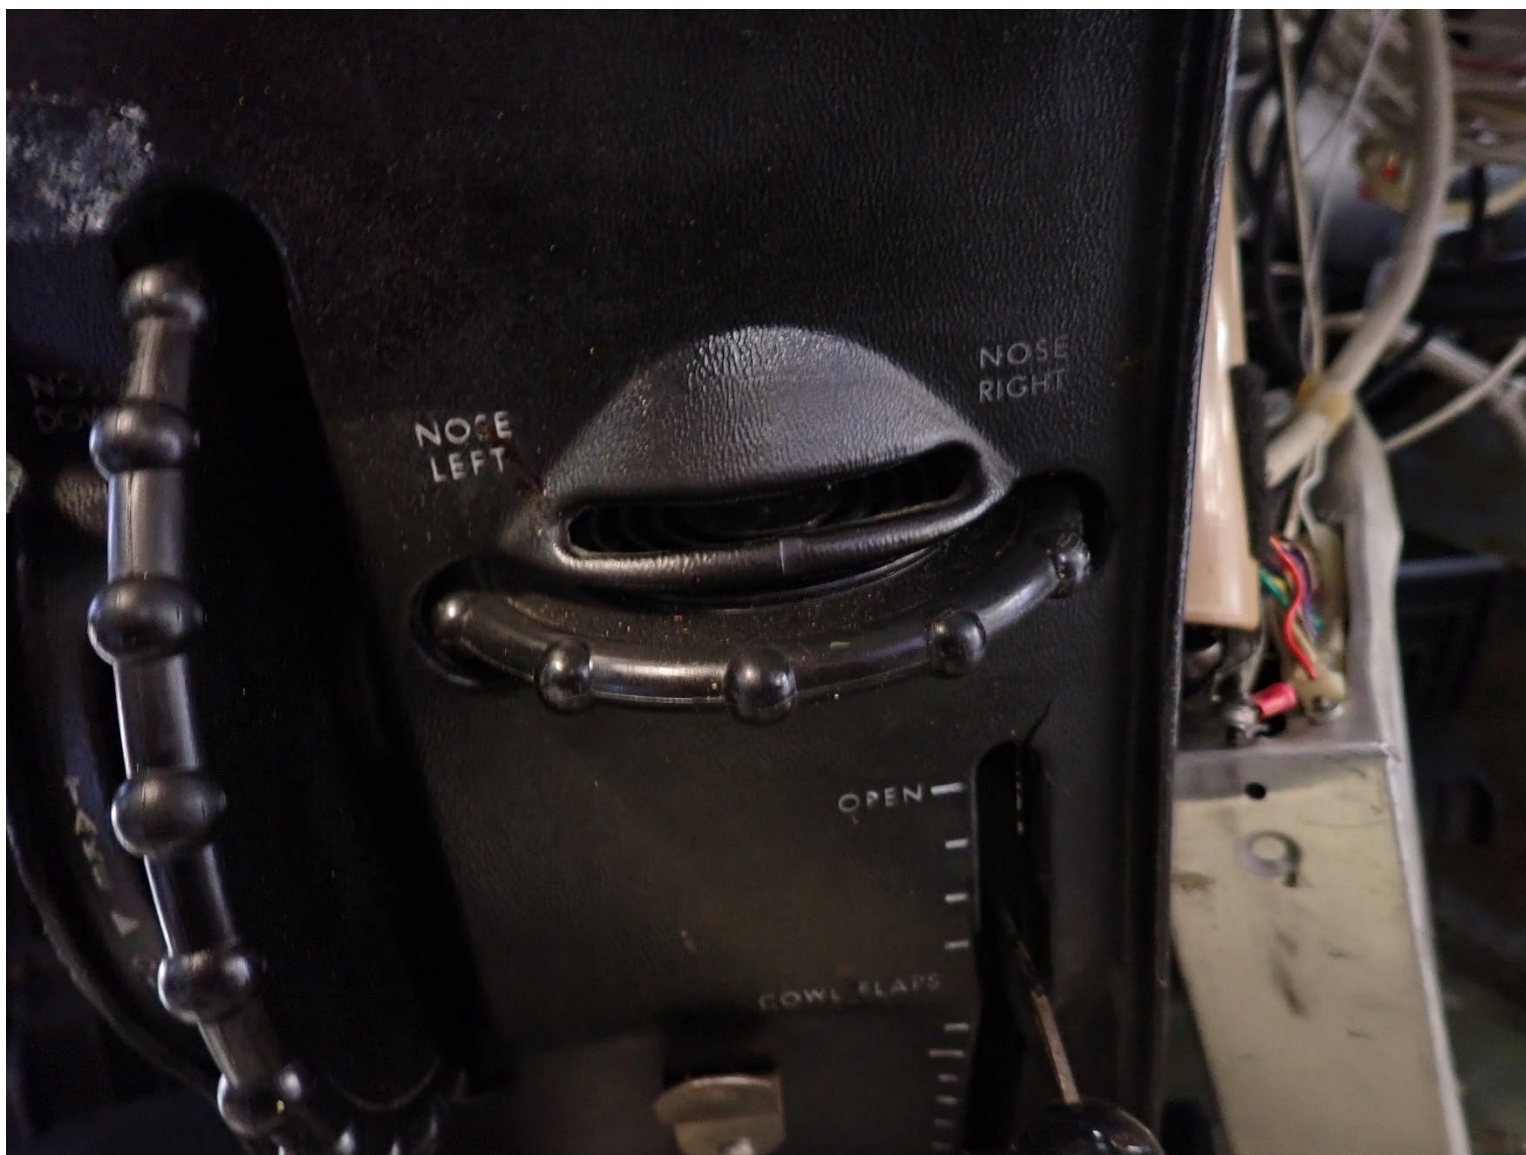
**Photograph 3 - Cockpit Rudder Trim Position (Courtesy of the Textron Aviation)**

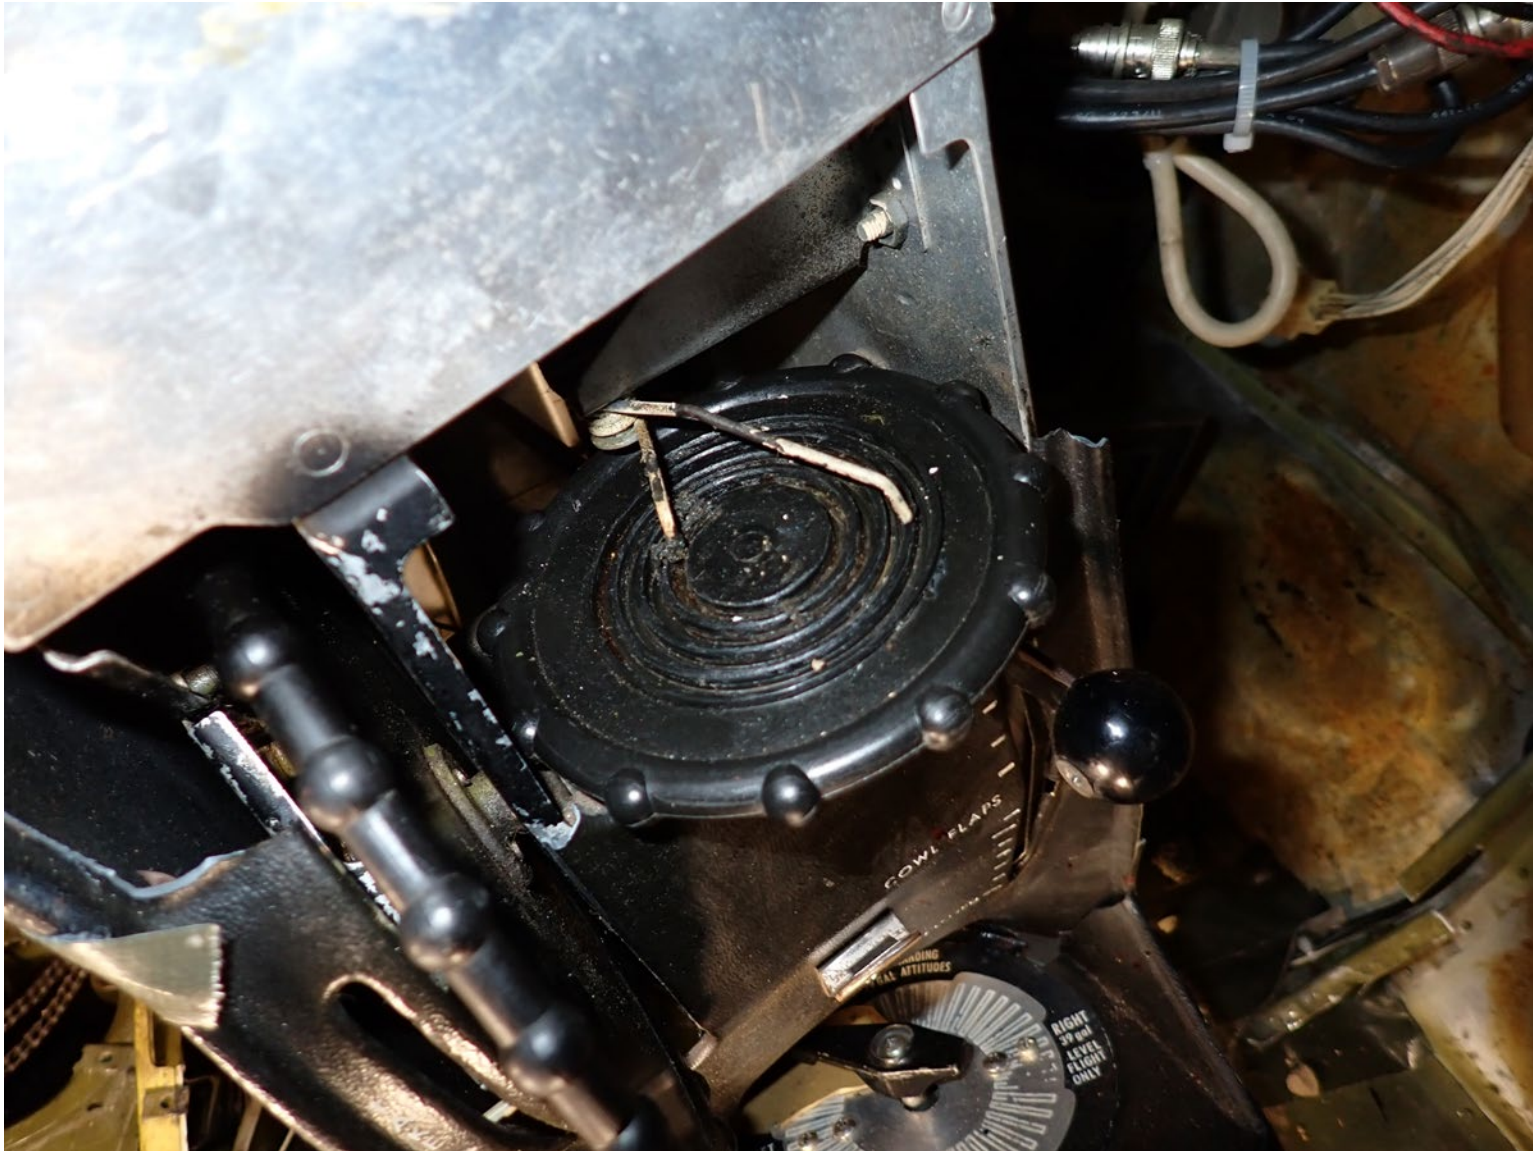
**Photograph 3 - Rudder Trim Indicator (Courtesy of the Textron Aviation)**
