# National Transportation Safety Board

CEN24LA210

## **AIRCRAFT EXAMINATION**

Location: Patterson, LA  
Date: 2/25/2024  
Time: 1645 CDT  
Airplane: Amateur-built Pulsar 1, N72BH

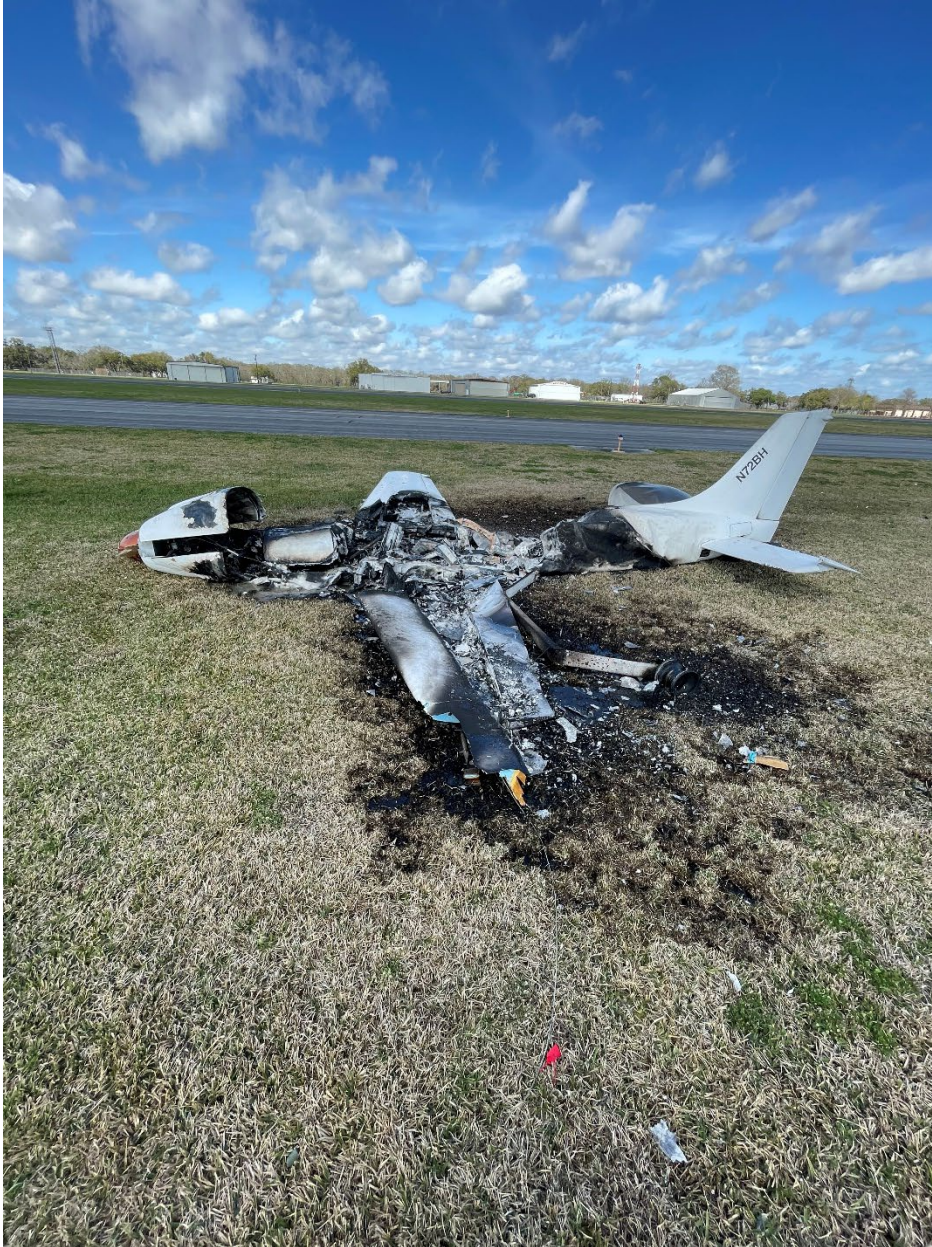
The accident site was not visited. Photos from the accident site were provided by the FAA. The airplane came to rest on airport property adjacent to a taxiway. A chain-link fence at the airport perimeter was struck by the airplane and the outboard portion of the left wing was found next to the fence. The airplane was resting upright on its belly. The tail surfaces and their respective control surfaces were still attached to the aft fuselage. The fuselage from the firewall aft to the forward end of the vertical stabilizer dorsal fin was almost completely consumed by the postimpact fire. The left wing was almost completely consumed by the fire. The right wing inboard portion

Figure 1. FAA photo of the airplane viewed from its left side.

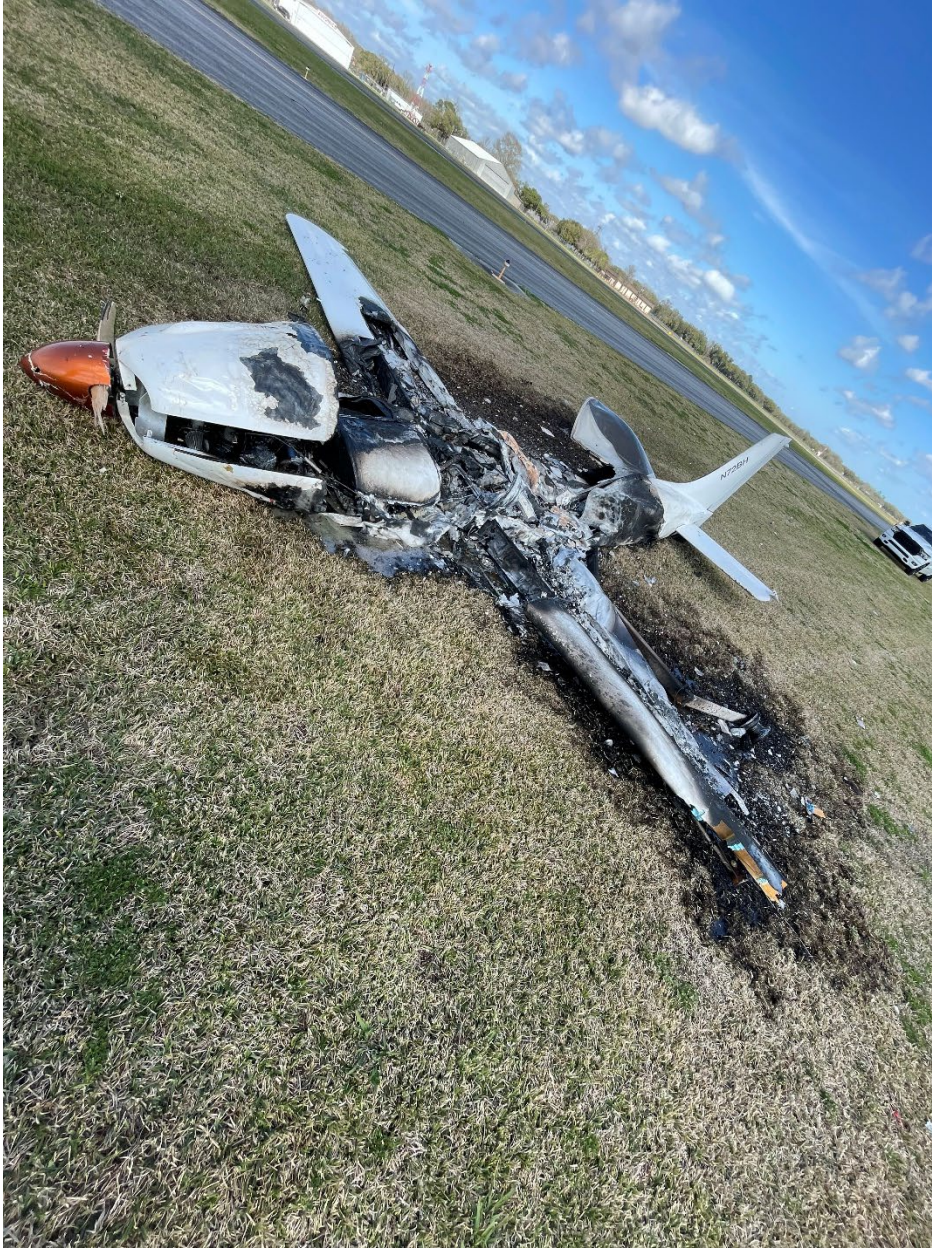
Figure 2. FAA Photo of the airplane viewed from its front left side.

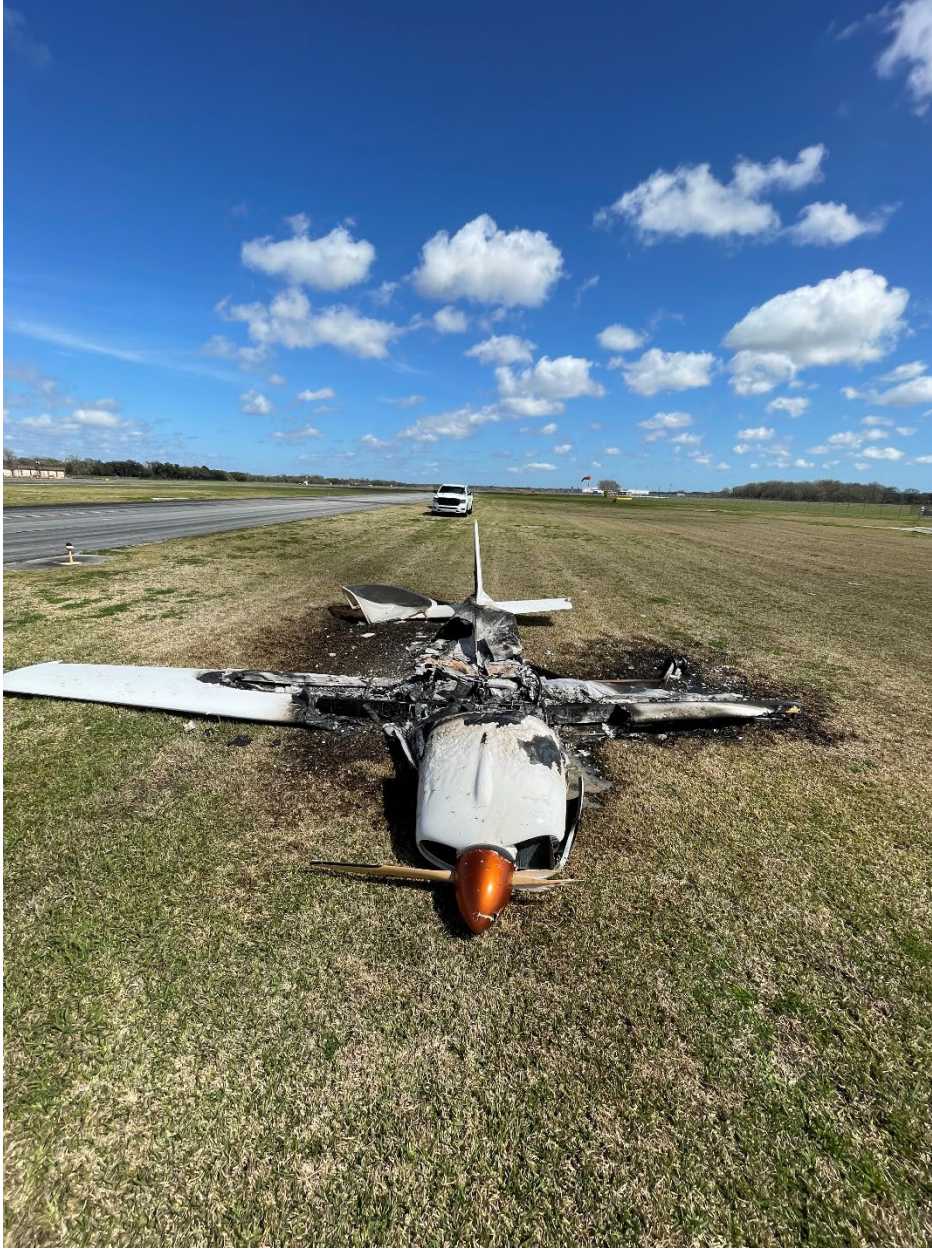
Figure 3. FAA Photo of the airplane viewed from the front.

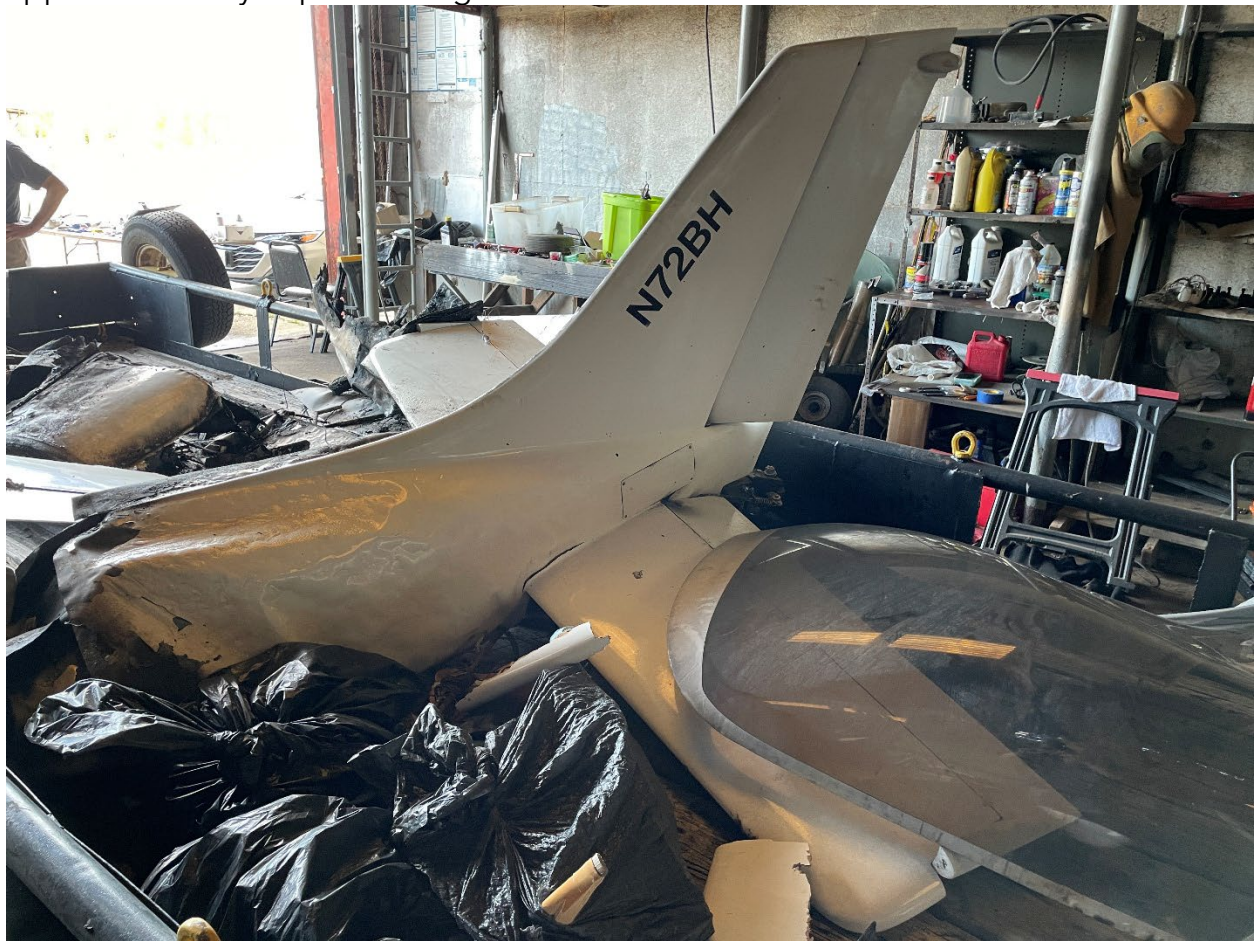
The airplane's tail surfaces remained attached to the aft fuselage. The elevators and rudder remained attached to their respective fixed surfaces. There did not appear to be any impact damage to the tail surfaces.

Figure 4. NTSB photo of the airplane's tail surfaces.

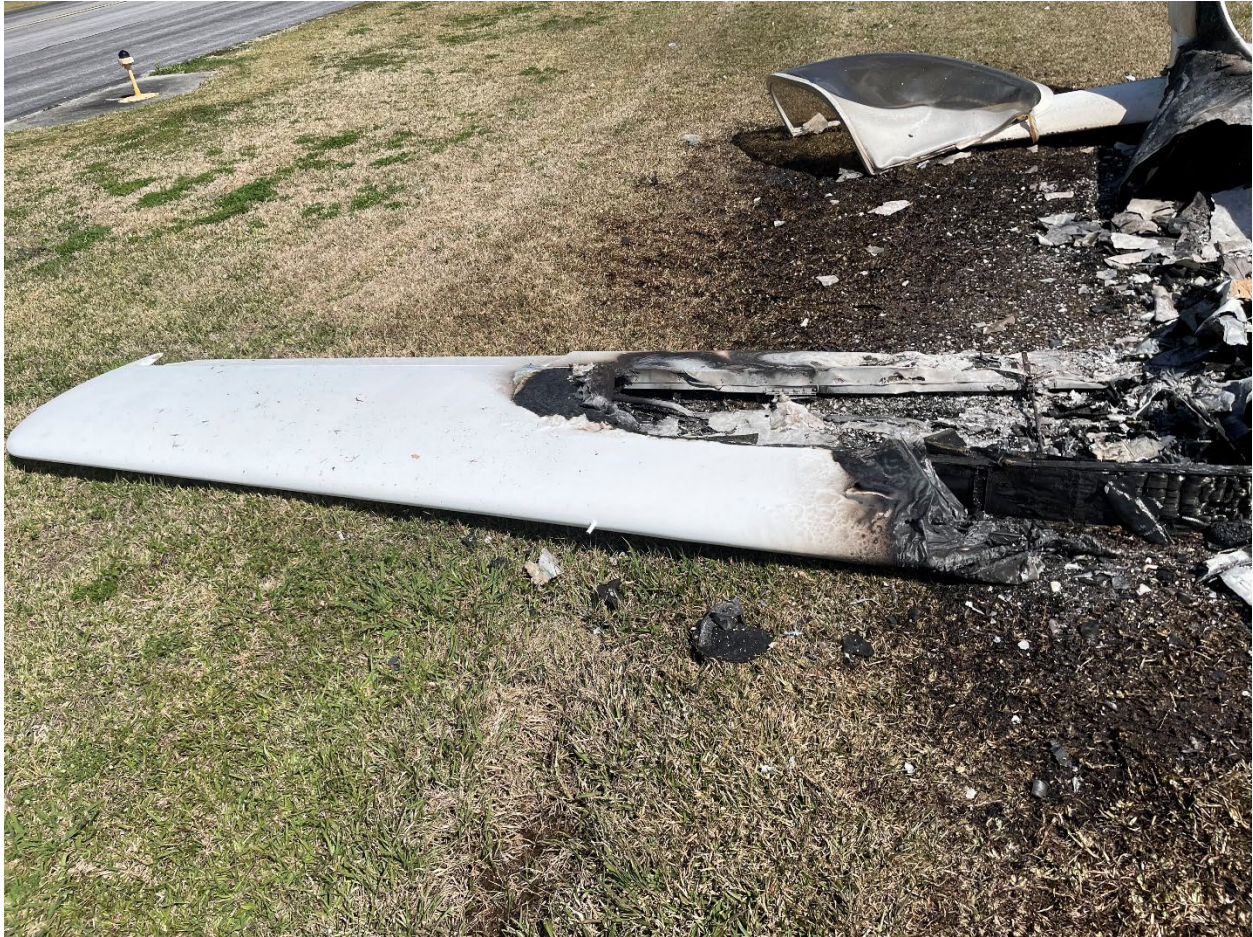
The airplane's wings were of wood construction. There was extensive fire damage to the inboard end of the wing. The portion of the right wing aft of the spar was more extensively damaged by fire. The aileron remained attached to the wing.

The burned flap could be see in photos resting in its usual position at the aft inboard end of the wing.

Figure 5. FAA Photo of the airplane's right wing at the accident site.

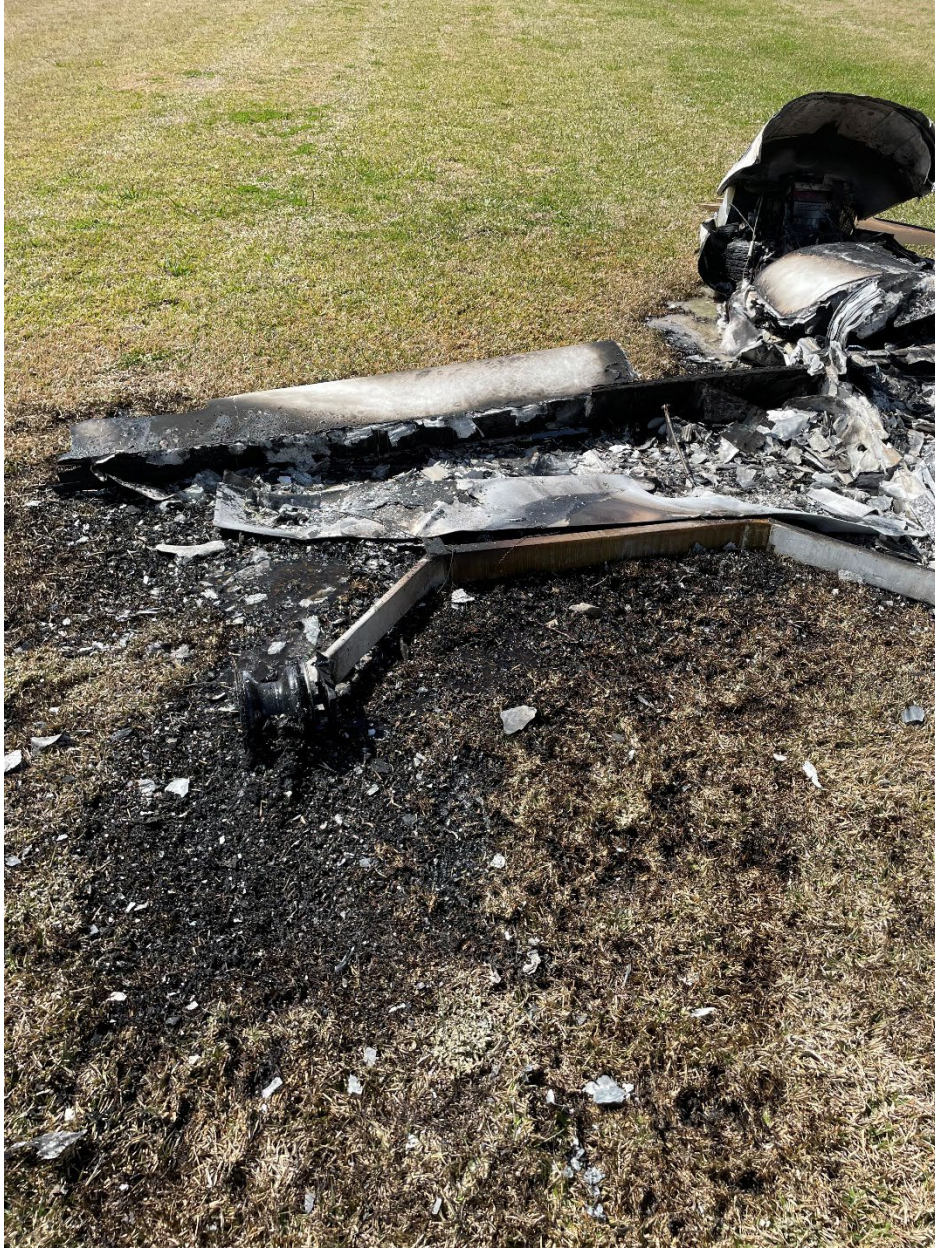
The outer aft portion of the left wing, including the aileron was separated from the remainder of the wing. These pieces were found next to the airport perimeter fence. The aileron was still attached to the portion of wing structure and the leading edge "D-cell" was found near the fence. The remainder of the wing, including the flap, was almost completely consumed by fire

Figure 6. FAA Photo of the airplane's inboard left wing. Also visible is the separated main landing gear.

Both the main and nose landing gear separated from the airframe. The main gear was found adjacent to the airplane's left wing at the accident site.

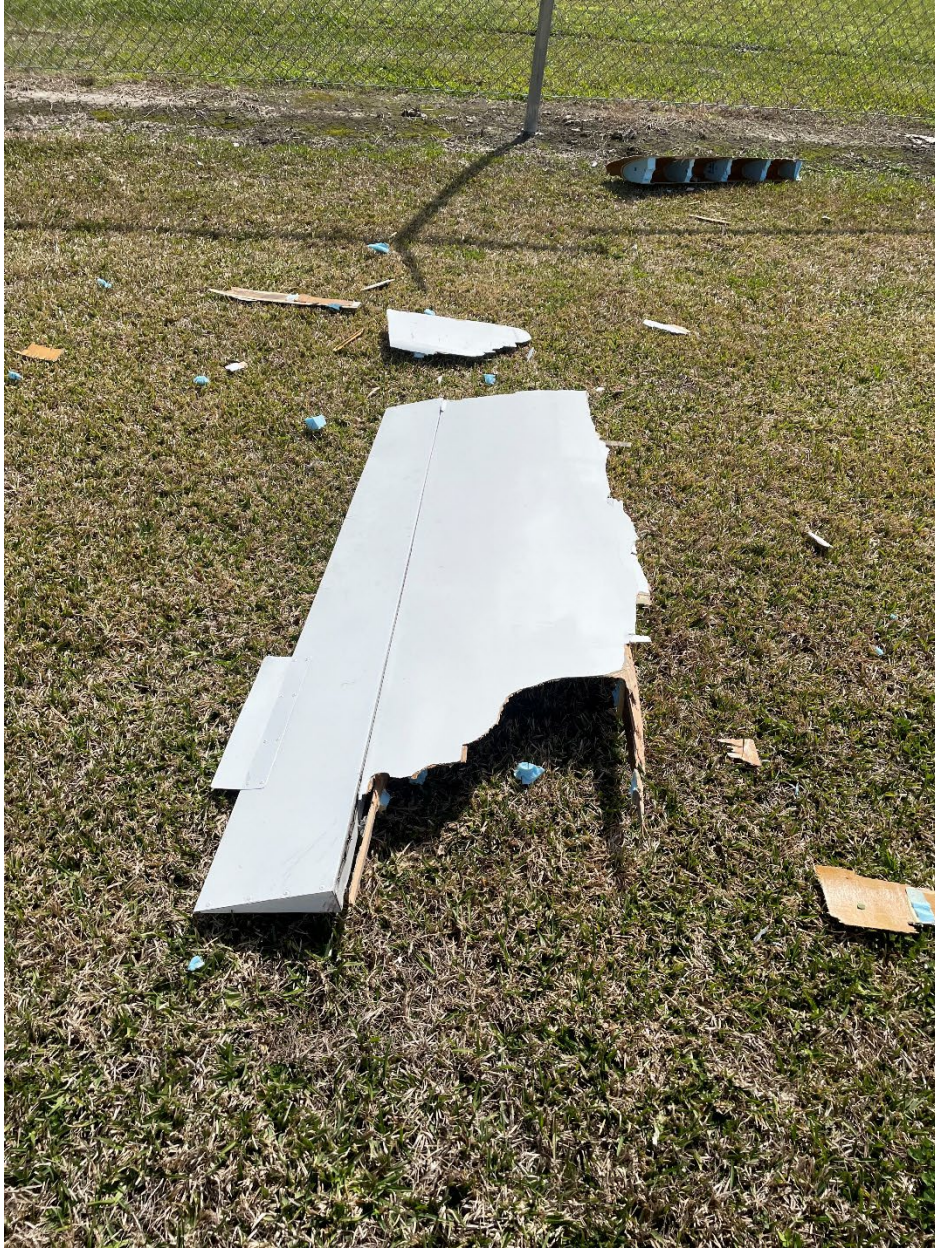
Figure 7. FAA Photo of the outboard aft portion of the left wing with aileron still attached.

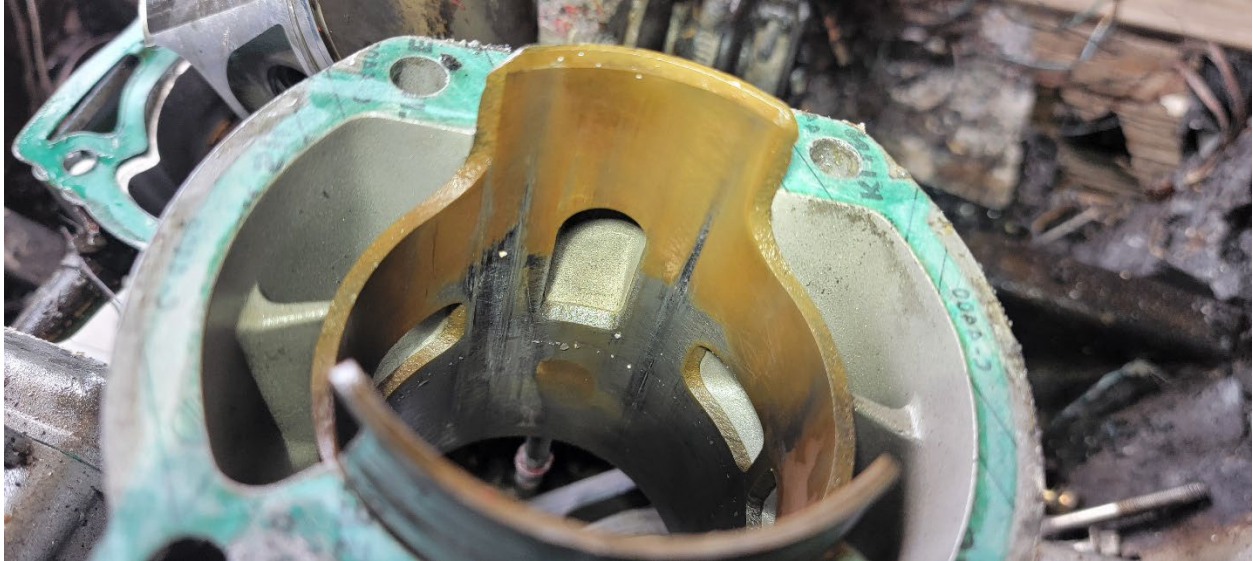
The engine was examined on March 12, 2024. The Engine was separated from the airplane. With the exhaust system removed the pistons were visible. The No. 2 piston had scoring on its side when viewed through the exhaust port. The No. 2 cylinder was removed and the scoring and evidence of seizure was confirmed with additional areas of scoring adjacent to the intake ports. The interior of the cylinder, the exterior of the connecting rod, and portions of the crankshaft within the No. 2 cylinder side of the engine were covered with a coating of corrosion (rust).

Figure 8. Rotec Photo of cylinder.

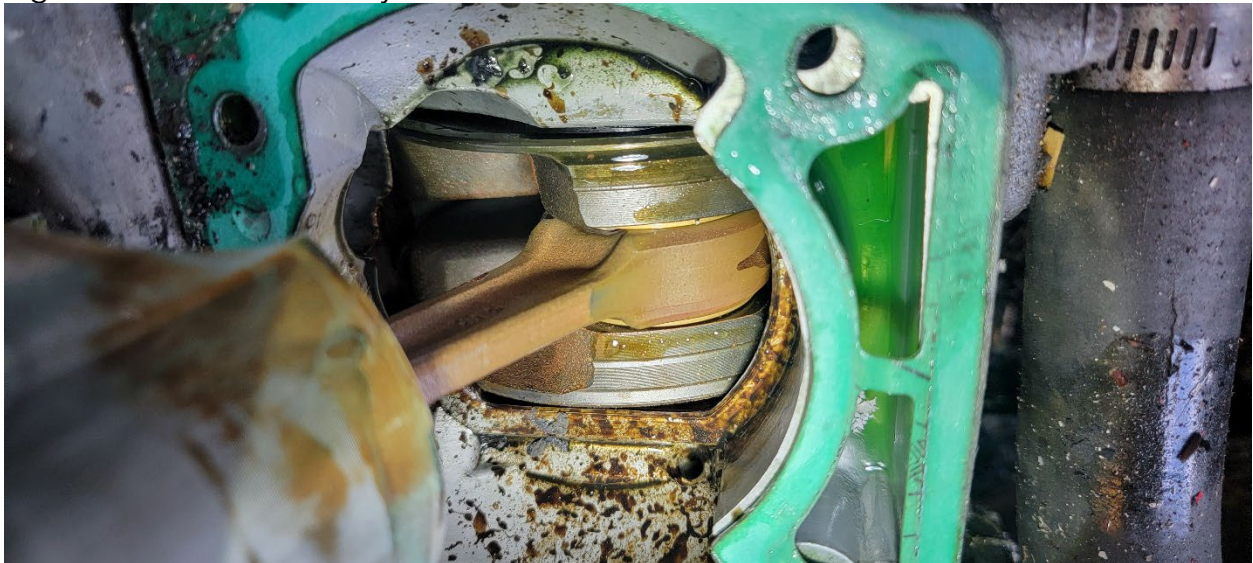
Figure 9. Rotec Photo of connecting rod and crankshaft.

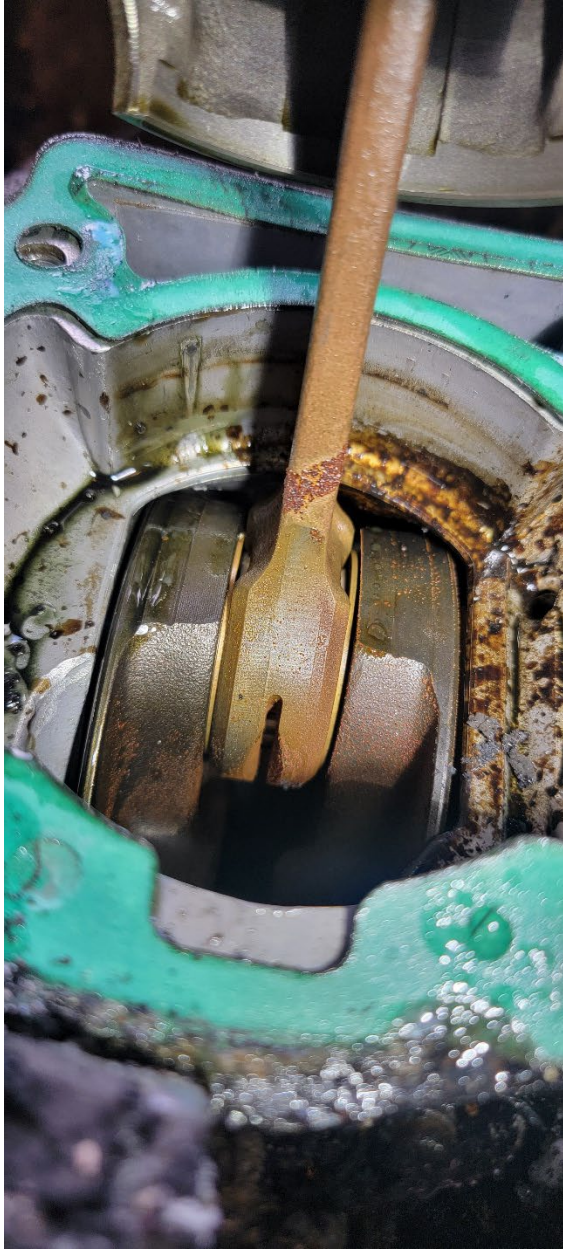
Figure 10. Rotec photo of connecting rod and crankshaft.
