# National Transportation Safety Board

CEN24LA121

## **MATERIALS LABORATORY**

Factual Report 24-086

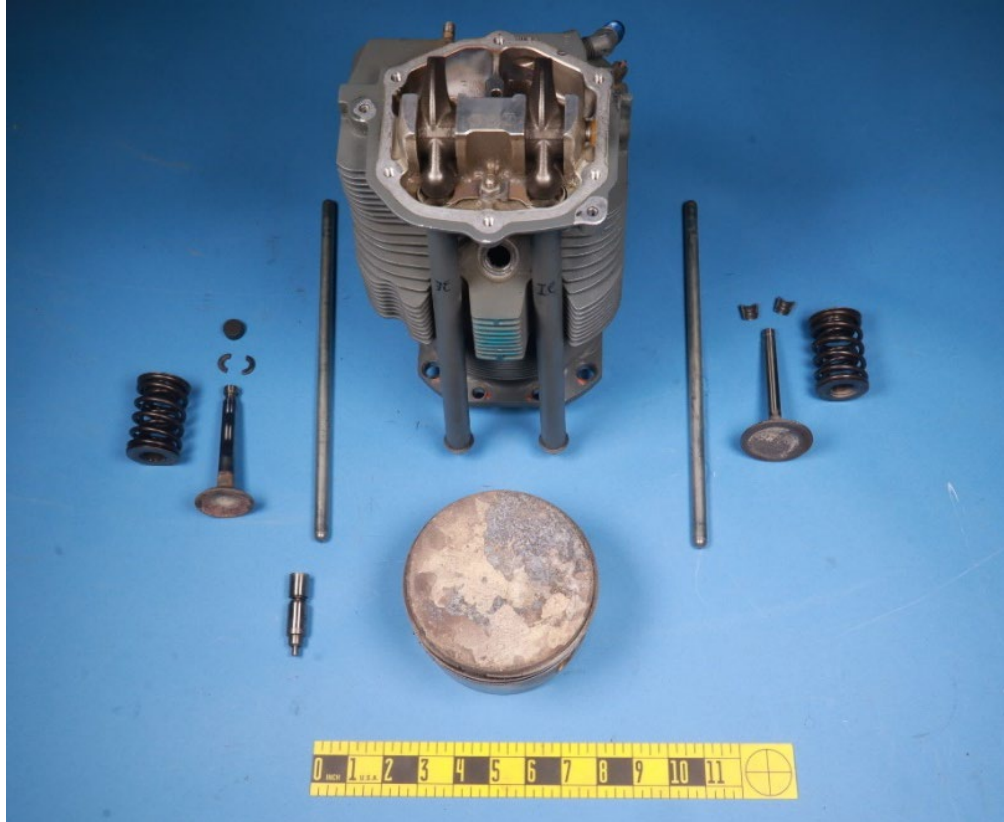
An overall view of the submitted components from a Lycoming O-360-A4M engine installed on the accident airplane is shown as received in figure 1. The submitted components included the number 2 cylinder and piston assemblies and associated components from the intake and exhaust valve trains consisting of valves, valve springs and seats, keepers and tip cap, and the exhaust lifter plunger assembly. In figure 1, the exhaust components are shown at the left of the image, and the intake components are shown at the right.

**Figure 1.** Overall view of the submitted components associated with the number 2 cylinder.

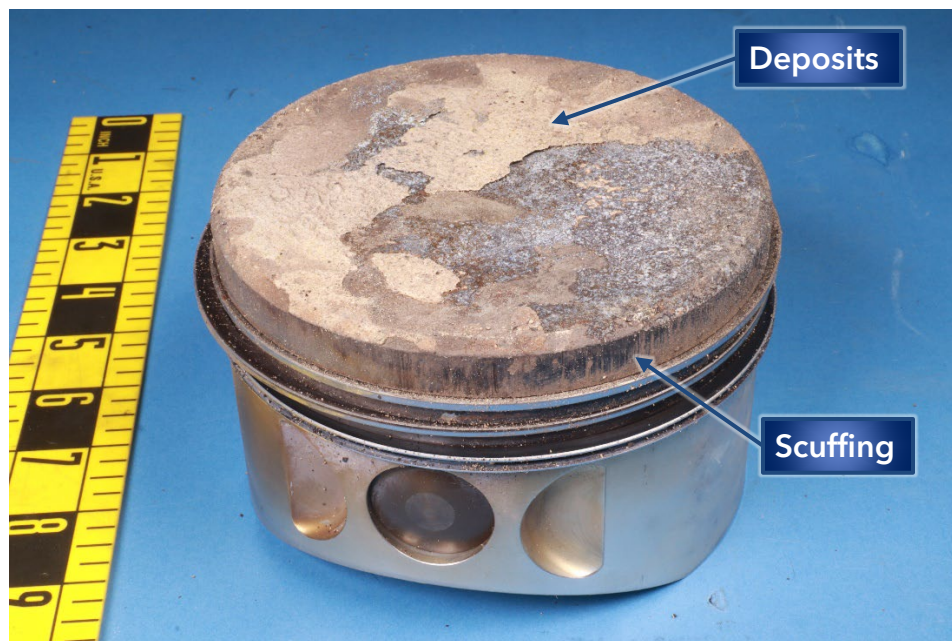
A closer view of the piston assembly is shown in figure 2. Relatively thick tan deposits covered most of the piston crown. Scuffing marks were observed at the outside edge between the piston crown and the outboard oil ring.

**Figure 2.** Piston assembly showing tan deposits on the crown and scuffing at the outside edge between the crown and the outboard oil ring.

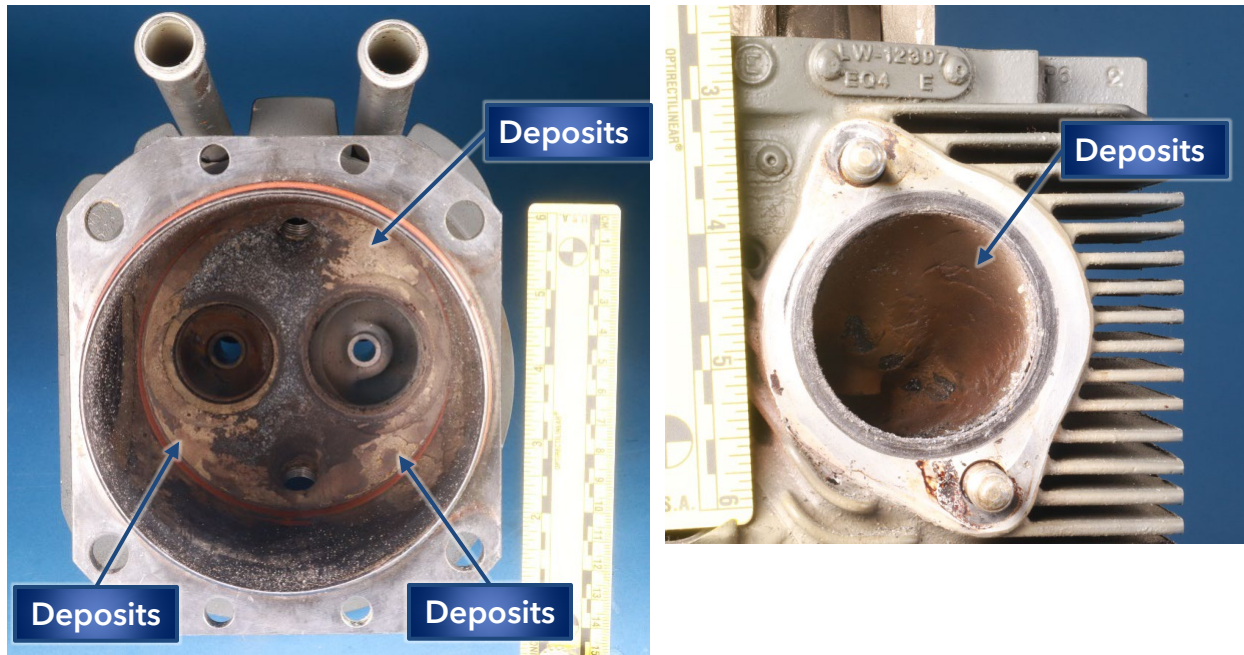
The interior of the cylinder assembly is shown in figure 3. Tan deposits were observed on the cylinder dome surfaces mostly around the outside diameter. Relatively thicker tan deposits were also observed in the exhaust port shown in the right image in figure 3.

**Figure 3.** Views of the cylinder interior (left image) and exhaust port (right image) showing tan deposits on the dome surface and thicker tan deposits in the exhaust port.

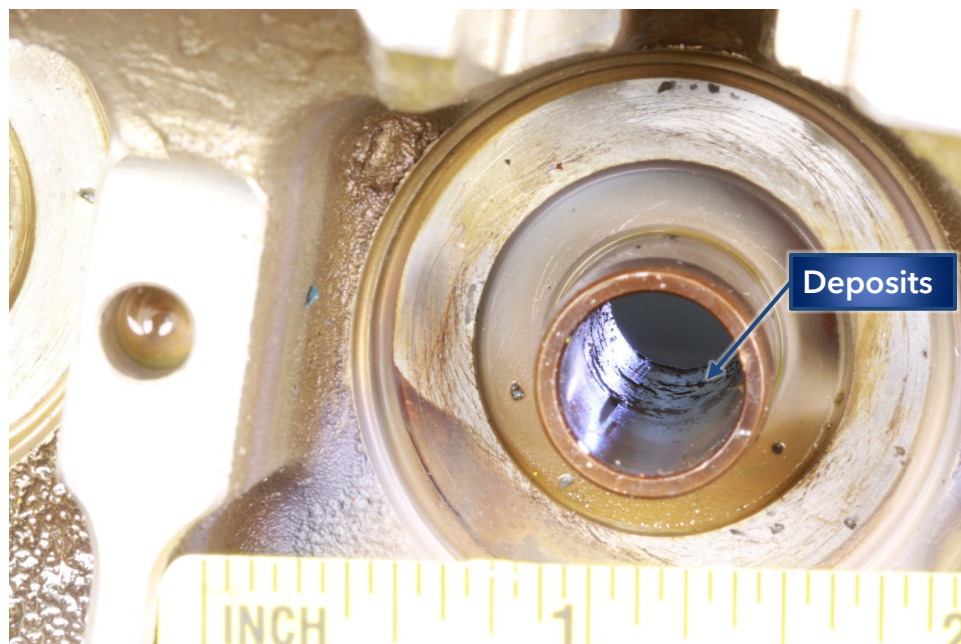
Dark deposits were observed on the interior surface of the exhaust valve guide as shown in figure 4. The deposits remained in place after a paper shop towel was

fed through the valve guide to remove any loose debris that might have been present.

**Figure 4.** Exhaust valve guide showing deposits on the interior surface in the inboard half of the guide.

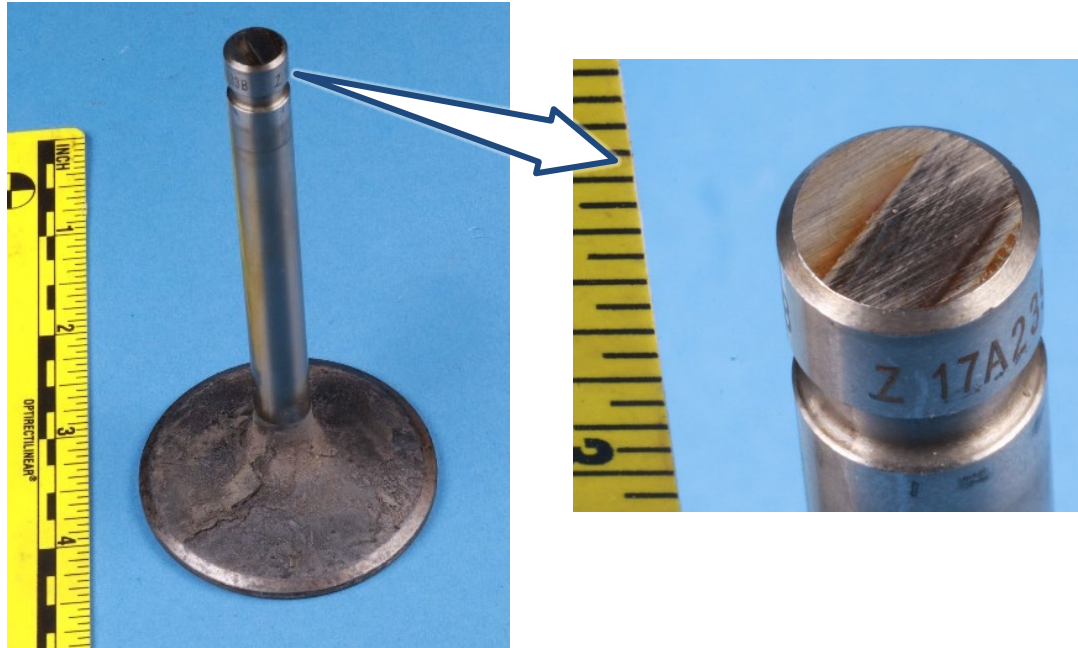
Views of the intake valve are shown in figure 5. Gray and black deposits with varying thicknesses were observed on the stem side of the valve head. On the intake valve tip face, a rectangular rocker contact patch was observed as shown in the right image in figure 5, a contact pattern consistent with a valve that was not rotating.

**Figure 5.** Intake valve showing black and gray deposits on the stem side of the head (left image) and a closer view of the rocker contact pattern on the tip face (right image).

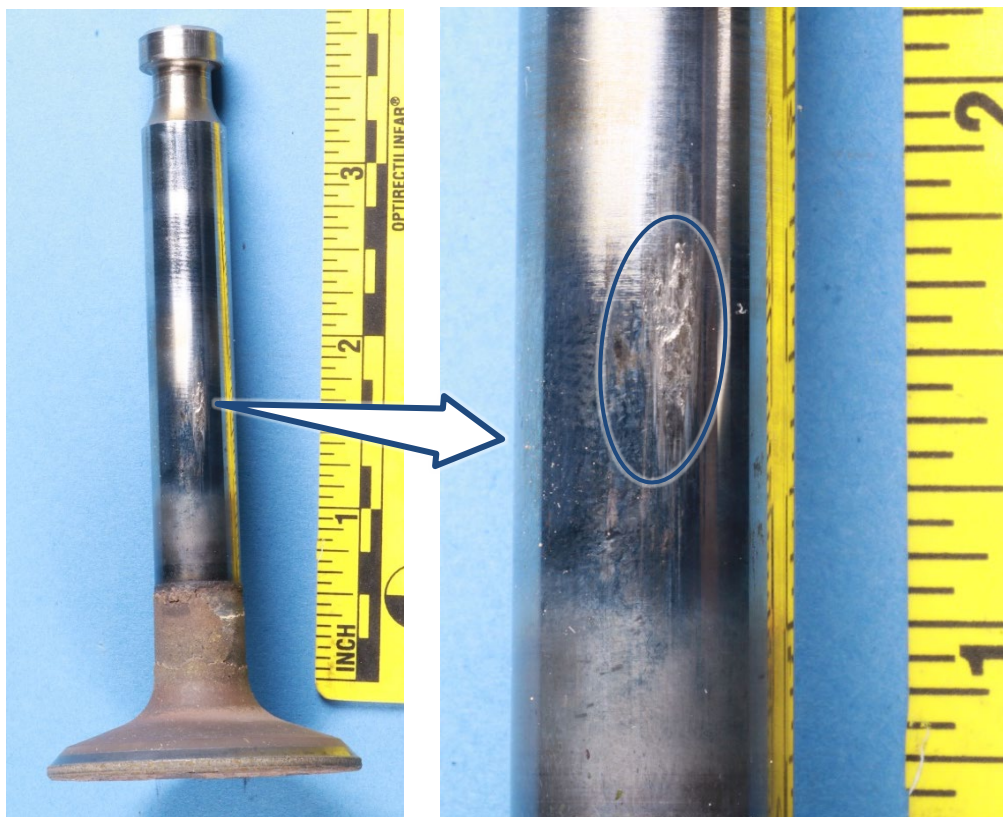
According to the examination summary from the engine examination conducted after the accident, the number 2 cylinder exhaust valve was found stuck in a partially open position and had been removed from the cylinder assembly with the use of penetrating oil and a mallet. The exhaust valve is shown as received for examination in figure 6. The neck area and adjacent surfaces on the head were covered with reddish brown deposits. Gray-colored raised deposits were observed on the side of the stem as shown in the right image in figure 6.

**Figure 6.** Exhaust valve showing raised deposits of smeared gray material (circled area) on the stem.

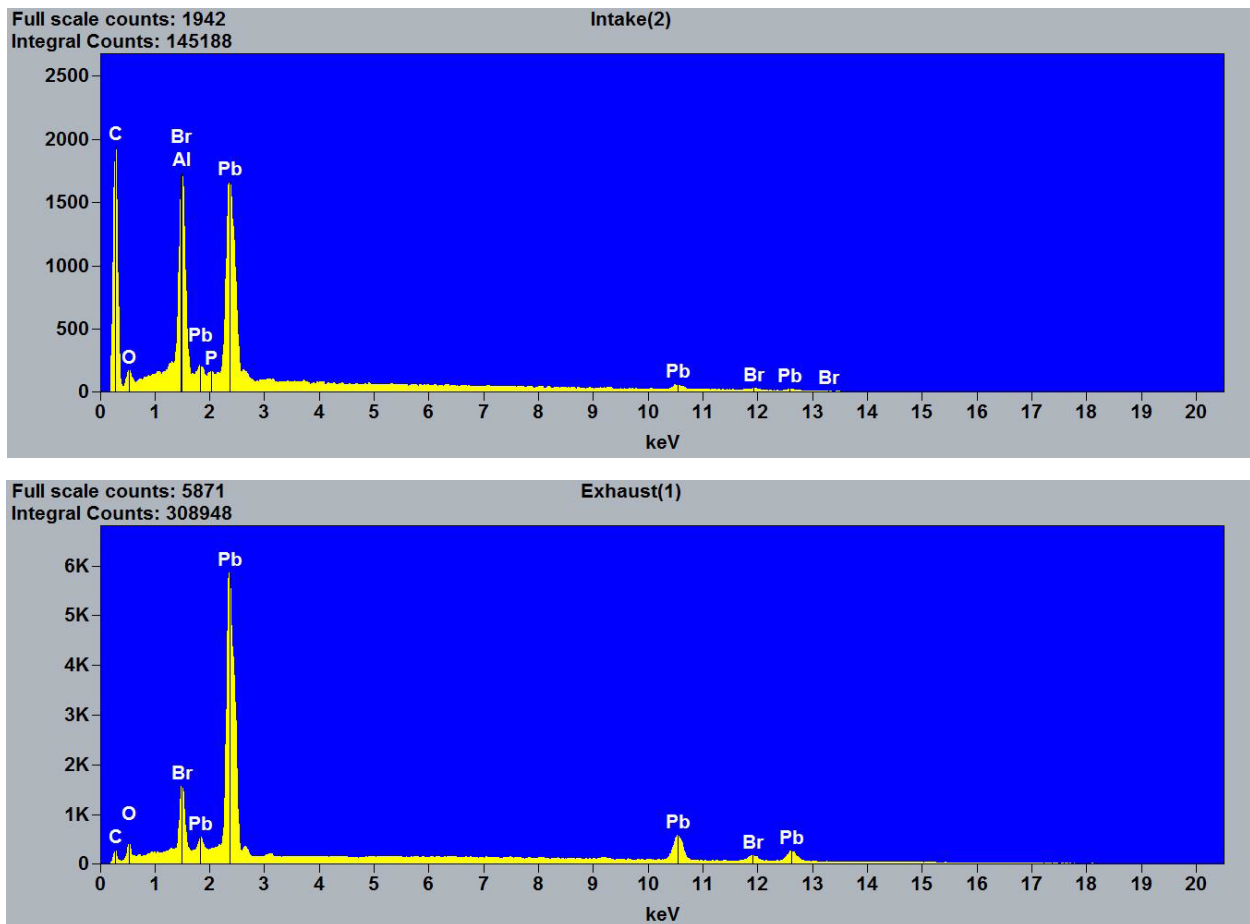
Samples of deposits on the intake and exhaust valves were collected for analysis using energy dispersive x-ray spectroscopy (EDS). A scalpel was used to collect a piece of the gray and black deposit from the intake valve head surface next to the neck, and the sample was transferred to a carbon tape-coated aluminum stub. A sample of the reddish-brown deposits on the neck area of the exhaust valve was also collected and transferred to a similarly prepared aluminum stub. The resulting typical EDS spectra for the two samples exposed to a 20 kV electron beam are shown in figure 7. The sample from the intake valve showed high peaks of lead and carbon with an overlapping high peak of bromine and aluminum. The sample from the exhaust valve showed a high peak of lead with relatively smaller peaks of bromine and carbon.

**Figure 7.** EDS spectra of deposits collected from the stem side of the intake valve head (upper spectrum) and from the neck area on the exhaust valve (lower spectrum).
