# National Transportation Safety Board

CEN24LA121

## EXAMINATION SUMMARY

Location: Watertown, SD  
Date: February 25, 2024  
Time: 1700 LCL  
2200 UTC  
Airplane: N38696, Piper PA-28-181, S/N 28-7790577

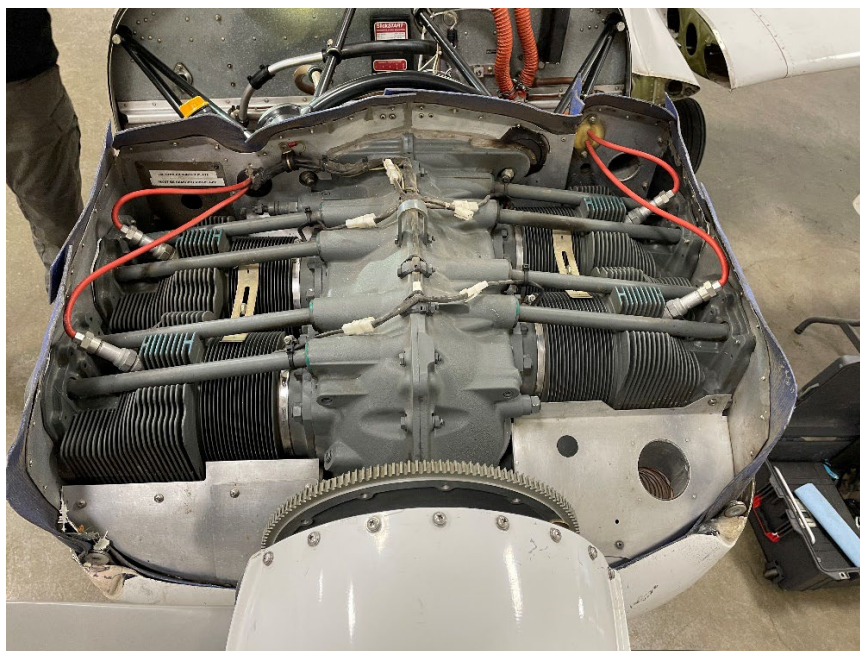
Visual examination of the engine prior to teardown showed no issues or abnormalities. All engine controls cables, fluid lines, and instrumentation cables were found secured with no abnormalities present. The engine was clean with no oil observed on the exterior of the engine. The cowling was secured with no damage or abnormal fluid deposits observed.

Figure 1. Engine prior to examination teardown

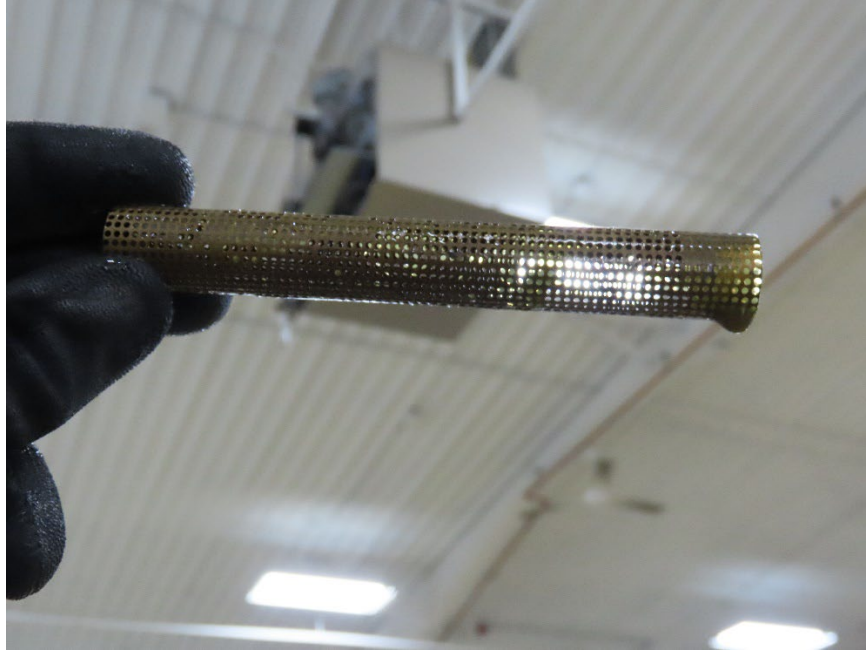
Oil dipstick was removed, and oil level observed at 8 quarts with relatively clean oil. Oil filter showed the oil was changed two days prior to the accident with an engine tach time of 5229.4. The filter was removed and examined with no metal observed in the media. Additionally, the oil screen was removed from the sump and examined by holding the screen next to an overhead light. No debris was observed and the oil was clean in appearance.

Figure 2. Oil Screen

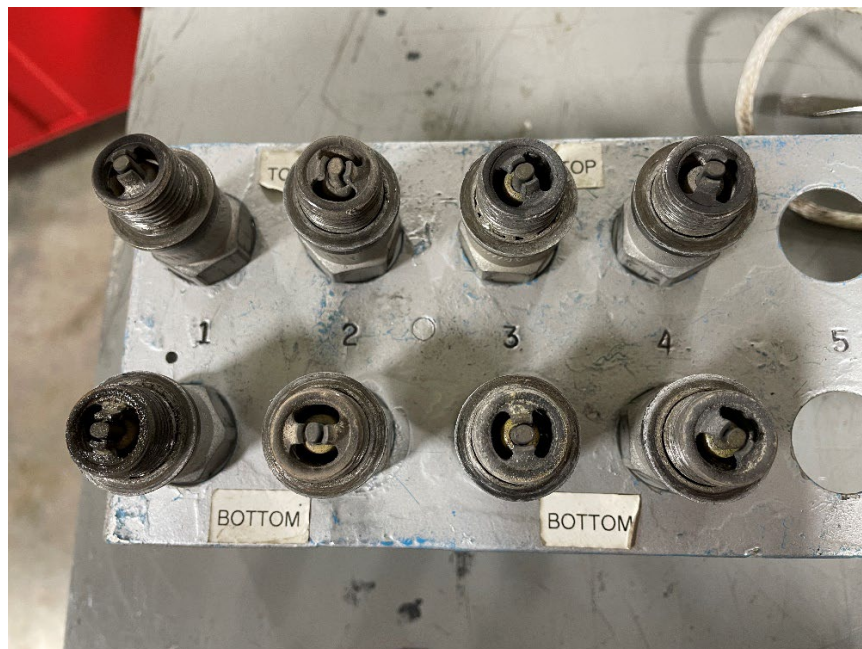
Spark Plugs were removed and observed to be all normally worn, except the lower spark plugs of Cylinder #3 and #4, as compared with the Champion Spark Plug Card. Lower spark plugs from Cylinder #3 and #4 had debris and lead fouling consistent with combustion deposits and produced a weaker spark on only one side when bench tested. The rest of the spark plugs produced a normal spark when bench tested.

Figure 3. Spark Plugs

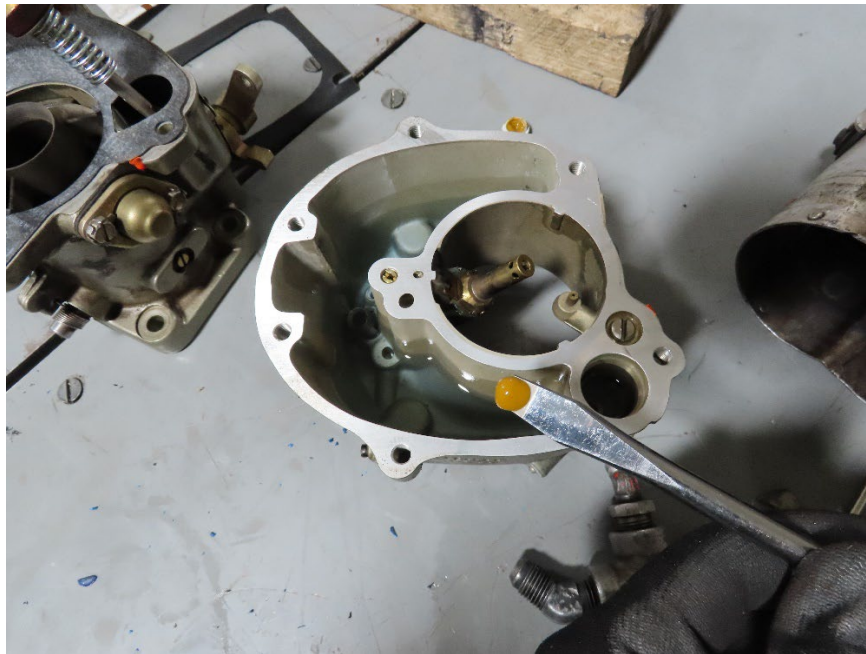
The carburetor was removed and examined with no observed abnormalities. The carburetor bowl still contained blue fluid consistent with 100LL Avgas. The fluid tested negative for the presence of water with the use of a color changing paste.

Figure 4. Carburetor Bowl with Negative Water Test

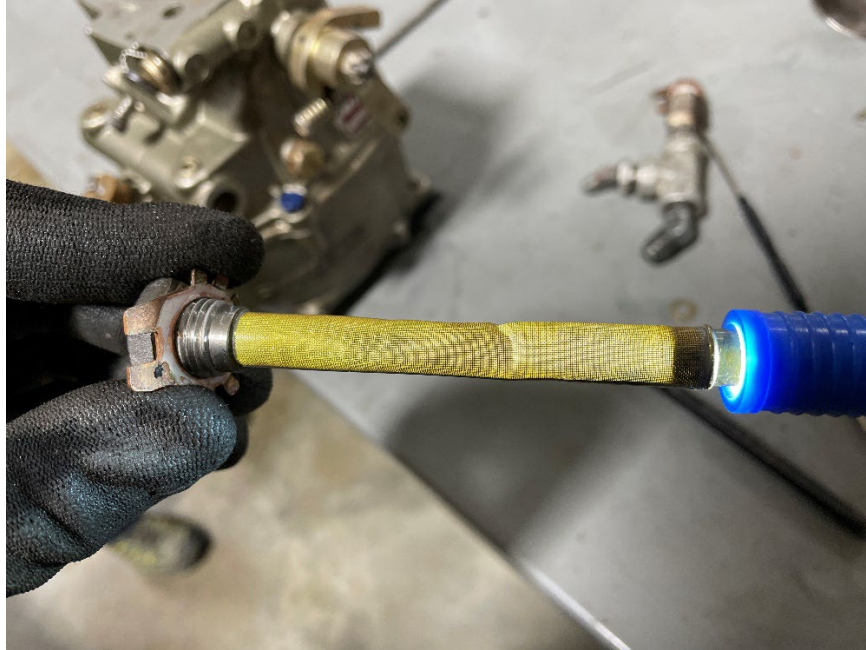
The carburetor floats also showed no signatures of hydraulic deformation or fluid within the floats. The carburetor fuel screen was removed and a flashlight was shined through the screen. No debris or foreign material was observed and the screen was intact.

Figure 5. Carburetor Fuel Screen

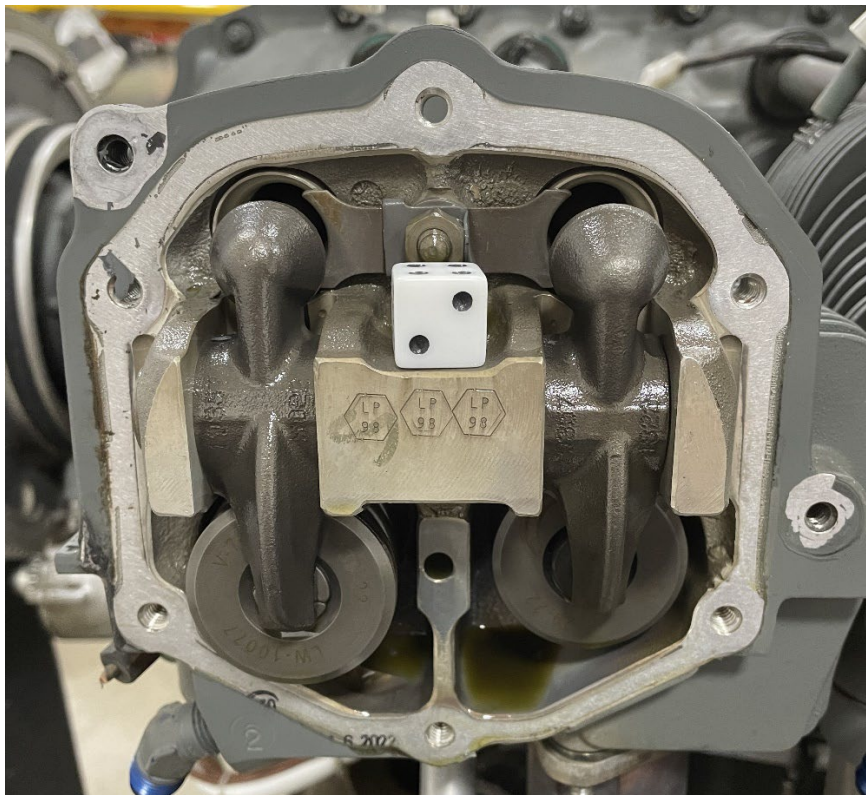
The engine crankshaft was rotated by hand with the propeller and engine continuity to the accessory section was observed. Normal valve movement was observed on Cylinders #1, #3, and #4. The #2 Cylinder Exhaust Valve was found to have zero movement and was stuck in a partially open position.

Figure 6. #2 Cylinder with stuck Exhaust Valve (Right)

A thumb compression test was performed on all cylinders with the #2 Cylinder having no observable compression. The #2 Exhaust Valve Push Rod and Rocker were observed to have normal range of movement when the engine was rotated by hand. The exhaust push rod was rolled on a granite table and found to be straight.

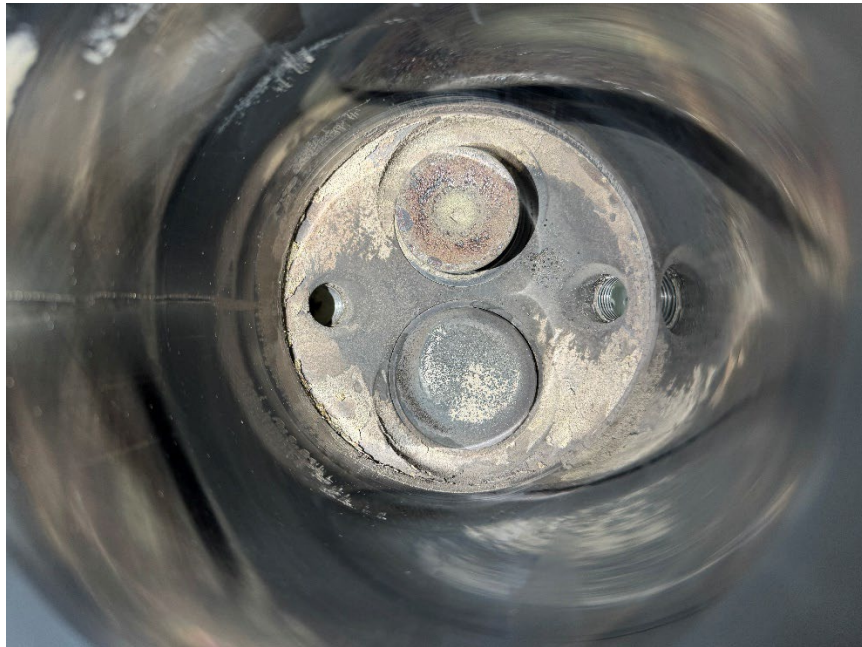
The #2 Cylinder was removed from the engine case and examined. The exhaust valve was found stuck in a partially open position. The exhaust valve face was unremarkable with a slight metallic sheen on the outer diameter of the face.

Figure 7. #2 Cylinder Inside View with Open Exhaust Valve (Upper)

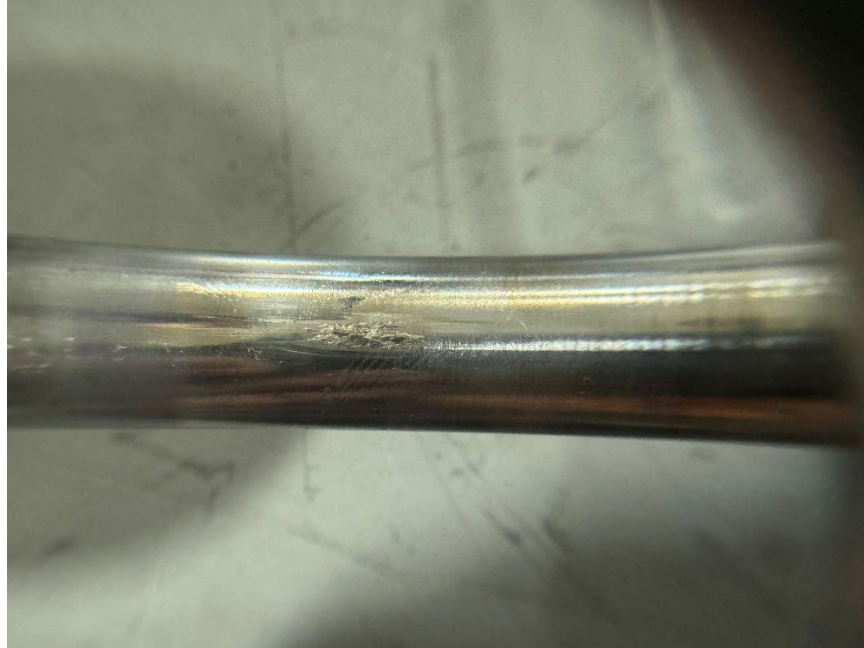
The exhaust valve was removed with the use of penetrating oil and a mallet. The valve was found to have a metallic like debris smeared at mid span. The stem was examined using a 10x power jeweler's loupe.

Figure 8. Metallic Like Debris on Exhaust Valve Stem

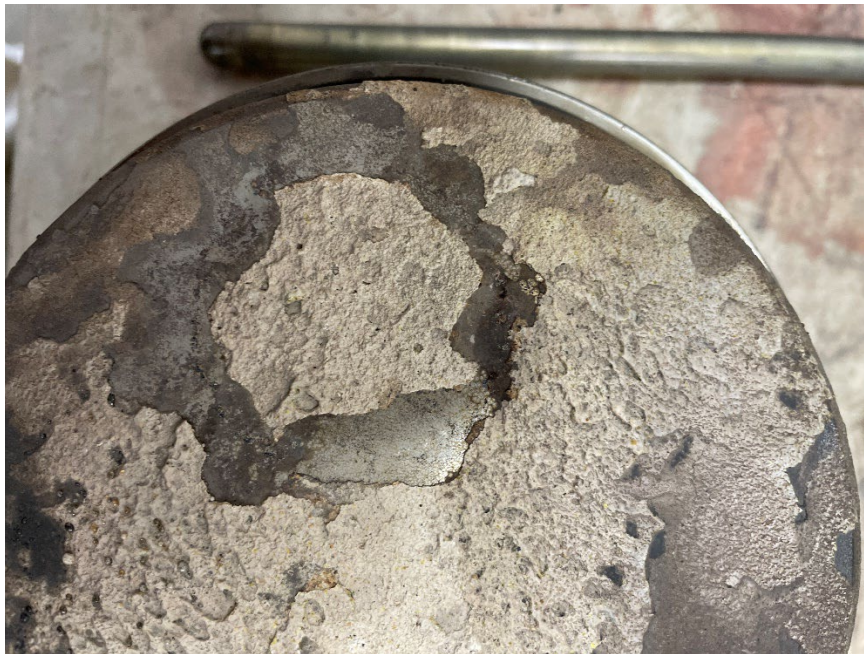
The cylinder valve guide was examined with a borescope and found to have foreign debris along about  $\frac{3}{4}$  of the guide length. The piston head was found to have a circular area of removed combustion deposits in the location of the exhaust valve. Additionally, a slight imprint of the exhaust valve was observed in locations along the circular area.

Figure 9. Circular Impression within Deposits on the Piston Head

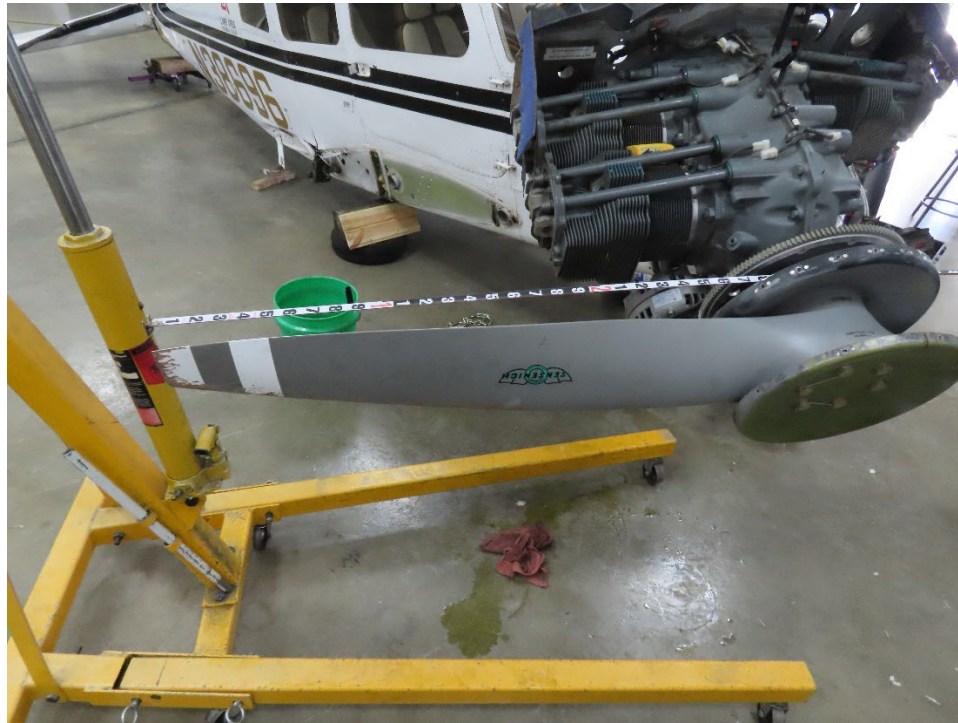
The propeller was found to be intact with no rotational bending or s bending. The blades were identified a Blade A and Blade B for documentation purposes. Only a slight aft bend was observed in blade A at 16 inches from the tip.

Figure 10. Propeller Blade A with Aft Bend.
