CEN24LA122

## INVESTIGATION PHOTOGRAPHS

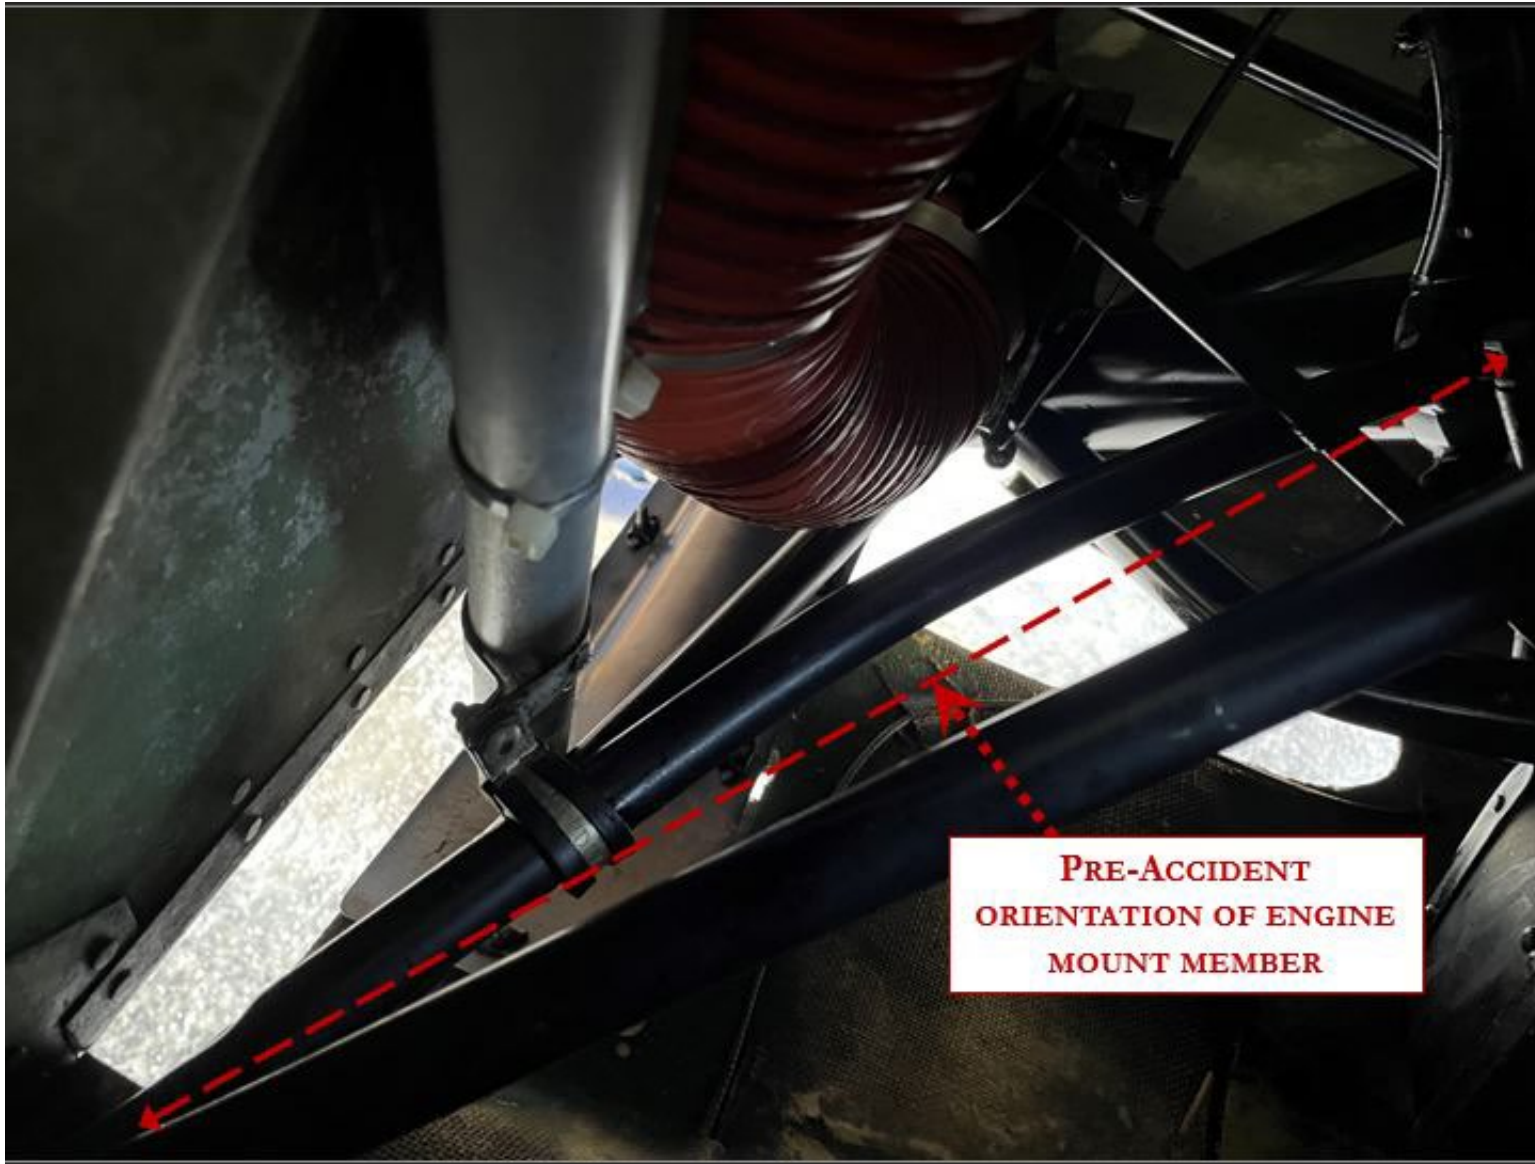
**Figure 1 - Damaged Engine Mount (Courtesy of FAA)**
