# National Transportation Safety Board

CEN24LA128

Group Chair's Factual Report

Location: West Lafayette, Indiana  
Date: March 6, 2024  
Time: 2140 eastern standard time  
Helicopter: Airbus Helicopters Deutschland MBB-BK117 C-2, registration N191LL

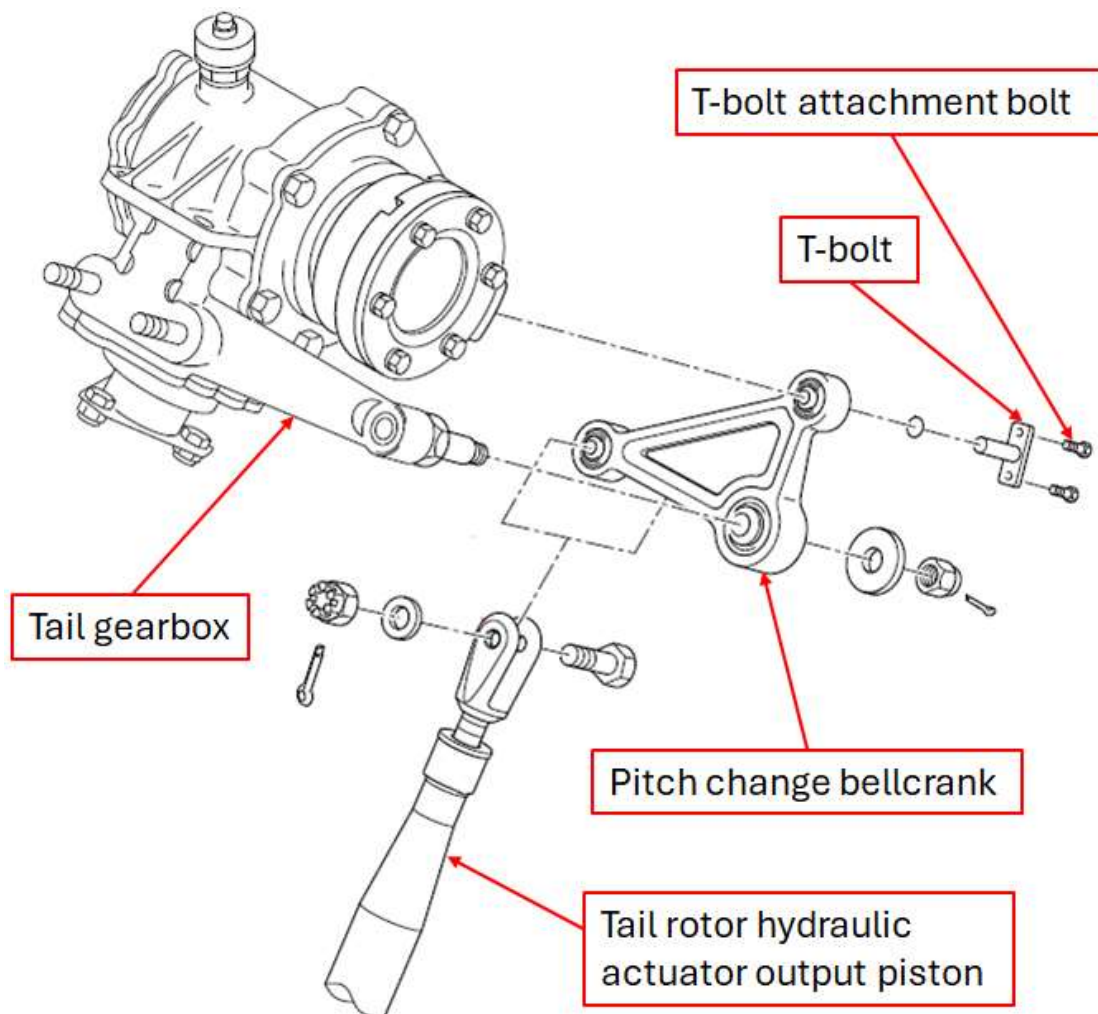
The pitch change bellcrank, which is mounted to the tail gearbox housing, is connected to the outer ring of the stationary section of the sliding sleeve assembly via a T-bolt, which functions as an unthreaded dowel (**Figure 1**). Two smaller, threaded attachment bolts secure the T-bolt to stationary sliding sleeve. The rotating section of the sliding sleeve, which moves axially along the tail gearbox output shaft, is connected to the tail rotor blade pitch change links. Movement of the sliding sleeve assembly results in pitch changes to the tail rotor blades.

**Figure 1.** A diagram of the installation of the T-bolt and associated attachment hardware onto the pitch change slider. (Courtesy of Airbus, modified by NTSB)

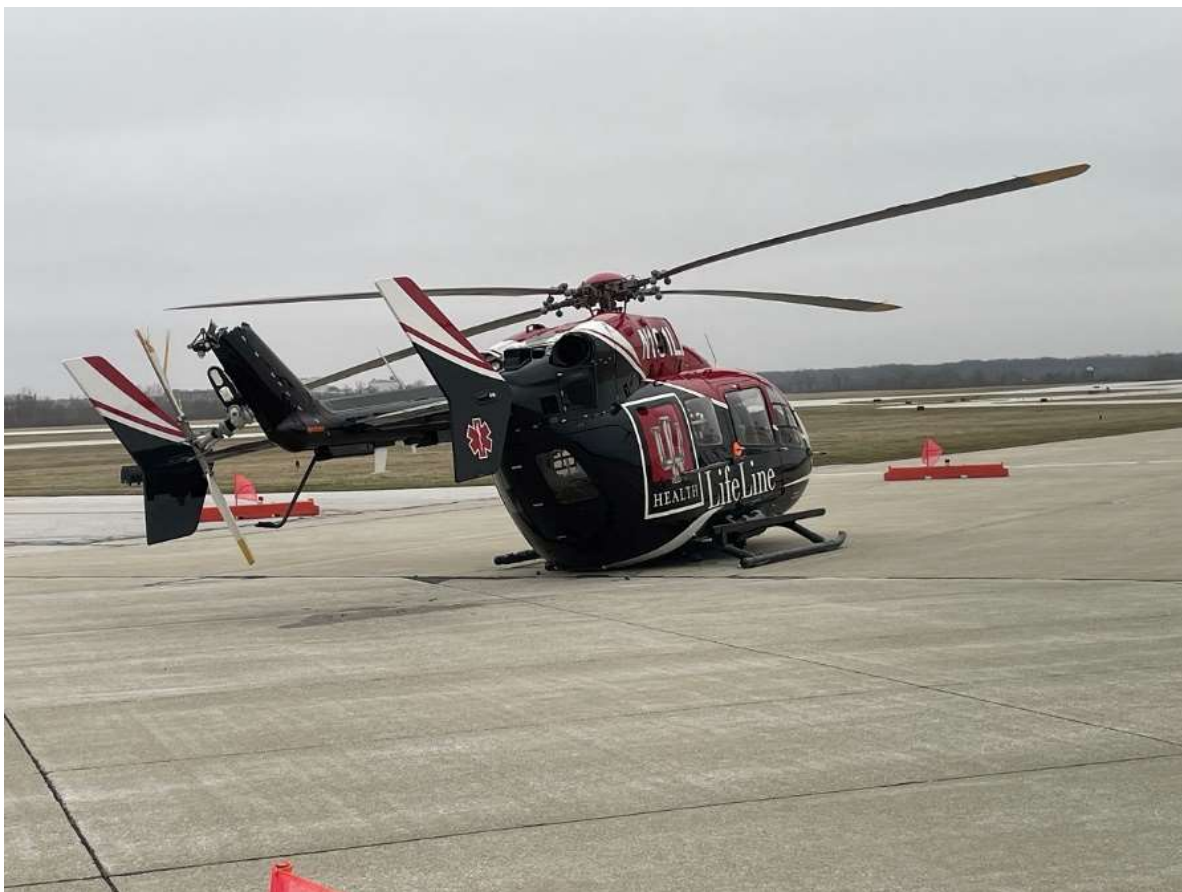
The accident helicopter came to rest upright with the left side slightly low due to the collapsed landing gear (**Figure 2**). The main and tail rotor systems did not show evidence of ground contact. The tail gearbox remained attached to the upper end of the vertical fin, but the upper end of the vertical fin had fractured and structurally separated from the remainder of the vertical fin but remained attached via wiring (**Figure 3**). The tail rotor drive shaft within the vertical fin, between the intermediate gearbox and tail gearbox, remained installed but its output flexible coupling had fractured and separated from the tail gearbox input flange adapter. The tail rotor remained installed on the tail gearbox, but one of the two tail rotor blades exhibited significant impact damage and splintering (**Figure 4**). The accident helicopter was recovered and transported to Paradigm Aerospace facilities in Mount Pleasant, PA.

**Figure 2.** The accident helicopter at LAF. (Courtesy of Metro Aviation)

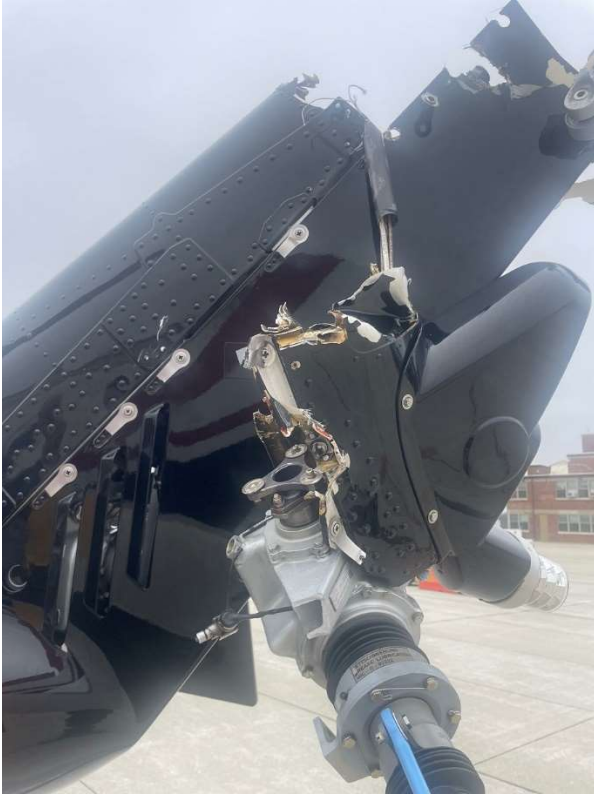
**Figure 3.** The tail gearbox attached to the separated upper portion of the vertical fin. (Courtesy of Metro Aviation)

The vertical fin remained installed on the tail boom except for its upper portion, which had fractured and separated. Wrinkling deformation was observed at the base of the vertical fin on both the left-forward and right-forward sides. The upper portion of the vertical fin, with the tail rotor gearbox and tail rotor head assembly still attached, remained partially attached to the helicopter only via wiring. The wiring was previously cut to facilitate recovery of the helicopter. At the forward end of the tail boom, at its attachment flange to the fuselage, the underside of the tail boom structure exhibited wrinkling deformation.

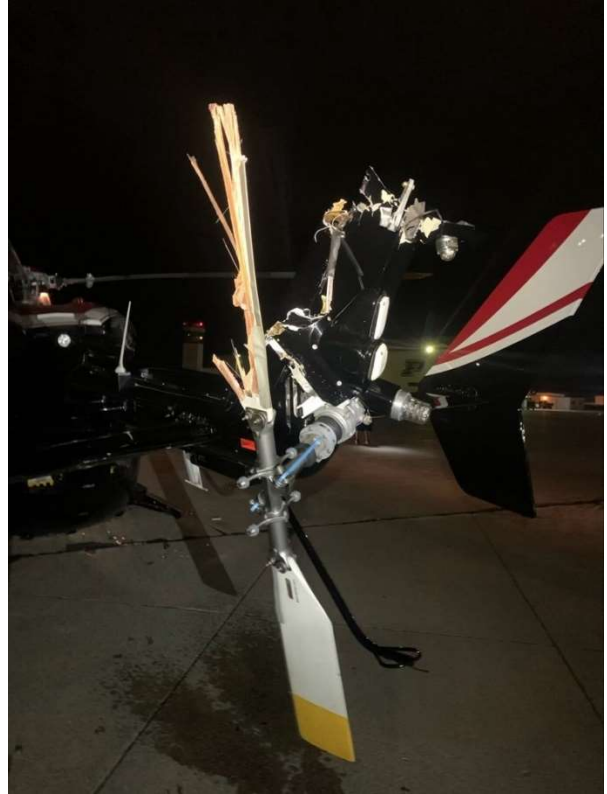
**Figure 4.** The tail rotor blades. (Courtesy of Metro Aviation)

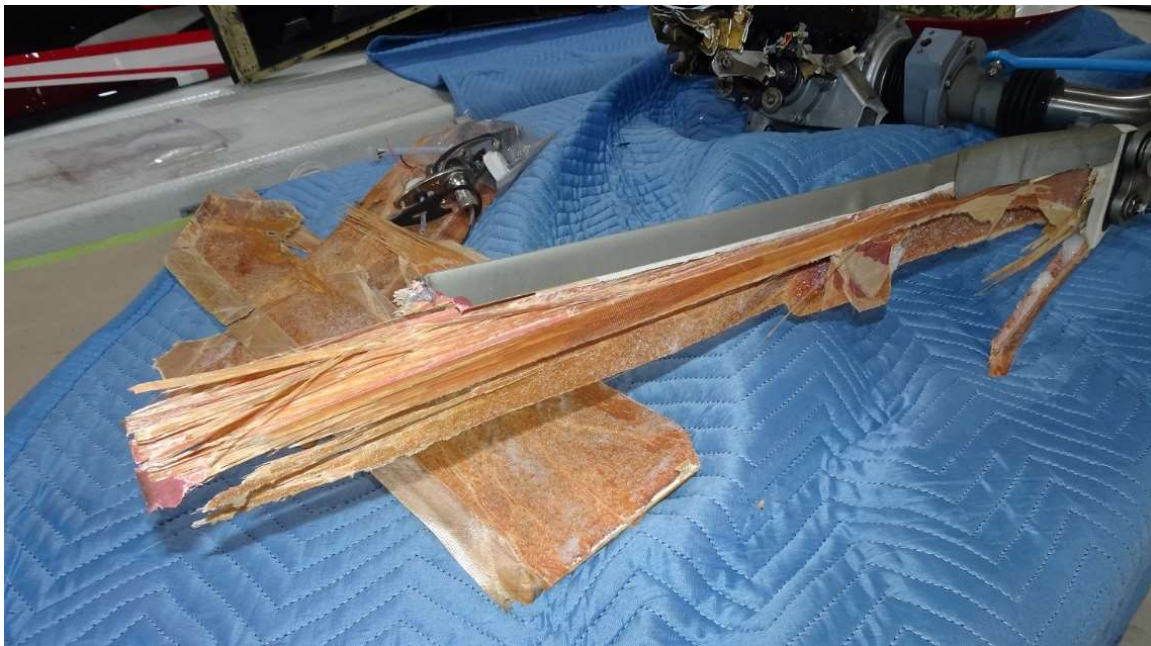
The tail rotor head assembly remained installed on the tail rotor shaft. The two tail rotor blades remained installed on their respective blade mounting forks (grips), which remained installed on the tail rotor head. One tail rotor blade, whose data plate had separated from impact damage<sup>3</sup>, exhibited an impact fracture about 25 inches outboard of the blade fitting bushings and the blade afterbody<sup>4</sup> had separated along the span of the blade (**Figure 5**). About a 4.5 inch segment of the leading edge abrasion strip, outboard of the impact fracture, had also separated.

**Figure 5.** The tail rotor blade exhibiting a fractured leading edge abrasion strip and missing its afterbody.

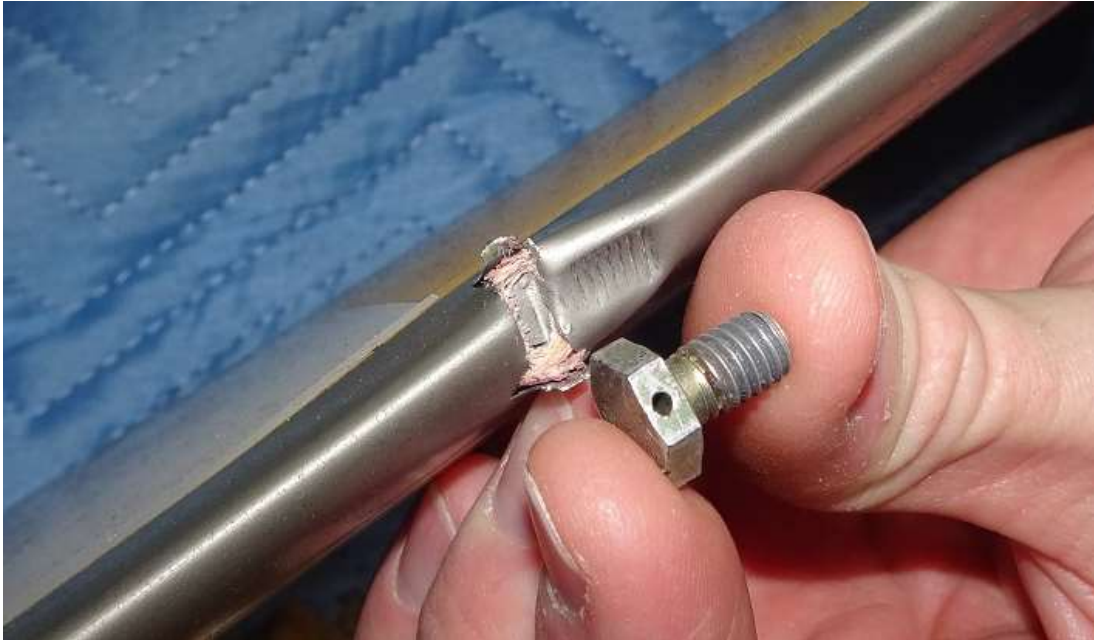
The second tail rotor blade, S/N 1511, was whole but had impact damage on its leading and trailing edges. On the second tail rotor blade, one leading edge impact, located about 10.5 inches outboard of the blade grip fastener, had imprints of threads. The thread imprint matched that of the attachment bolt for the tail rotor control T-bolt (**Figure 6**). A main rotor blade exhibited impact damage at its tip end leading edge that was similar in size to the leading edge of the tail rotor blade. The underside of this main rotor blade had an impact divot into the blade core.

**Figure 6.** A T-bolt attachment bolt (found on the ground at the accident site) and the impact damage to the leading edge of tail rotor blade S/N 1511.

One T-bolt attachment bolt was found on the ground at the accident site and did not exhibit anomalous deformation or damage, such as excessively worn threads (**Figure 6**). The second T-bolt attachment bolt was found within the area of the No.1 (left) engine bay. The second T-bolt attachment bolt did not exhibit excessively worn threads or fracture, but one side of its threads exhibited a flattened appearance (**Figure 9**). Neither of the T-bolt attachment bolts showed remnant safety wiring attached to them or within their safety wire holes. The No. 1 engine exhaust cowl exhibited a puncture, and the engine exhaust duct exhibited an impact mark, both consistent in size with contact by the attachment bolt. The T-bolt was found lodged into a honeycomb panel at the aft-lower area of the fuselage, adjacent to the fuel cell (**Figure 10**). A puncture into the fuselage skin, just below the aft clamshell doors, was found near the T-bolt. Except for the pitch change slider connection to the pitch change bellcrank, all fasteners remained installed with their appropriate safety wiring or cotter pins. The pedals in the cockpit were moved both full left and full right pedal forward, resulting in movement of the pitch change bellcrank at the vertical fin.

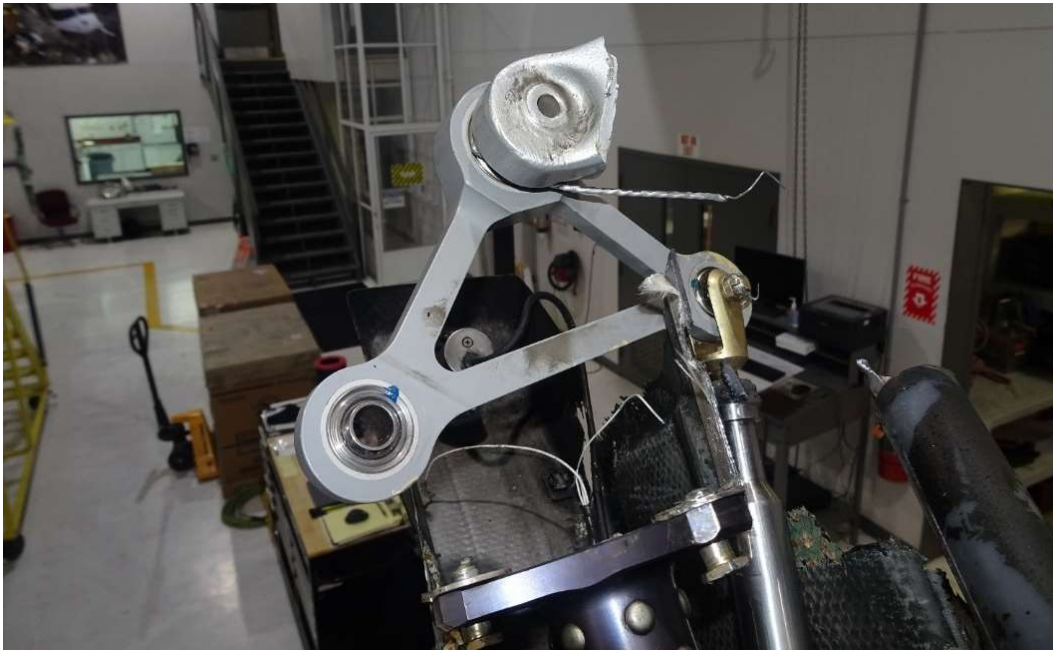
The pitch change bellcrank remained installed on the vertical fin and was connected to the tail rotor hydraulic actuator's output piston (**Figure 7**). The pitch change bellcrank was not connected to the sliding sleeve assembly. The spherical bearing for the pitch change bellcrank, to which the stationary sliding sleeve attaches, exhibited smooth movement and did not exhibit anomalous damage. The two attachment bolt holes, on the outer ring of the stationary section of the sliding sleeve assembly, did not exhibit elongation and the internal threads did not exhibit evidence of anomalous damage (**Figure 8**). The installation hole for the T-bolt, on the outer ring of the stationary section of the sliding sleeve assembly, appeared intact and did

**Figure 7.** The pitch change bellcrank on the upper side of the vertical fin.

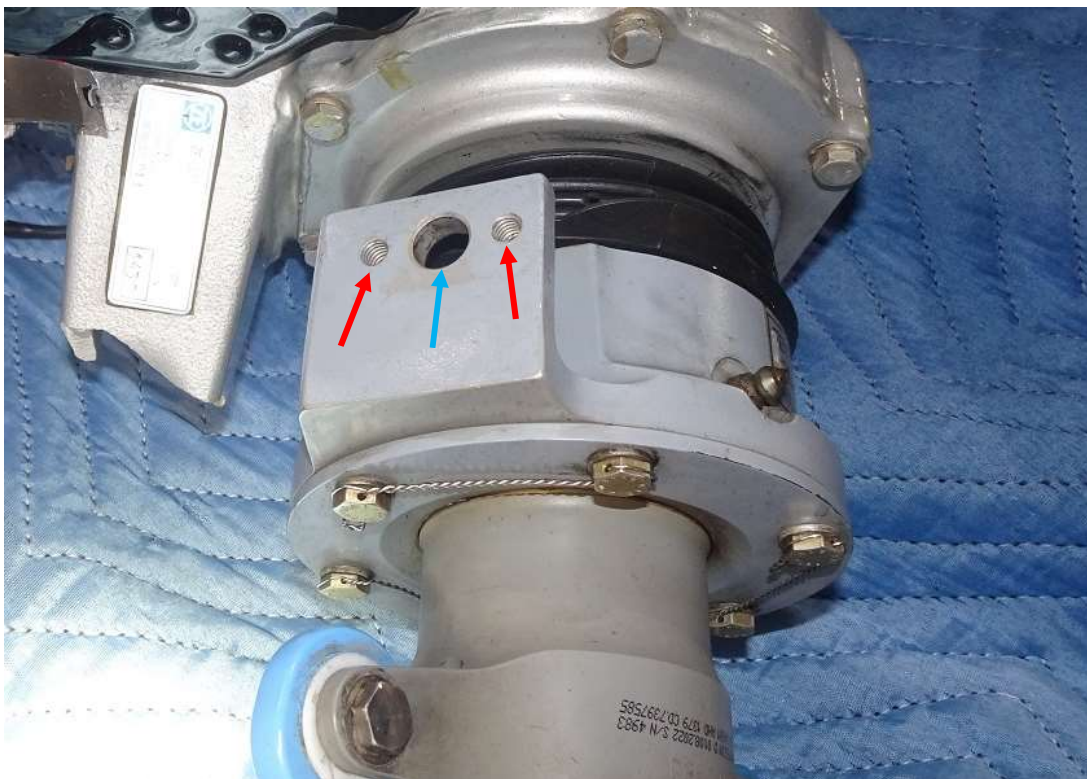
not exhibit anomalous damage such as elongation or ovalized appearance. Remnant grease was observed within the bottom T-bolt hole.

**Figure 8.** The pitch change slider with the holes for the T-bolt (blue arrow) and T-bolt attachment bolts (red arrows).

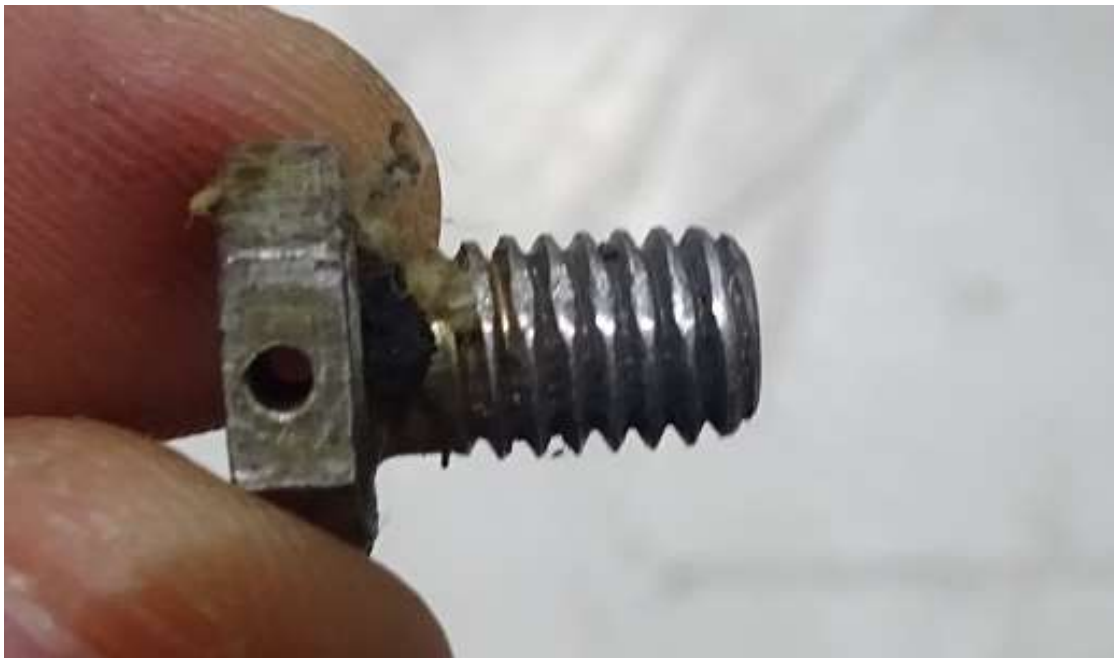
**Figure 9.** The second T-bolt attachment bolt, found near the No. 1 engine exhaust duct, exhibiting a flattened appearance on a portion of its threads.

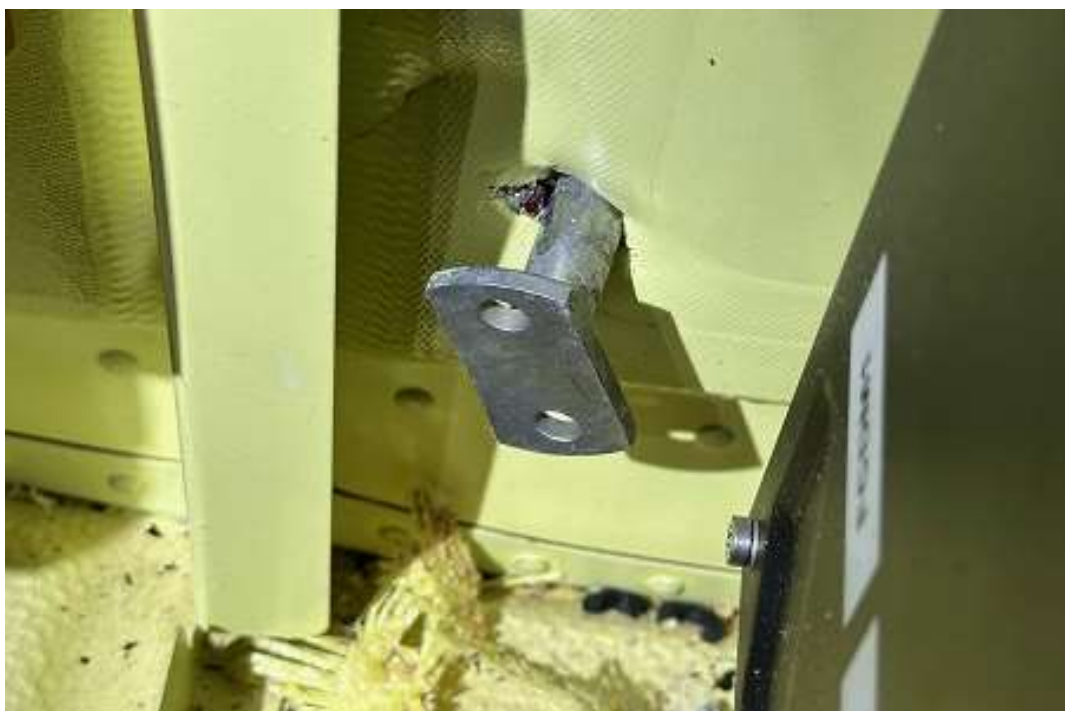
**Figure 10.** The T-bolt found lodged into a honeycomb panel. (Courtesy of Metro Aviation)
