CEN24LA128

## INVESTIGATION PHOTOGRAPHS

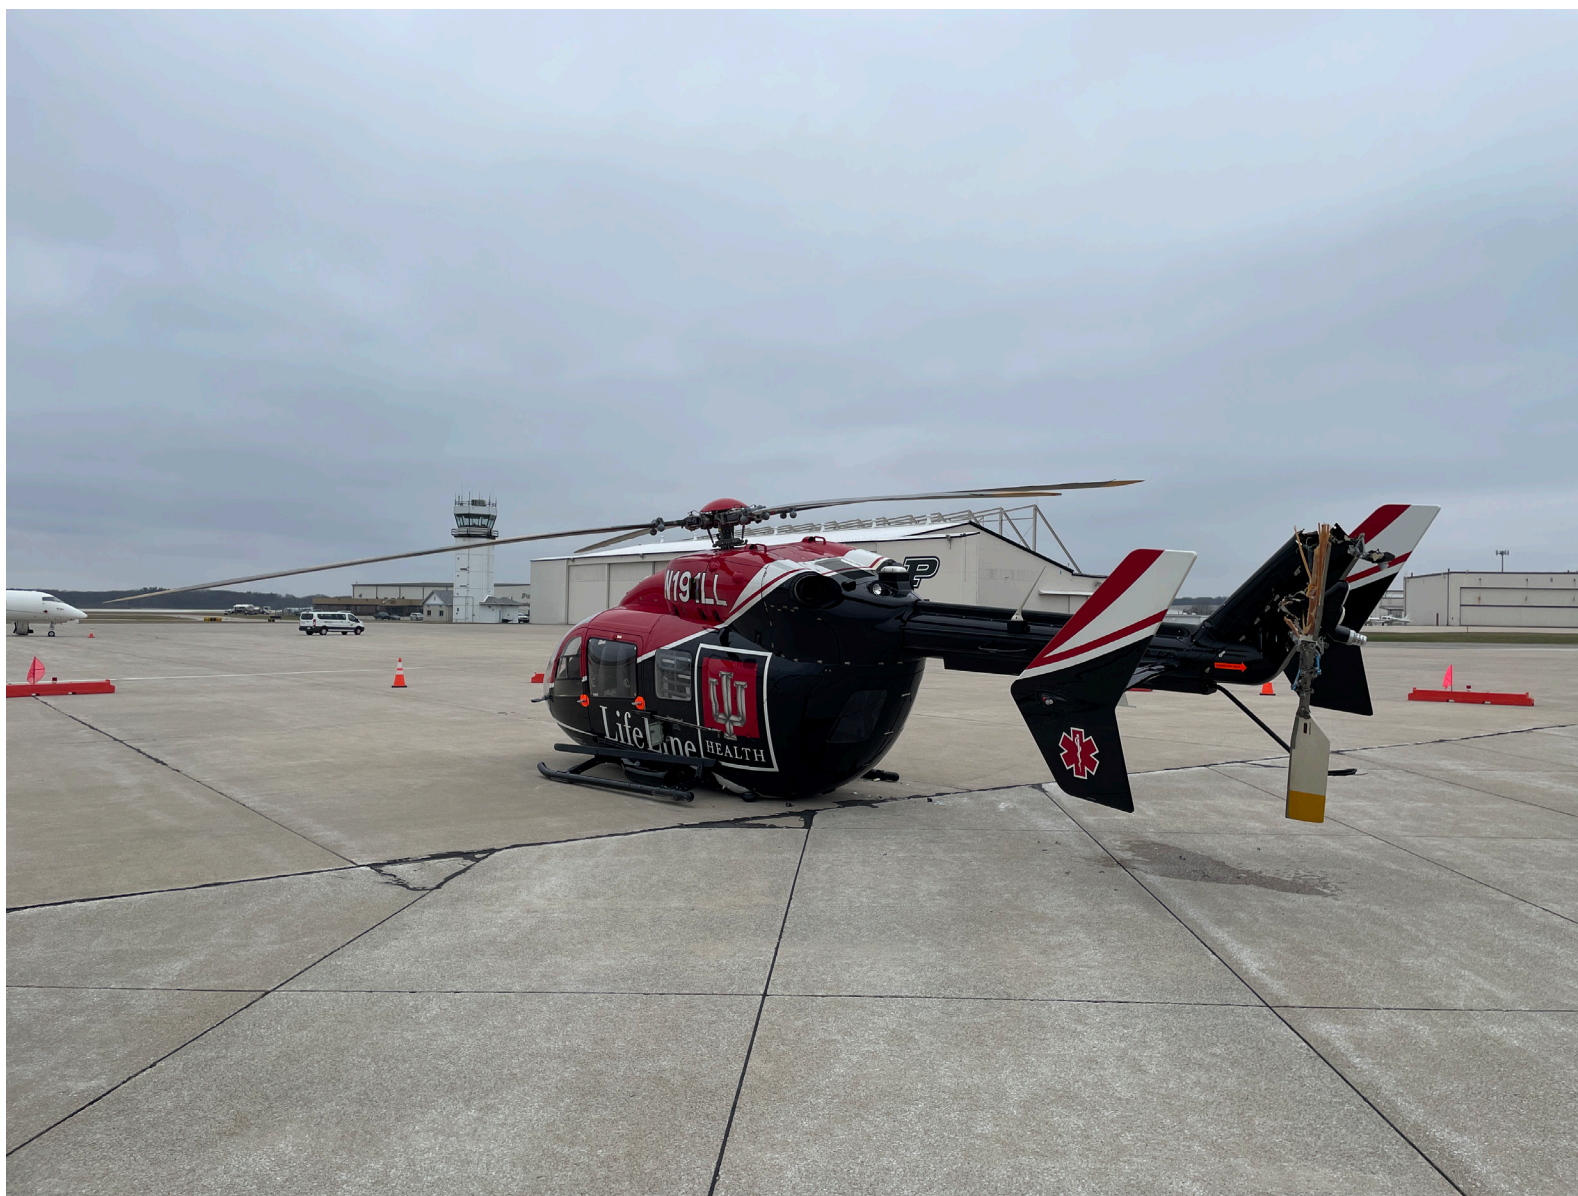
**Photograph 1 - Accident site (Courtesy of FAA)**

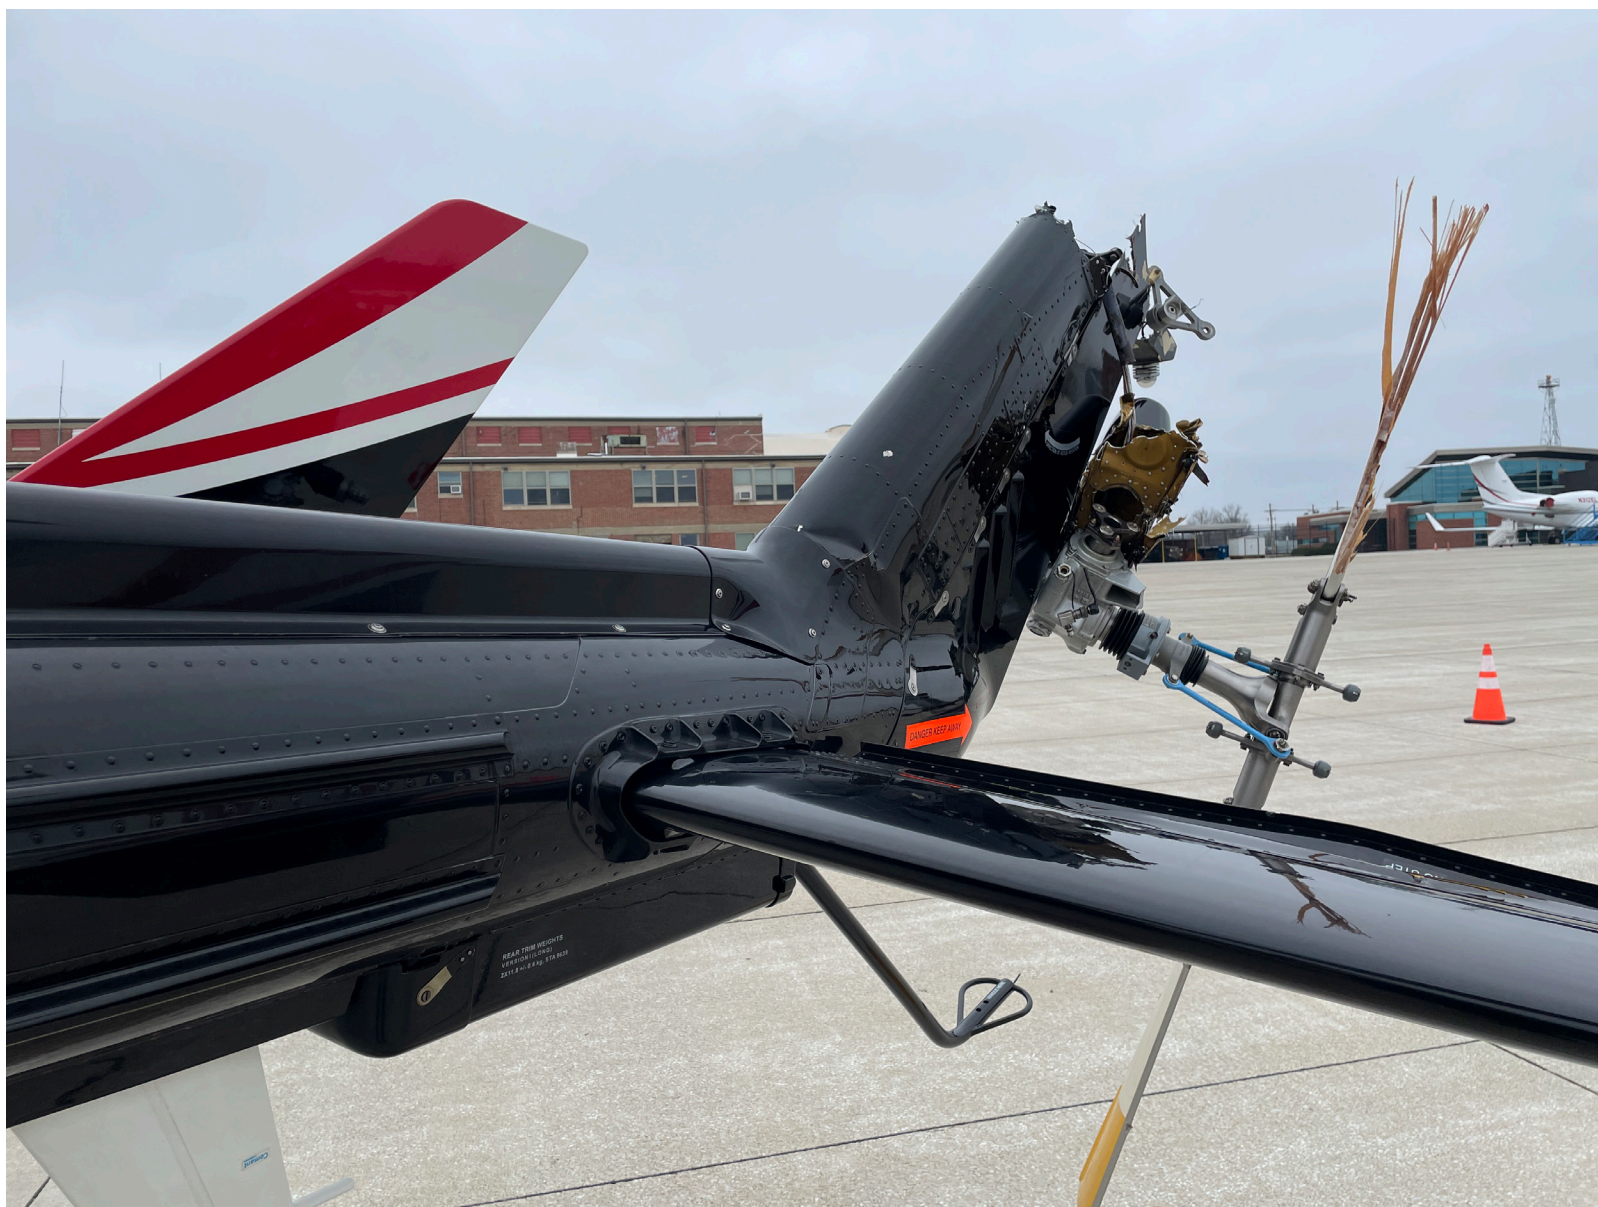
**Photograph 2 - Tail rotor assembly (Courtesy of FAA)**

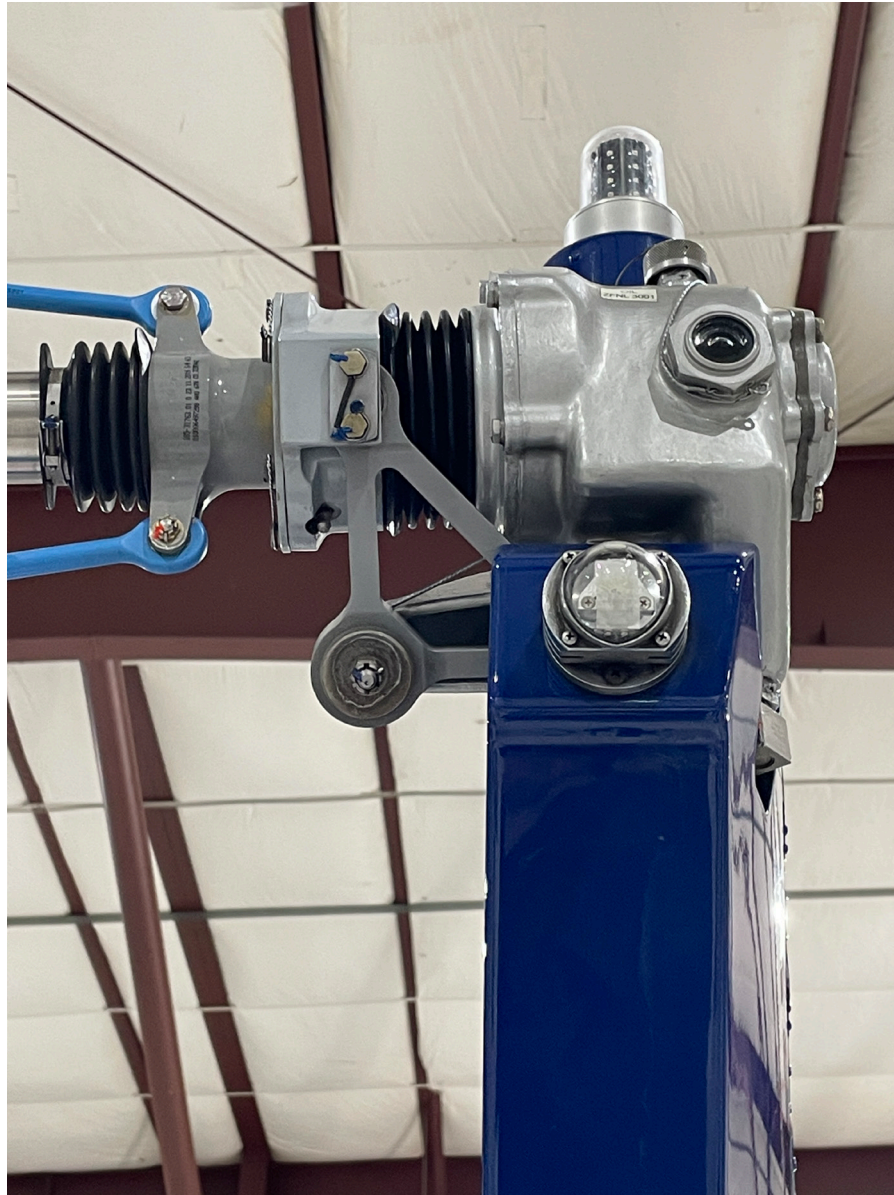
**Photograph 3 - T-bolt installation on exemplar helicopter (Courtesy of NTSB)**
