# National Transportation Safety Board

CEN24LA137

## FIELD NOTES

Location: Port Lavaca, Texas  
Date: March 16, 2024  
Time: 1645 CST  
Helicopter: N280WR 1977 Enstrom F280C

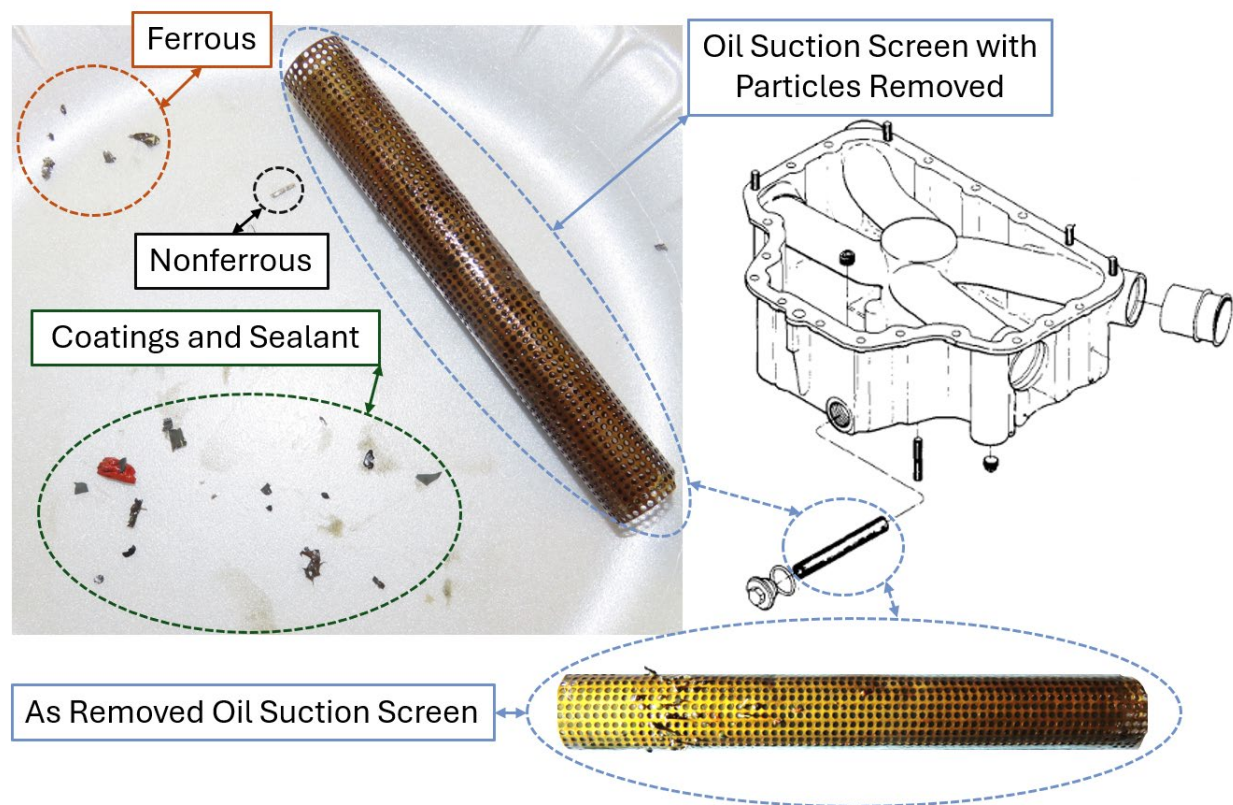
An STC oil filter was found installed to the engine and removed for examination. The screen showed some debris in the form of orange silicone, deposits, and a small amount of ferrous metallic debris. The suction screen was tightly installed to the engine, removed, and examined. Additional silicone and organic type material was found along with a few pieces of ferrous metal. The pilot owner could not recall the

last time the suction screen was removed or cleaned.
