CEN24LA138

## INVESTIGATION PHOTOGRAPHS

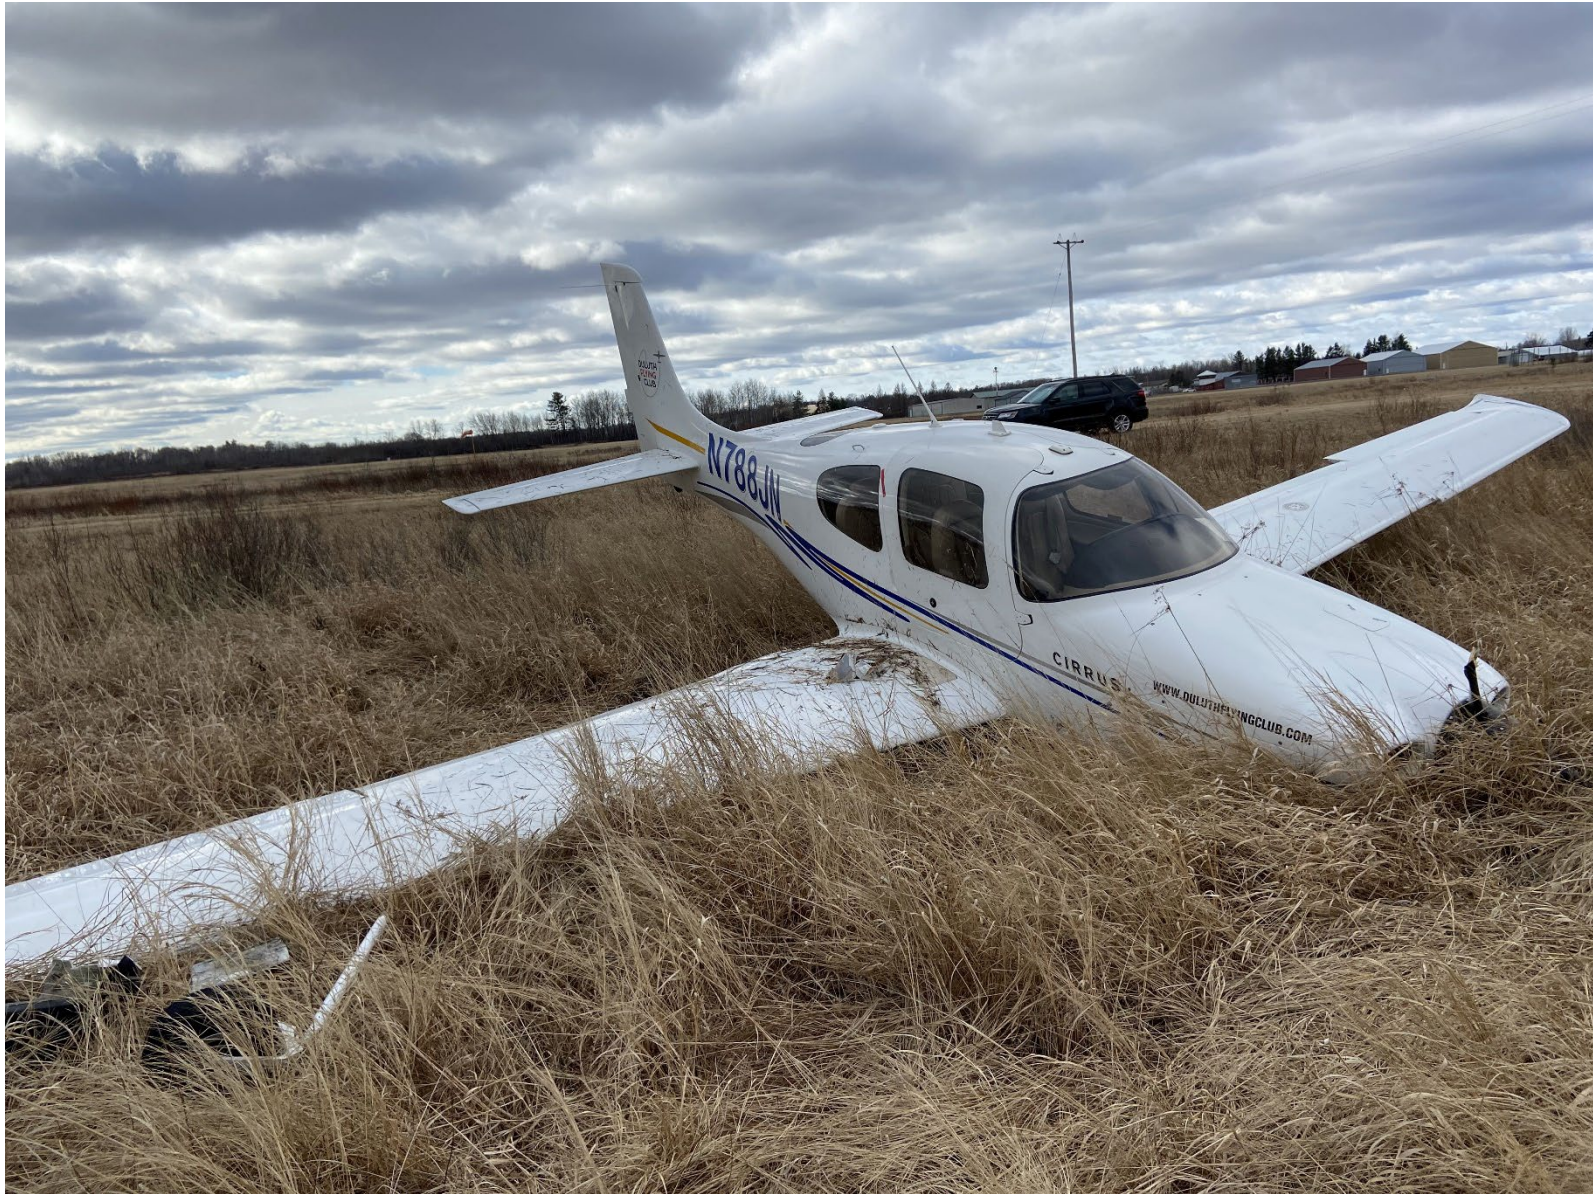
**Photograph 1 - Accident airplane (Source: Federal Aviation Administration)**

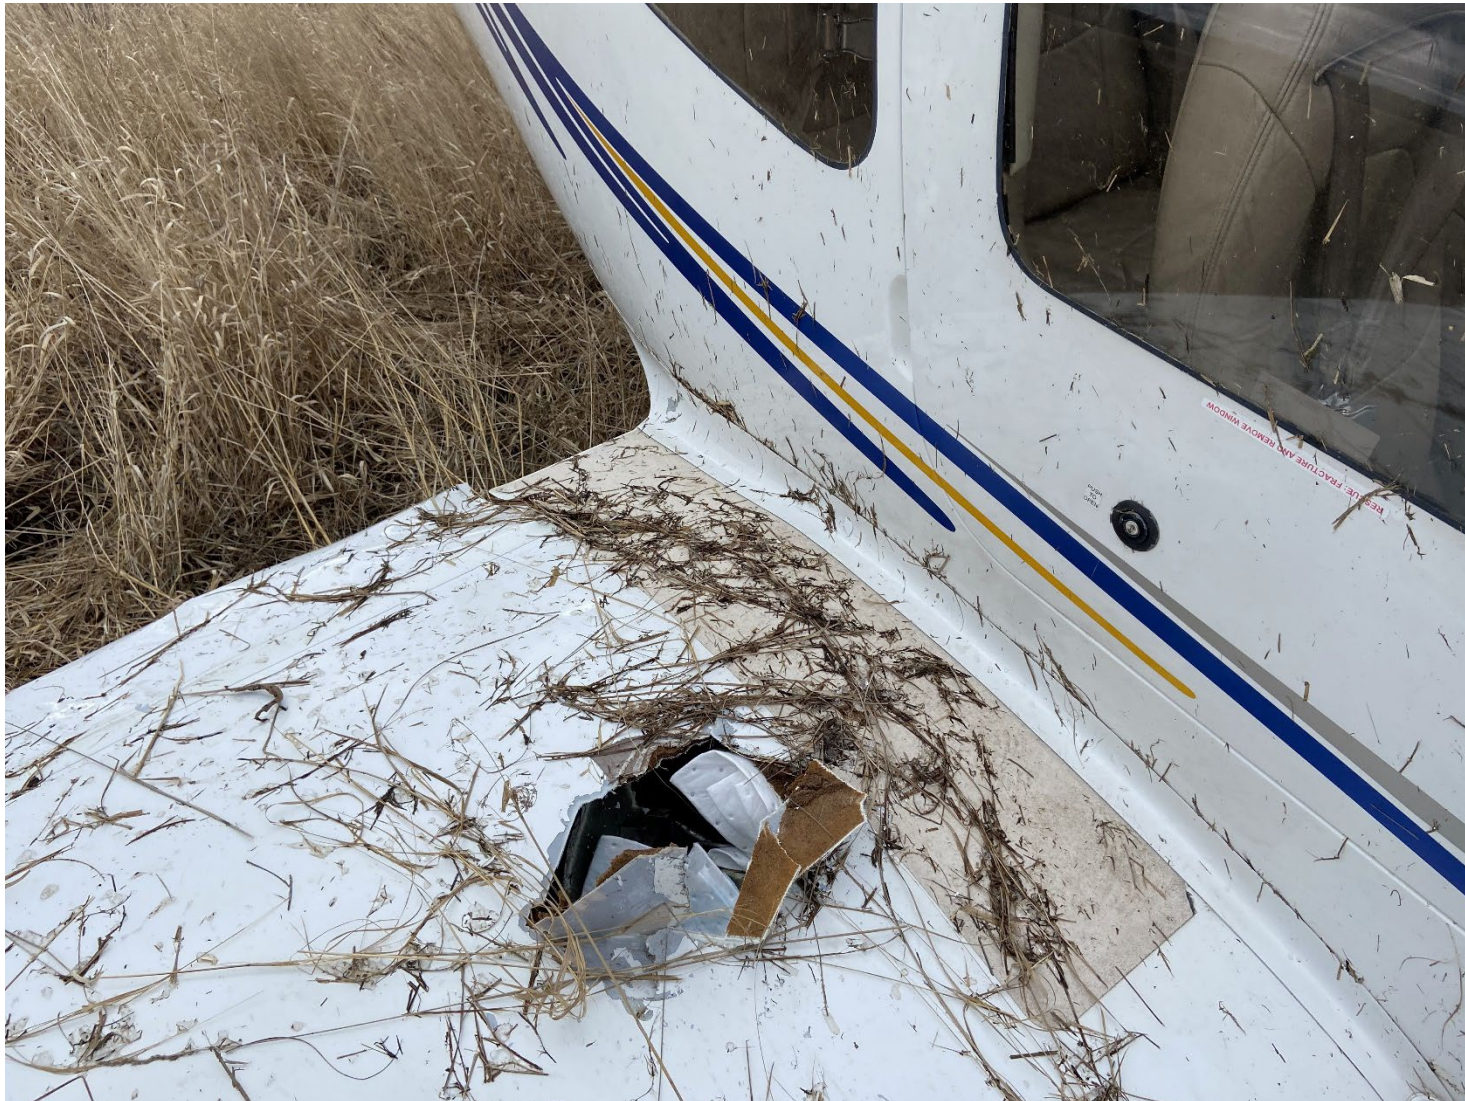
**Photograph 2 - Right wing damage (Source: Federal Aviation Administration)**
