# National Transportation Safety Board

CEN24LA140

## **ENGINE DATA MONITOR**

Location: San Saba, Texas  
Date: March 25, 2024  
Time: About 1142 CDT  
Airplane: Cessna T210M, N498TB

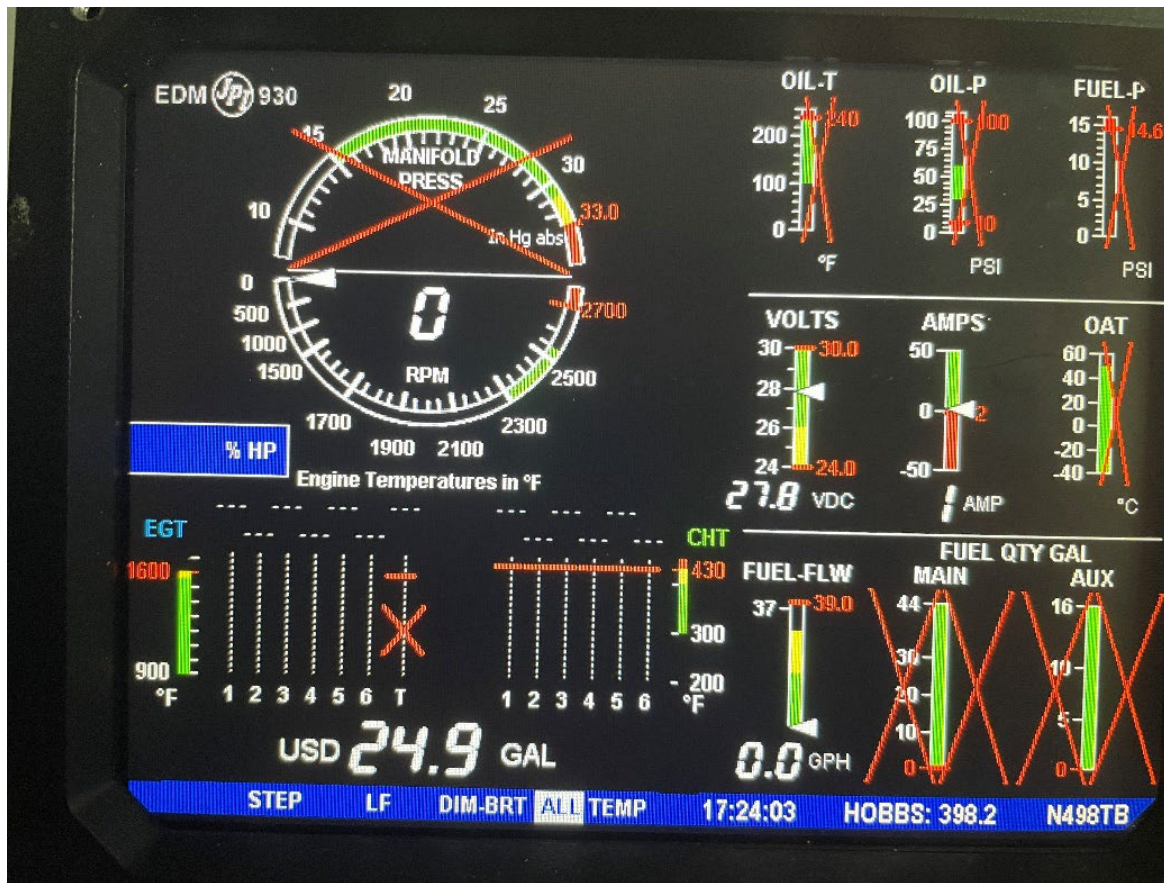
The EDM 930 was in good condition (Figure 1 and 2) and the data were downloaded using the manufacturer's procedure.

**Figure 1.** Recorder screen powered on during data extraction effort.

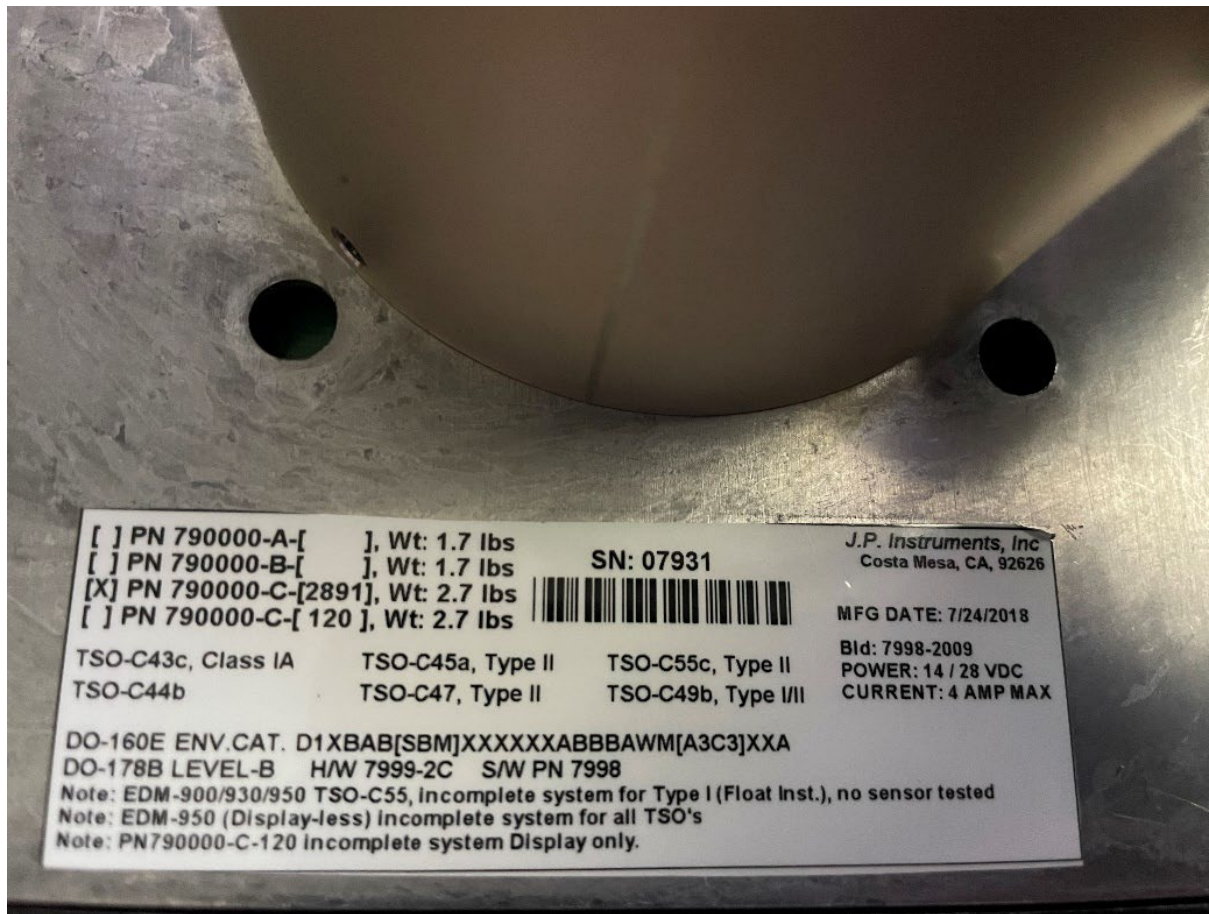
**Figure 2.** EDM 930 data tag on the rear of the unit face

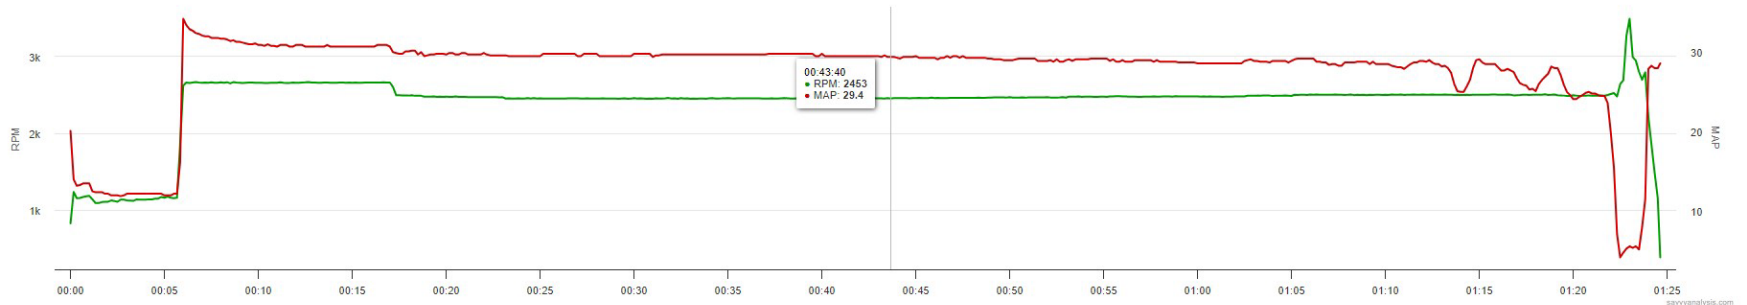
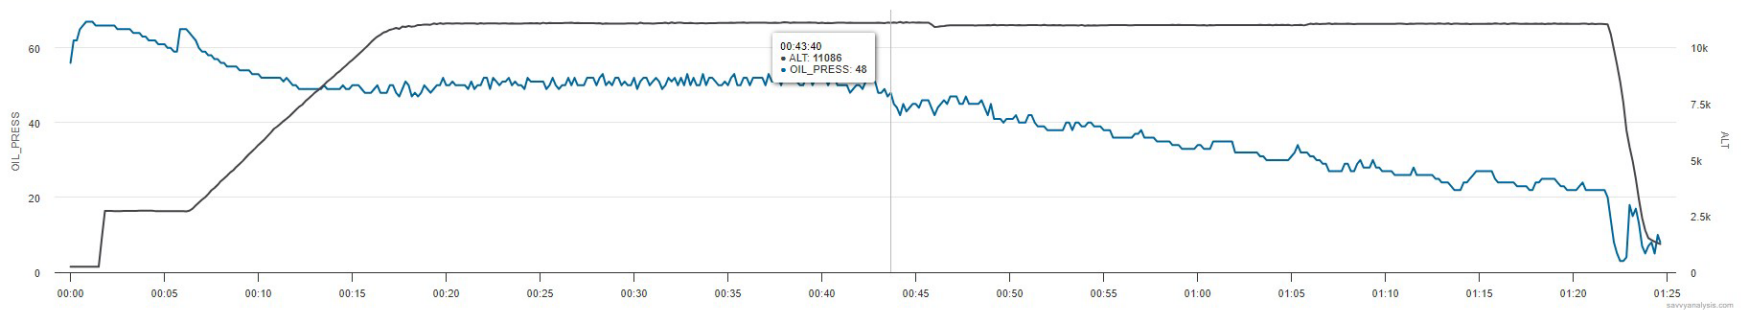
**Figure 4.** Plot of basic parameters for the entire accident flight.

Figure 4 shows that near the halfway point in the flight the oil pressure started to steadily decrease, and the altitude remained about 11,000 ft. Near the end of the flight the oil pressure decreased below 10 psi and the manifold pressure decreased below 10 inches of mercury, as the altitude rapidly decreased and the engine RPM rapidly increased to about 3,500 RPM from about 2,500 RPM. In the remainder of the flight the oil pressure fluctuated between 4 and 18 psi, the manifold pressure increased to about 18 inches, and the RPM steadily decreased.

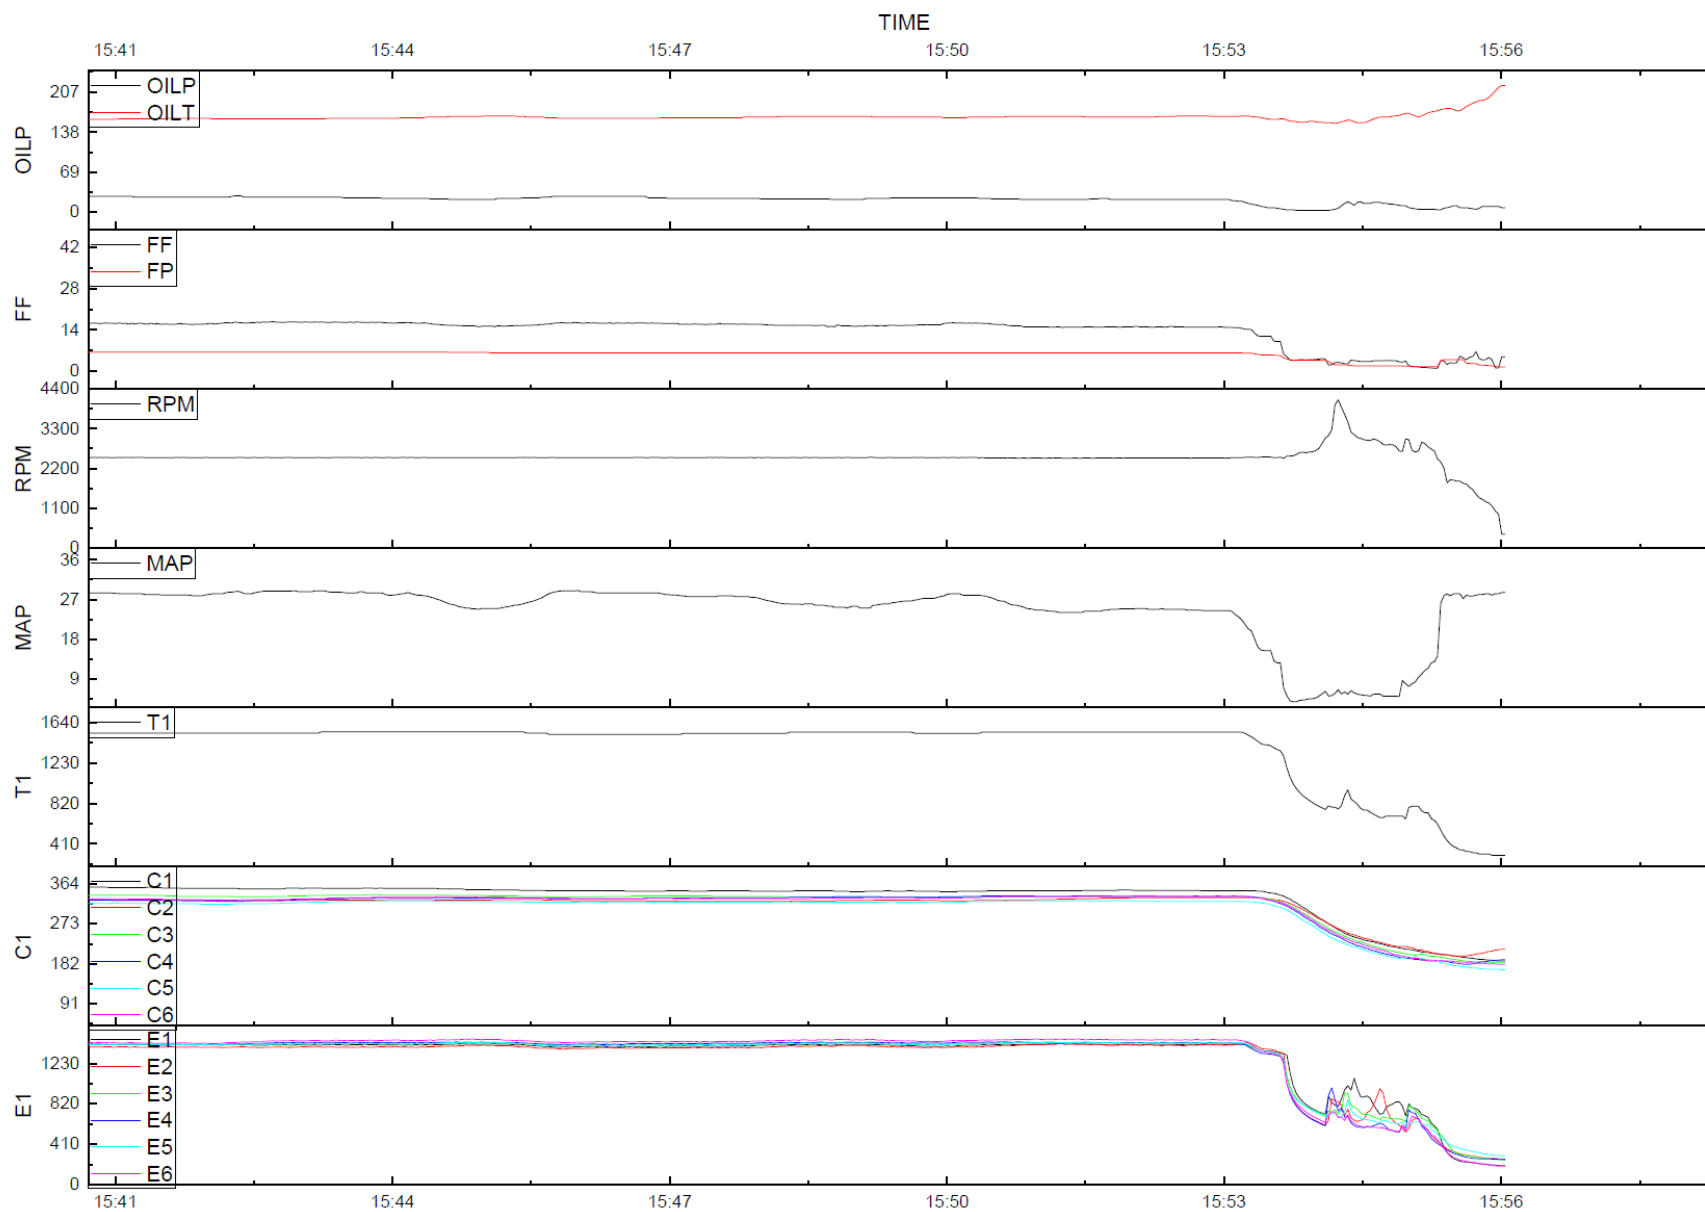
The final recorded data indicated: 8 psi oil pressure, 28.6 inches manifold pressure, 386 RPM, 4.9 gph fuel flow, 1.4 psi fuel pressure, and altitude 1,254 mean sea level (about 20 ft agl).

**Figure 6.** Plot of basic parameters for the end of the accident flight.

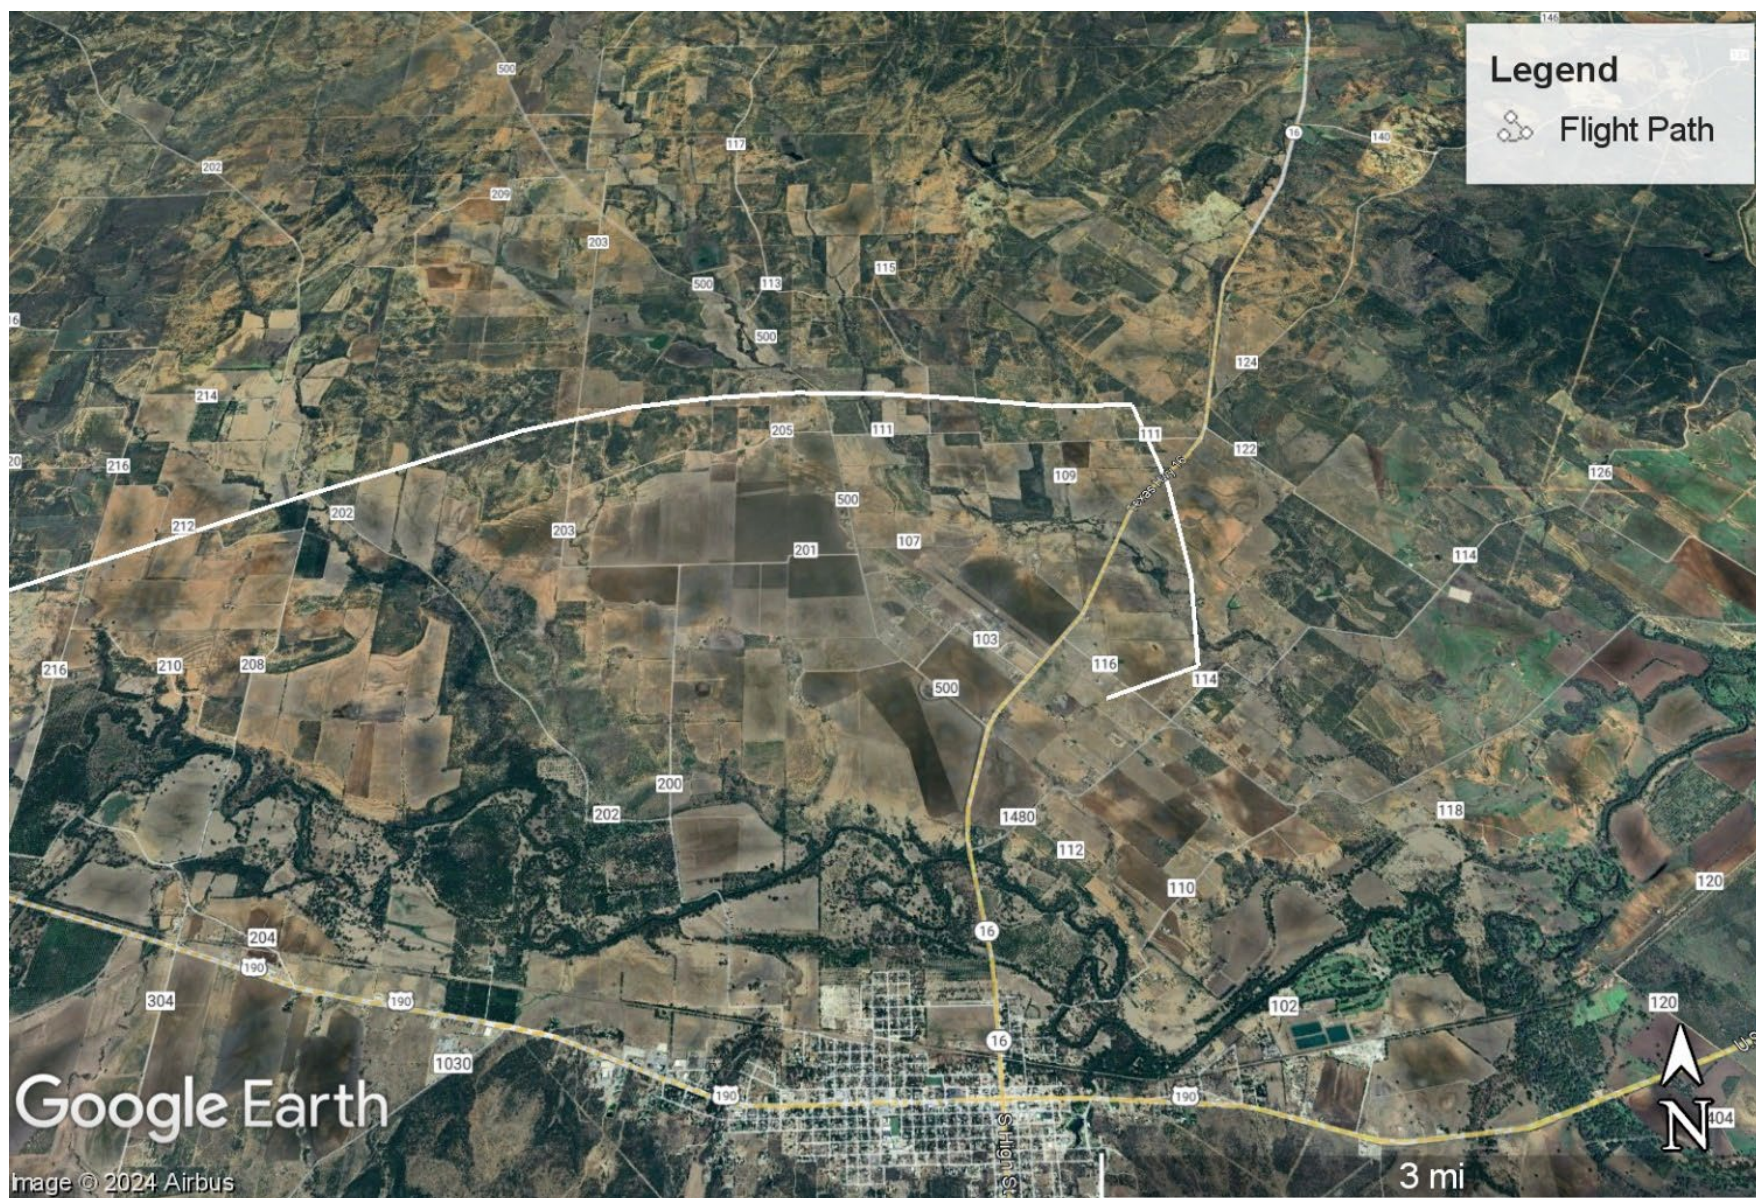
**Figure 7.** End of accident flight track overlaid on Google Earth.

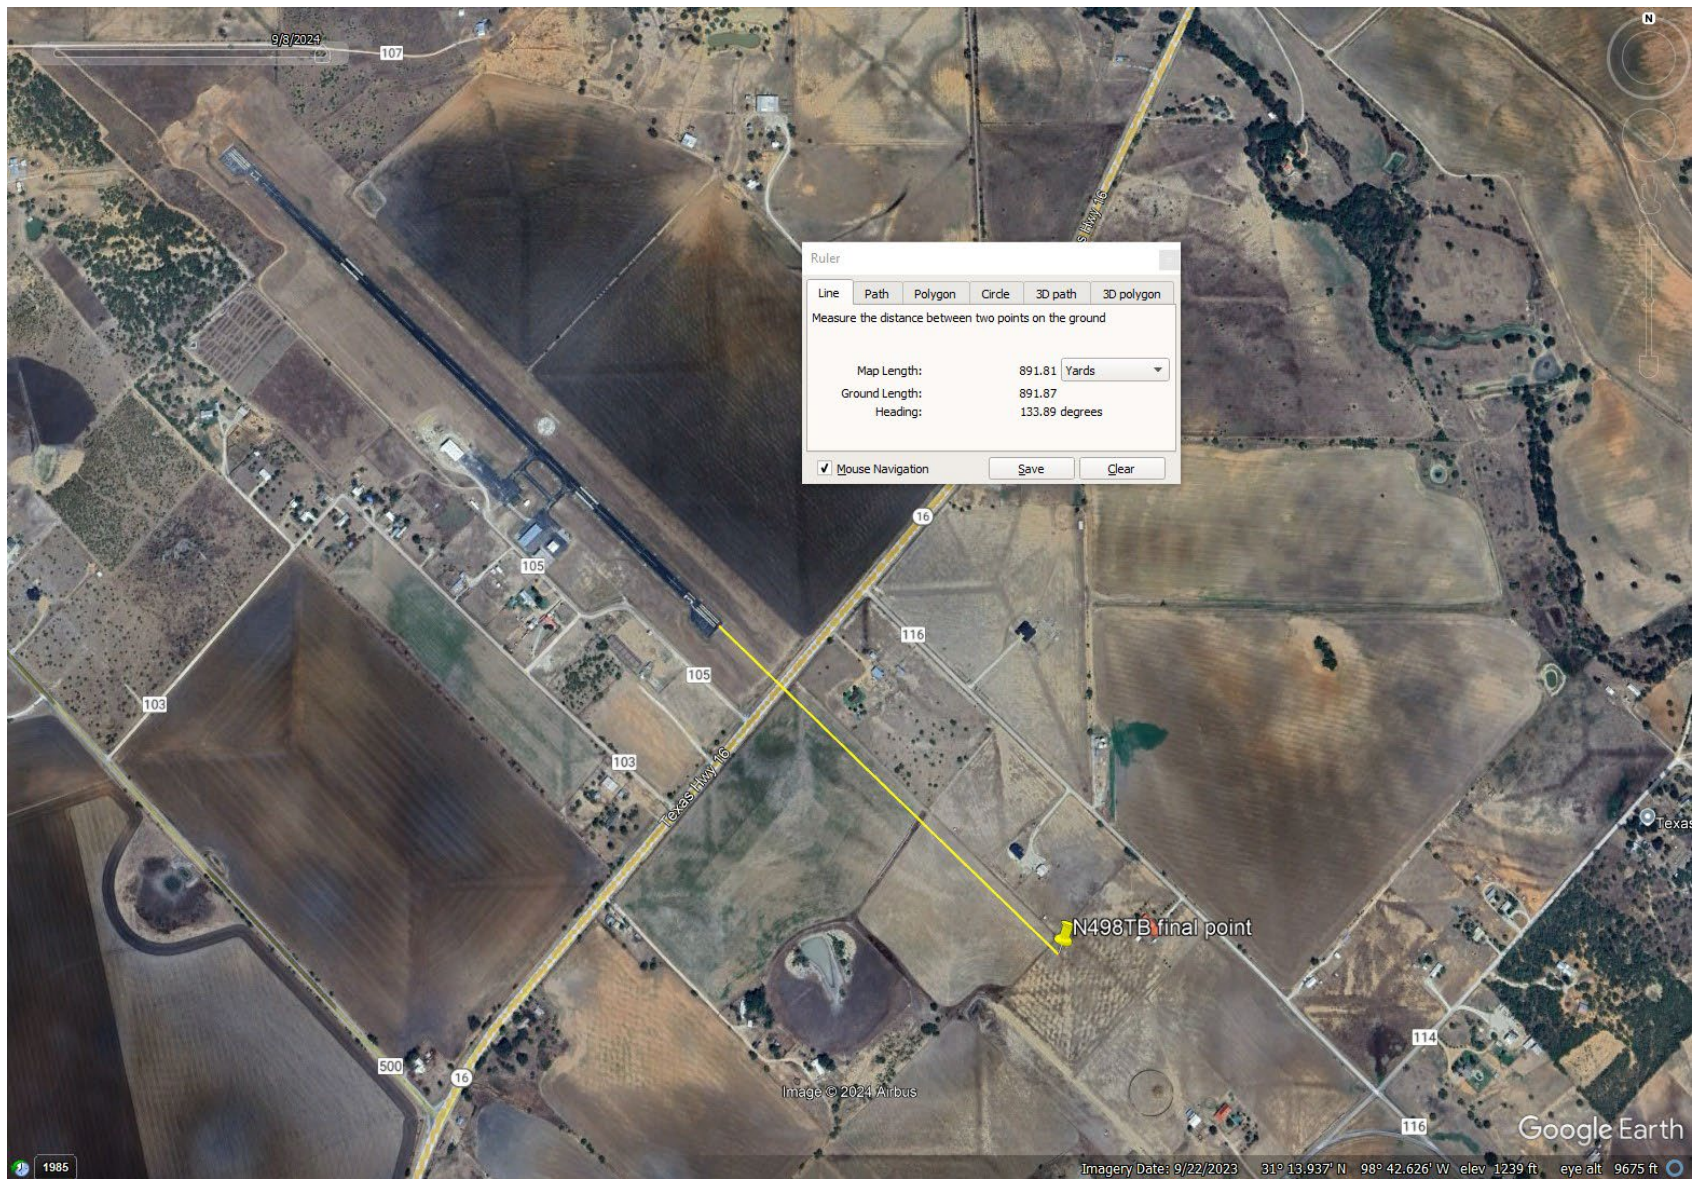
**Figure 8.** Google Earth view showing the distance (891 yards) from the final recorded point to the beginning runway 31 at San Saba County Municipal Airport.
