Alex Lemishko  
Senior Air Safety Investigator  
Aviation Safety - Central Region

**Subject:** Engine Examination, N498TB, CEN24LA140

On April 17, 2024, personnel from the San Antonio FSDO observed a teardown of a Continental engine IO-550-P5B, serial number 1032321. Current time on the engine is 398.2 hours.

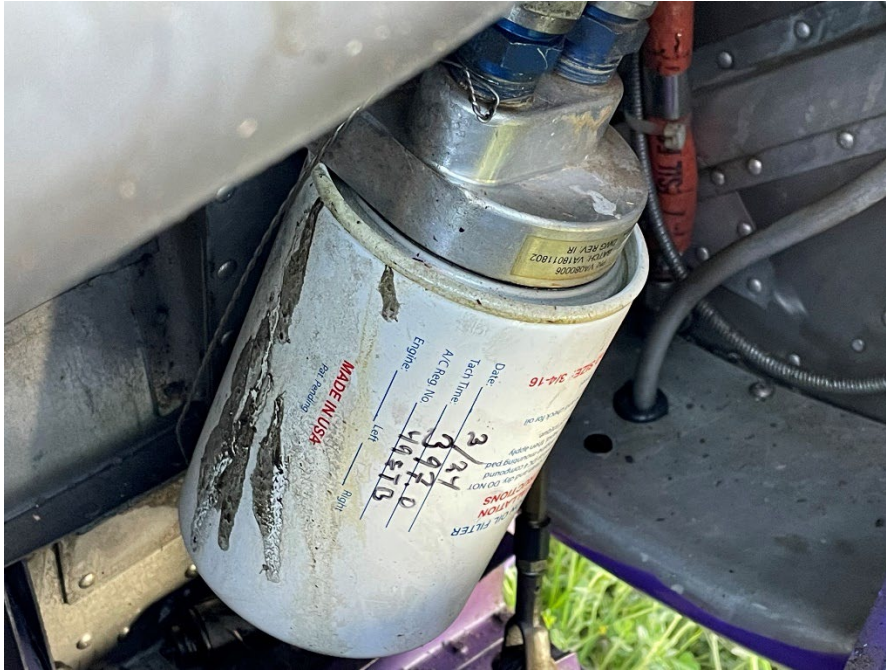
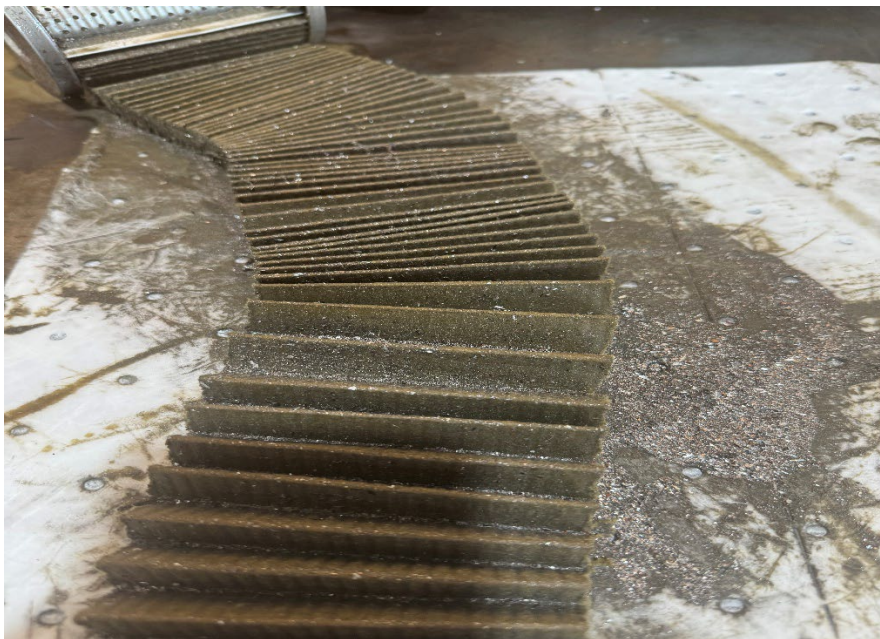
Initial observation revealed a catastrophic failure with evidence of a fire resulting from the fuel line being broken during the accident sequence. The oil filter showed it was installed on March 24, 2024 at 397.0 hours. Oil filter inspection revealed metal particles.

Oil filter element showing metal contamination.

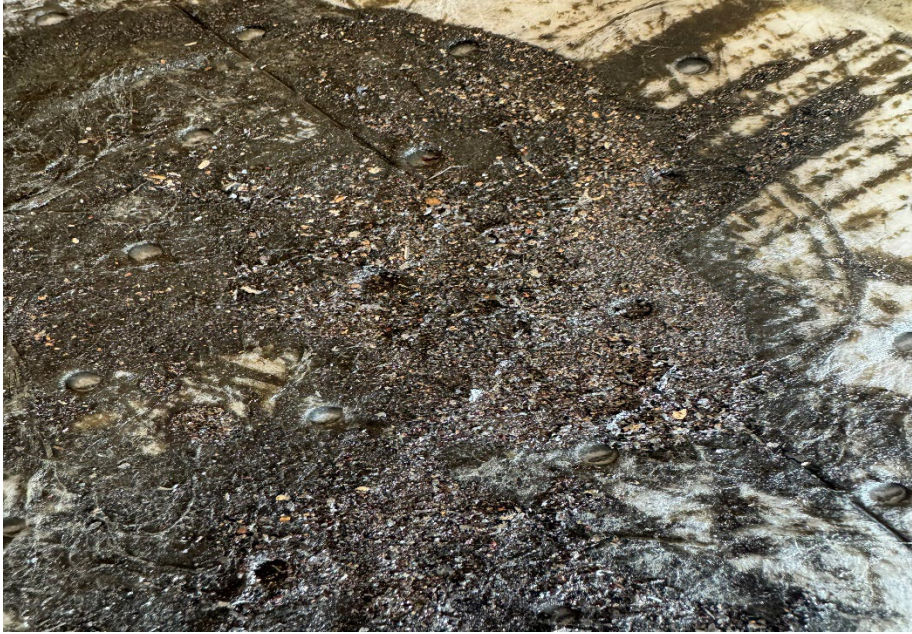
Debris found in the oil filter.

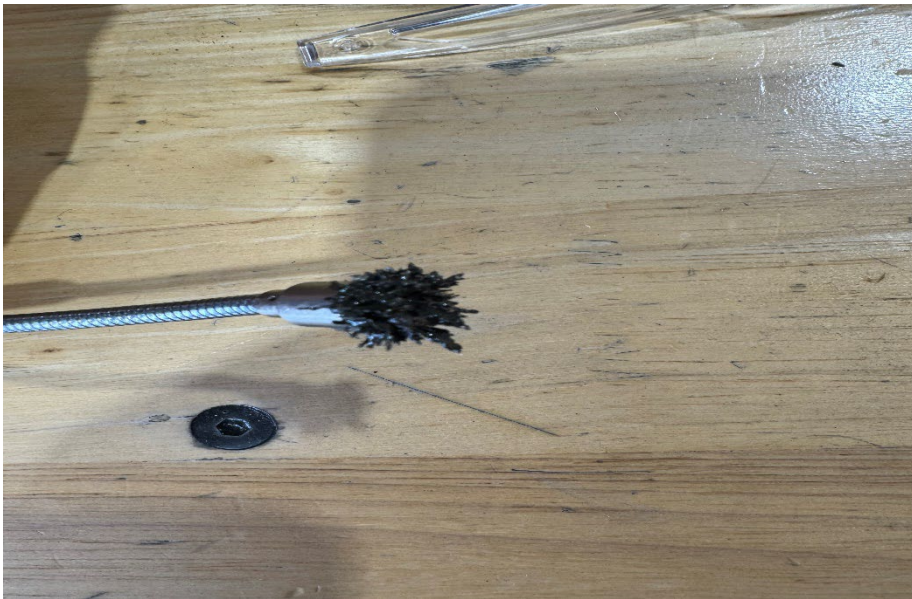
Metal debris picked up from the oil filter.

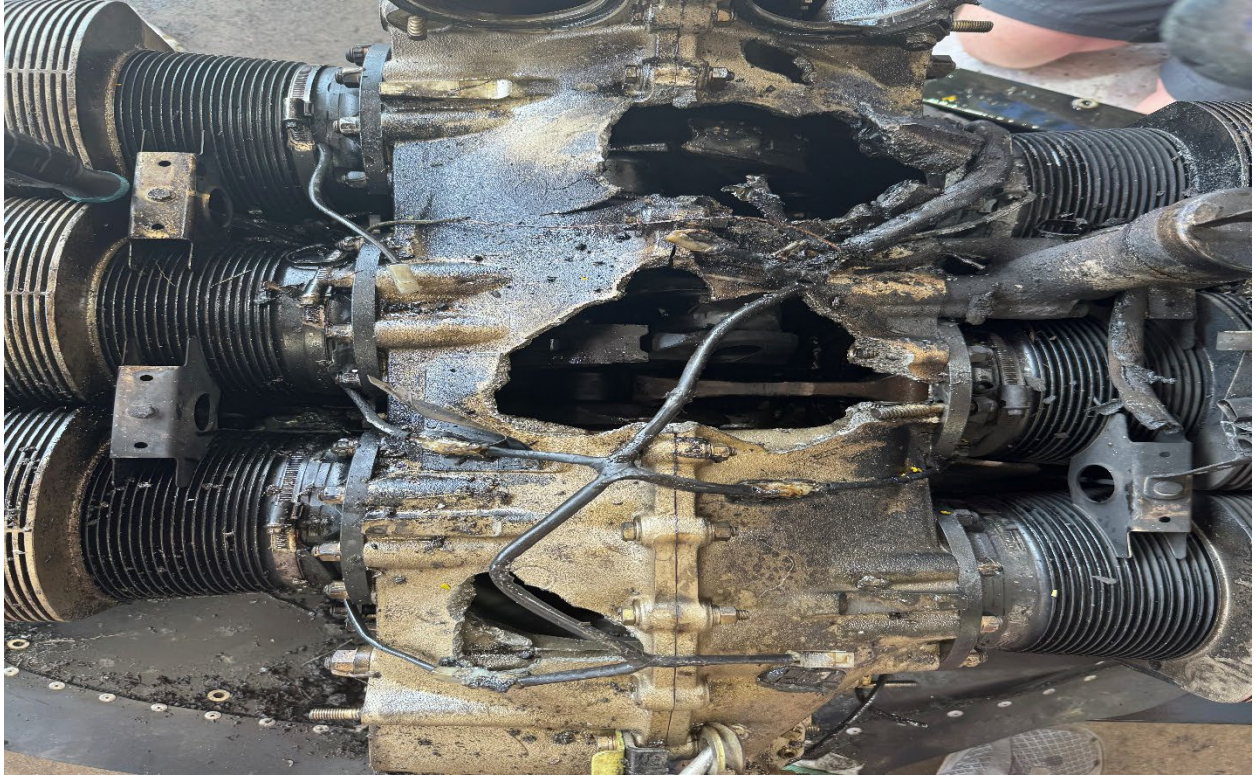
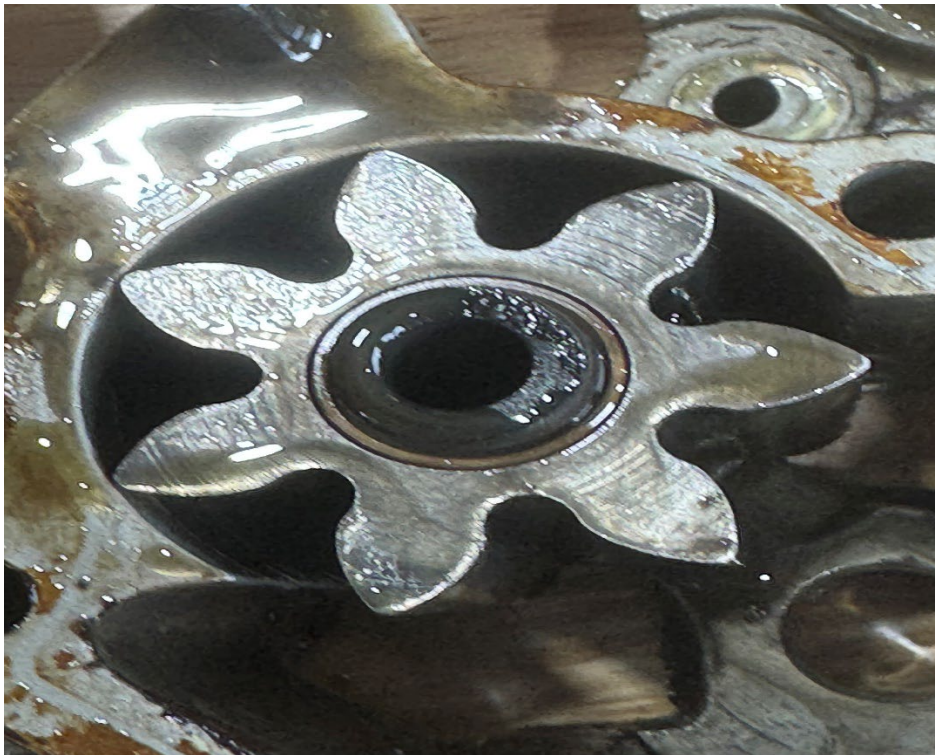
Initial observation revealed a catastrophic failure with multiple holes in the case near the number 2, 3 and number 5 cylinders. The number 2 cylinder connecting rod was outside of the case and its associated piston pin was not located. No abnormalities were noted on the turbo. The spark plugs were not properly torqued. No oil was noted on external engine surfaces or in the engine compartment.

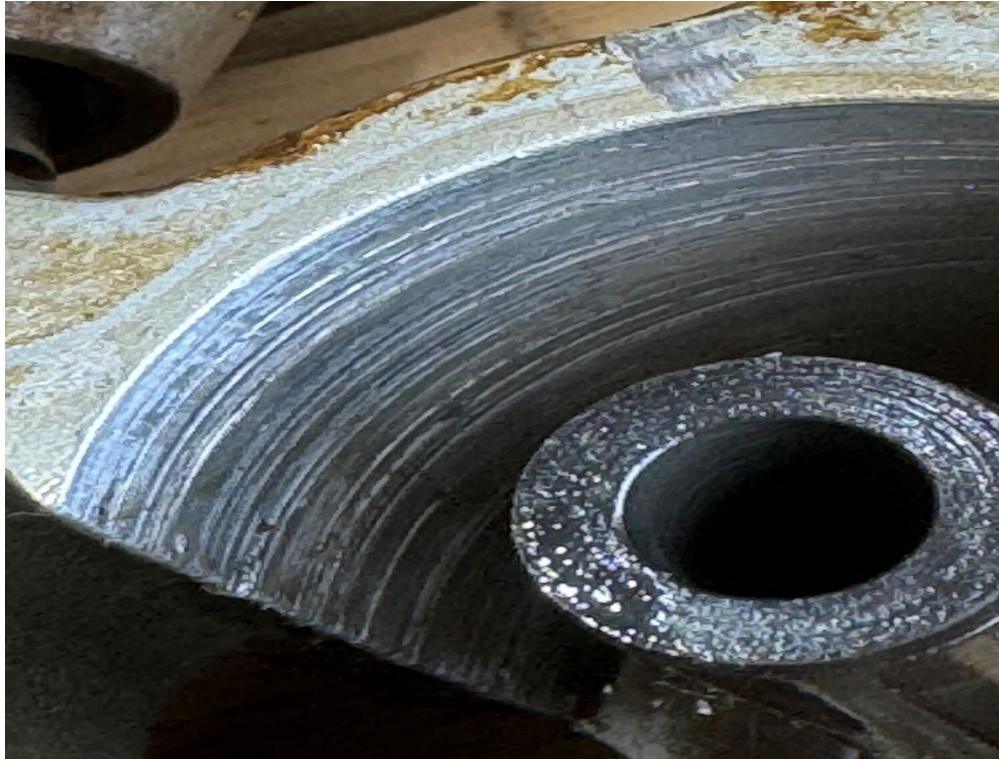
Removal of the oil pump revealed metal particles and the internal gear was difficult to turn.

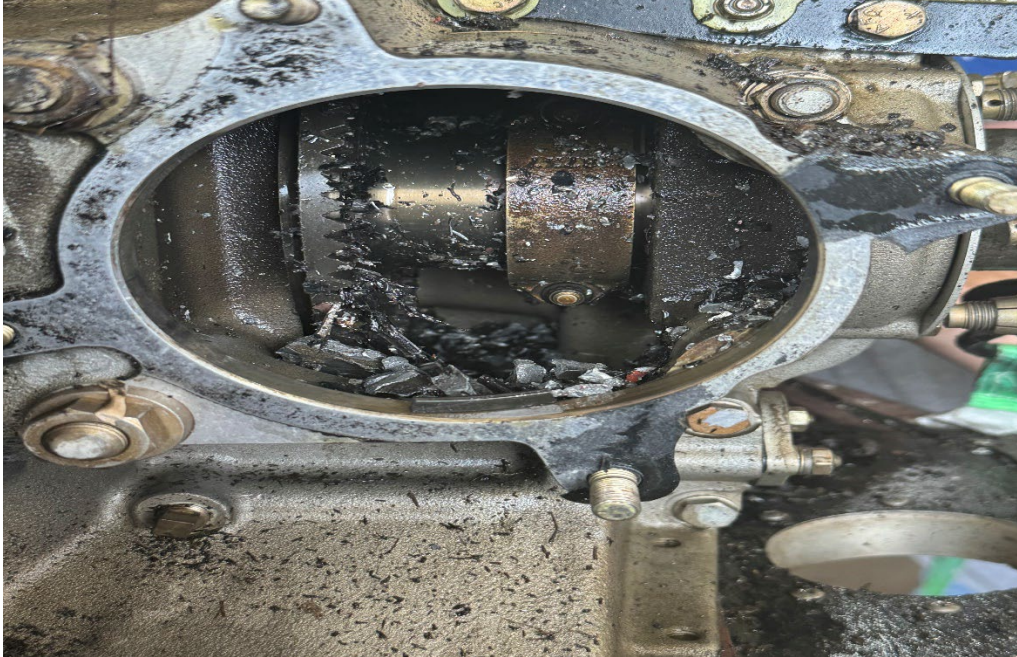
The alternator was removed and showed damage to the elastomeric bearing and large metal particles with the case.

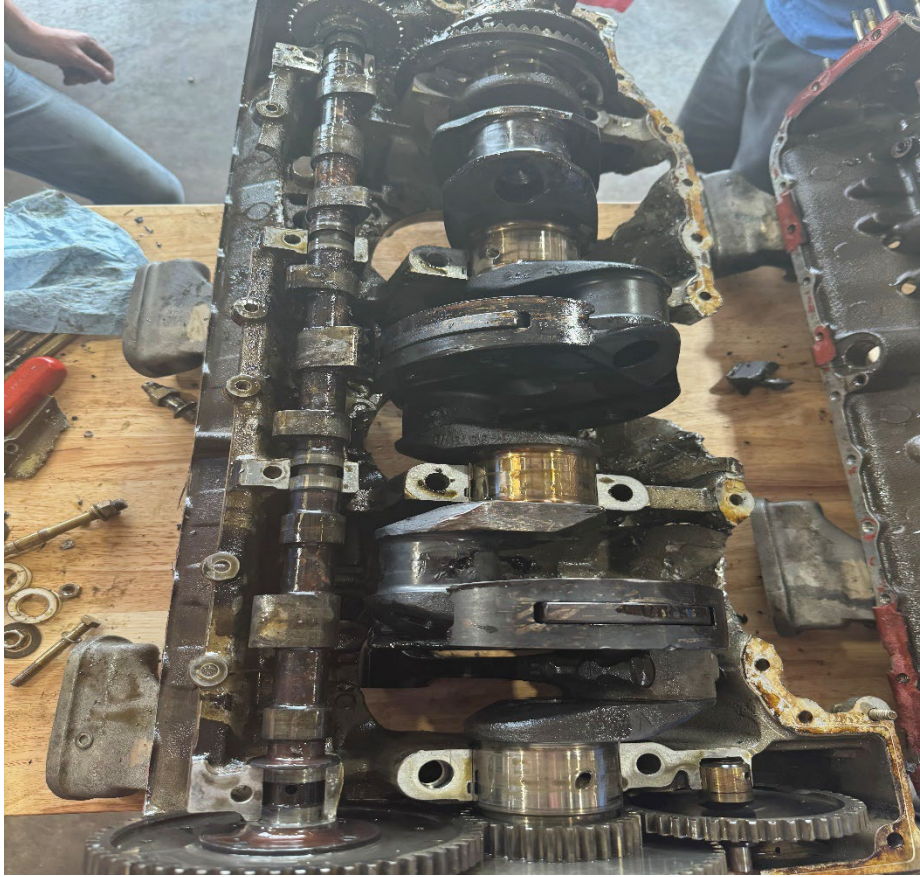
Removal of the oil pan revealed large pieces of metal debris.

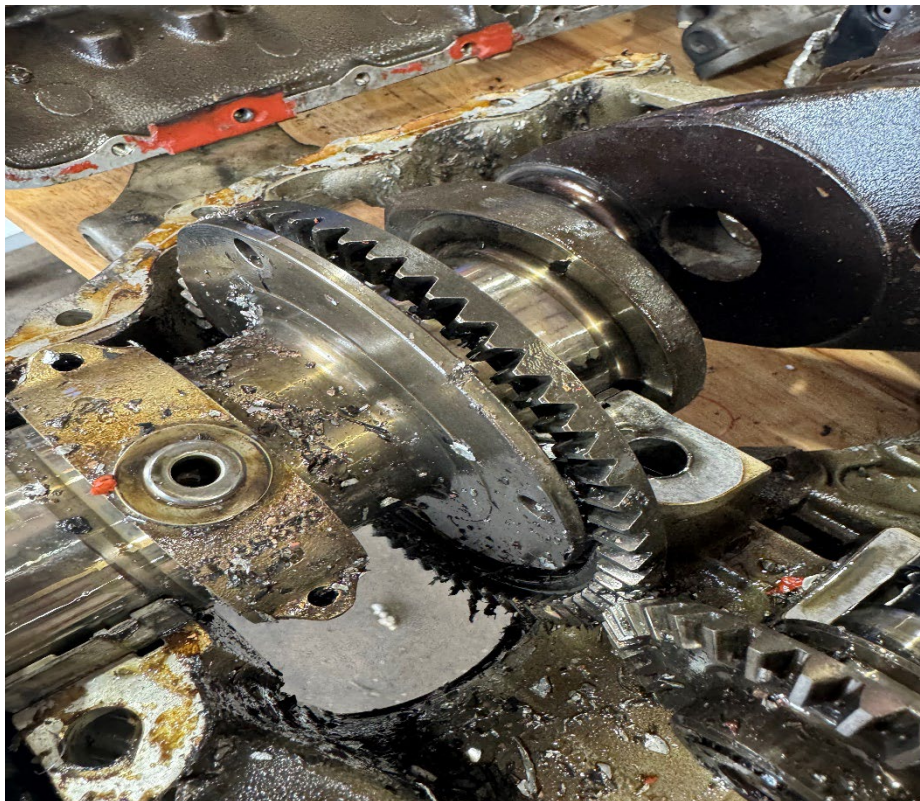
Crankshaft  
counterweights  
were intact.

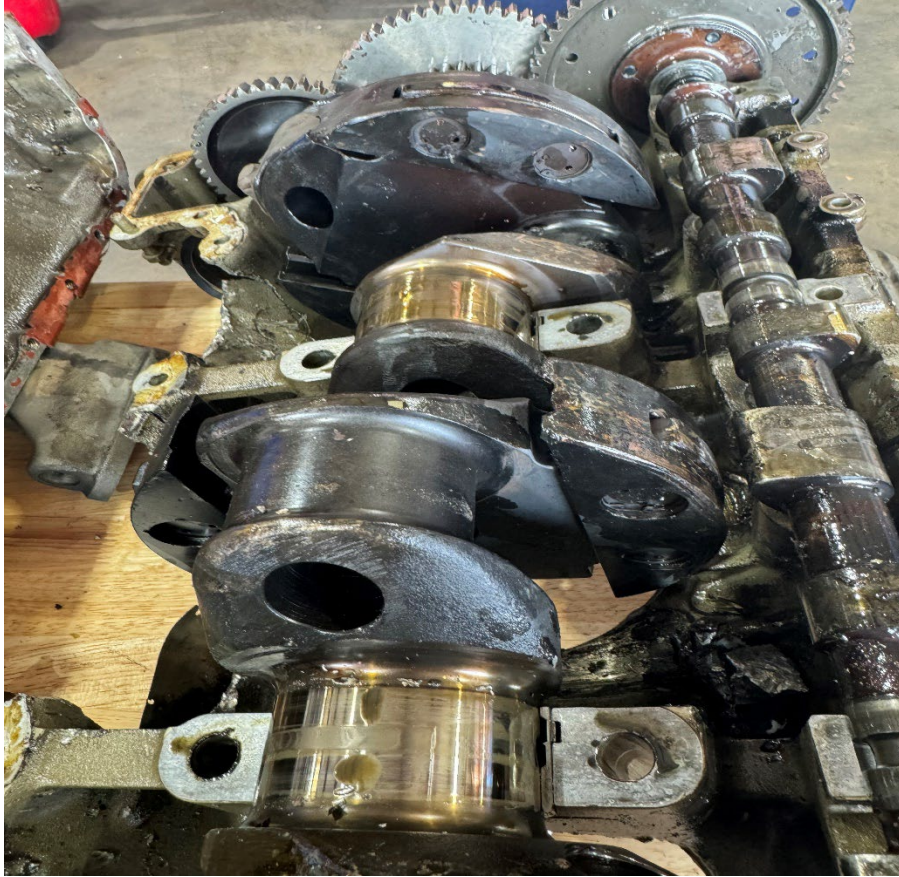
Internal  
alternator  
drive gear  
bolts were  
stripped from  
their location.

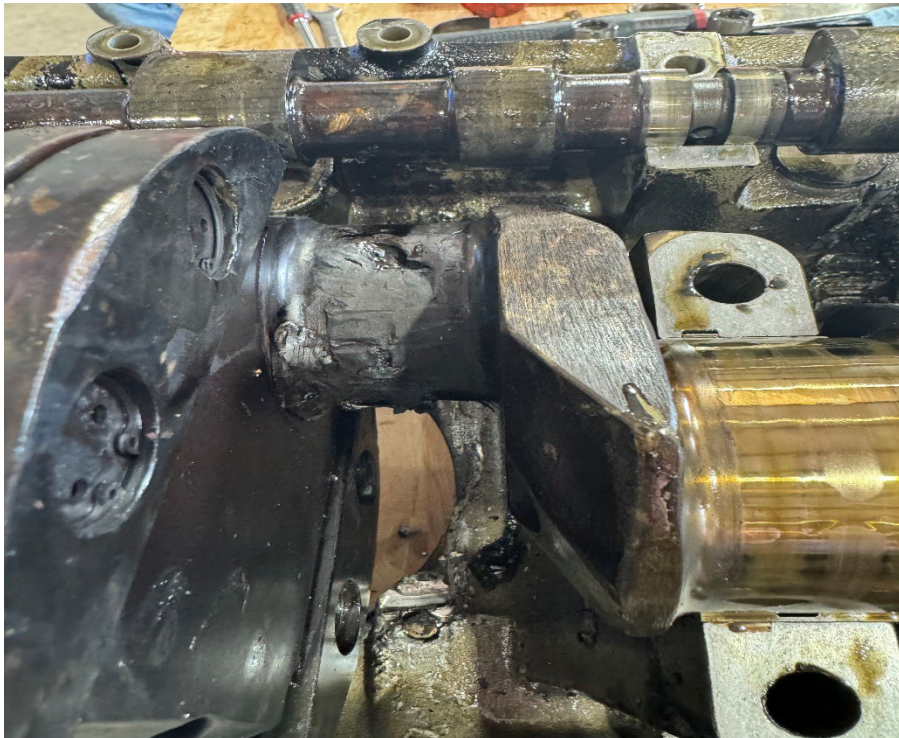
Close examination showed oil covering the main journals.

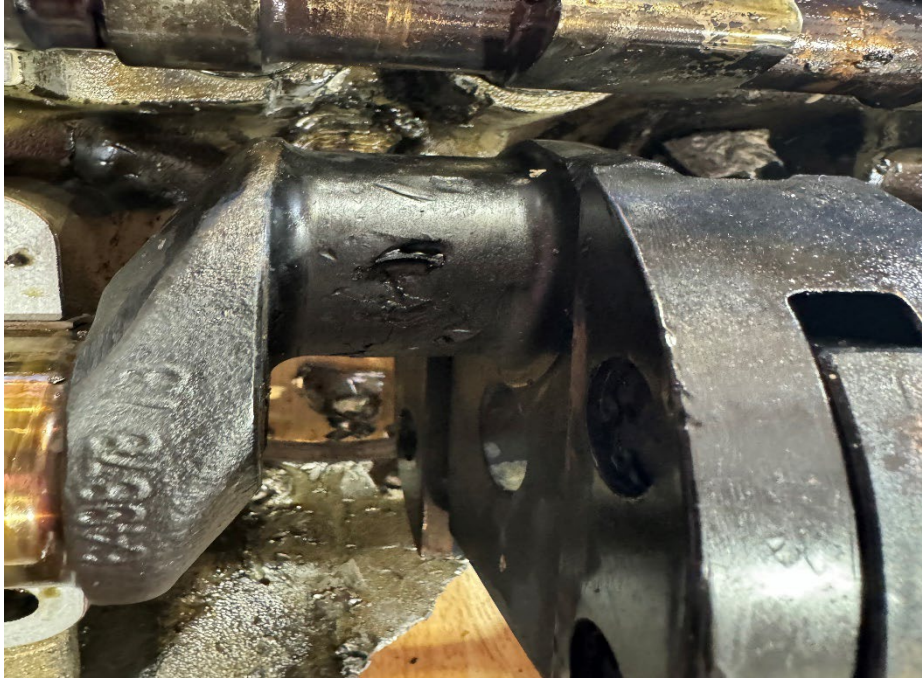
Connecting rod journals showed no indication of oil and were severely damaged. Number 2 cylinder connecting rod attach point shown.

Teardown revealed extensive damage to the internal engine components, primarily to the connecting rods where no bearings were located and extensive damage to the crankshaft connection points were observed. It was determined the engine oil level was too low to properly lubricate the connecting rods resulting in a catastrophic failure.

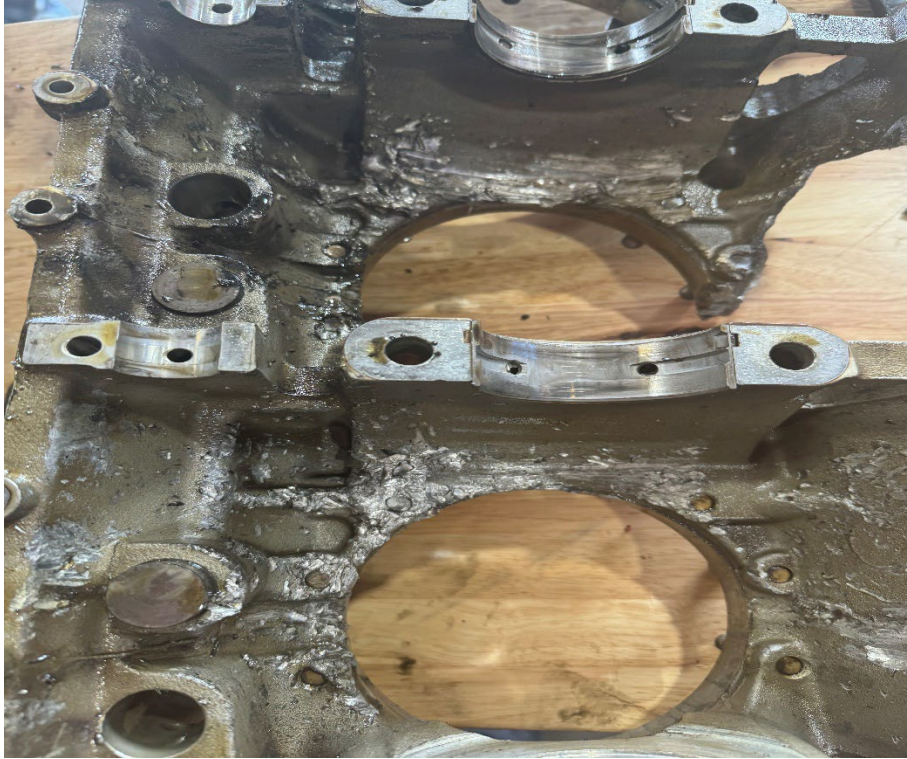
Connecting rod  
base failure.

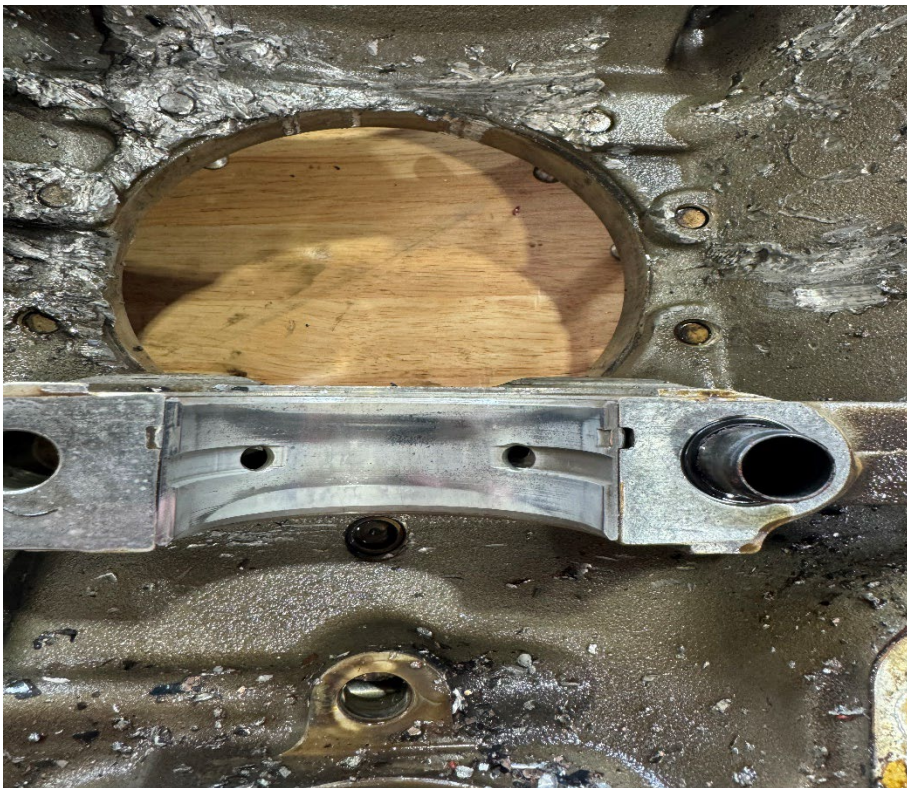
Internal case damage.
