# National Transportation Safety Board

CEN24LA144

## **AIR TRAFFIC CONTROL**

Group Chairman's Factual Report

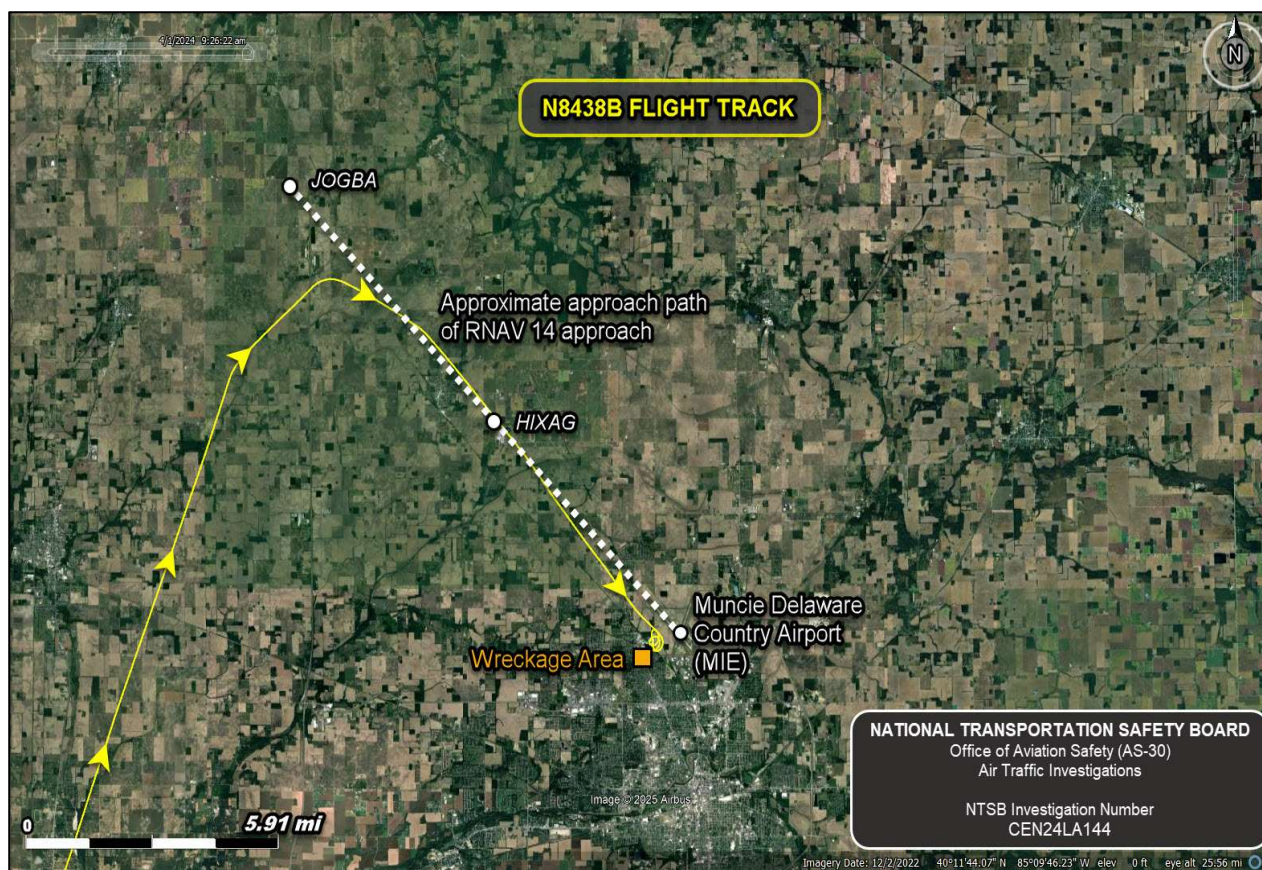
Figure 2 is an aerial view graphic<sup>12</sup> illustrating the flight path of N8438B. According to surveillance data, the aircraft tracked off course and subsequently made several right-hand turns of varying degrees. A dashed white line was used to illustrate the approximate final approach path for the RNAV RWY 14 approach.

**Figure 2.** Overhead view N8438B approach course. A dashed white line was used to indicate the approximate approach path for the RNAV runway 14 approach.

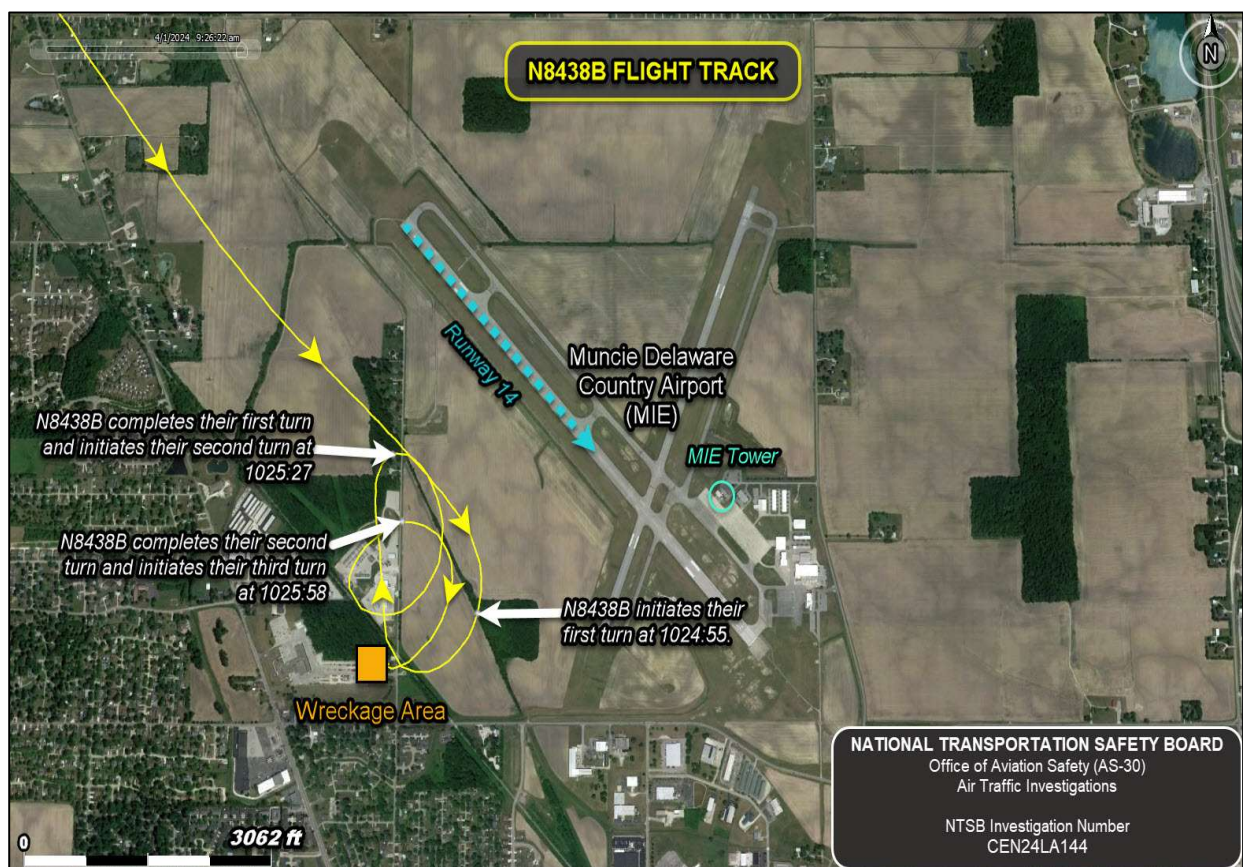
The pilot of N8438B then completed two clockwise 360 degree turns and was midway through the third turn when surveillance data stopped at 1026:22, approximately 0.8 nm southwest of the approach end of runway 14 at MIE.

Figure 3 illustrates the multiple turns made by N8438B and their positional relationship to runway 14 and the control tower.

**Figure 3.** Overhead view of N8438B conducting multiple right hand turns with the times each turn was conducted.

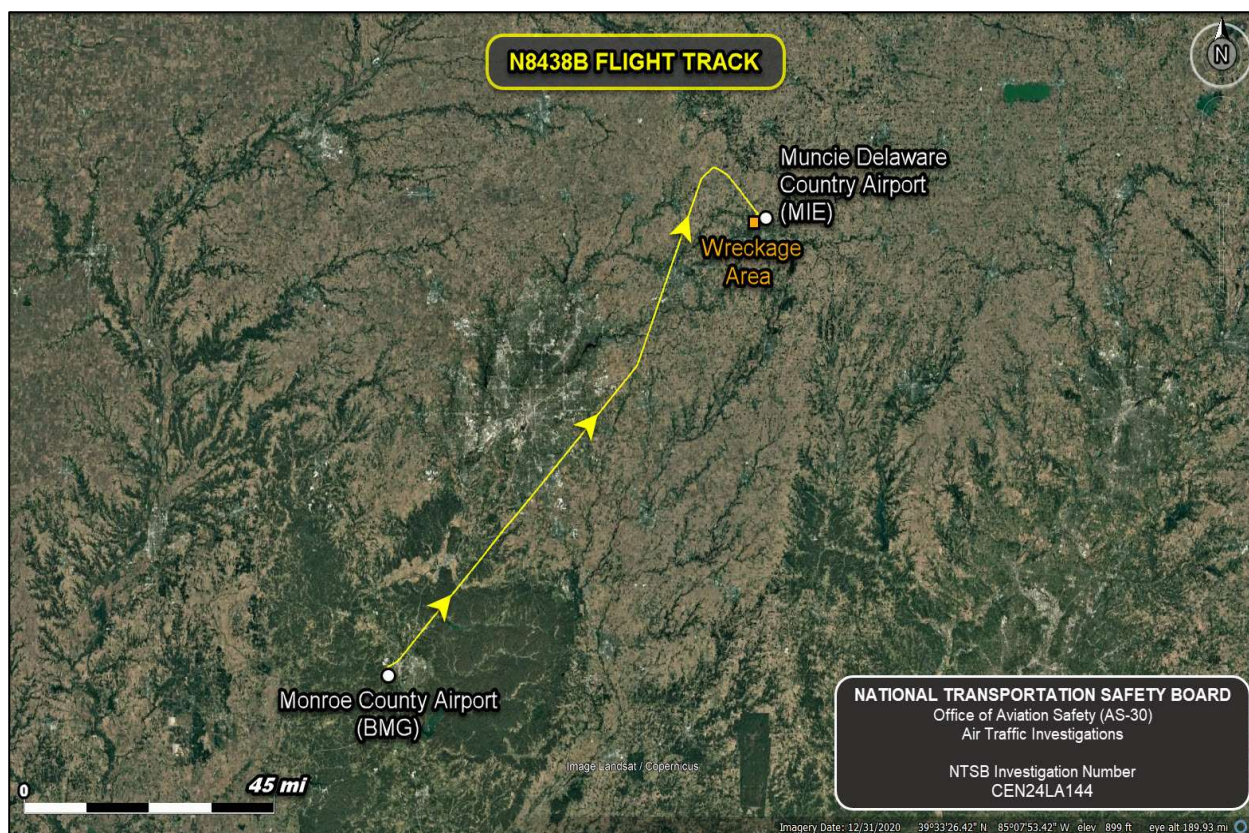
**Figure 4.** Overhead view of the flight track of N8438B.
