# National Transportation Safety Board

CEN24LA145

## **EXHAUST & CABIN HEAT SYSTEM EXAMINATION SUMMARY**

Location: Alpine, Arkansas  
Date: April 2, 2024  
Time: 1056 CDT  
1556 UTC  
Airplane: N86UM, Mooney M20E, S/N 1137

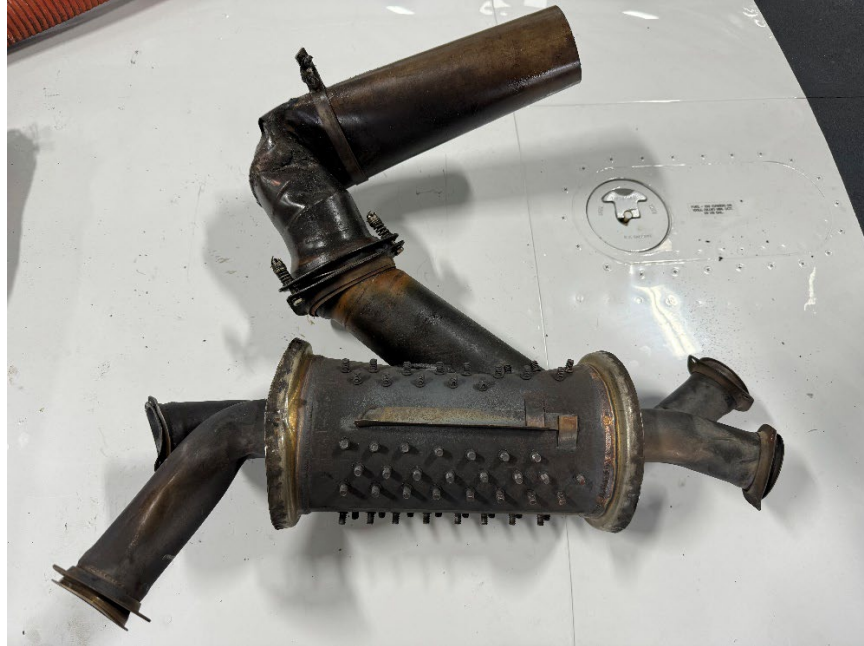
This Mooney M20E is equipped with a Hanlon & Wilson Engine Exhaust System that consists of a single muffler, heat shroud, and exhaust pipe. Visual inspection shows the exhaust system was still properly attached to the engine with crush damage and bending in the aft direction of the exhaust pipe. The exhaust pipe bend was at an existing repair weld. Partial separation of the exhaust pipe at the muffler flex fitting was also observed.

Figure 1. Exhaust System as removed.

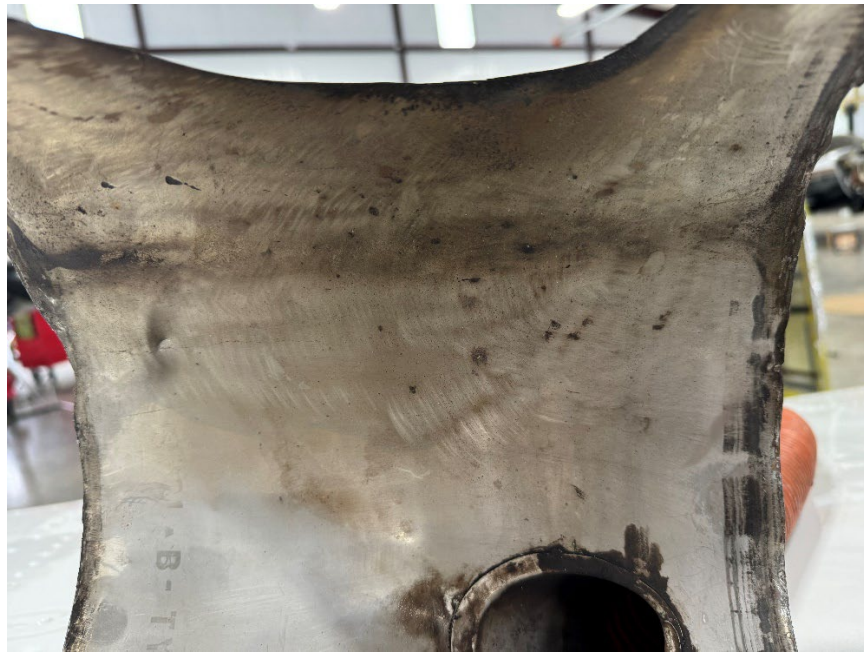
The exhaust system was removed at the cylinder exhaust tube flex fittings for teardown of the muffler and inspection of the exhaust pipe repair weld. The muffler cabin heat shroud was in good condition with one area of exhaust blowby. The air inlet scat tube was in good condition and properly attached to the air intake and heat shroud.

Figure 2. Muffler Cabin Heat Shroud with area of exhaust blowby.

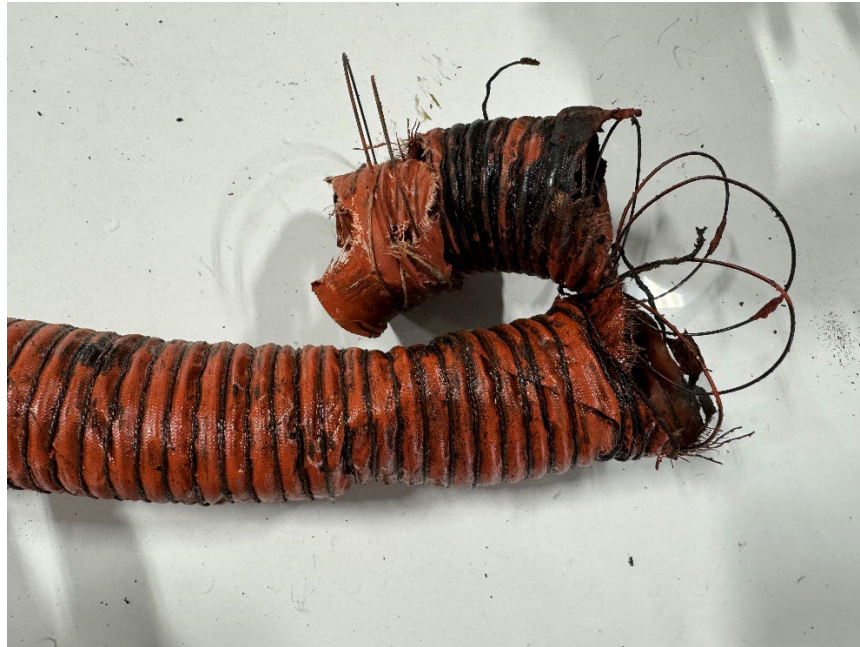
The heat shroud cabin air outlet scat tube was properly attached to the heat shroud outlet and cabin [heat] air cover assembly, P/N 640047-501. The tube had an area of scorched and missing material that was located at the exhaust pipe repair weld. The tube had engine oil and exhaust sooting present on both the exterior and interior of the damaged area.

Figure 3. Damaged scat tube.

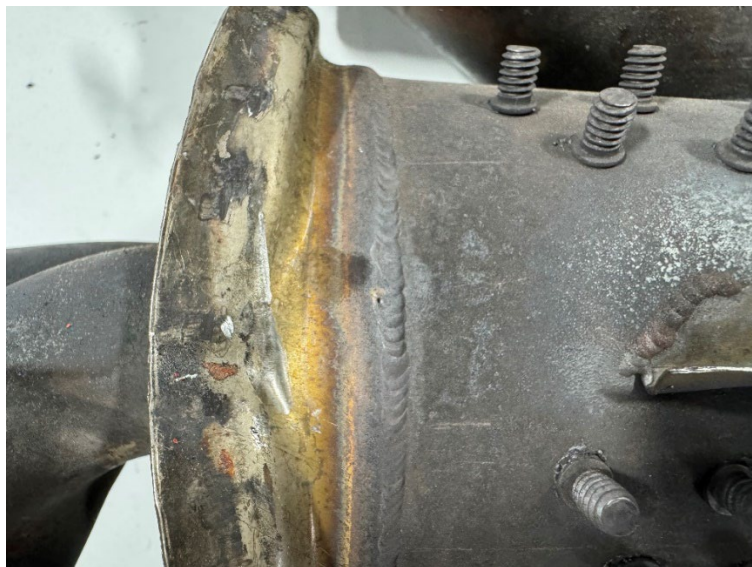
The muffler was in good condition with one pin hole located along the edge of a weld.

Figure 4. Pin hole in muffler.

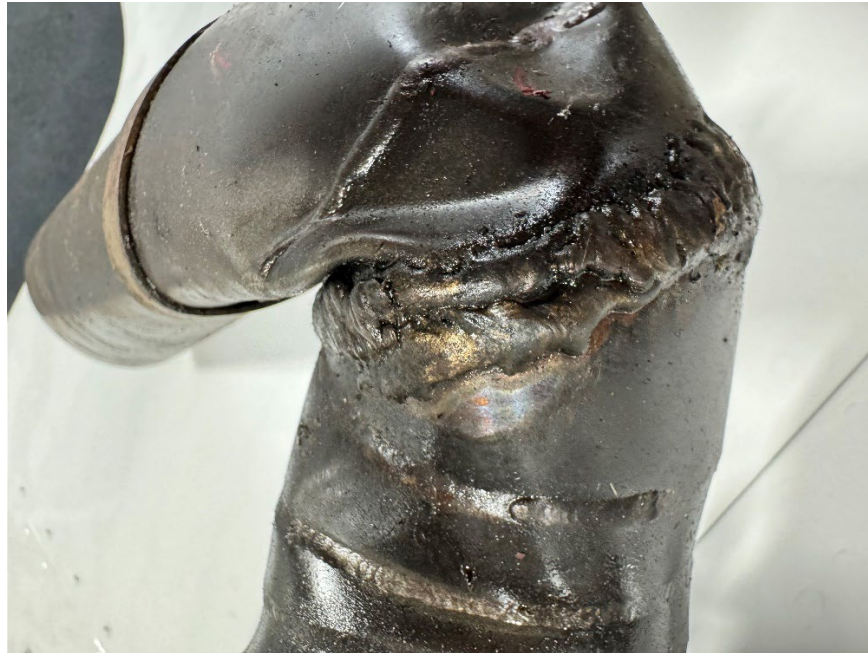
The exhaust pipe had a repair weld located about five inches from the muffler flex fitting. The weld contained multiple cracks and holes with engine oil penetration and exhaust sooting. This weld was also located at the damaged area of cabin heat scat tubing.

Figure 5. Exhaust repair weld

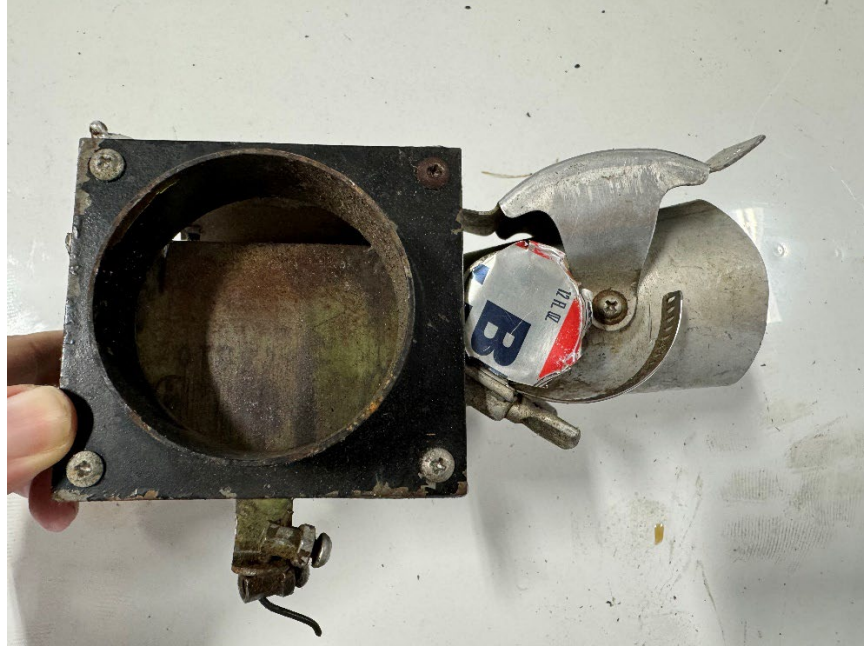
Visual inspection showed minor crush damage to the junction box (Index #7) and a fracture of the cabin heat valve control arm (Index #10). The inlet scat tube was properly attached to the cover assembly and the cover assembly was attached to the firewall base plate. One screw was observed to be missing from the cover to base plate connection. The junction box outlet ducts (Index #19 & 20) were found disconnected with unapproved parts covering both outlets. Additional unapproved parts were found covering various scat tubing inlets within the glareshield assembly.

Figure 7. Junction Box with an unapproved part covering the outlet.

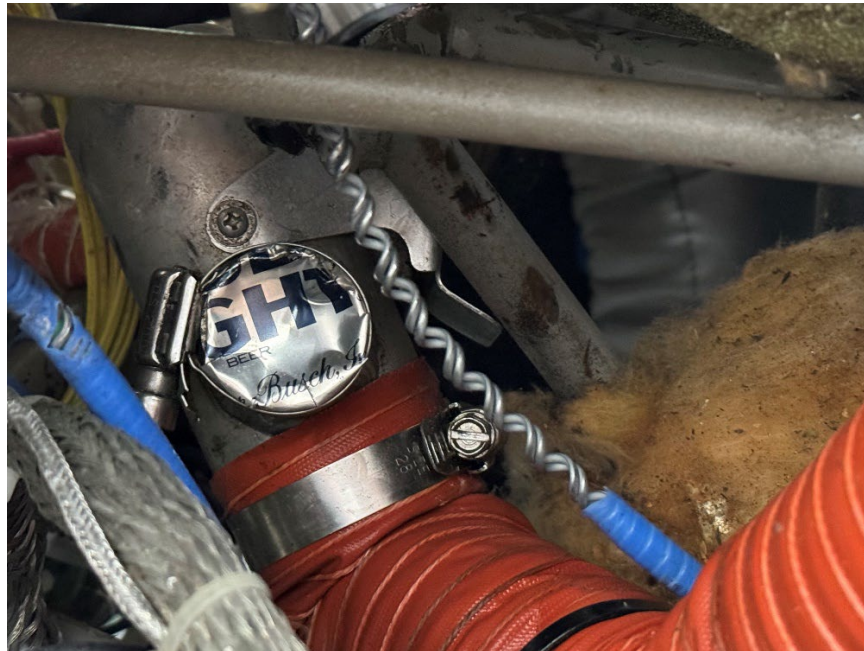
Figure 8. Cabin Air scat tube with an unapproved part covering the inlet.

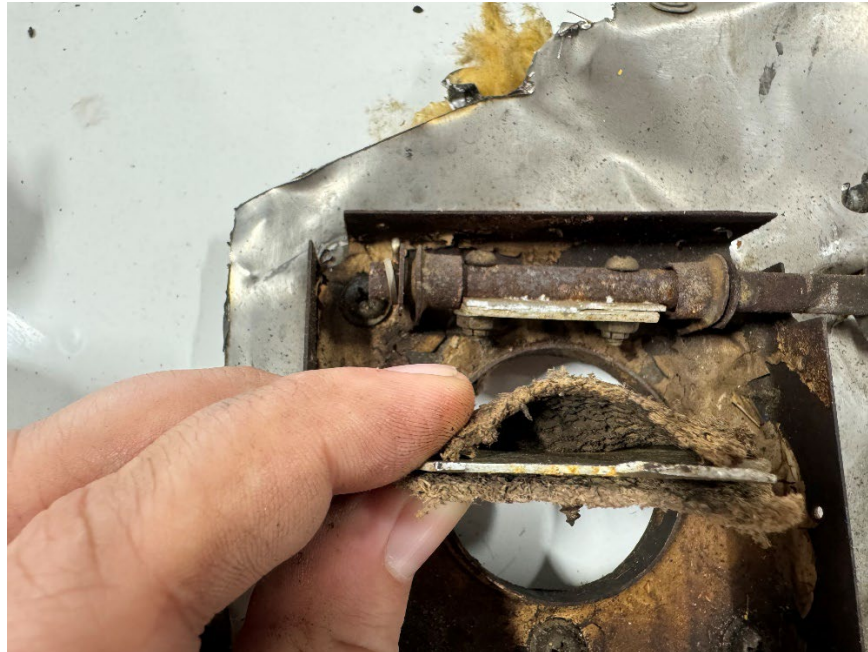
The cabin air cover assembly was removed from the base plate with the valve plate, P/N 640047-11, found separated from the control arm, P/N 653-032-11. The fracture was inspected with a 10x power jeweler's glass on both surfaces. The surfaces had a dull appearance with various discolorations within and along the fracture. The plate edges were observed to have scuffing along all machined edges. The valve control arm moved freely when rotated by hand.

Figure 9. Valve plate and base fracture surfaces.
