CEN24LA146

Group Chair's Factual Report - Attachment #2  
Pratt & Whitney Canada Materials Investigation Report  
October 20, 2025

**Extract from Report No.: 24-060**

**Vincent Flying Service Inc.  
Schweizer Grumman Ag-Cat Model 164B, N75099  
Kaplan, Louisiana  
April 2, 2024  
PT6A-15AG, 14007**

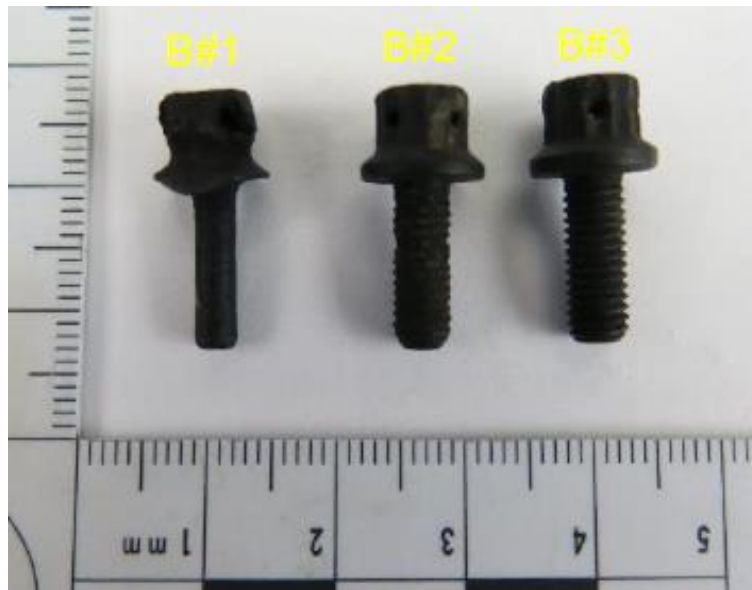
**Photo No. 1**

- 4.1 General view of the three bolts in their as-received condition arbitrarily identified as B#1, B#2 and B#3 (Photo No. 1). The bolt markings were no longer visible. The general aspect of the bolts showed oxidation and varying degrees of material loss, most likely due to erosion.

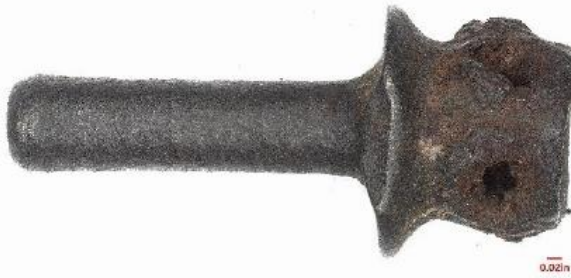
**Photo No. 2**

- 4.2 The bolt #1 showed no remnants of the silver plating on the surface (Photo No. 2). The bolt threaded portion was worn down/eroded with no remaining threads visible (Photo No. 2). The bolt head and the washer section have been worn and deformed (Photo No. 2 & Photo No. 3).

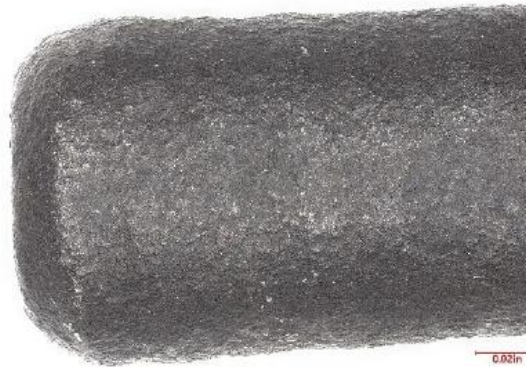
Photo No. 4

- 4.3 Magnified view of the bolt #1 thread surface area showed faint remaining threads (Photo No. 4). The remaining surfaces were oxidized with corrosion product on the bolt head (red arrows, Photo No. 88). The general aspect of the bolt is consistent with being exposed to hot gasses.

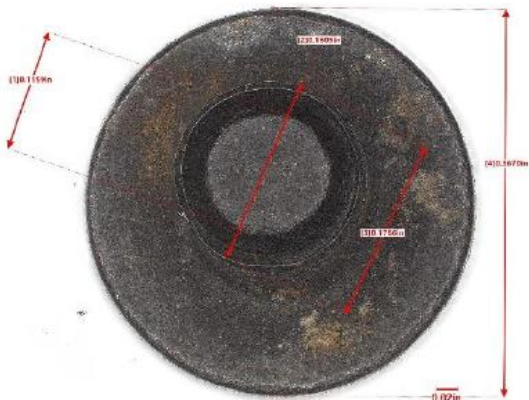
Photo No. 6

- 4.5 The bolt #2 showed no remnants of the silver plating on the surface. The measured diameter of the bolt is 0.177 inches at the bolt heads (Photo No. 6) which is within acceptable range as per drawing specification. A portion of the thread has been reduced to 0.161 inches at the mid-length of the bolt (red bracket, Photo No. 7).

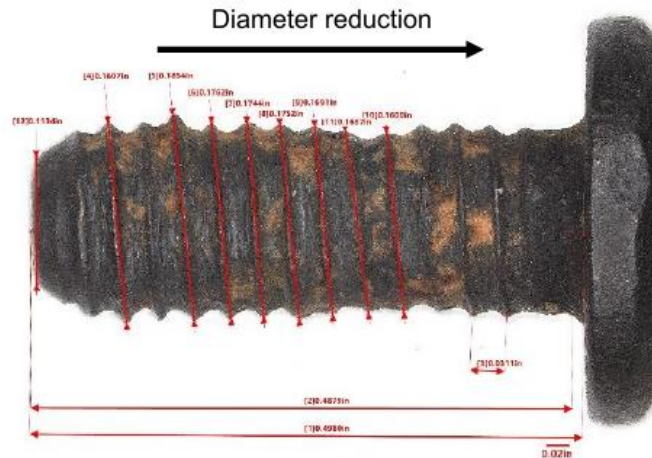
**Photo No. 8**

- 4.6 Magnified view of the bolt #2 thread showed the progressive diameter reduction from the tip of the bolt toward the head (Photo No. 8).

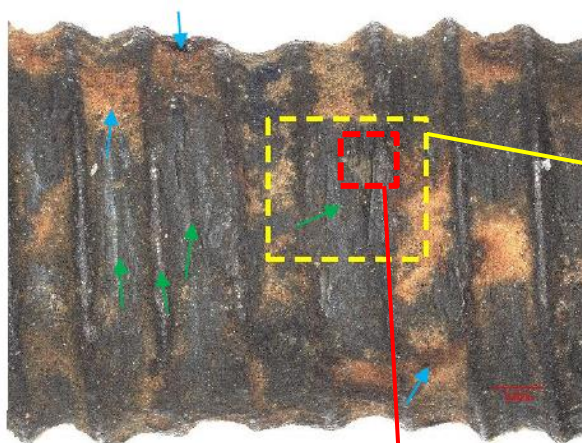
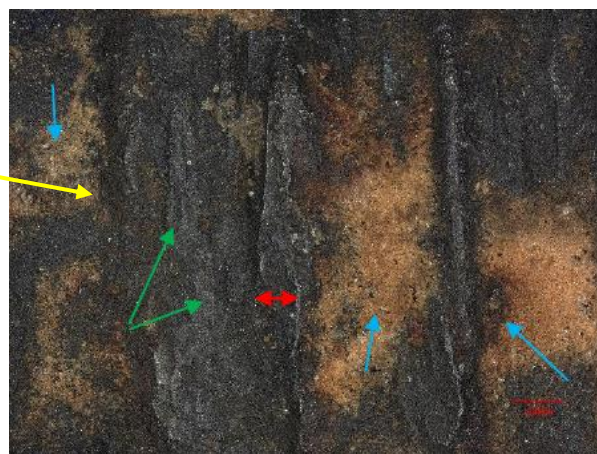
- 4.7 Magnified view of the damaged area indicated by the red bracket in Photo No. 90 showed area of wear damage (green arrows, Photo No. 9 & Photo No. 10), stripped thread (double ended arrow, Photo No. 10) and presence of corrosion product (blue arrows, Photo No. 9 & Photo No. 10. The remaining thread of the bolt #2 did not show any evidence of damage indicative that the thread has been stripped. SEM images showed the surface of the bolt #2 and a suspected striped thread (Photo No. 94 & Photo No. 12). SEM-EDS analyses using semi-quantitative and standardless method were performed (Table No. 1). The contents of the primary elements detected (Fe, Mo, Cr, Mn) on the surface do not match the base material composition. High oxygen content was noted on the surface and near the thread indicating presence of corrosion.

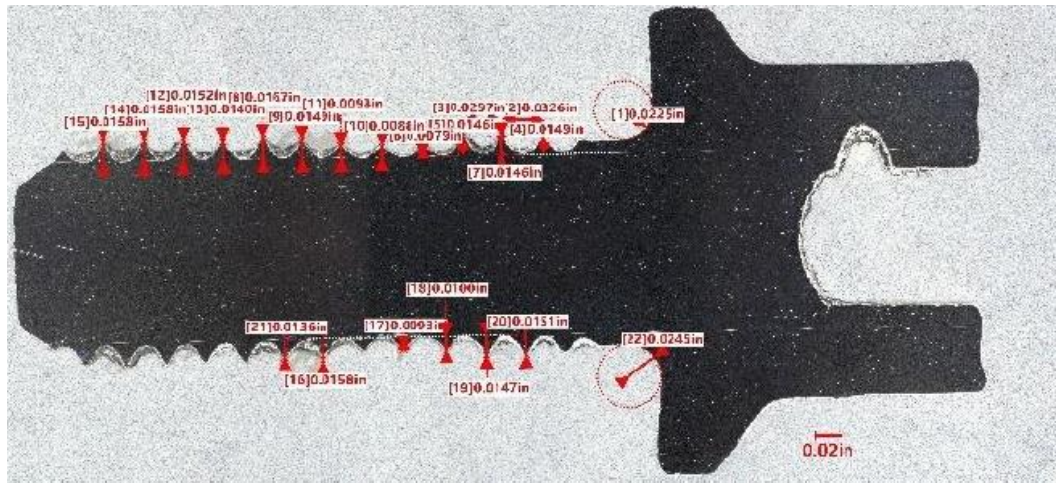
Photo No. 13

- 4.8 Cross section taken through the bolt #2 showed the reduction in diameter and material loss on the thread (Photo No. 13). Measurement of the thread showed variation between the damaged and undamaged threads.

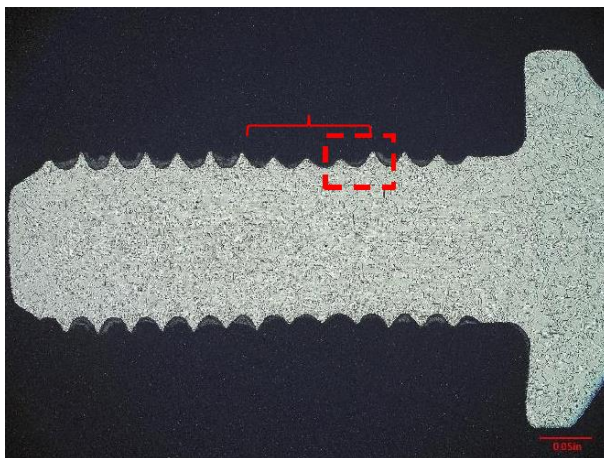
Photo No. 14

- 4.9 Metallographic cross section of the bolt #2 where the threads exhibited the most damage (red bracket, Photo No. 14). The bolt microstructure consists of an equiaxed grains typical of solutioned and aged stainless steel (Photo No. 14). No anomalies in the original material were observed. Microstructure of the damaged threads showed no significant variation in grain size between threads (Photo No. 15). Microhardness measurement taken on the threaded section and the core section of the bolt were 142.4 VHN500g and 128.6 VHN500g respectively suggesting that the material was exposed to hot temperature exceeding 1325°F which is the temperature of the precipitation heat treatment.

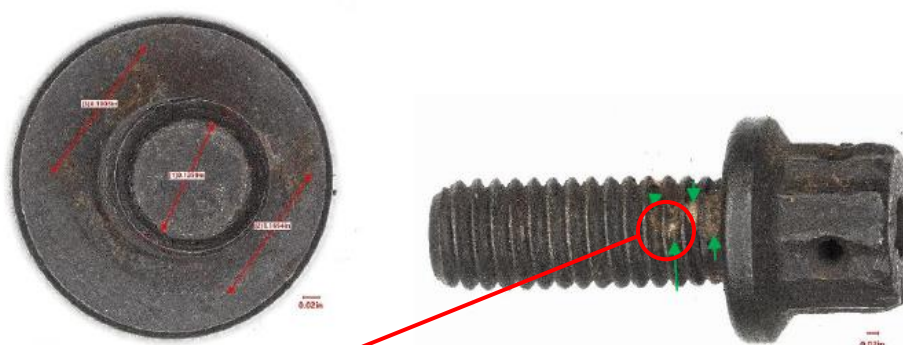
**Photo No. 16**

- 4.10 The bolt #3 showed no remnants of silver flash visible on the surface. The diameter of the bolt is within the acceptable range as specified in the drawing. Oxidation product and contamination were observed on the bolt threads (green arrows, Photo No. 16). SEM-EDS analyses of the bolt #3 surface and embedded contaminants were performed (Photo No. 17). Presence of compounds with concentration of Cr and O were observed on the thread surface indicative of corrosion products (Spectra No. 1 & 2, Table No. 2). Remnants of silver plating was detected indicative that the bolt #3 had less degradation than the bolt #1 & #2. Presence of high amount of N, Si, and C suggested presence of a foreign compound on the surface (Spectra No. 3 & 4, Table No. 2).

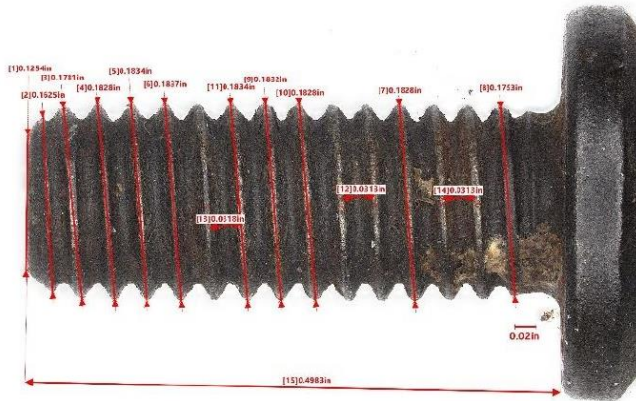
**Photo No. 18**

- 4.11 Examination of the thread on the bolt #3 showed no diameter reduction from the tip of the bolt toward the head (Photo No. 18). No significant wear or damage was observed on the bolt threads. High magnification of the thread revealed linear indication (red arrows, Photo No. 19). The bolt #3 head showed deformed regions (yellow arrows, Photo No. 20).

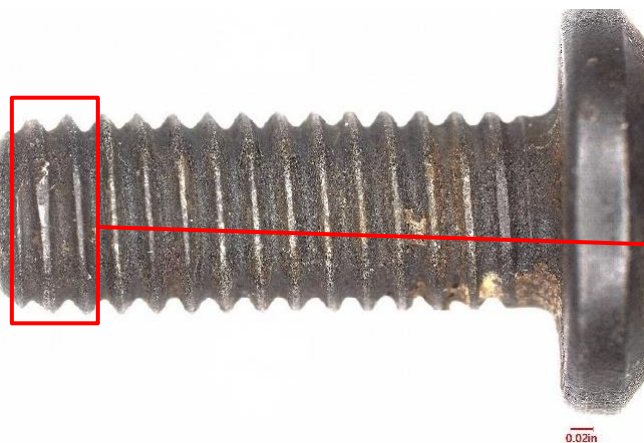
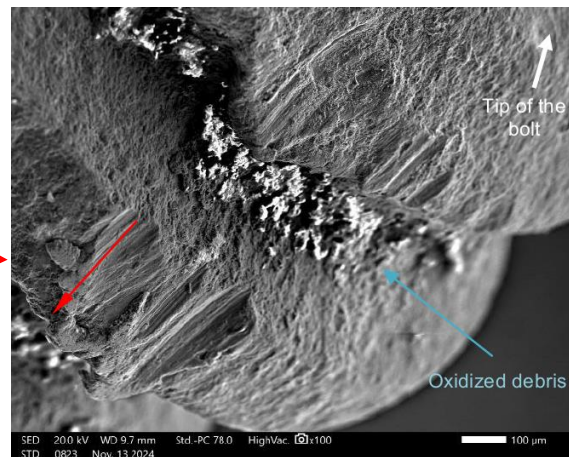
- 4.12 Views of the damaged areas on the tip of the bolt #3 showed traces of rubbing damage (Photo No. 104 & Photo No. 22).

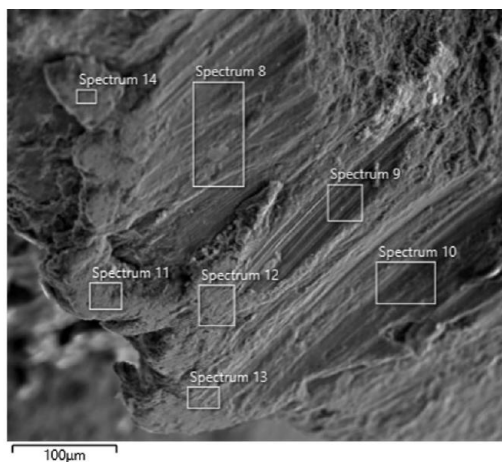
**Photo No. 23**

- 4.13 SEM-EDS using semi-quantitative and standardless method of the damaged area of the bolt #3 thread showed the main elements consistent with the material of the bolt. It was noted that the Cr content was lower than the minimum allowable criteria. Spectra #14 shows the Ni content higher than the maximum allowable content specified in the drawing which suggest possible transferred material from the power turbine containment ring where the bolt was assembled. The presence of high level of S and P is consistent with airborne contamination (Photo No. 23 & Table No. 3).

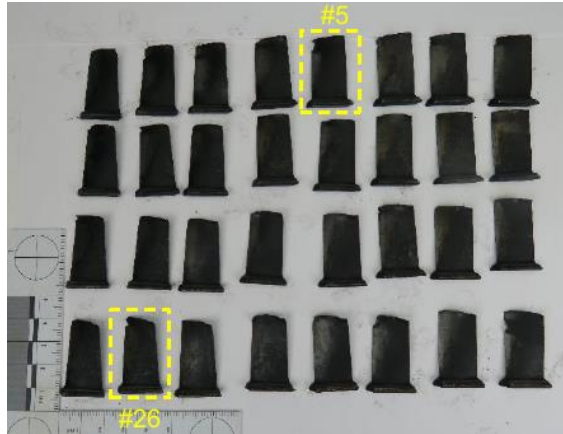
Photo No. 24

- 4.14 General view of the 2<sup>nd</sup> stage compressor blades in their as-received condition arbitrarily identified from 1 to 32 (Photo No. 24). Two compressor blades (#5 and #26) exhibited significant damage and were selected for further analysis (yellow dashed rectangles, Photo No. 107).

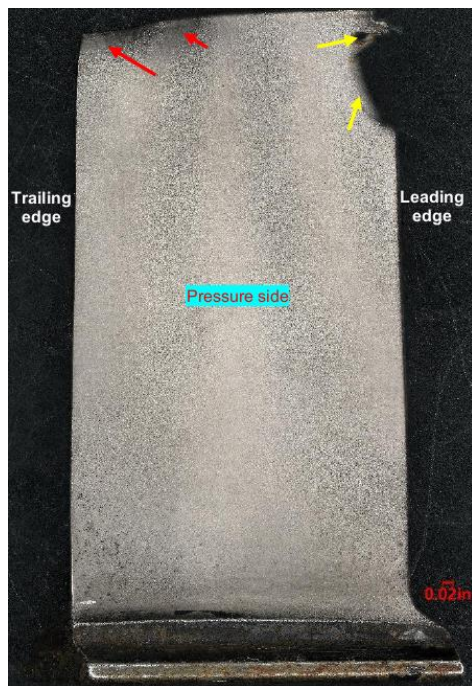
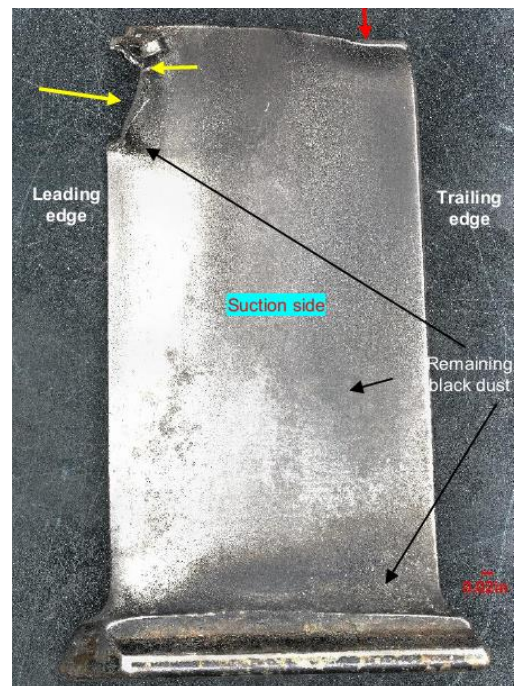
- 4.15 View of the 2<sup>nd</sup> stage compressor blade #5 (post-cleaning) showed evidence of deformation and curled metal near the tip (red arrows, Photo No. 25 & Photo No. 26) and impact damage at the leading edge (yellow arrows, Photo No. 25 & Photo No. 26). The damage suggest that the impact occurred from the pressure side towards the suction side.

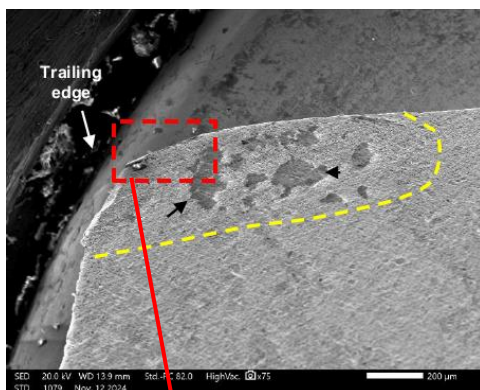
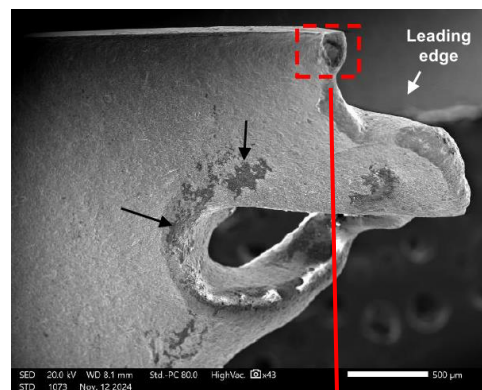
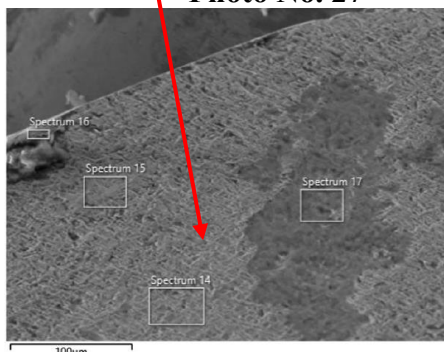
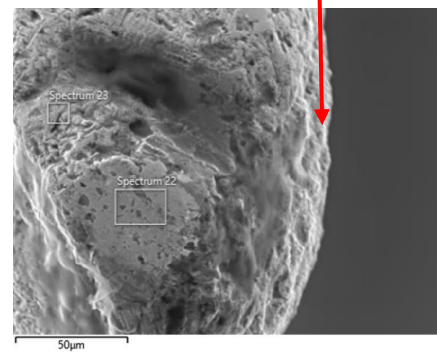
- 4.16 SEM images of the deformed metal observed at the tip of the blade # 5 trailing edge and the impact damage at the leading edge showed that the main elements are consistent with the compressor blade material for all spectra except spectra #17 which shows high Al content suggesting smeared material (Photo No. 27 to Photo No. 30). All spectra show high aluminum content suggesting smeared/transferred material. The presence of Ti and V in spectra #16 and #17 is also considered as transferred materials. The dark region (spectra #17) showed elements that are consistent with ingested airborne contaminants. The presence of high level of S, P and Mg are consistent with airborne contamination (Photo No. 27 to Photo No. 30 and Table No. 4).

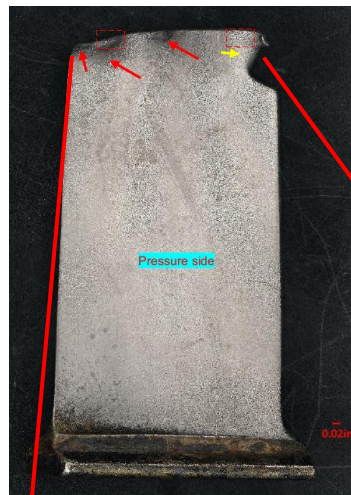
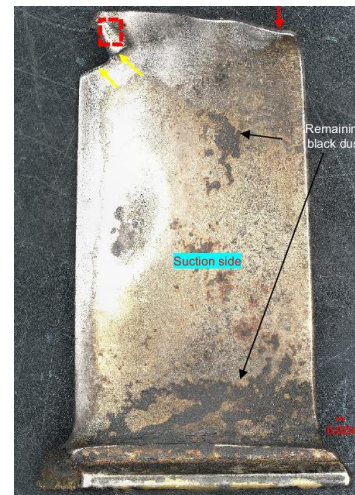
- 4.17 View of the blade #26 (post-cleaning) showed evidence of deformation and curled metal near the tip (red arrows, Photo No. 31 & Photo No. 32) and impact damage at the leading edge (yellow arrows, Photo No. 31 & Photo No. 32). The damage suggest that the impact occurred from the pressure side towards the suction side. SEM-EDS analyses using a semi-quantitative and standardless method showed that the main elements are consistent with the compressor blade except for the spectra #10 (Photo No. 33 & Photo No. 34 and Table No. 5). All spectra showed a high level of Al content exceeding the specified material requirement. The fact that Al was found on all spectra, especially in area exhibiting no evidence of rubbing, suggest that transferred material could be from a coating upstream. In addition, Spectra #8, #9, and No 10 showed presence of Ti, Al and V as transferred materials. The spectra #8 and #9 V/Ti and Al/Ti ratio are close to the Ti6Al4V.

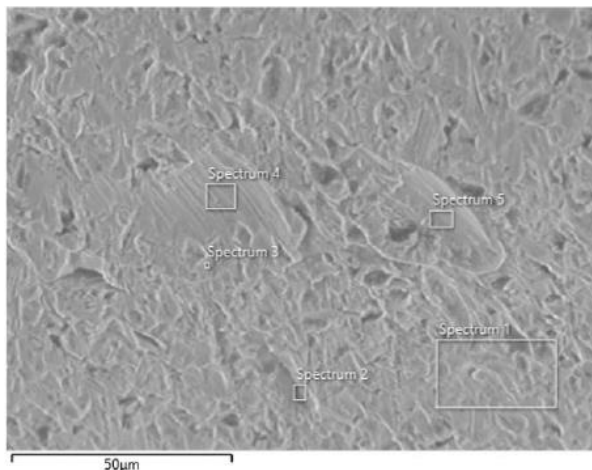
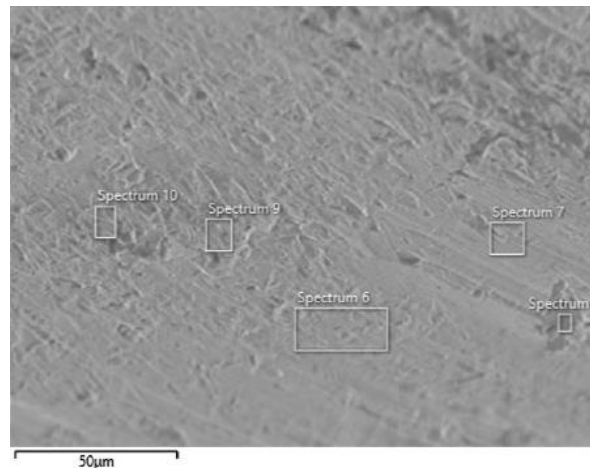
- 4.18 SEM-EDS analyses using a semi-quantitative and standardless method showed that the main elements are consistent with the compressor blade (Photo No. 35 & Photo No. 36 and Table No. 6). No evidence of foreign material was detected.

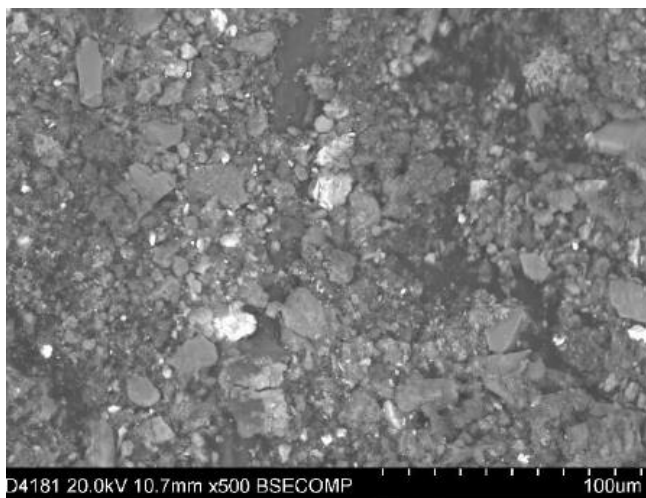
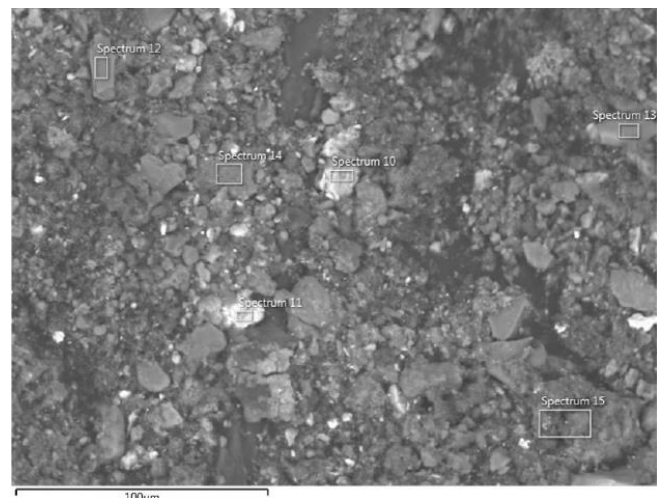
- 4.19 SEM-EDS analyses of the dust/black particles gathered from the surface of the compressor blade suction side using a semi-quantitative and standardless method showed significant presence of oxygen along with other elements such as sodium, calcium, potassium, magnesium and chlorine all consistent with ingested environmental contaminants (Photo No. 37 & Photo No. 38 and Table No. 7). The presence of high sulphur contents in two spectra along with high carbon content could suggest ingestion of exhaust gases. Aside from the elements consistent with the airborne contaminants, no element foreign to the assembly were detected.

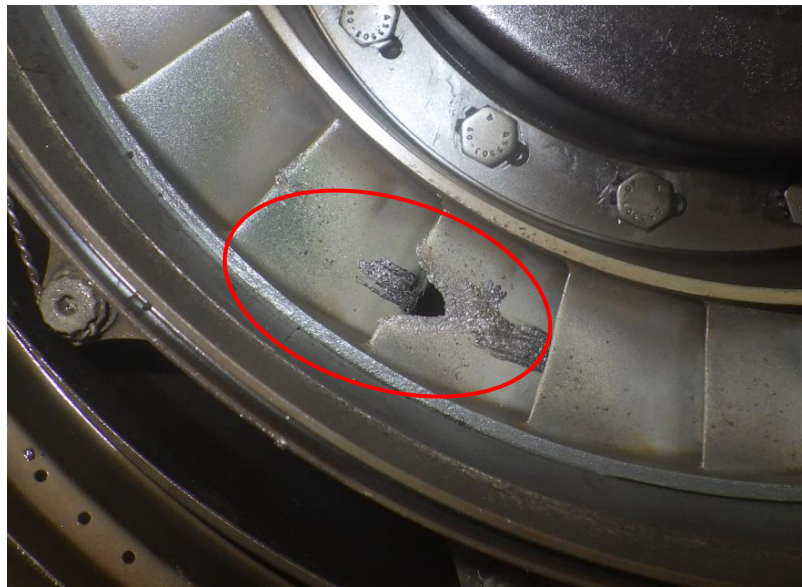
**Photo No. 39**

- 5.1 The two particles mechanically detached from the CT vane (Photo No. 39) were sent to the chemical laboratory (Photo No. 40). SEM-EDX analyses were performed on both particles and were identified as nickel alloy in presence of aluminum, titanium, chromium, cobalt, niobium and molybdenum (Photo No. 41 & Photo No. 40 and Tables No. 8 & 9). The alloy is undefined to a specific material. The high level of aluminum concentration could suggest the presence of a coating.
