# National Transportation Safety Board

CEN24LA146

## **POWERPLANTS**

Group Chairman's Factual Report

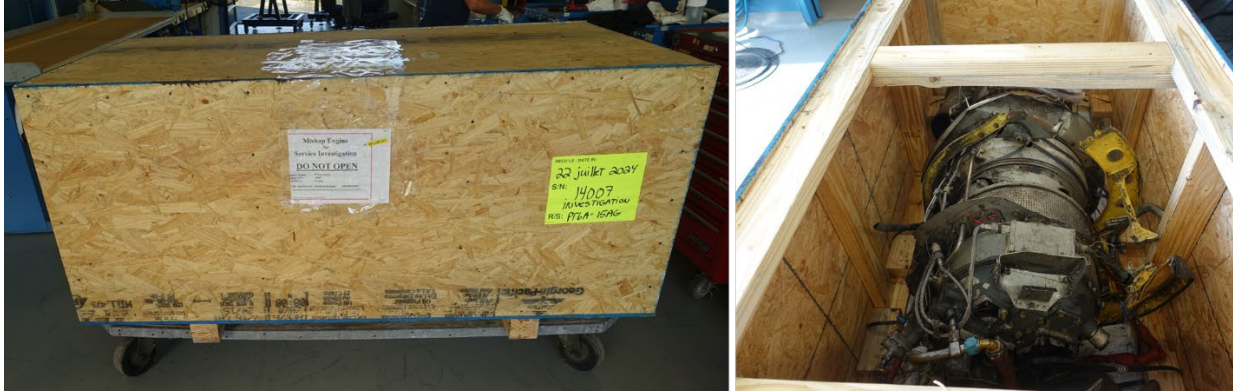
**Photo 3- ESN PCE-14007 Shipping Container, as Received**

The engine was secured in a wood shipping crate in the P&WC Plant 5, Service Investigation Quarantine Area when the NTSB arrived (**Photo 3**). The engine was shipped with the 3 o'clock position facing down and was held in place with banding to prevent movement. Multiple airframe components were shipped with the engine including a section of the engine mounting structure, fuel hoses, and sections of engine harness. When the engine was lifted by overhead hoist, clear fluid drained from the engine that looked and smelled consistent with water. The airframe components were removed to facilitate installation in the engine work stand (**Photos 4, 5, and 6**).

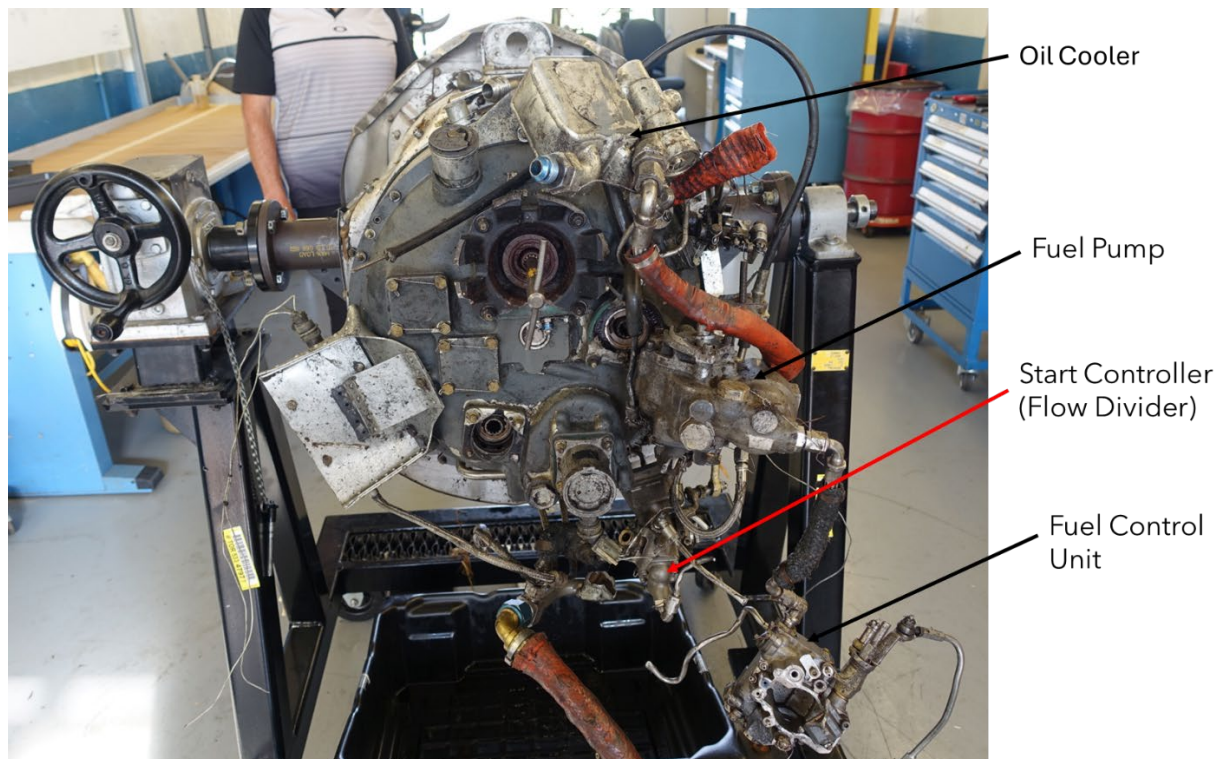
**Photo 7- Accessory Gearbox Components, Impact Damage**

All engine surfaces were covered with dirt and pond debris. There was no evidence of undercowl fire or radial uncontainment through the engine cases. The fuel pump and FCU exhibited impact damage and were separated from the accessory gearbox (AGB) mount pad and the flange connecting the two components was fractured. The start controller had impact deformation and was partially separated from the engine. The oil cooler and ignition exciter box had crushing damage and were displaced. The starter generator, No. 3 and 4 bearing scavenge pump, and RGB oil scavenge pump were not shipped with the engine, but their respective AGB mount pads were damaged consistent with separation during the impact sequence (**Photo 7**). The exhaust case had impact damage 360 degrees around the engine and clear liquid was pooled at the 6 o'clock position. The power turbine blades visible through the exhaust were all full length and in good condition. The propeller governor remained attached to the engine, but the speed lever assembly was impact damaged and the lever was rotated past the maximum stop (**Photo 8**). The beta valve plunger was manually opened and closed, and it moved smoothly across the stroke travel length. Beta components including the beta arm, retaining pin, and carbon block were deformed and/or out of normal position. The Ng and Nf spools were both seized and could not be rotated. The P3 and Py<sup>2</sup> line b-nuts connections were lockwired and torqued.

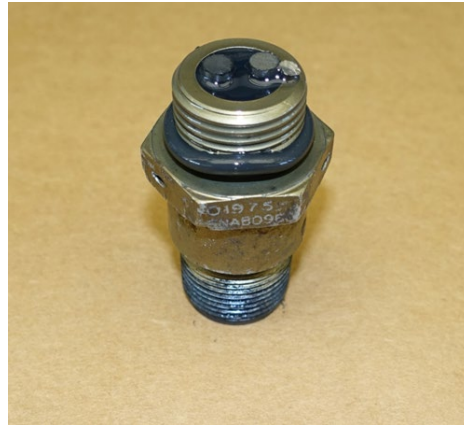
**Photo 9- RGB MCD Chip**

The RGB magnetic chip detector<sup>3</sup> (MCD) plug had one metal chip attached to one of the poles that did not bridge the gap between the poles (**Photo 9**). The oil and fuel filters had no visible obstructions between the filter pleats and appeared in good condition (**Photo 10**). The P3 air filter bowl and filter were filled with clear liquid (**Photo 11**).

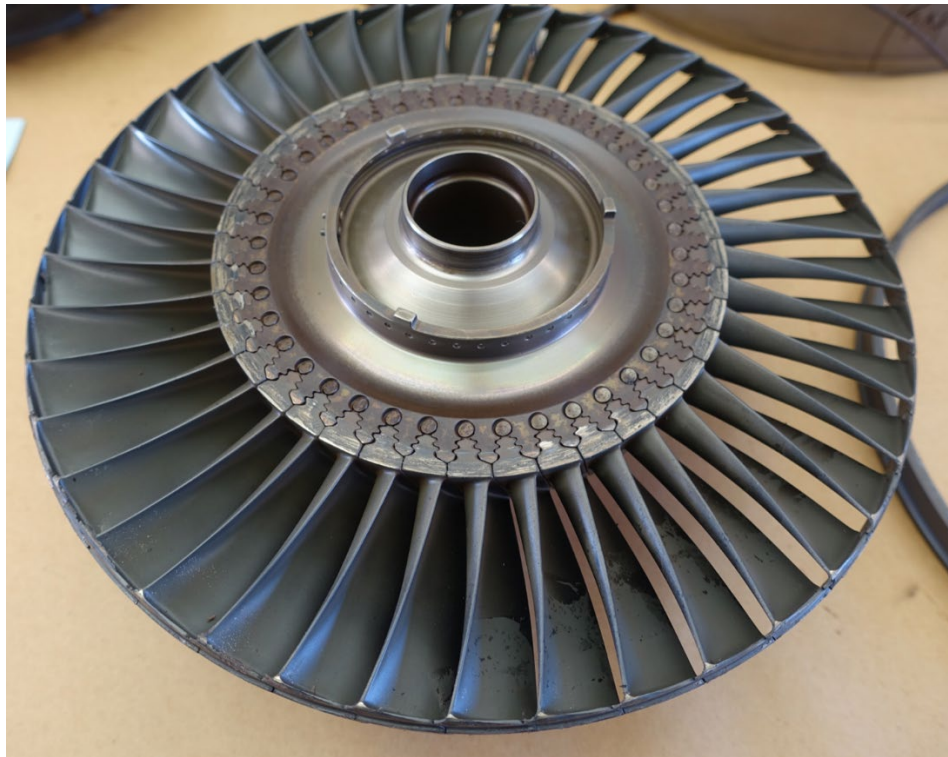
The PT blades were all complete with no leading or trailing edge impact damage (**Photo 12**). A 180 degree section of the blades were discolored with a debris that could be easily wiped off by hand, consistent with water submersion. The PT blade fir trees on the leading edge side of the disk had 360 degree rub damage with coincident circumferential rub on the aft/trailing edge side of the PT vane baffle. The PT vane baffle circumferential rub was deepest from the 10 to 6 o'clock positions and static impact marks were also present from the 4 to 10 o'clock positions (**Photo 13**). The PT blade outer platform had 360 degree rub damage with coincident rub on the PT blade shroud and aft surface of the PT outer diameter vane ring (**Photo 14**). The PT shaft was in good condition and unremarkable. The No. 3 roller bearing and No. 4 thrust (ball) bearing elements were intact and rotated smoothly (**Photo 15**).

**Photo 12- PT Blades, Fir Tree Circumferential Rub**

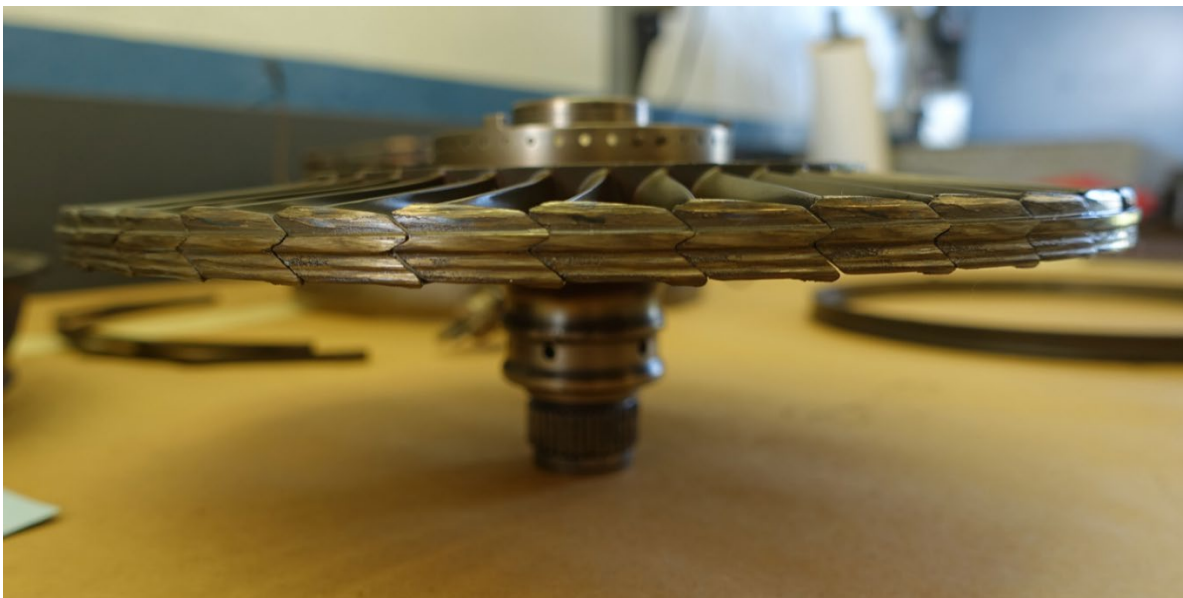
**Photo 14- PT Blade Outer Platform Rub**

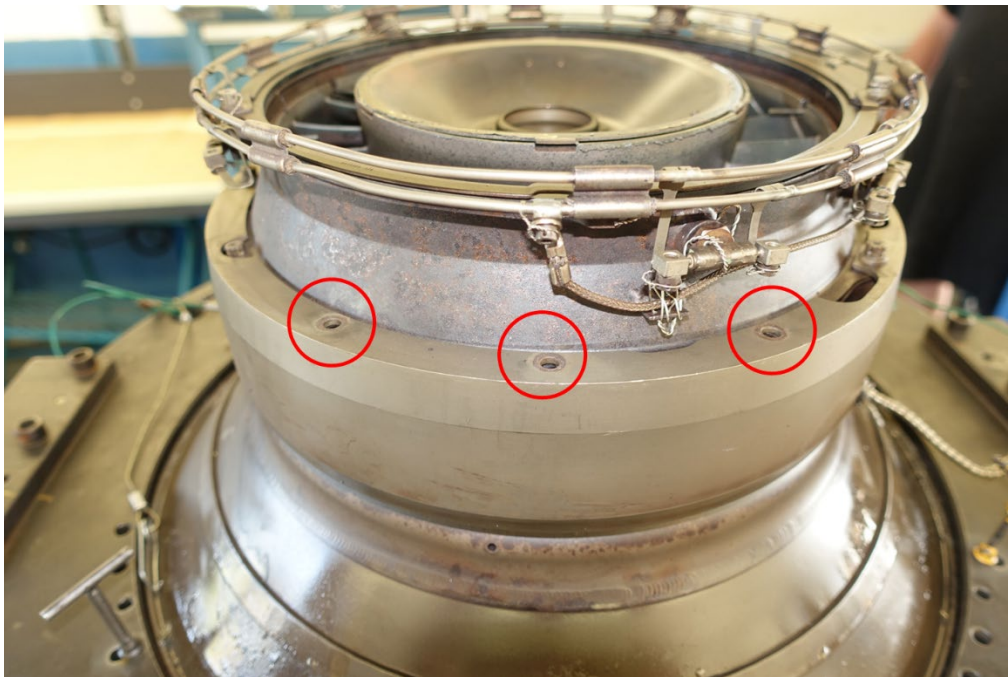
During disassembly, it was noted that three bolts were missing from the power turbine containment ring (**Photo 16**). The remaining bolts were not lockwired, as called out in the engine maintenance manual.

**Photo 16- Power Turbine Containment Ring, Bolts Missing**

The three loose bolts recovered from the large exit duct were arbitrarily identified as Bolt #1, Bolt #2, and Bolt #3 (**Photo 41**). The bolt dimensions were consistent with the missing PT containment ring bolts that were documented during the engine teardown. The markings on all three bolts were no longer visible and each exhibited oxidation and varying degrees of material loss. Bolt #1 showed no evidence of remaining silver plating. All Bolt #1 threads were eroded, and the head and washer section were worn and deformed. Bolt #2 also had no remaining silver plating. Bolts threads were still present and the thread diameter at the bolt tip was measured at 0.177 inch, which met minimum drawing specification. A second bolt thread diameter measurement at mid-length was 0.161 inch, indicating a progressive diameter

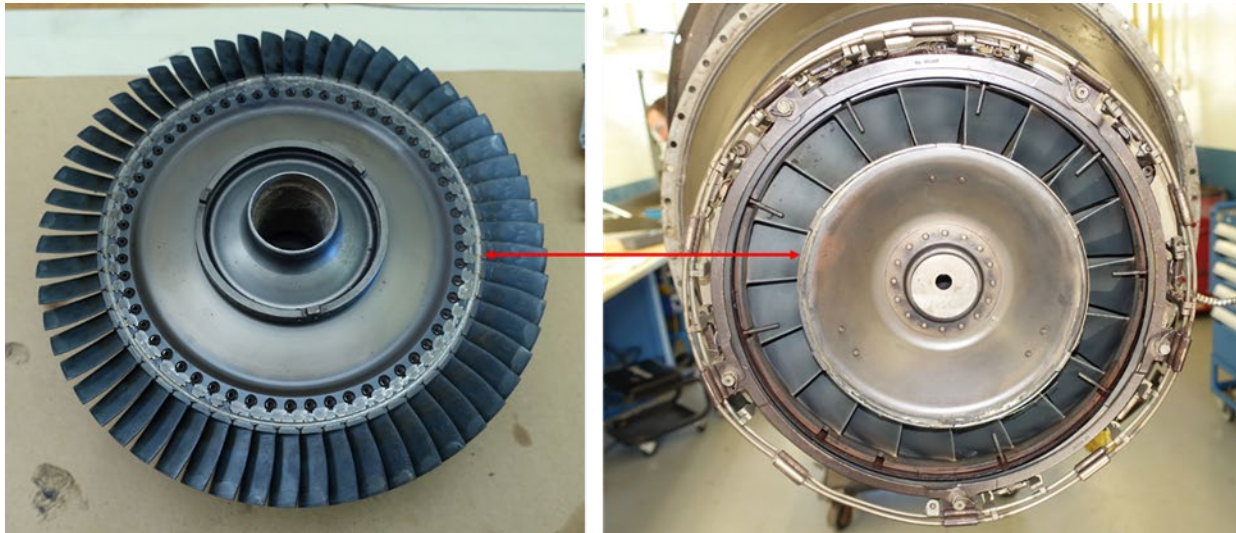
The CT blades were all complete and in good condition. Both the leading and trailing edge surfaces had dark discoloration that could be wiped off with a rag. The trailing edge CT blade platforms had 360 degree rub with coincident rub on the

forward side of the PT vane baffle (**Photo 17**). There was light tip rub on the CT blade tips and CT blade shroud.

**Photo 17- (L) CT Disk Trailing Edge, (R) PT Vane Baffle and Vanes**

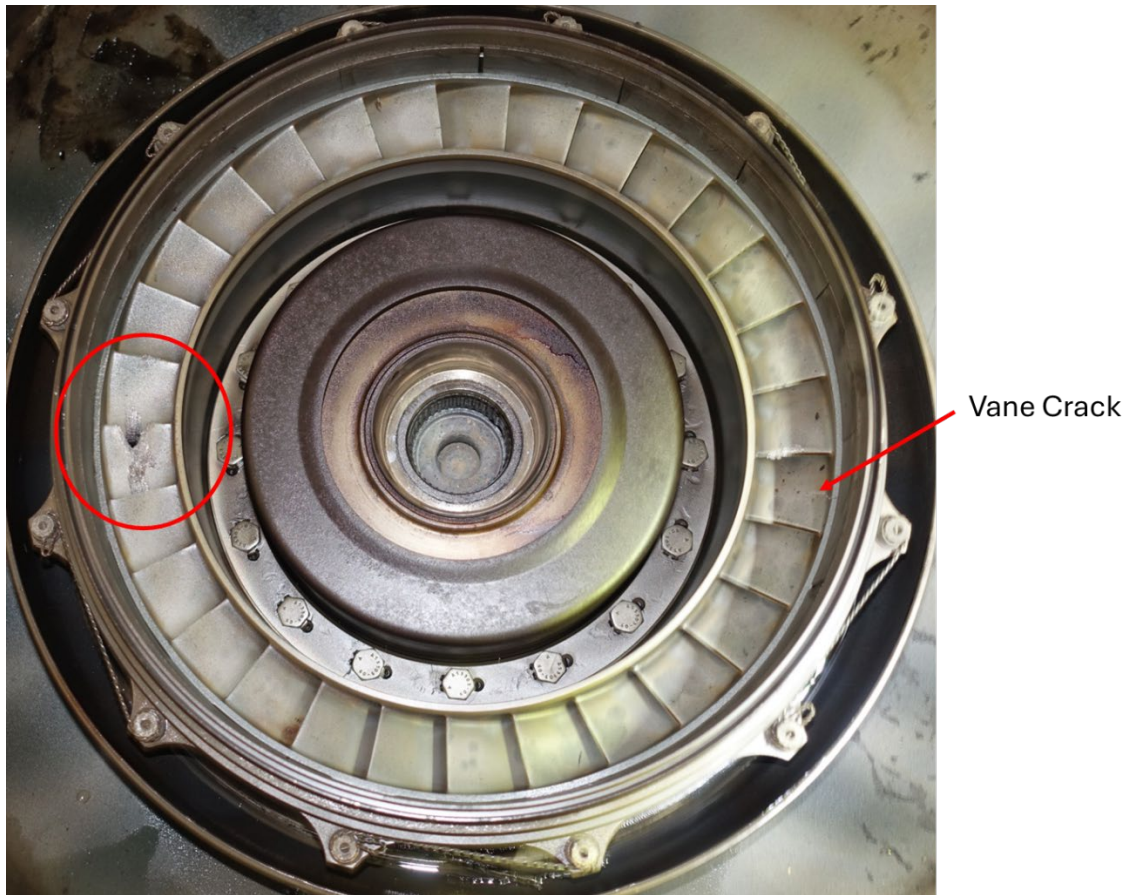
One CT nozzle vane at approximately the 8 o'clock position was missing material at the trailing edge/suction side midspan with shiny metal adhered along the full vane chord in line with where the vane material was missing (**Photo 18**). The adjacent, succeeding vane also had metal deposited on the trailing edge. One vane at approximately the 2 o'clock position had a crack at the outer platform that was visible on both the pressure and suction sides of the vane. The vane adjacent to the cracked vane also had metal deposits adhered to the trailing edge. The CT vane ring was sent to the P&WC Materials Laboratory to analyze the deposited material.

**Photo 18- CT Vane Damage, Missing Material, Metal Deposits**

The foreign material removed from the CT vanes was analyzed by SEM-EDS and identified as nickel alloy in presence of aluminum, titanium, chromium, niobium, and molybdenum (**Photo 43**). The source of the alloy could not be determined.

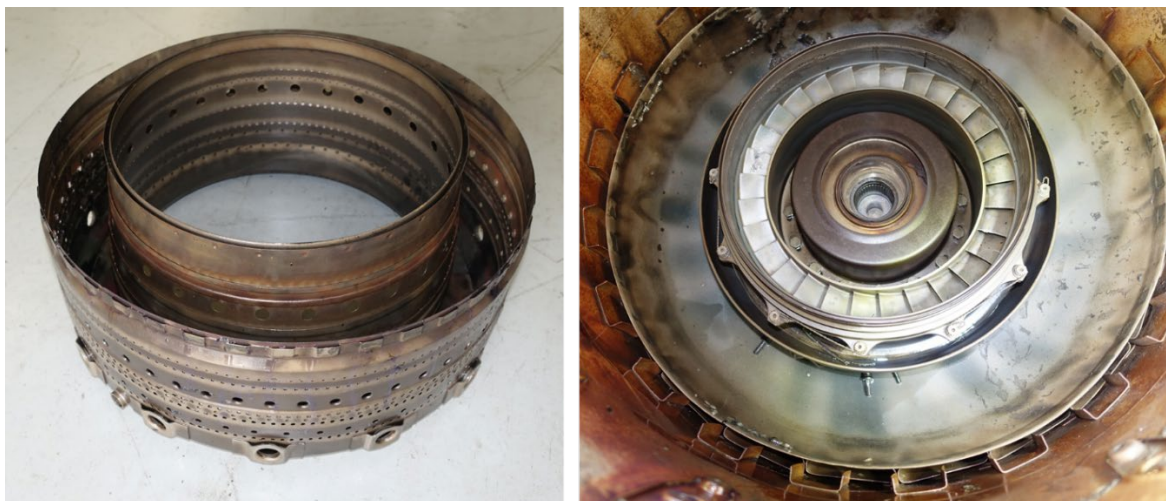
The combustion liner was intact and in good condition with no evidence of uneven wear, localized discoloration, or burn through. The fuel nozzles were all secure and did not have indications of carbon buildup or obstructions on the nozzle tips. Three loose bolts were recovered in the combustor large exit duct that appeared consistent with the missing power turbine containment ring bolts (**Photo 19**). The threads were stripped from one of the recovered bolts and the bolt shank and head appeared oxidized and deformed. The other two bolts also exhibited indications of discoloration and oxidation. The bolts were retained for materials analysis.

**Photo 19- (L) Combustion Liner, (R) Loose Bolts in Large Exit Duct**

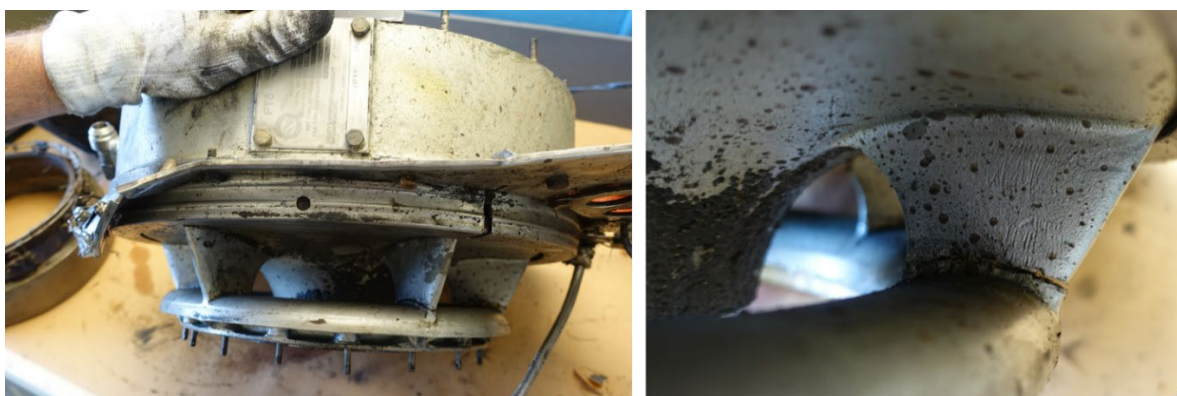
The inlet screen had minor dirt and pond debris buildup. Three of the six inlet case struts had transverse fractures consistent with impact (**Photo 20**). The fractured struts were located on the top half of the compressor case.

**Photo 20- Inlet Case Strut Fractures**

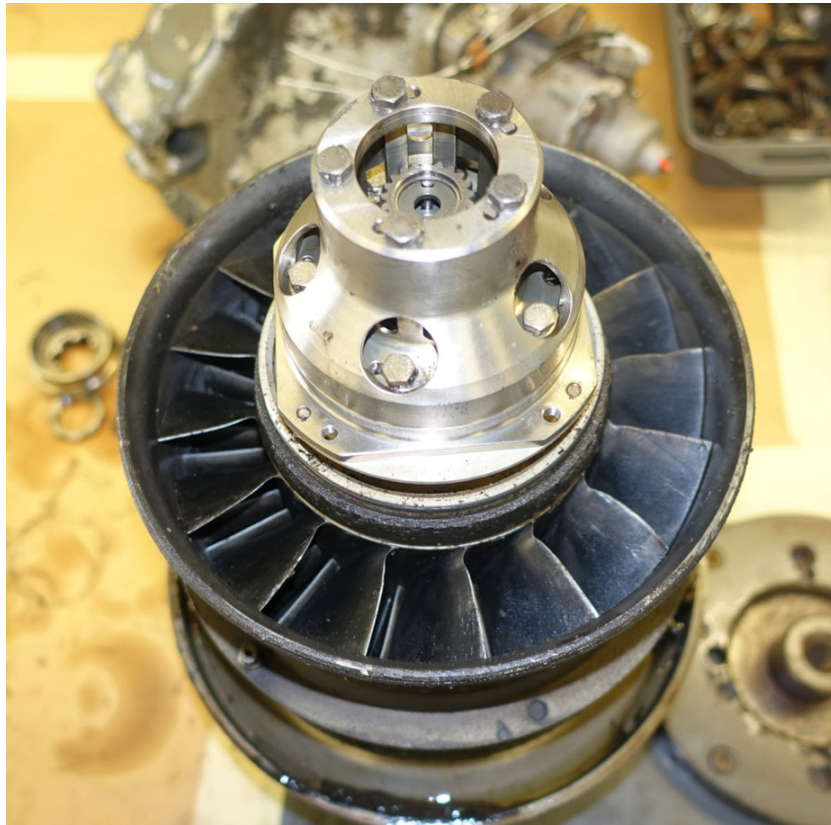
The compressor module was discolored and had a scum-like buildup at multiple locations. The 1<sup>st</sup> stage blades had leading edge erosion (**Photo 21**). The 1<sup>st</sup> stage stator vanes, 2<sup>nd</sup> stage blades, 2<sup>nd</sup> stage stator vanes, and 3<sup>rd</sup> stage blades had hard body impact damage, most concentrated along the outer half of the blade/stator vane span (**Photo 22**). The compressor impeller vanes were all intact and in good condition with light 360 degree vane tip rub. There was coincident 360 degree rub on the compressor impeller shroud (**Photo 23**). The No. 1 thrust, and No. 2 roller bearings were intact and rotated smoothly<sup>4</sup> (**Photo 24**). The compressor

**Photo 21- 1<sup>st</sup> Stage Compressor Blades**

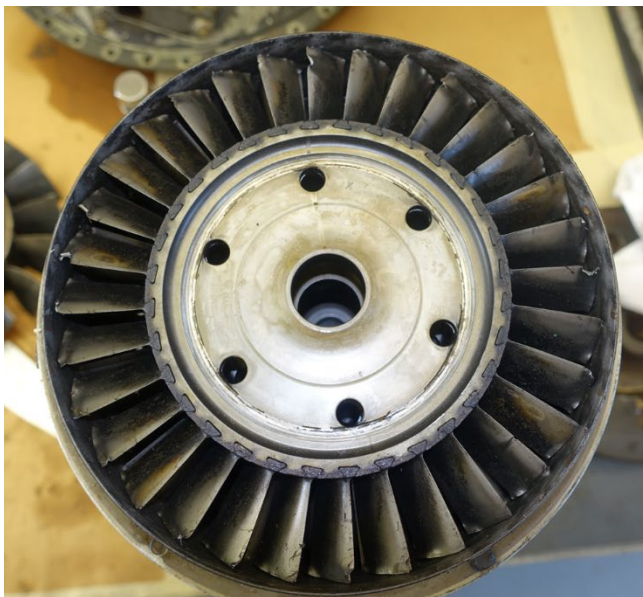
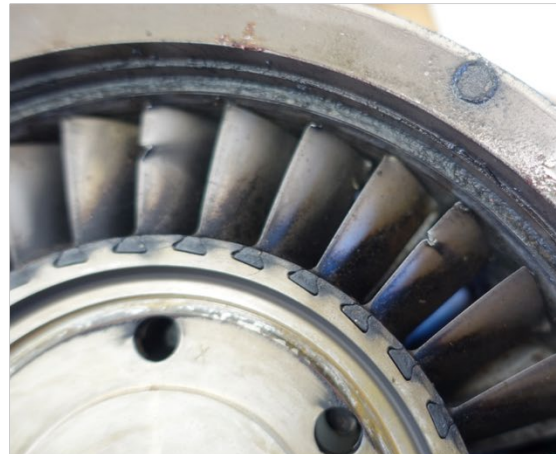
**Photo 22- (L) 2<sup>nd</sup> Stage Compressor Rotor Blade Damage, (R) 3<sup>rd</sup> Stage Compressor Rotor**

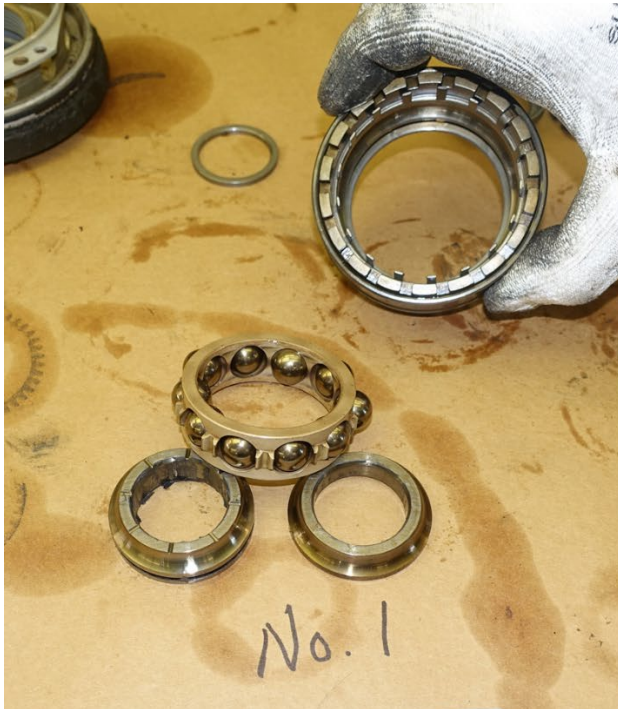
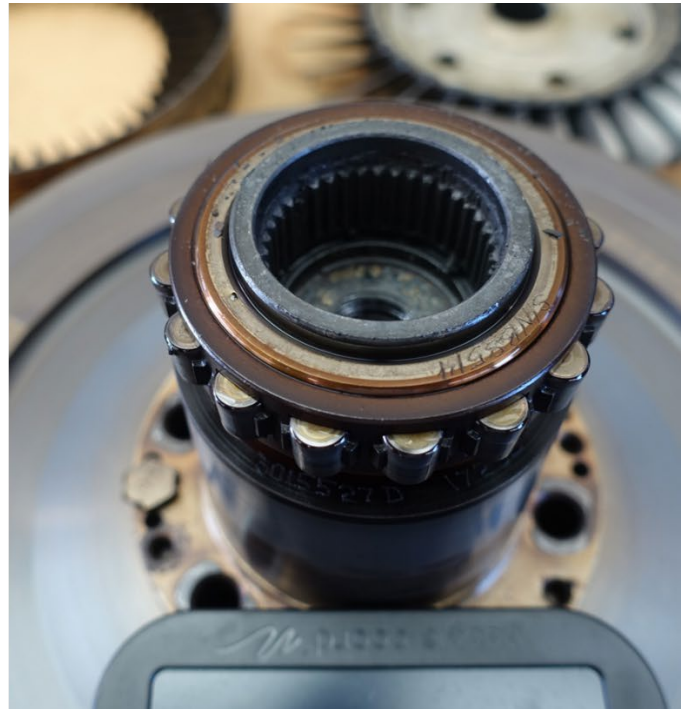
**Photo 24- (L) No. 1 Bearing, (R) No. 2 Bearing**

<sup>4</sup> All four engine bearings had minimal oil wetting. The bearings were submerged in water following the accident.

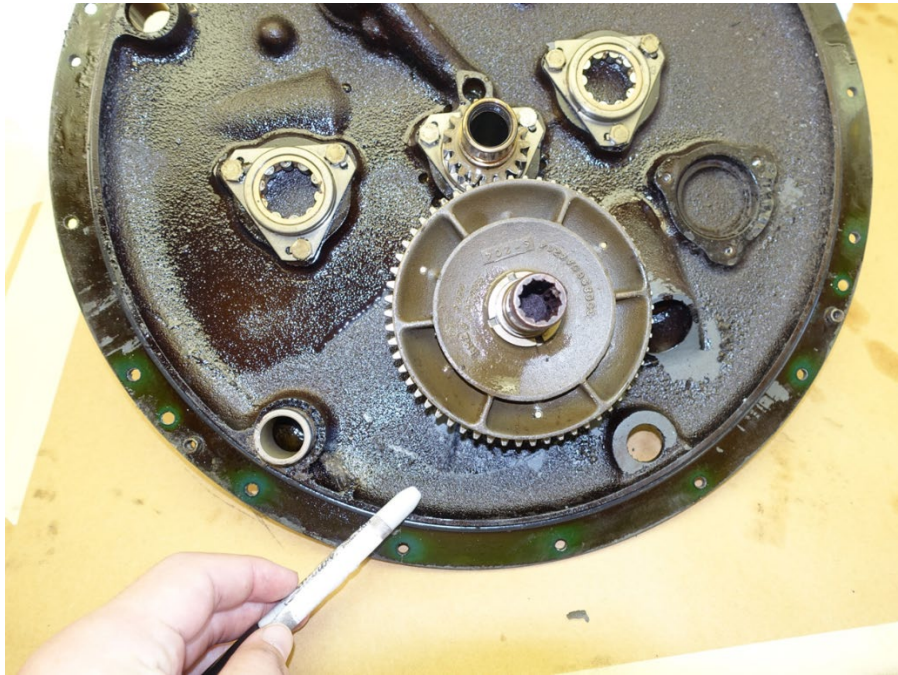
The AGB housing cover had a penetration and surrounding deformation at approximately the 6 o'clock position that prevented the AGB breather gear from rotating (**Photo 25**). All other internal gears were intact (**Photo 26**). The oil pressure supply and scavenge pumps rotated with light resistance but following disassembly, all gears were intact.

**Photo 25- AGB Case Impact Damage, 6 o'clock Position**

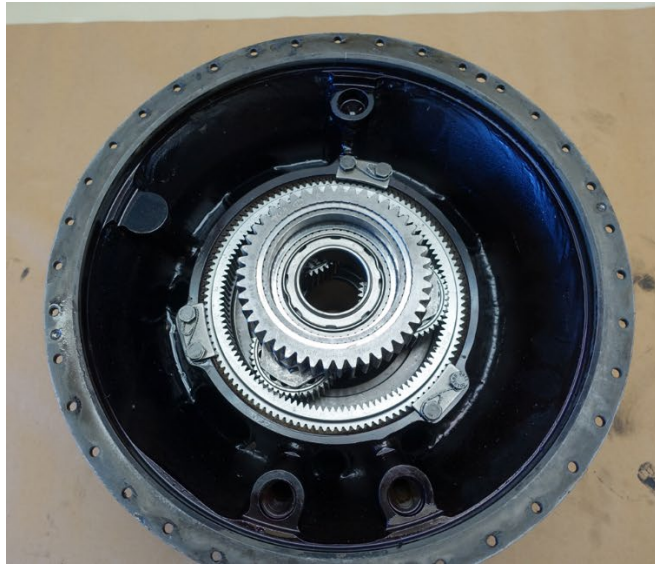
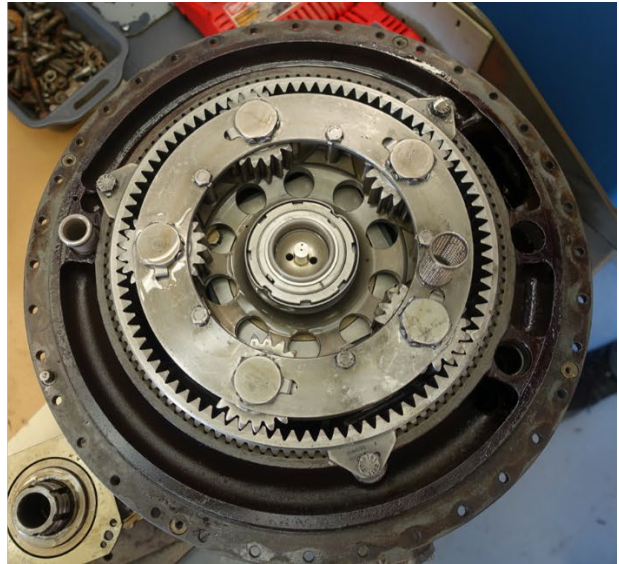
**Photo 27- RGB Gears**

The RGB was disassembled, and the sun gear and high speed gears (planet gears) were intact and rotated smoothly (**Photo 27**). The RGB MCD strainer had slimy residue adhered to the screen. The RGB oil strainer had minor dark debris buildup, but the screen was not obstructed (**Photo 28**).

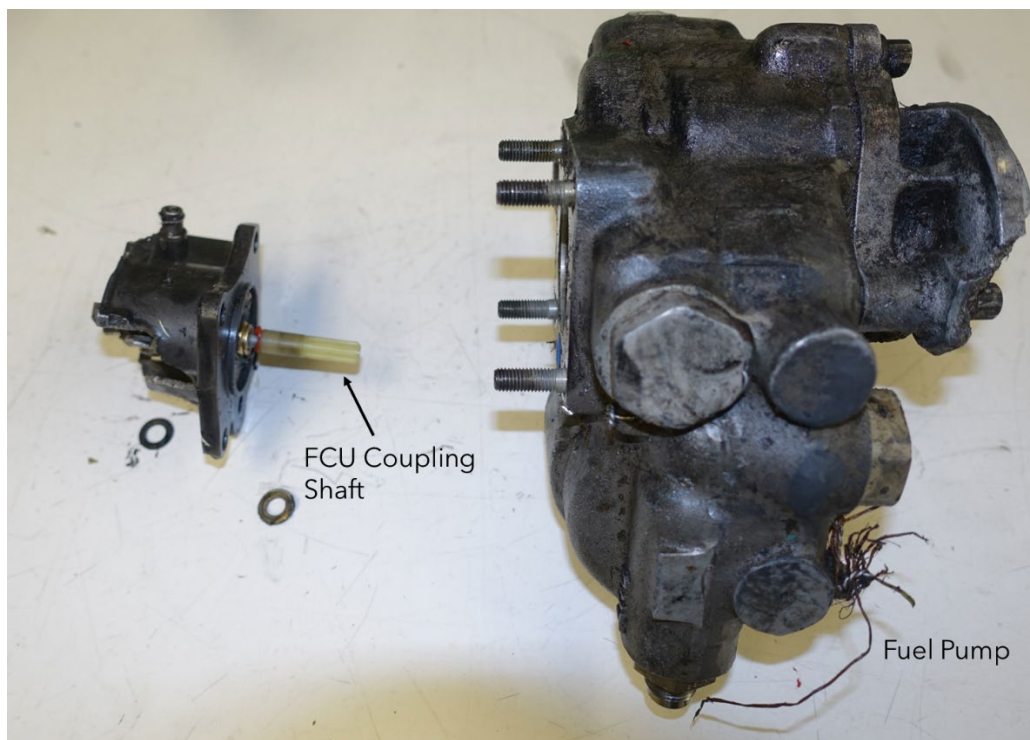
**Photo 29- FCU-to-Fuel Pump Coupling Shaft**

The fuel pump remained attached to the AGB, but the FCU was fractured at the drive body and separated from the fuel pump. The exterior surfaces of both components were coated in dark earthen debris. The fuel pump-to-FCU nylon coupling shaft was intact and there was continuity between the two components<sup>5</sup> (**Photo 29**).

<sup>5</sup> According to P&WC, the fuel pump to FCU coupling will often experience a torsional failure when there is a sudden engine stoppage at high power due to impact.

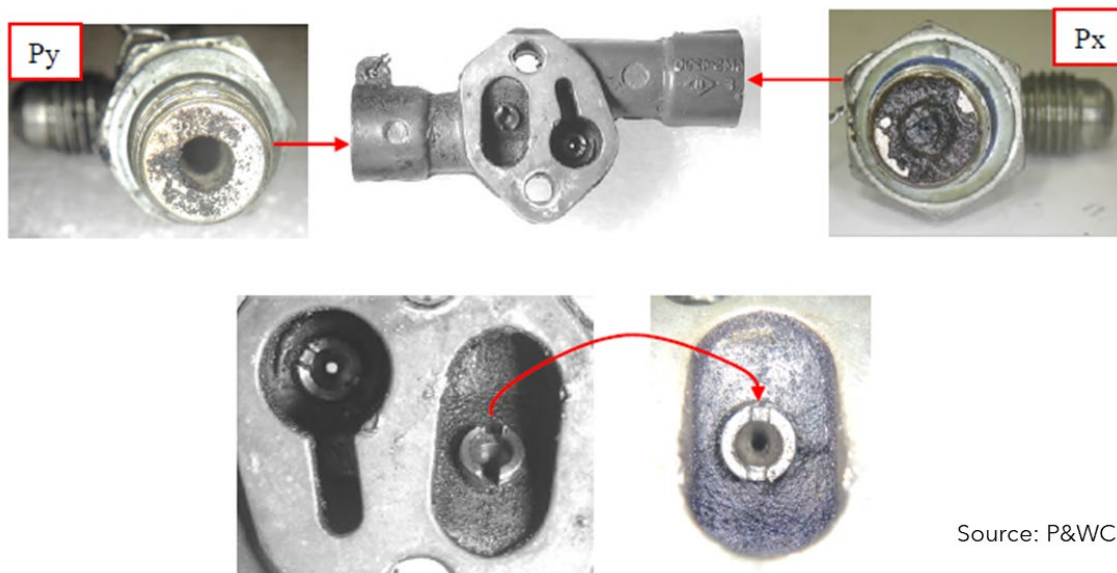
**Photo 30- FCU Air Inlet Adapter, Px and Py Fittings, Px and Py Orifices**

missing. The FCU air inlet adapter Px and Py fittings both had dark debris accumulation, with more significant buildup on the Px fitting. The air inlet adapter Px and Py orifices both had dark discoloration but neither the Px and Py orifices were obstructed (**Photos 30**). The Px and Py inlet adapter fittings and FCU air inlet adapter were retained for additional lab analysis. The FCU bellows had impact damage at the FCU case nut that deformed the threaded portion of the acceleration bellows. The acceleration bellows were intact, and the bellows measurement was within allowable component manual limits (**Photo 32**). A pressure leak check was performed on the FCU governor bellows that confirmed that there was no air leakage. The FCU metering valve was intact and undamaged. The metering valve slid smoothly in the valve sleeve. The FCU torque arm was intact and passed a pressure leak check. The FCU bypass valve diaphragm was intact and in good condition. The FCU data plate back face was marked "OH 7/08/2021", indicating that the unit was overhauled on July 8, 2021. The partially disassembled FCU is shown below in **Photo 33**.

Debris samples were collected from multiple locations on the FCU air inlet adapter and Px and Py fittings with a tungsten needle. The samples were analyzed by Fourier Transform Infrared Spectroscopy (FTIR) and SEM-EDS. All samples collected contained an ester based compound as well as silicon, aluminum<sup>6</sup>, and carbon. Particles of silicon, oxygen, and carbon were present in all samples, and suggested silicates/silicon carbide present in the environment. The P&WC materials lab analyzed the Px and Py orifices under magnification and confirmed neither orifice was obstructed by debris.

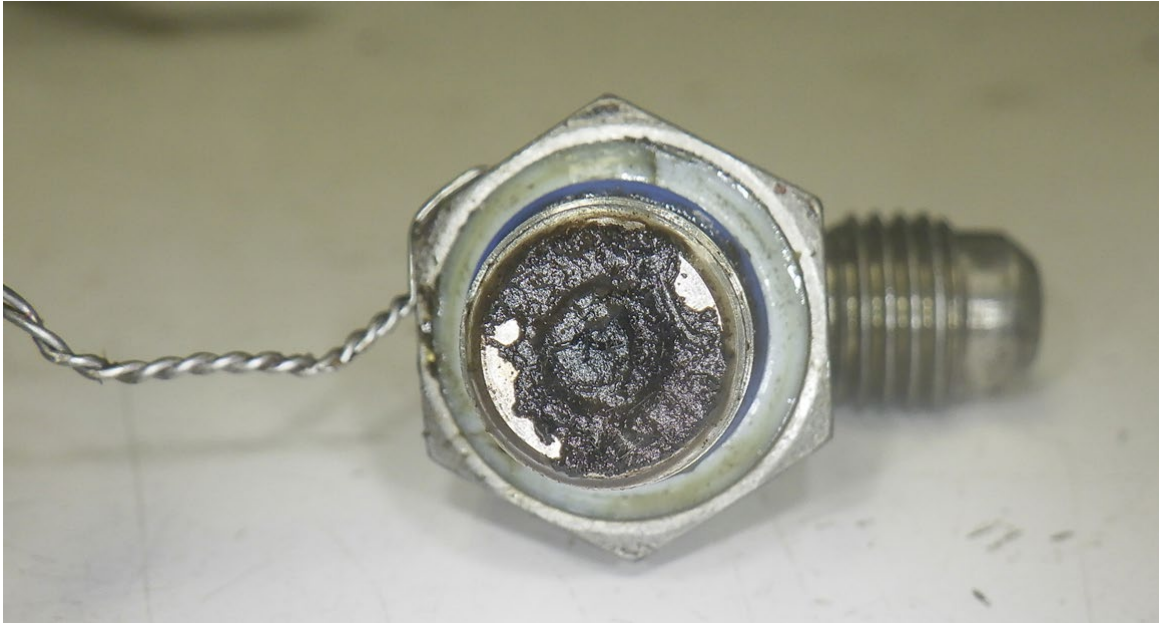
**Photo 31- FCU Air Inlet Adapter, Px Fitting Obstruction**

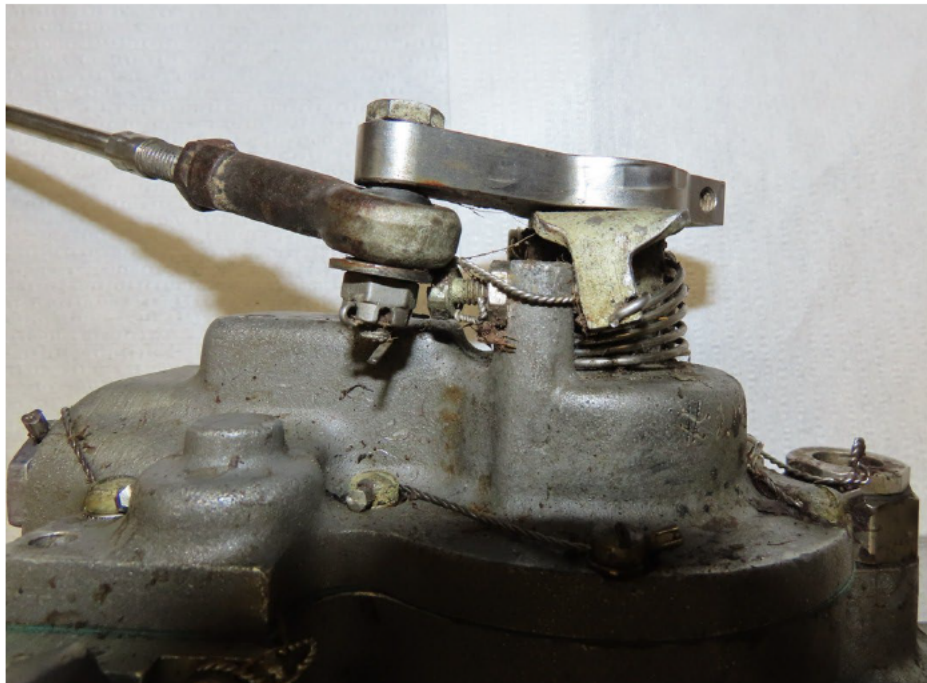
The propeller governor was intact with grass and dirt debris on external surfaces. The customer installed hardware and speed setting lever had impact deformation, and the lever stop was displaced beyond the high speed stop. The reset lever rotated along the full length of travel, but the mechanic stated that the rotation felt "a little sticky." The driveshaft rotated normally. The lockwire, seals, and torque sealant were non-Woodward parts. The propeller governor was installed on the test bench in the as-received condition (**Photo 37**). The governor was tested in accordance with test specification procedure (TSP)-810, revision AH. Multiple test points were outside of specification due to the speed setting lever deformation (**Photo 38**). The customer installed hardware attached to the speed lever was removed, which restored normal rotation of the speed setting lever. The bench test procedure was run again, and all test points were consistent with similar service run

**Photo 38- Propeller Governor, Speed Setting Lever Stop Damage**

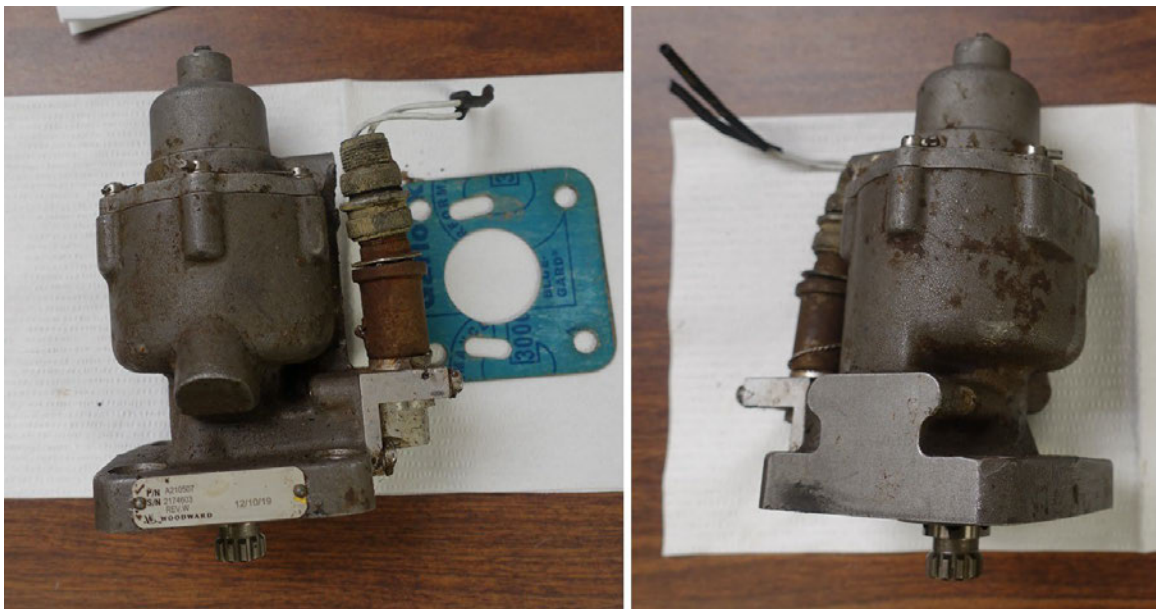
**Photo 39- Overspeed Governor, as Received**

The overspeed governor was intact with grass and dirt debris on external surfaces (**Photo 39**). The receptacle was bent but the wiring appeared to remain connected. The mechanic noted non-Woodward lockwire, seals, and torque sealant. The input driveshaft rotated normally. The overspeed governor was installed on the test bench and tested in accordance with TSP-847, revision AC (**Photo 40**). The maximum speed was recorded above specification. According to Woodward, the recorded value was typical of customer field adjustment. All other test points were within TSP specification.

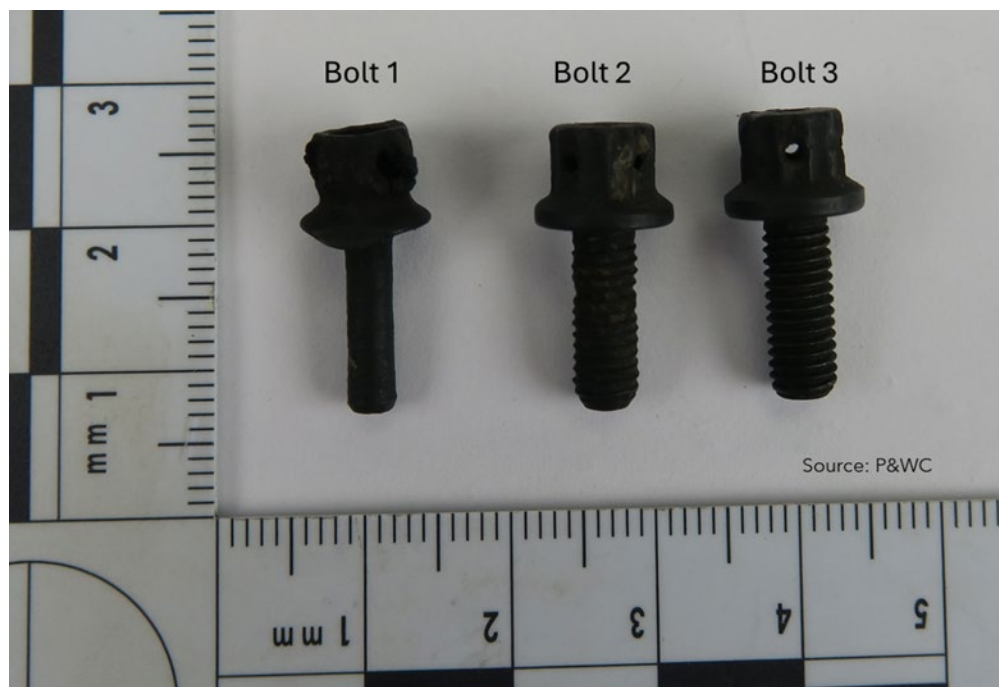
**Photo 41- Loose Bolts Recovered from Combustor Large Exit Duct.**

reduction along the bolt length. A magnified visual examination of the remaining threads did not show evidence that the threads had been stripped. Scanning Electron Microscopy- Energy Dispersive X-Ray Spectroscopy (SEM-EDS) identified iron, molybdenum, chromium, and manganese as the primary elements present on the bolt surface. These elements are not consistent with the bolt base material composition. The high oxygen content on the surface was consistent with corrosion. A cross section of Bolt #2 was taken to perform microstructure analysis. The bolt microstructure consisted of grains typical of solution aged stainless steel with no anomalies observed. Microhardness measurements at the threaded section were consistent with the bolt being exposed to temperatures exceeding 1325°F. The Bolt #3 thread diameter met drawing specification without evidence of diameter reduction along the bolt length. SEM-EDS analysis of the bolt surface identified corrosion products and remnants of silver plating. There was also a high amount of nitrogen, silicon, and carbon which were consistent with foreign debris.

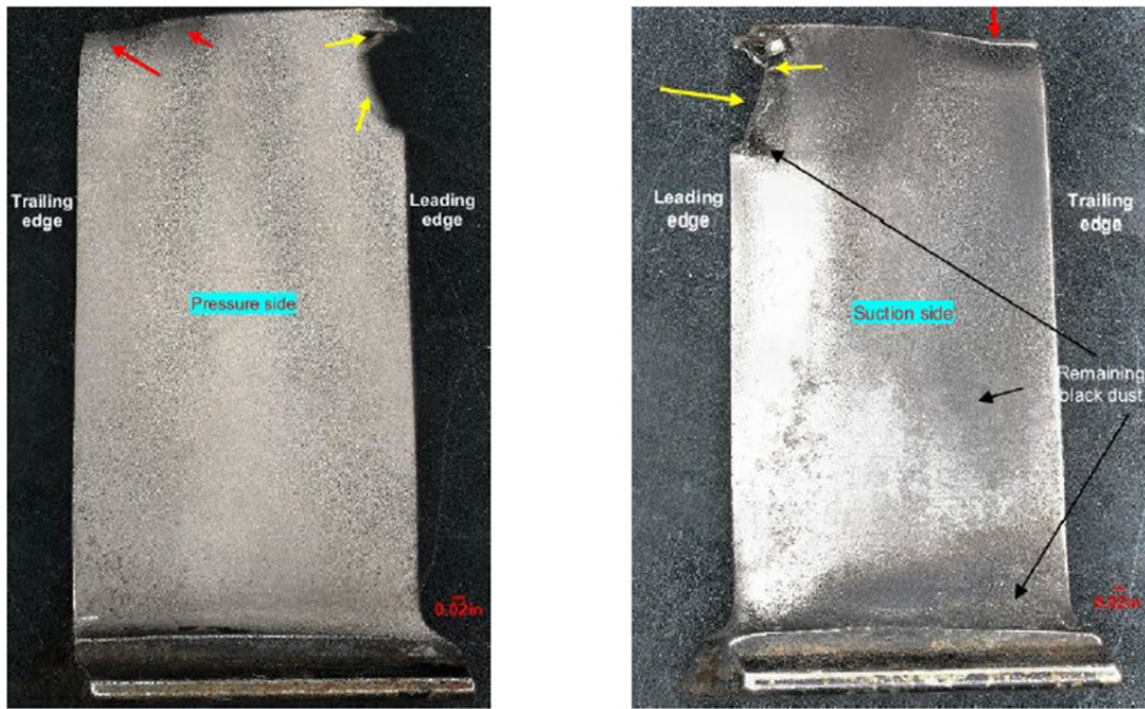
All 32 2<sup>nd</sup> stage compressor blades were received at the lab and arbitrarily identified from 1-32. Blades #5 and #26 had the most significant damage and were selected for analysis. Both blades (5 and #26) showed evidence of impact deformation along the blade tip and leading edge (**Photo 42**). The direction of deformation was from the pressure side toward the section side. SEM analysis of the metal at the blade tip identified aluminum content consistent with transferred material. The source of the transferred aluminum could not be determined. According to P&WC, there are no components in the engine gaspath upstream of the 2<sup>nd</sup> stage compressor blades with similar material composition. The remaining foreign

materials detected on the examined blades were consistent with airborne contaminants. The blade base material met drawing specification, and no other material anomalies were identified.

**Photo 42- 2<sup>nd</sup> Stage Compressor Blade #5 Damage**

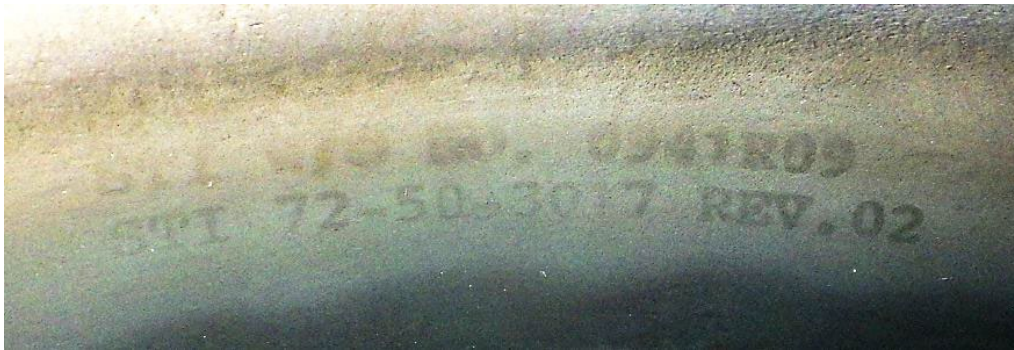
**Photo 44- CT Vane Ring Markings**

The compressor turbine vane ring was marked STI W/O No. 0941R09 STI 72-50-3017 Rev. 02. According to P&WC, the markings indicated that the CT vane ring underwent a non-P&WC approved repair. The CT vane repair was performed by an FAA approved repair station.
