# National Transportation Safety Board

CEN24LA147

## AIRCRAFT EXAMINATION

Location: Bluff Dale, TX  
Date: 4/3/2024  
Time: 2211 cdt  
Airplane: N8946, Bellanca 7KCAB

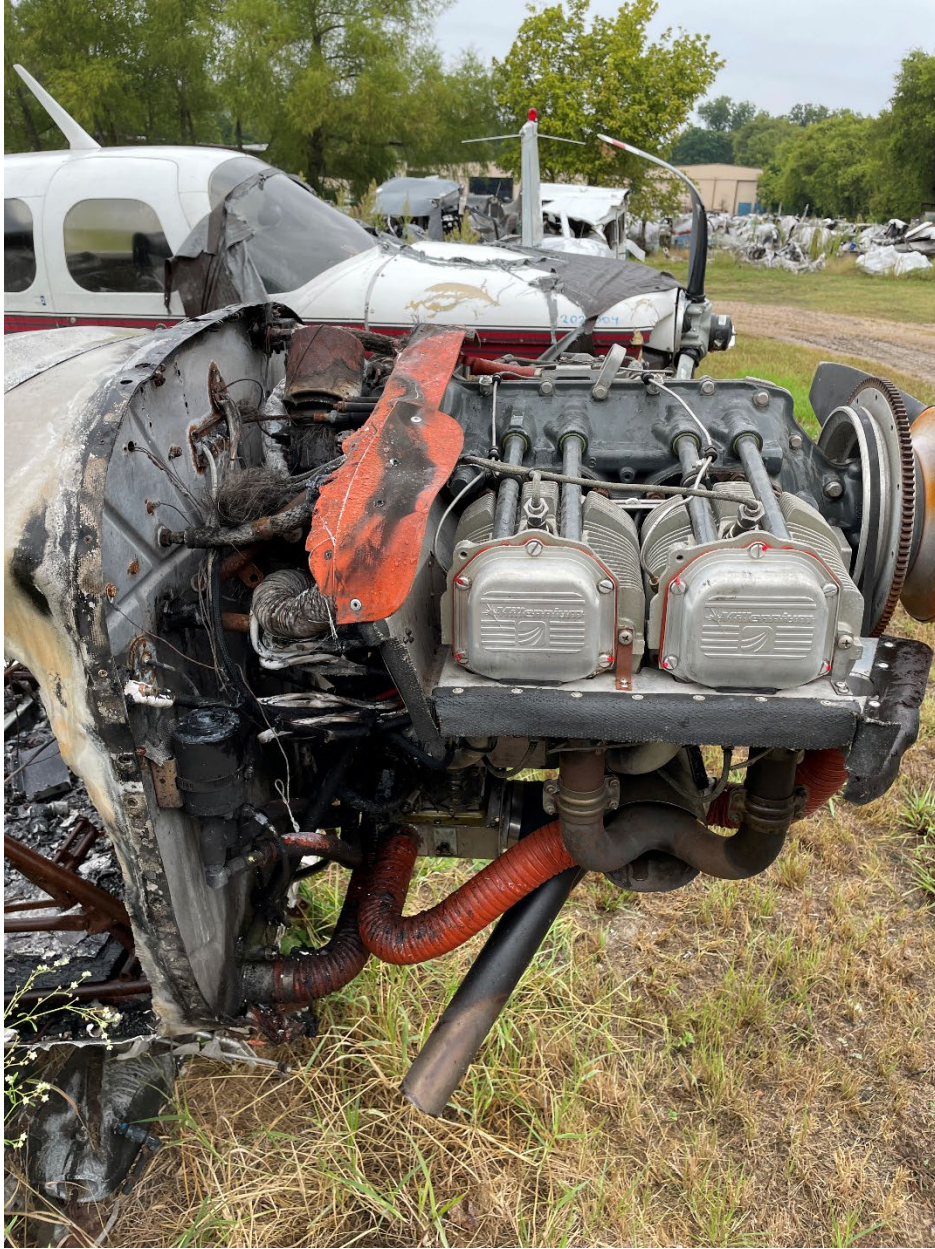
that the fire was coming out of the cowling near the oil filler access door on the cowling. During the examination, the cowling was removed, and fire damage was evident toward the rear of the engine. The lower part of the engine, including the sump and carburetor area, did not have significant evidence of fire damage. Based on damage to components in the engine compartment, the damage appeared to be centralized near the centerline of the engine between the firewall and the rear of the engine. The fuel and oil hoses on the rear of the engine all had fire damage as did other engine components in that area. The fittings on each hose were not found to be loose. A bundle of wires near the engine mount had melted and their conductors were in contact with the metal engine mount tube. The extent of the fire damage to hoses and other components in the area prevented positive determination of the source of the fire.

Figure 1. Engine viewed from right side.

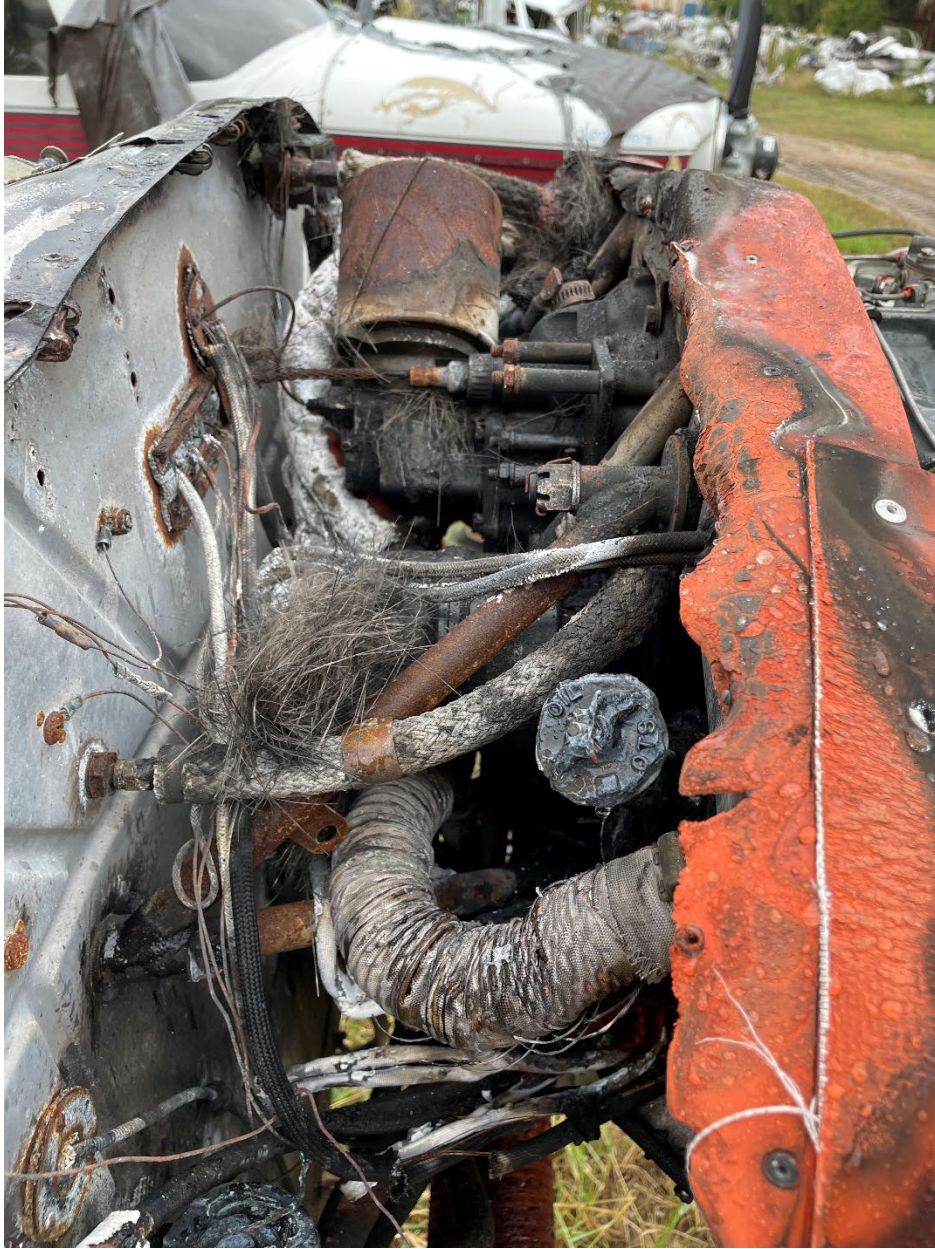
Figure 2. Area between engine and firewall as viewed from right side.

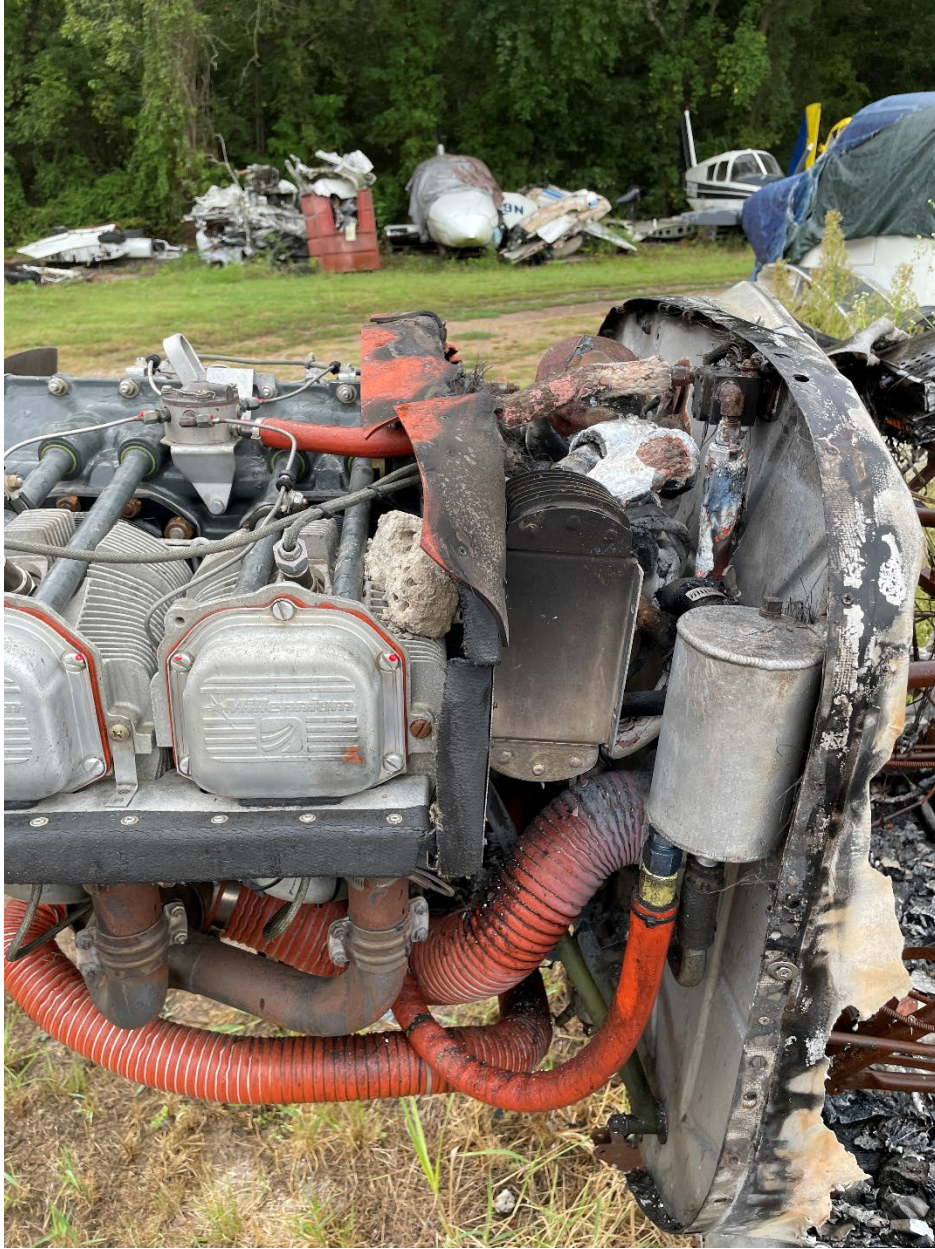
Figure 3. Engine viewed from left side.

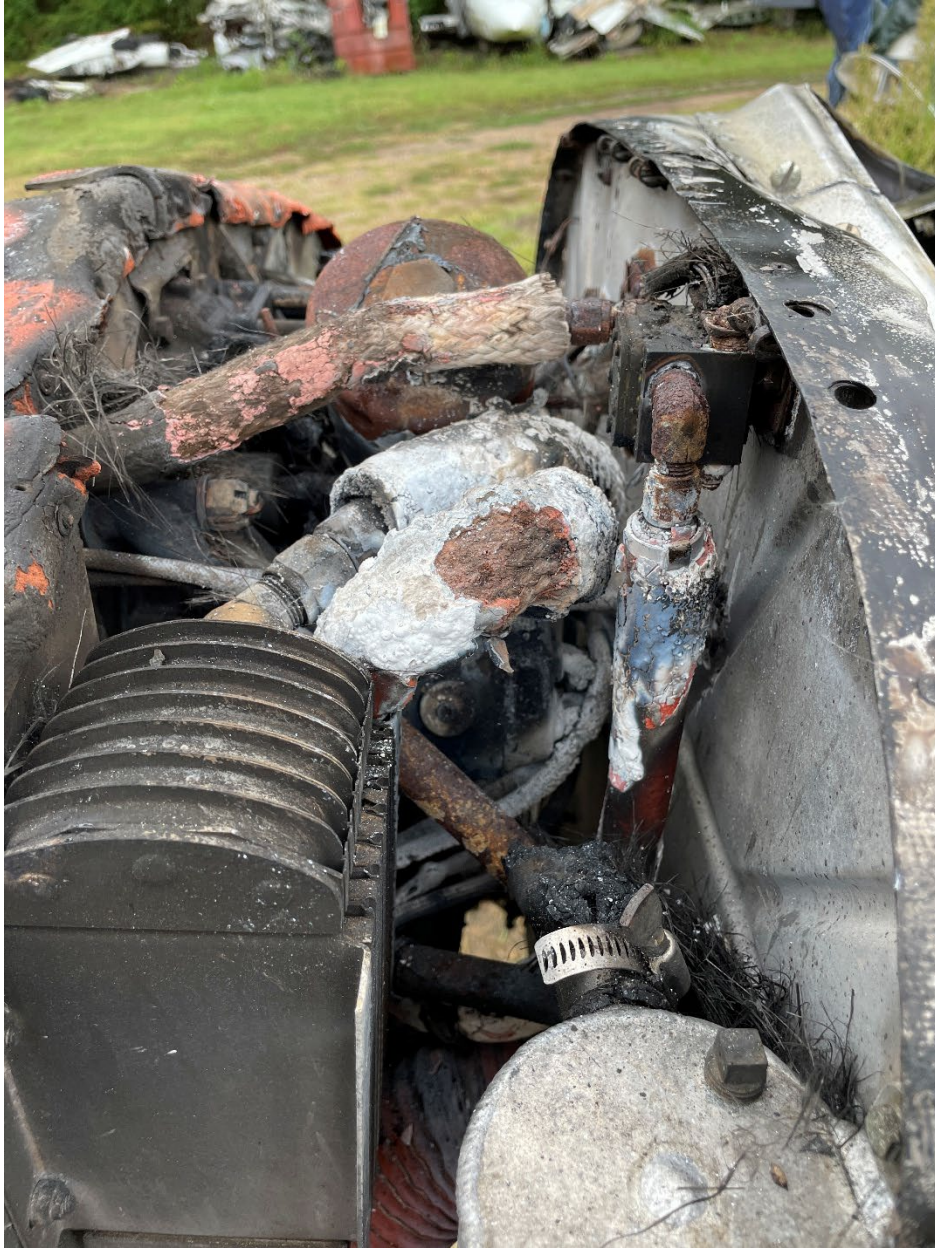
Figure 4. Area between engine and firewall as viewed from left side.
