[CEN24LA152]

## INVESTIGATION PHOTOGRAPHS

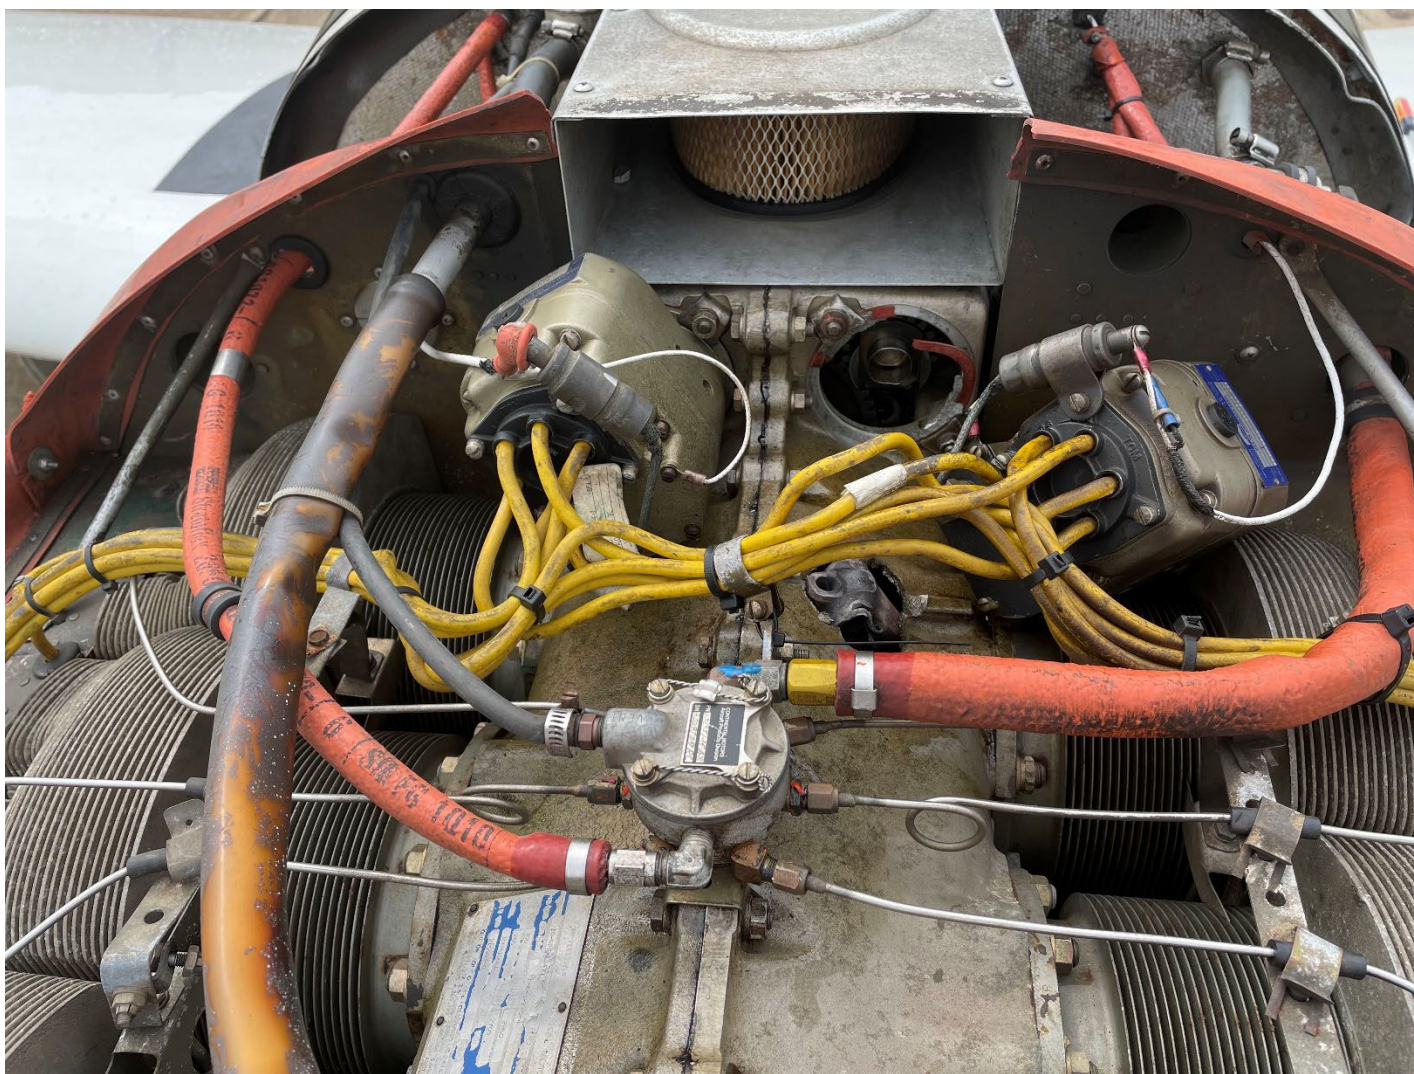
**Photograph 1 - Engine (Courtesy of FAA)**

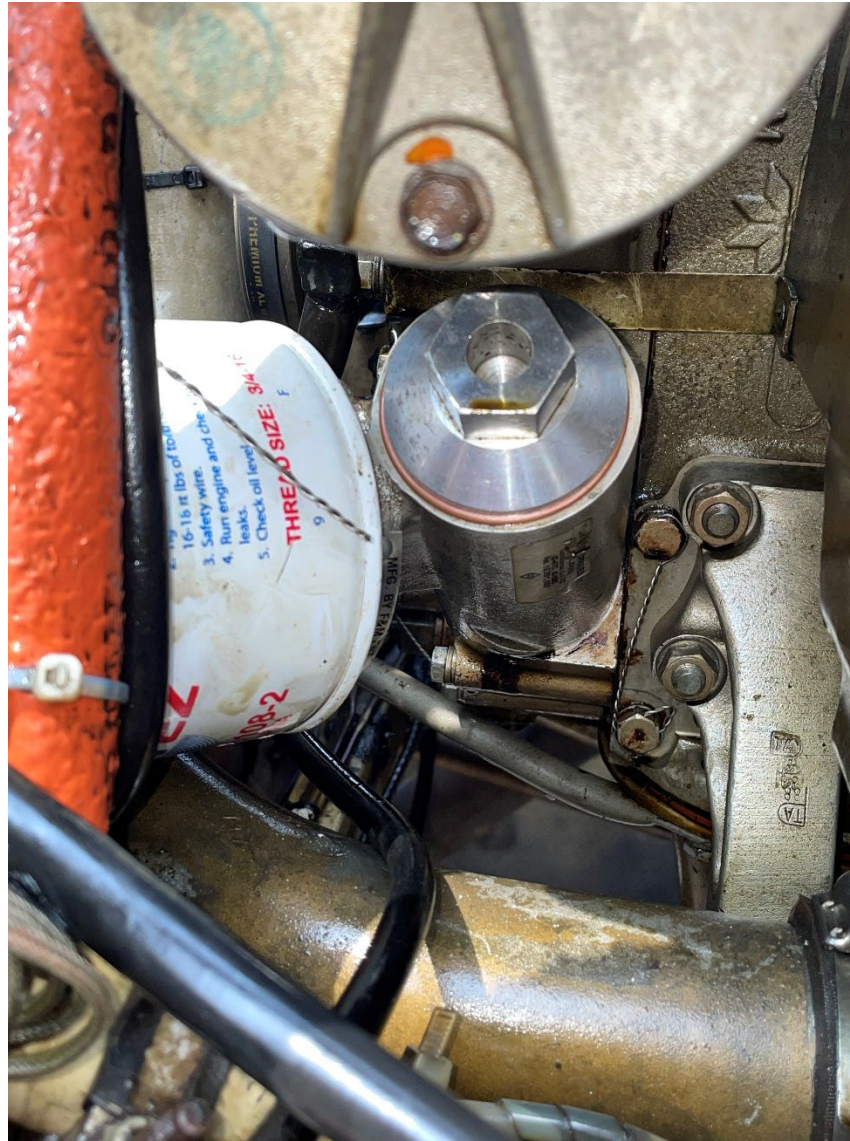
**Photograph 2 - Oil filter and oil adapter - note cut safety wire (Courtesy of FAA)**

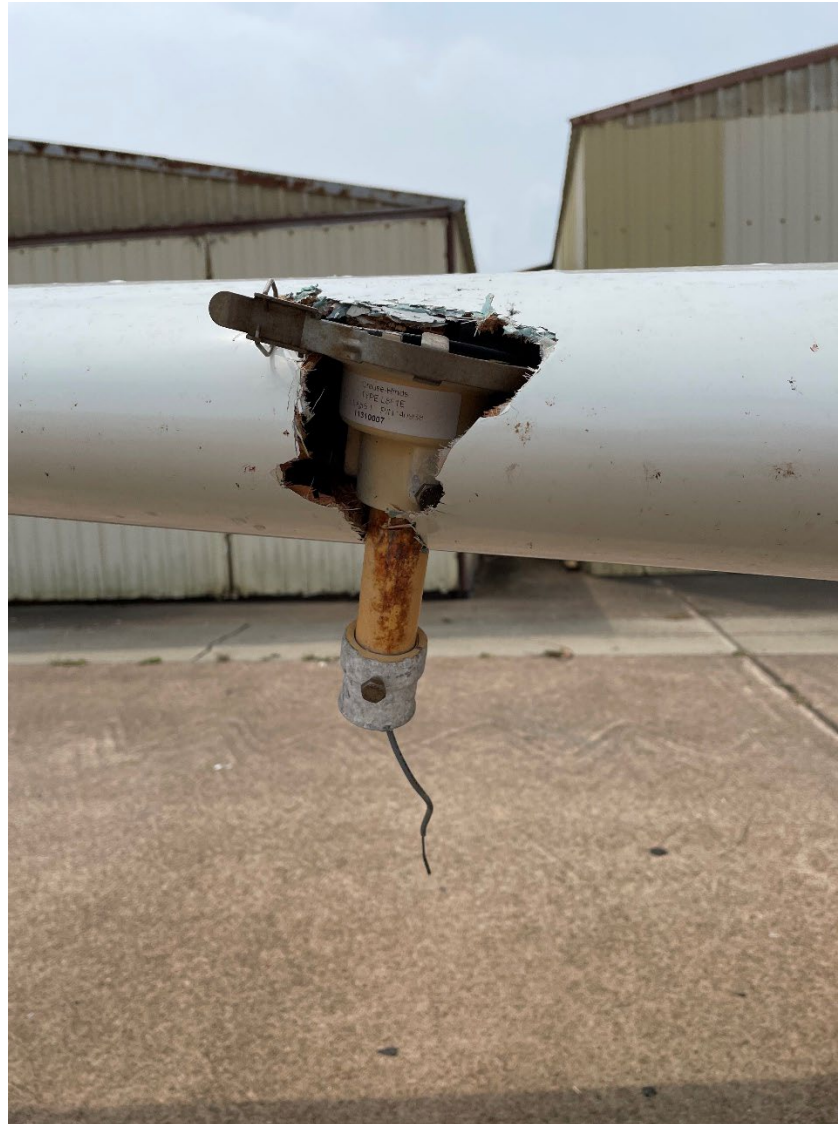
**Photograph 3 - Runway light in wing (Courtesy of FAA)**

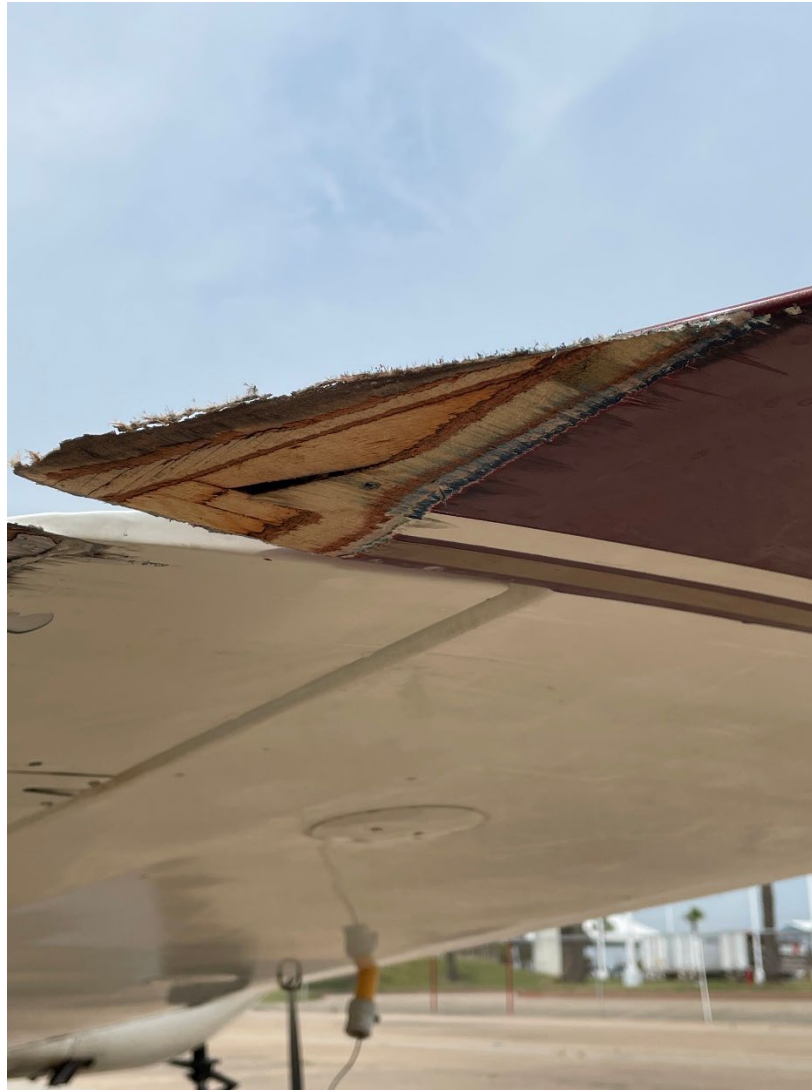
**Photograph 4 - Damage present on outboard end of right wing (Courtesy of FAA)**
