# National Transportation Safety Board

CEN24LA155

## EXAMINATION SUMMARY

Location: Sullivan, Missouri  
Date: April 11, 2024  
Time: 0825 central daylight time  
Airplane: Piper PA-32, N651ED

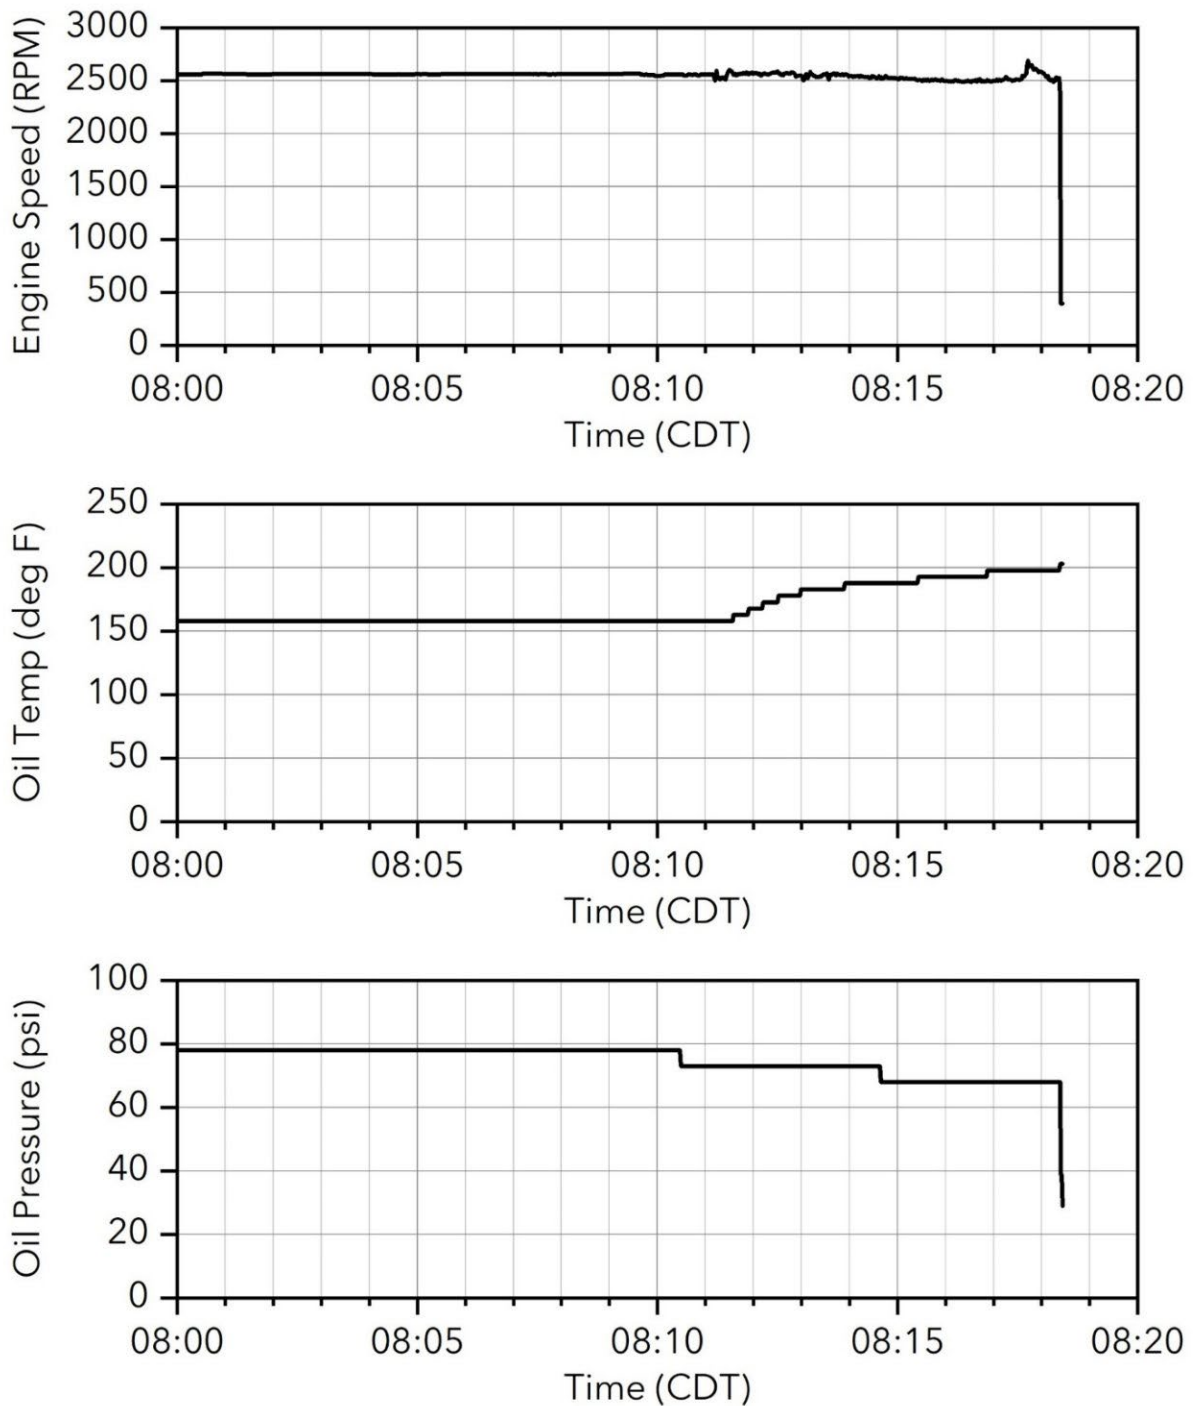
## **Figure 1: Plots of recorded engine data (engine speed, oil temperature, oil pressure)**

A postaccident review of the airplane's engine monitor data revealed an increase in oil temperature and a decrease in oil pressure before the total loss of engine rpm, as shown in figure 1.

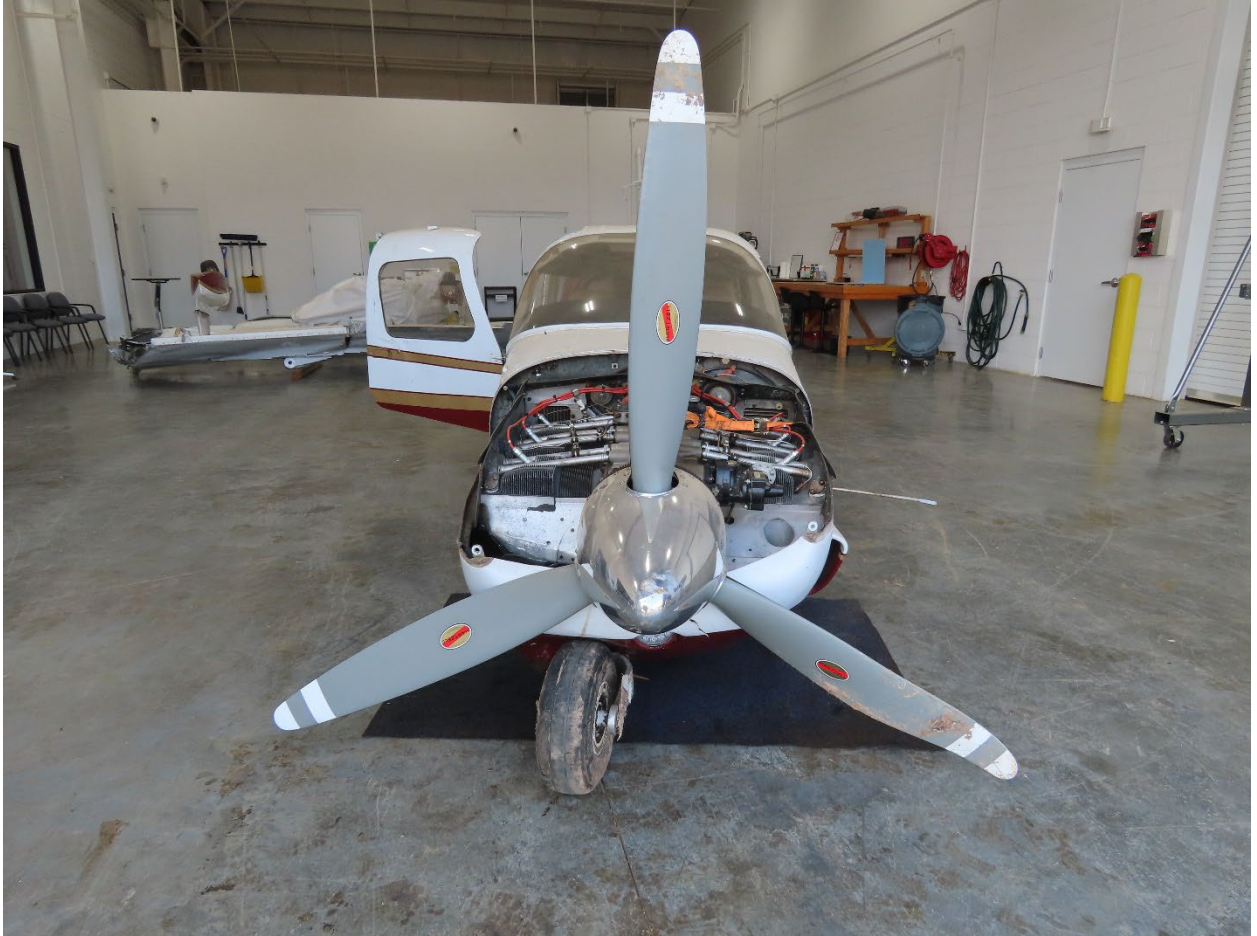
**Figure 2.** Propeller, engine and fuselage as presented for examination.

Little to no impact damage was noted to the engine or its accessories except for a crack in the engine case above the number 3 cylinder on the right hand engine case half and bent pushrods on cylinder number 3. The engine mount suffered minor impact damage from the collapsing of the nose gear during the accident sequence. The 3-bladed propellor was found attached to the engines crankshaft with one of the three blades having a small bend towards the tip (Figure 2). The other two blades remained undamaged.

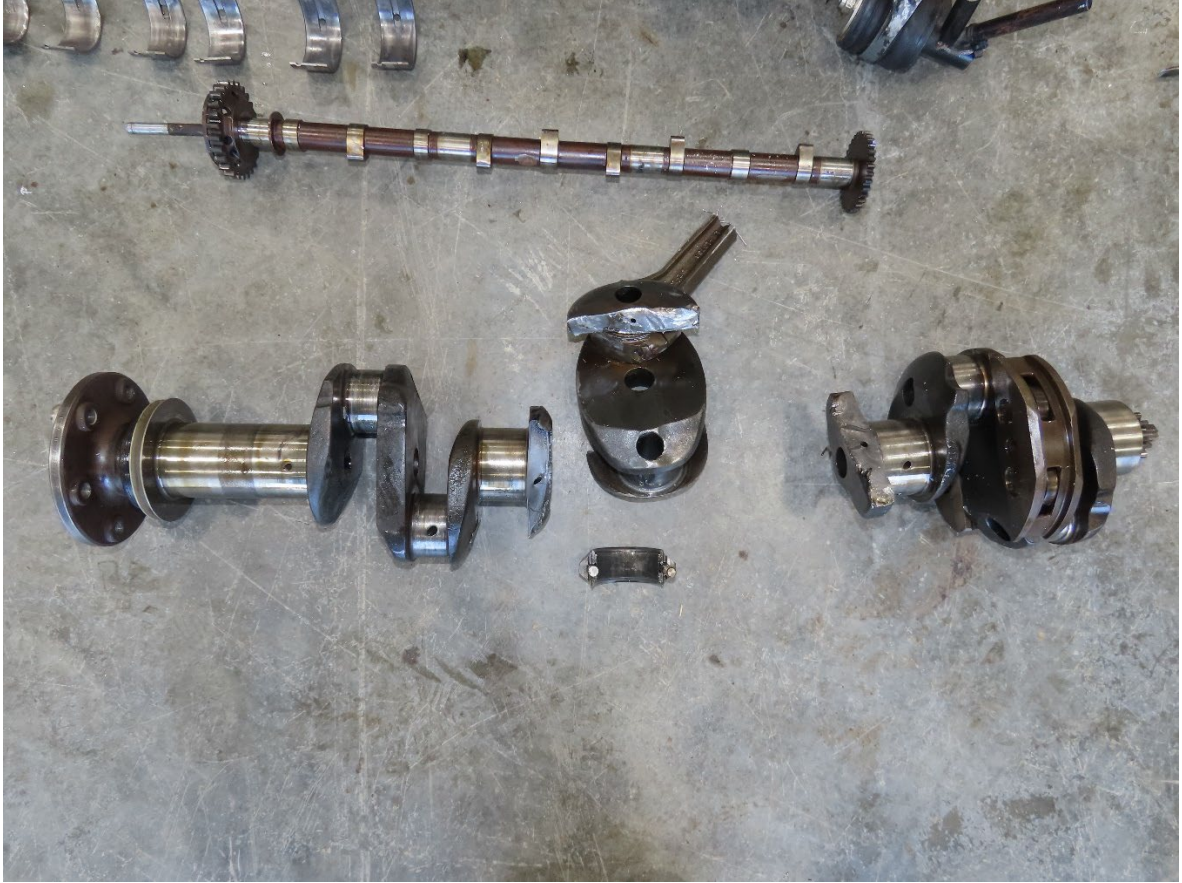
**Figure 3.** Crankshaft

All cylinders were found tightly installed to the engine case and removed for examination. Cylinders number 1, 2, and 6 were removed with minor resistance once attaching hardware was removed. Cylinders 3, 4, and 5 were met with resistance during the removal process due to internal engine damage but eventually removed from the case halves. The case halves were split by removing all thru studs. The engines crankshaft was found to be fractured in two different areas (Figure 3). The crankshaft was sent to the NTSB materials laboratory for further analysis. Metal shavings were found inside the case (Figure 4). The center portion of crankshaft containing the journals for cylinder numbers 3 and 4 were fractured and punctured a hole through the bottom the engine case halves into the oil sump. The connecting rod for cylinder number 4 remained attached to the crankshaft but was found fractured near the piston pin end of the rod. The connecting rod for cylinder number 3 was found attached to the crankshaft and piston pin but was twisted along its axis. The camshaft was intact with no observed fractures. All lobes were undamaged and did not show signs of wear or corrosion. Damage was noted along its overall length in the form of gouges and bends from rotating components coming into contact during the accident sequence only. Tappets for the intake side of cylinder number 3 and 4 were noted to be fractured along each shaft but present within the engine at time of the exam. These fractures appear consistent with rotation damage caused during the accident sequence.
