# National Transportation Safety Board

CEN24LA155

## **MATERIALS LABORATORY**

Factual Report 25-052

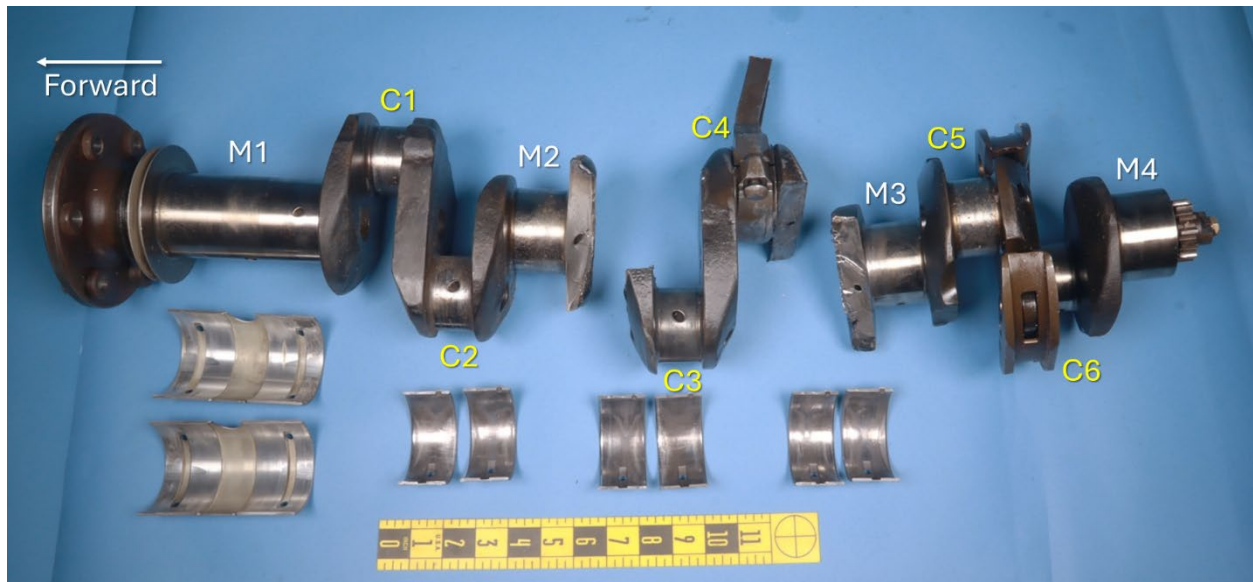
Figure 1 shows the crankshaft and several adjacent components, as received by the NTSB Materials Laboratory. The crankshaft, which had fractured through two of the webs, also included the remnants of a connecting rod and cap at the number 4 location. The counterweights on the web between the C5 and C6 journals were still attached.

Figure 1. The fractured pieces of the crankshaft, positioned with the bearings, as received.

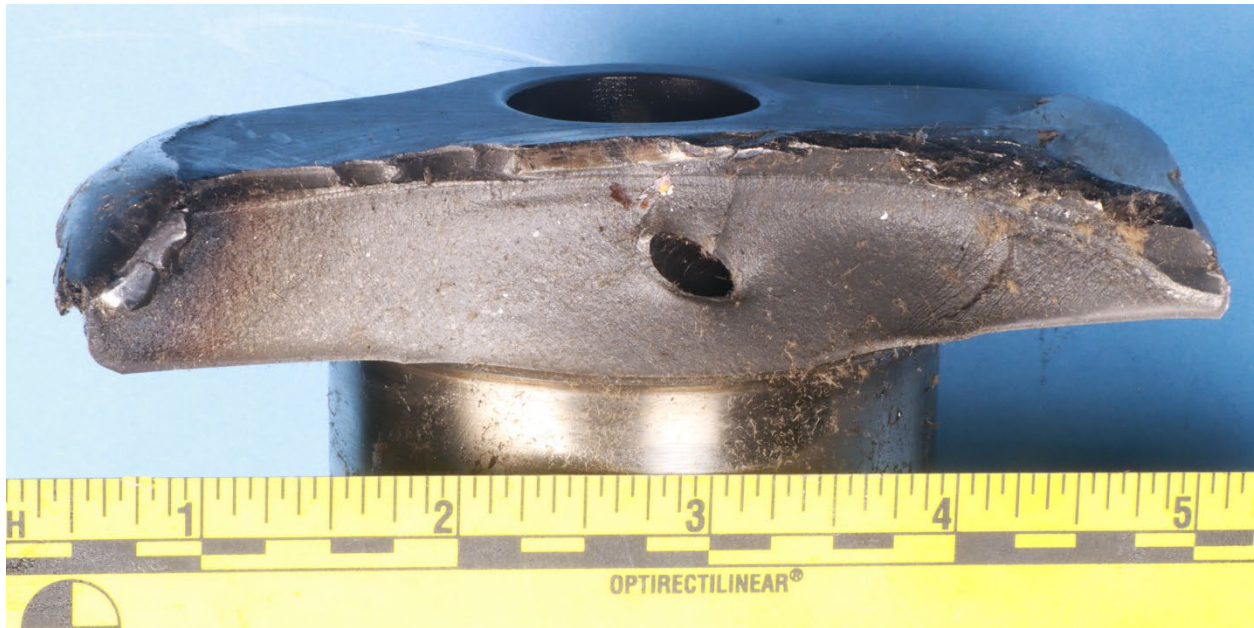
The crankshaft had fractured through the webs between M2 and C3 journals, and between the C4 and M3 journal positions. Figure 2 shows the fracture surface of the web between M2 and C3, displaying crack arrest marks consistent with progressive crack growth from the radius between the web and M2 journal, propagating towards the aft direction. The other web fracture surface exhibited prominent crack arrest and ratchet marks consistent with crack growth from the radius along the C4 side, as shown in Figure 3 after removing the attached connecting rod.

The crack dimensions on the forward fracture surface (near M2) measured 4.64 inches wide by 0.84 inches deep (or 94% of the total web thickness of 0.89 inches), whereas the aft fracture surface crack in Figure 3 measured 3.99 inches by 0.89 (or 90% of the total web thickness of 0.98 inches).

Figure 2. The fracture surface of the crankshaft web between the M2 and C3 locations, viewed from the M2 (forward) side.

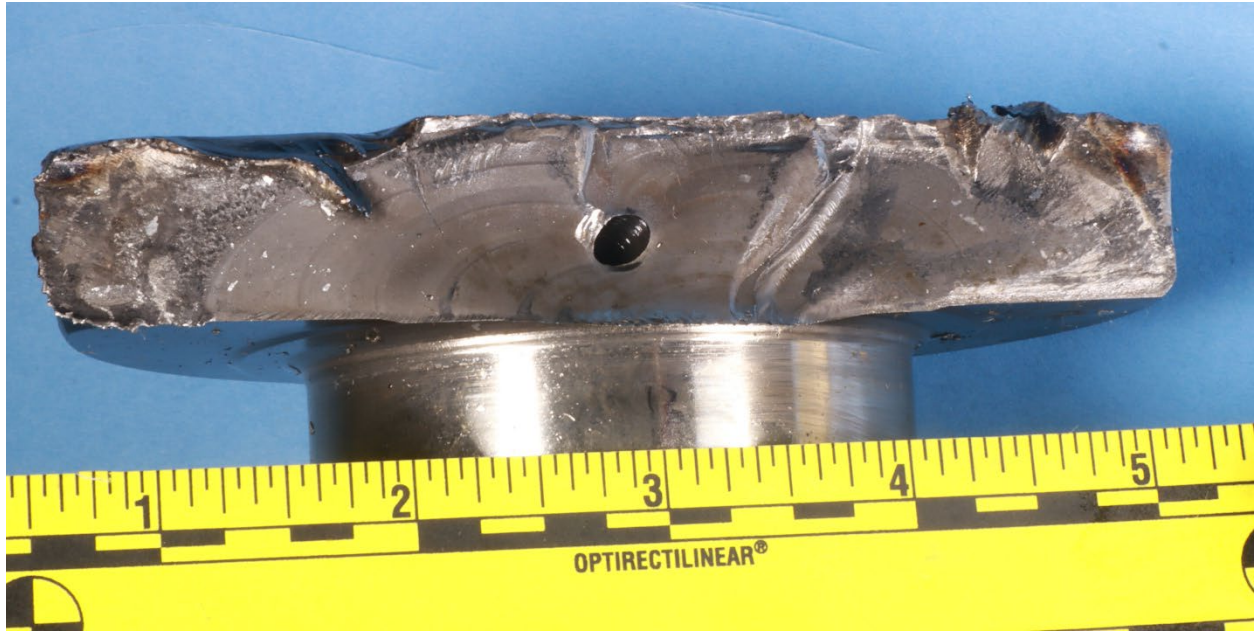
The other web fracture surface, located aft between the M3 and C4 journals, exhibited more prominent crack arrest and ratchet marks, as demonstrated in Figure 3. The initiation area is illustrated in Figure 9, showing multiple crack initiation sites along different planes, exhibiting ratchet marks that developed between the sites during fatigue crack propagation. With this web fracture, the fatigue crack initiation sites were located along the edge of the C4 journal radius, and the crack propagated forward through the web cross-section before the remaining 10% subsequently fractured from overstress.

Figure 3. The fracture surface of the crankshaft web between the M3 and C4 locations, viewed from the C4 (aft) side.

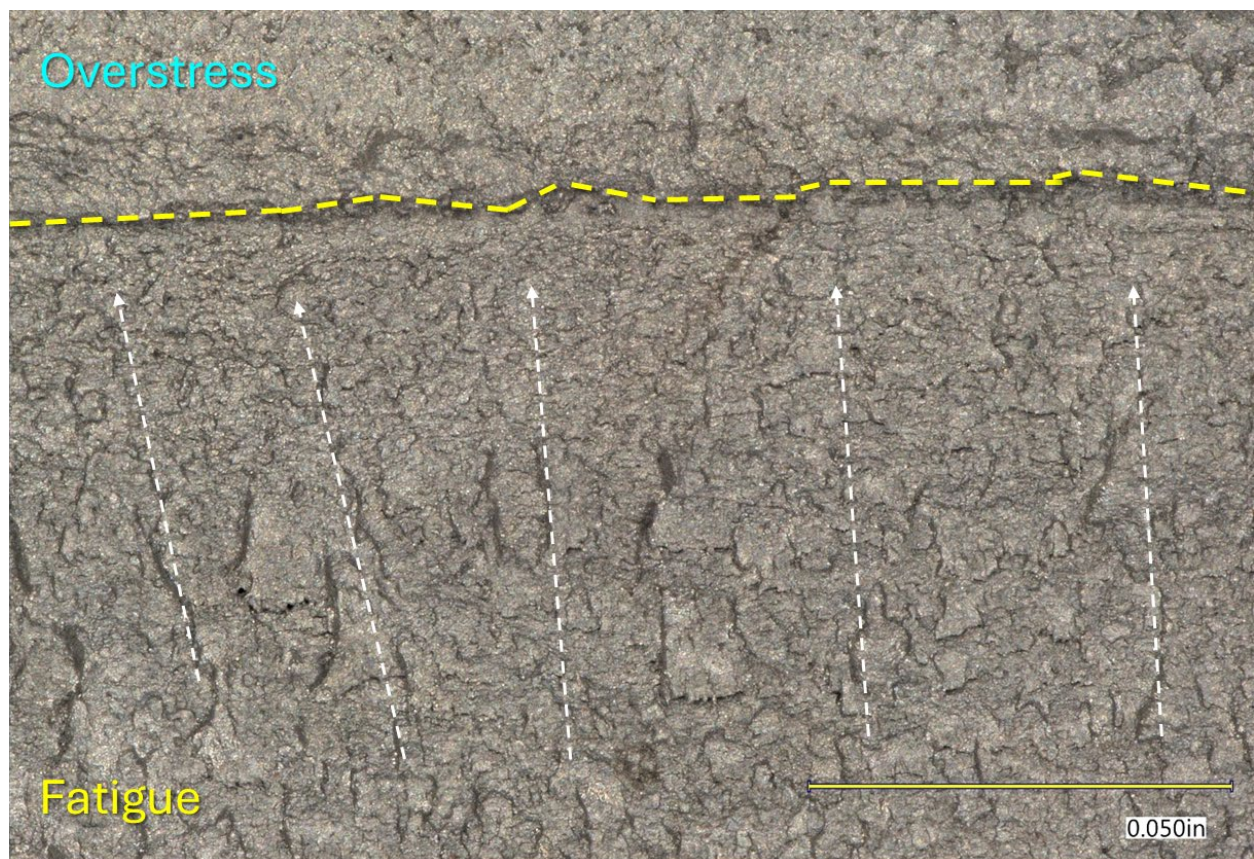
Figure 4 shows the end of the crack on the web fracture between M2 and C3, showing distinct regions with disparate fracture features. When examined using a field emission scanning electron microscope (SEM), the crack revealed striations consistent with fatigue crack propagation (see Figure 5). Outside this area (as delineated in the upper portion of Figure 4), the fracture surface exhibited dimpled rupture, consistent with subsequent overstress fracture. The macroscopic fracture features were consistent with a compression curl from an overstress fracture in bending during final separation.

Figure 4. End of the fatigue crack on the M2 web fracture surface.

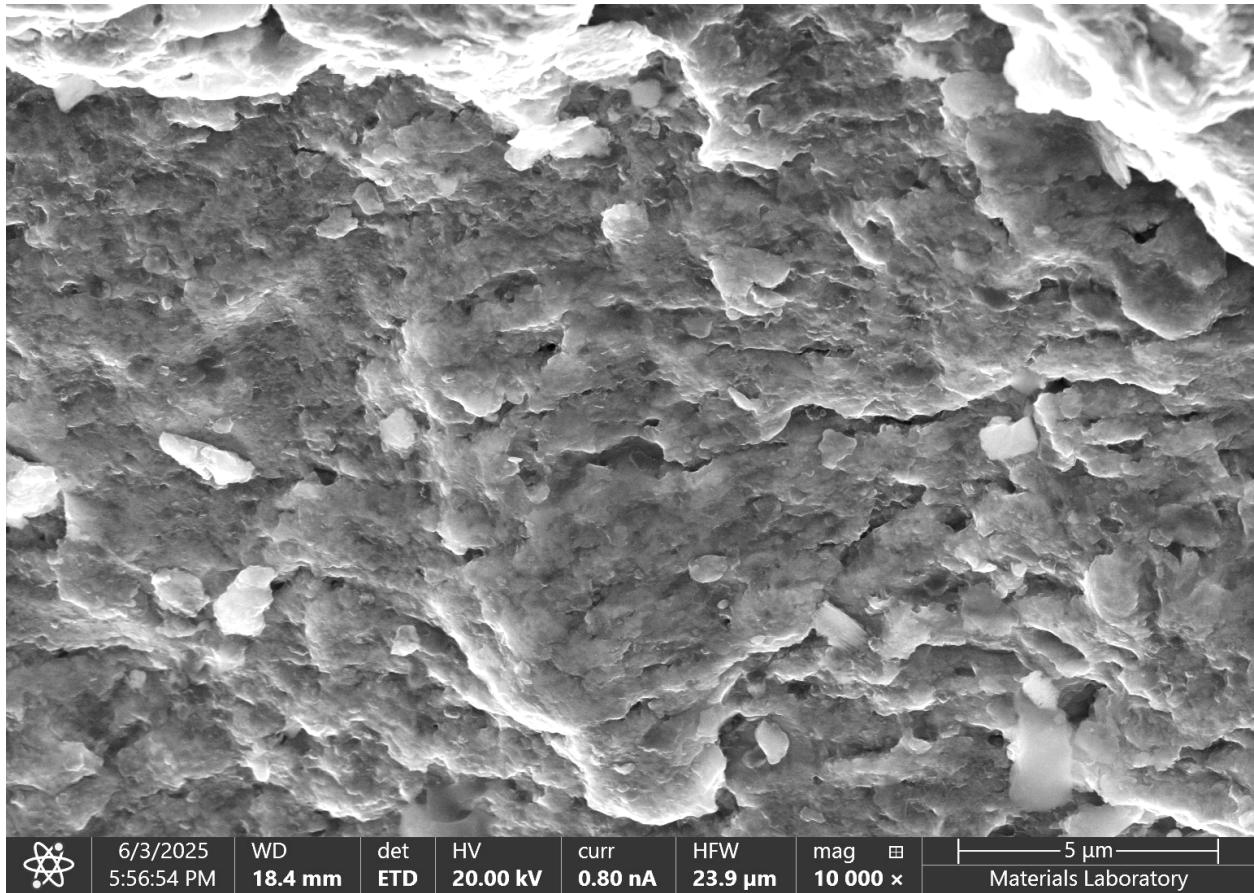
Figure 5. Secondary electron (SE) micrograph of fatigue striations on the fatigue region of the M2 fracture surface shown in Figure 4.

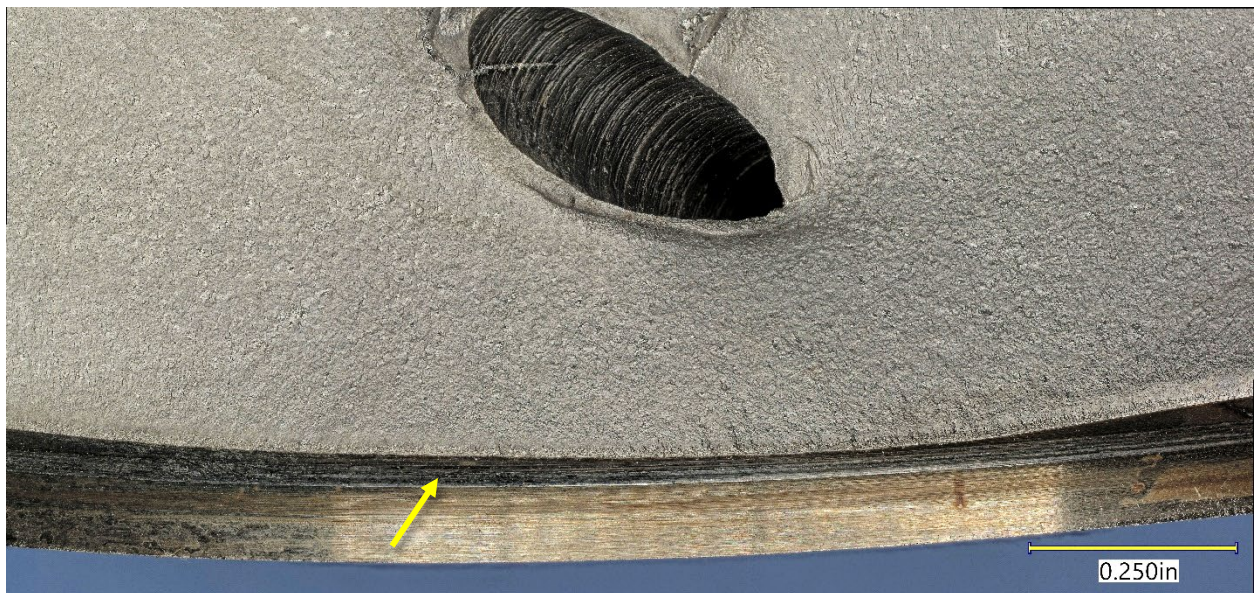
Figure 6 shows a closer view of the edge of this forward web fracture, highlighting the radius between the M2 journal and the web. Concentric crack arrest marks emanated from the area annotated by the yellow arrow, consistent with propagation

Figure 6. Montage image of the crack initiation site of the M2 fracture surface (yellow arrow).

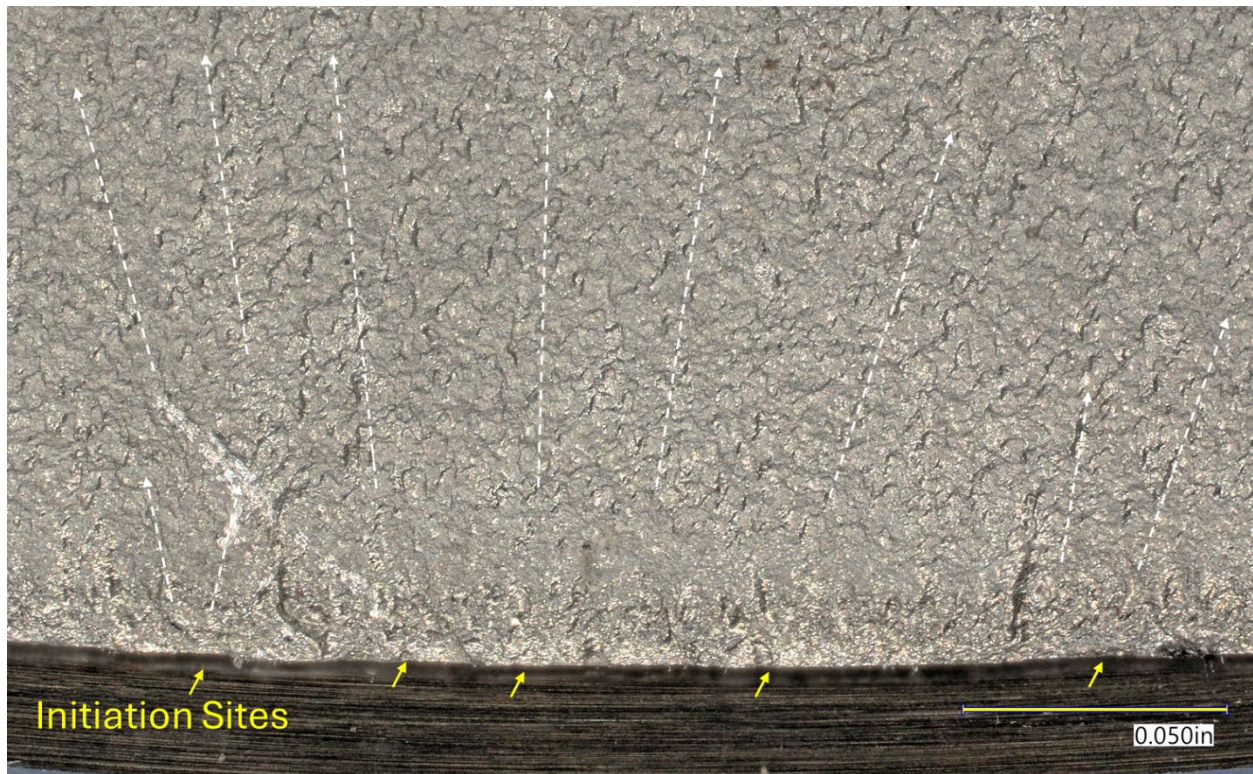
from an initiation region along the surface edge. Though faint, ratchet marks were present near the edge, consistent with multiple crack initiation sites, as exemplified in Figure 7.<sup>2</sup> This figure identifies several initiation sites with yellow arrow annotations and indicates the general direction of early crack growth.

Gouge marks were observed along the fracture surface edge in Figure 7 and Figure 8, oriented parallel to the fracture surface edge. These features indicate that this fatigue cracking had initiated along the radius of the M2 journal, and propagated aftward through most of the web cross section before completely fracturing.

Figure 7. Closer view of the crack initiation site in Figure 6.

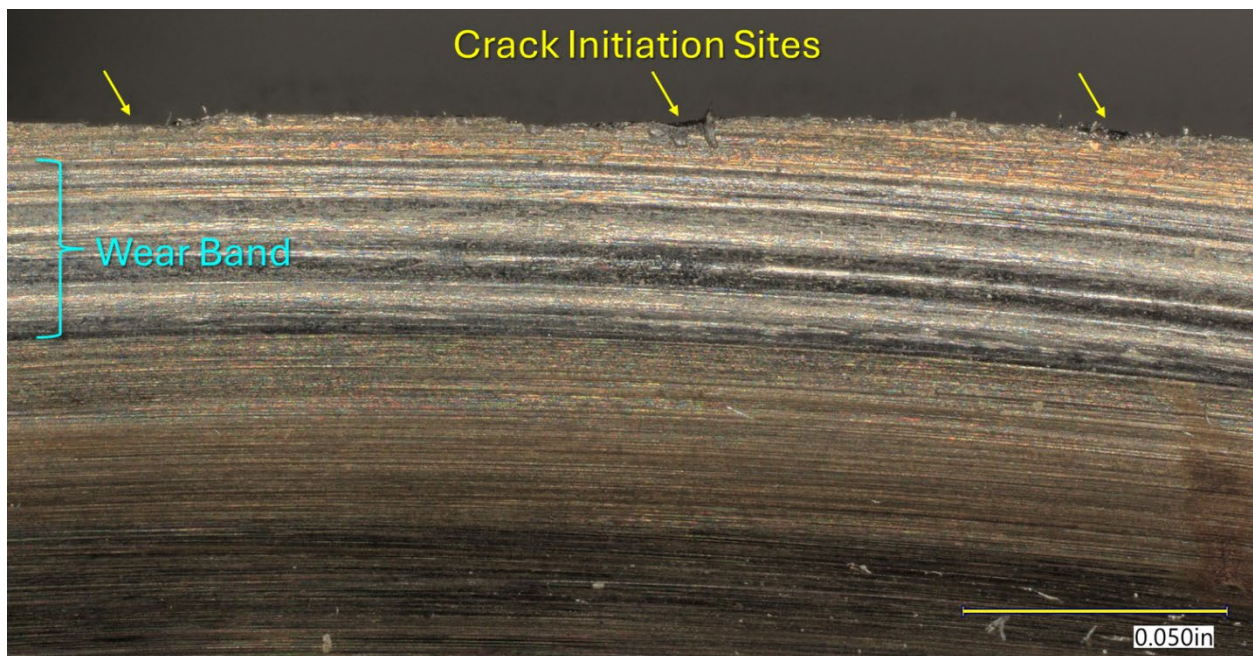
Circumferential wear bands were identified along the radius of the M2 journal bearing. As demonstrated in Figure 8, one of these bands was near the initiation sites of the fatigue crack that propagated through the web between the M2 and C3 journals. This wear band was measured at a width of 0.034 inches (0.86 mm).

Figure 8. View of the radius surface under the web fracture surface edge in Figure 7, showing a circumferential wear band.

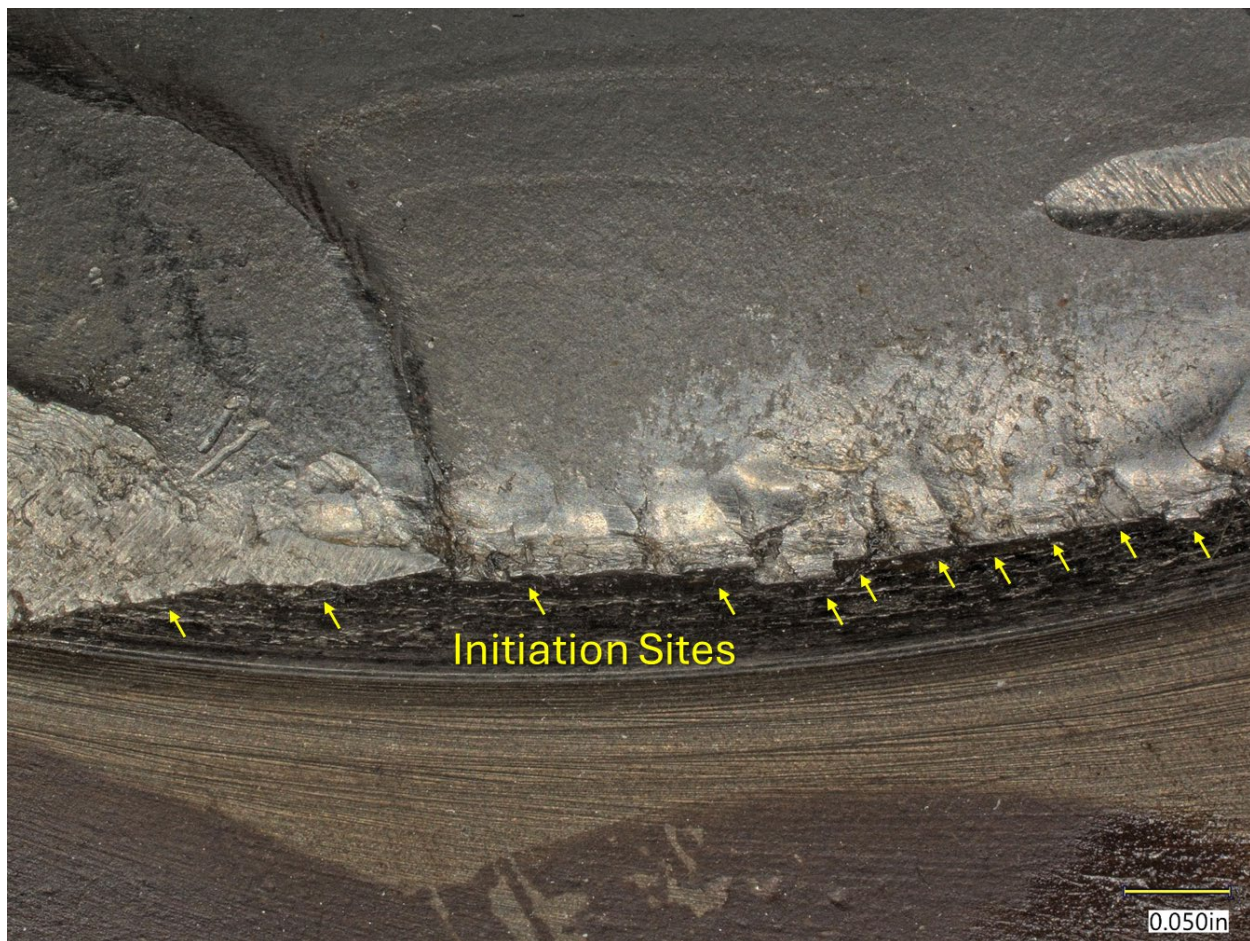
Figure 9. The initiation sites and ratchet marks on the edge of the crankshaft web fracture between the M3 and C4 journal, from the radius with the C4 journal (forward face).

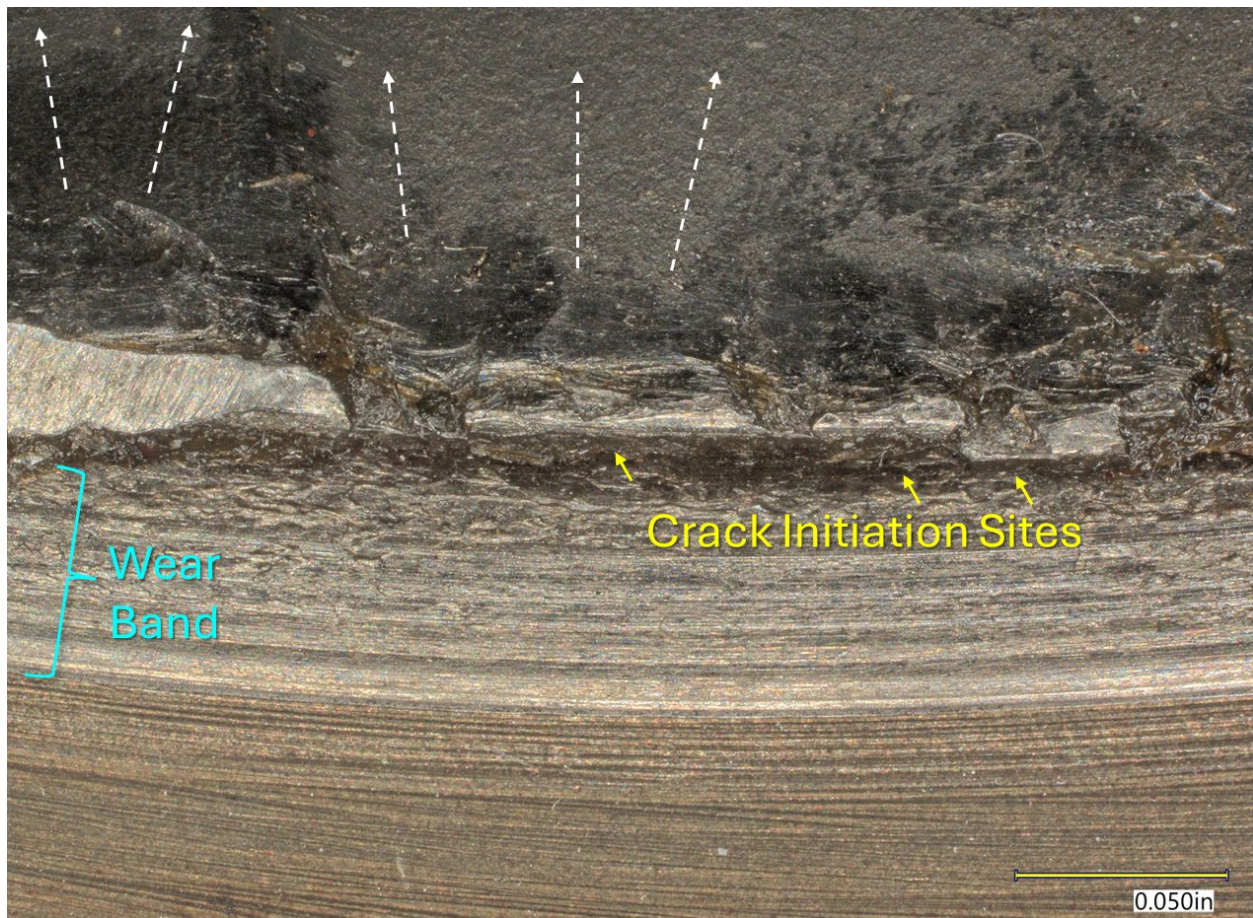
Similar to the forward web fracture, the fatigue cracking that initiated from the radius of the C4 journal was located near wear bands, shown in Figure 10. This band was approximately 0.051 inches (1.30 mm) wide, and several initiation sites were located along this circumferential feature. The radius surface along the initiation sites also exhibited folding and smoothing of material, consistent with adhesive wear in a rotational direction.

Figure 10. View of the radius surface under several fatigue crack initiation sites from the fracture surface edge in Figure 9, showing a circumferential wear band.

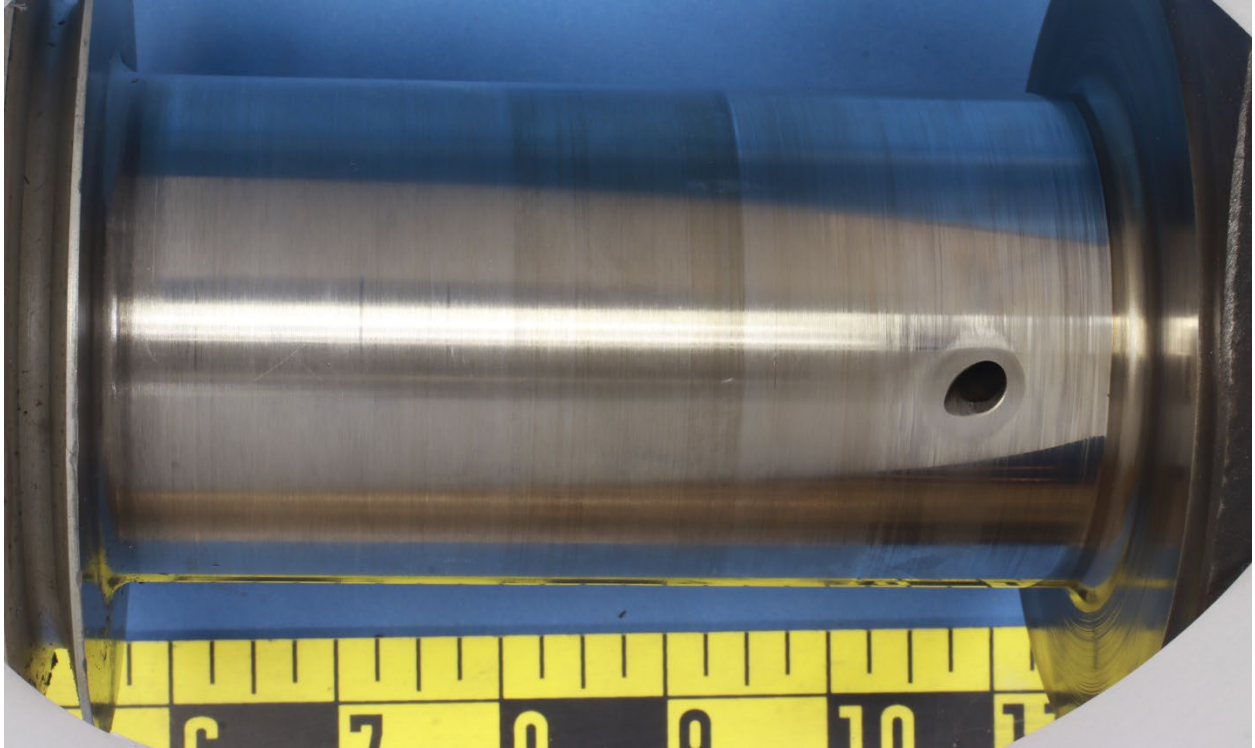
| Bearing | Min. Diameter (in.) | Max. Diameter (in.) | Notes |
|---|---|---|---|
| M1 | 2.617 | 2.619 | Two wide circumferential wear bands |

Figure 11. The M1 journal surface from the crankshaft.

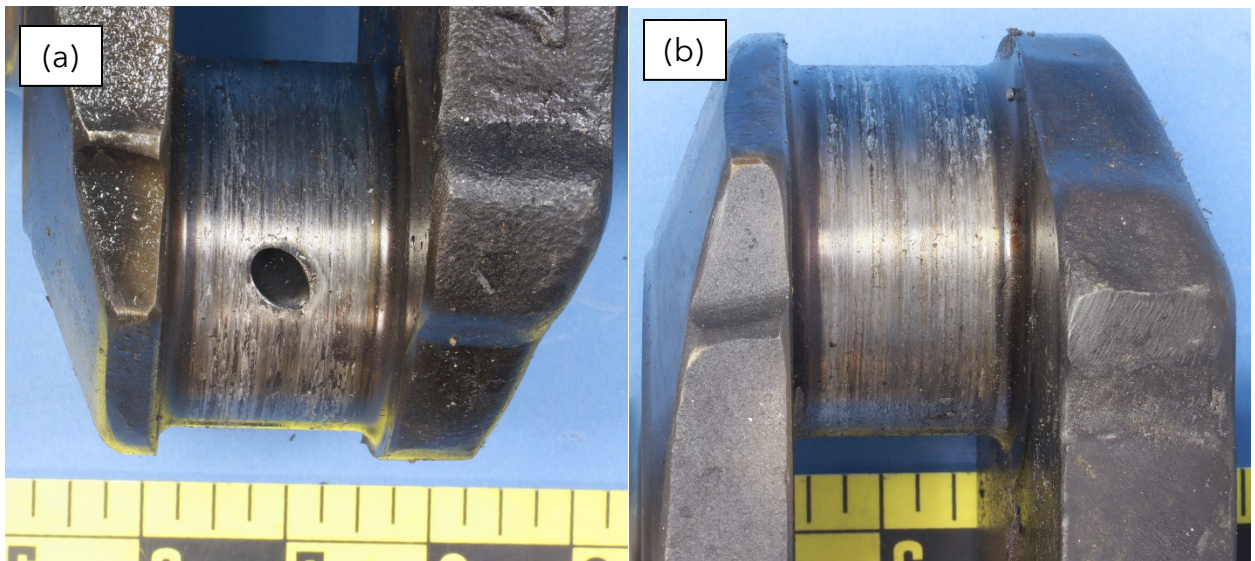
Table II and the figure set also highlight the wear and damage patterns present. The most damaged journal surfaces were those of the C1 and C2 positions, as shown in Figure 12. The C1 journal surfaces from opposite sides, as received, and Figure 13. These journals exhibited severe gouging and localized plastic deformation, consistent with abrasive wear typical of bearing disintegration and entrained debris. The nearby C1 position also exhibited circumferential gouge marks, consistent with entrained wear debris during rotation.

| Bearing | Min. Diameter (in.) | Max. Diameter (in.) | Notes |
|---|---|---|---|
| C1 | 2.243 | 2.255 | Gouge marks and spalling; rougher surface |

Figure 12. The C1 journal surfaces from opposite sides, as received.

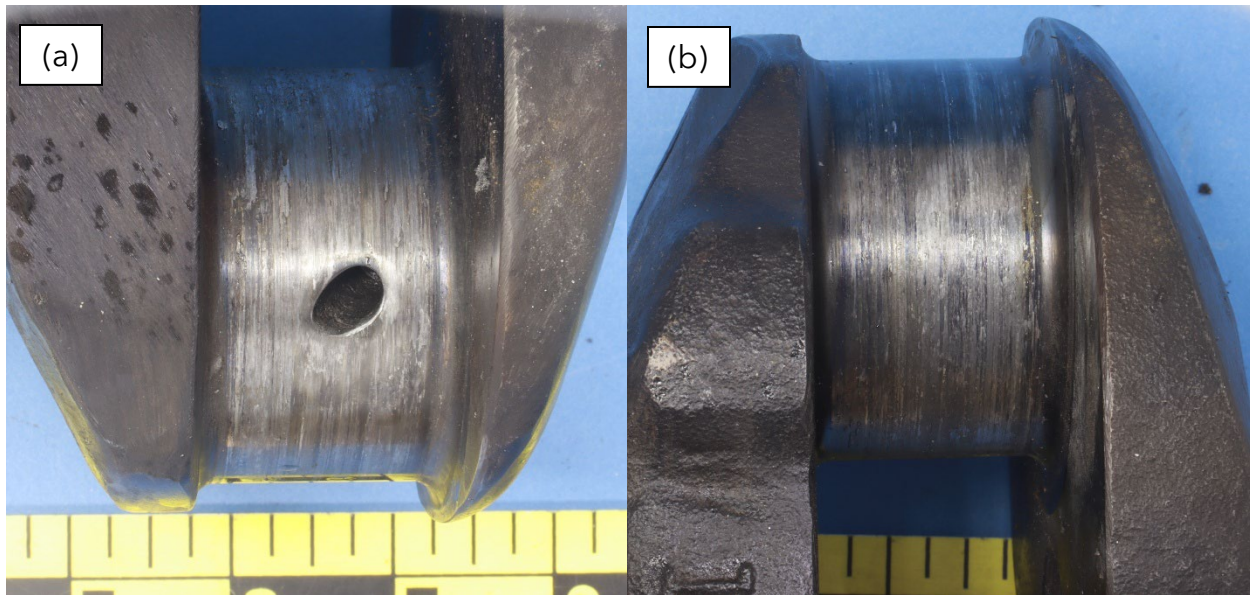
| Bearing | Min. Diameter (in.) | Max. Diameter (in.) | Notes |
|---|---|---|---|
| C2 | 2.243 | 2.257 | Wear marks and abrasion |

Figure 13. The C2 journal surface from opposite sides, as received.

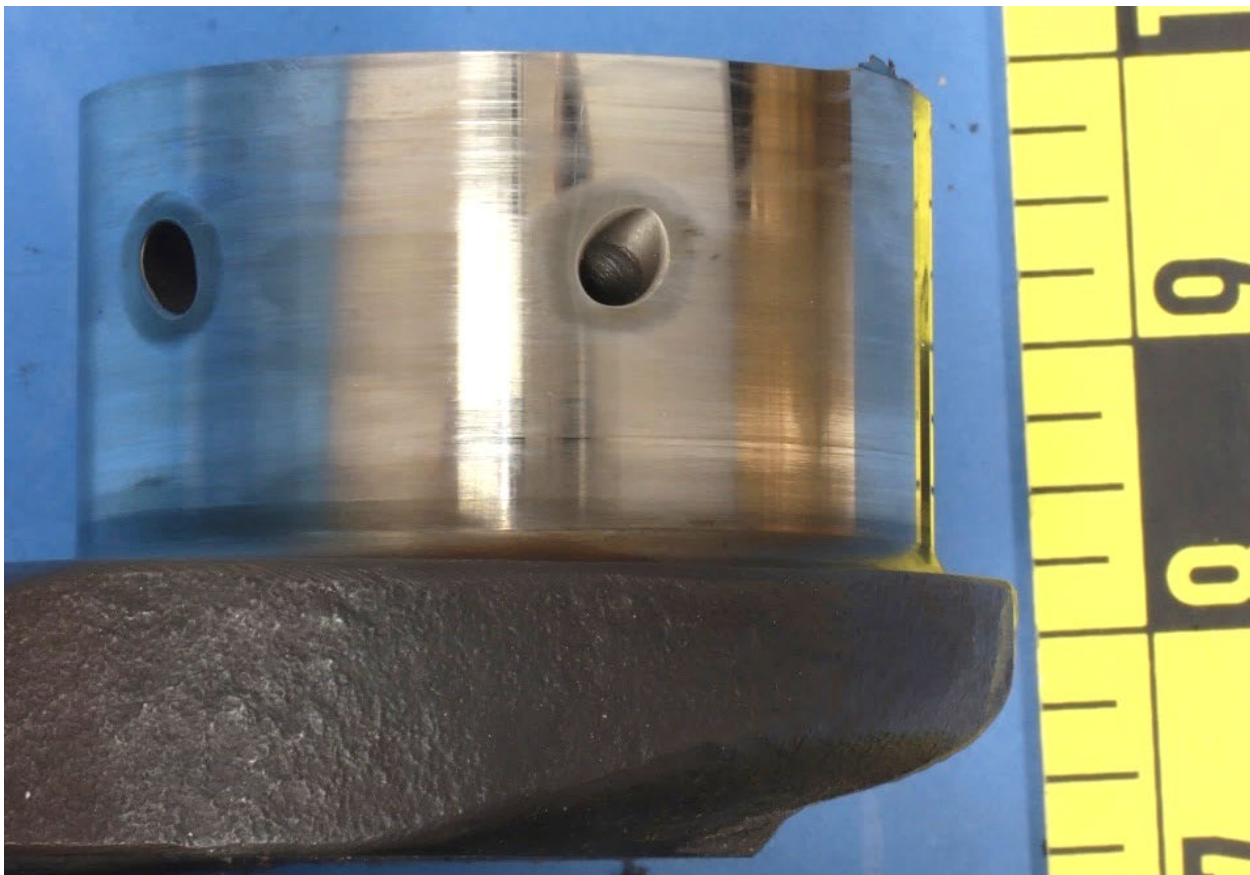
The M2 and M3 journals did not exhibit severe wear marks, though the M2 did exhibit a duller reflection along the center. The major wear signatures on these two locations were along the radii with the webs, coinciding with the fatigue crack initiation sites.

Figure 14. Side view of the M2 journal, after cleaning and sectioning of the web fracture surface.

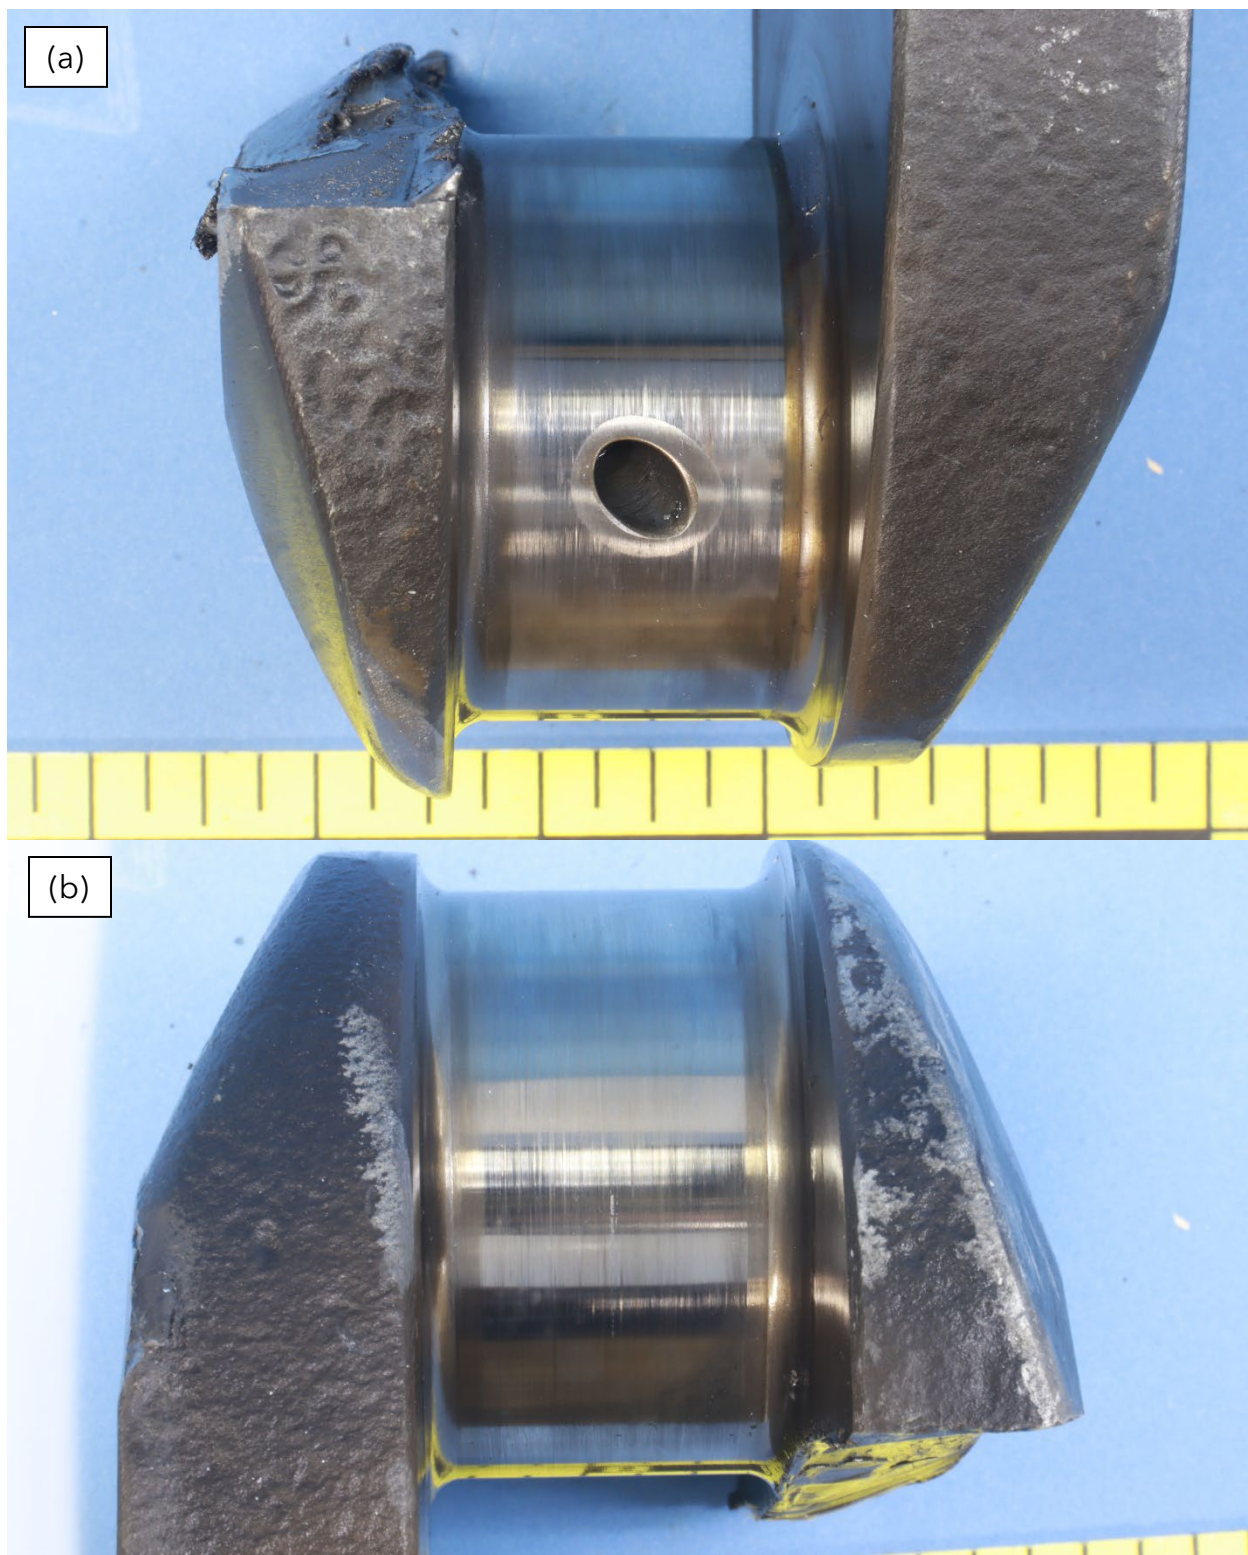
The C3 position in Figure 15 exhibited blue and tan discoloration, consistent with heat tinting from high temperature exposure to the lubricating oil. The C5 journal exhibited dark brown marks, consistent with burnt or decomposed oil. This position also showed a small area with spalled surface material.

| Bearing | Min. Diameter (in.) | Max. Diameter (in.) | Notes |
|---|---|---|---|
| C3 | 2.242 | 2.252 | Blue and tan discoloration |

Figure 15. Opposite views of the C3 journal surfaces.

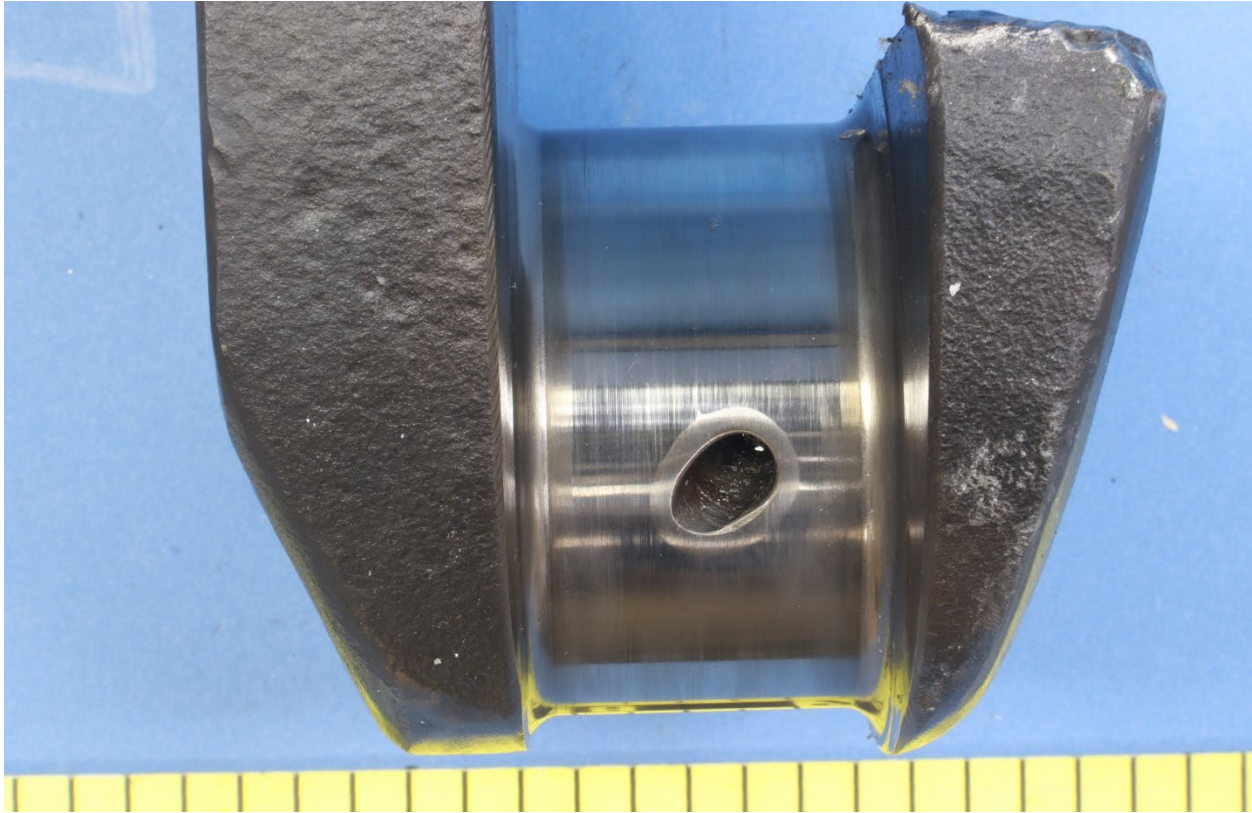
| Bearing | Min. Diameter (in.) | Max. Diameter (in.) | Notes |
|---|---|---|---|
| C4 | 2.245 | 2.253 | Smooth surface with some chatter marks |

Figure 16. View of the C4 journal and associated fracture surface, after removal of the connecting rod remnant and cleaning.

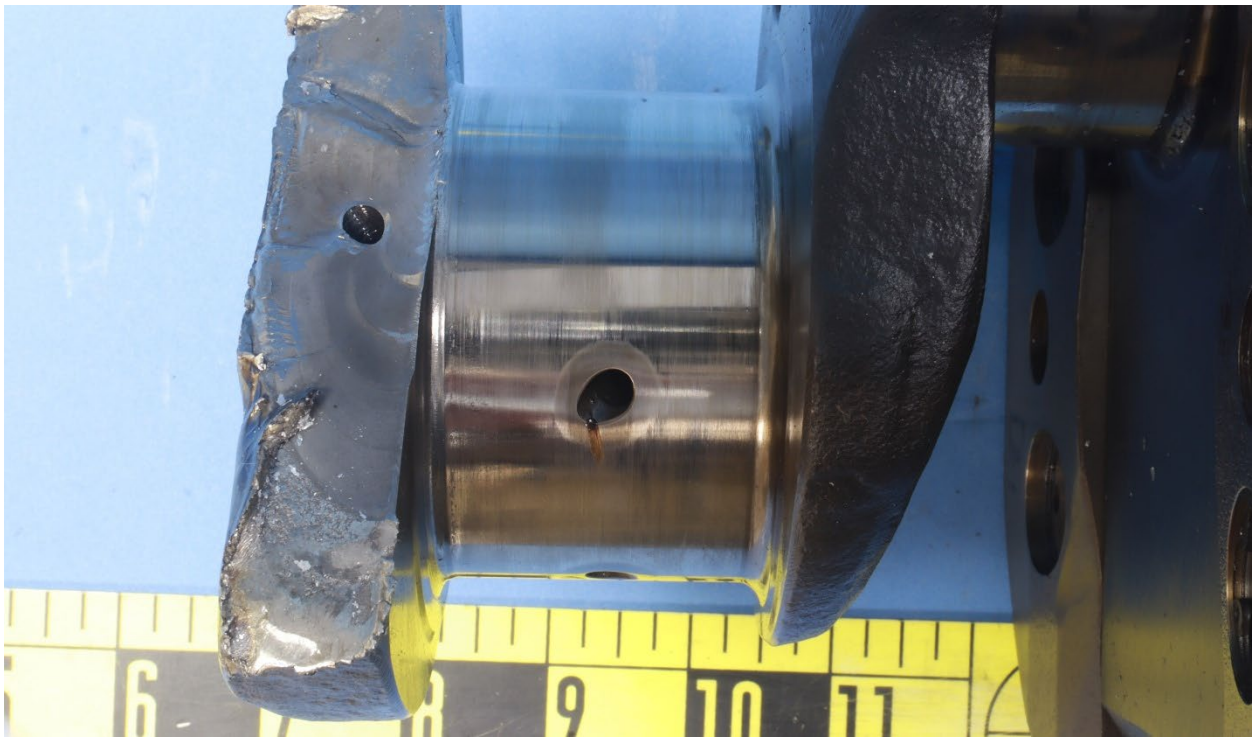
| Bearing | Min. Diameter (in.) | Max. Diameter (in.) | Notes |
|---|---|---|---|
| M3 | 2.617 | 2.628 | Fracture surface crack initiation from web radius |

Figure 17. The M3 bearing surface, with the fractured web that mates to the one in Figure 16.

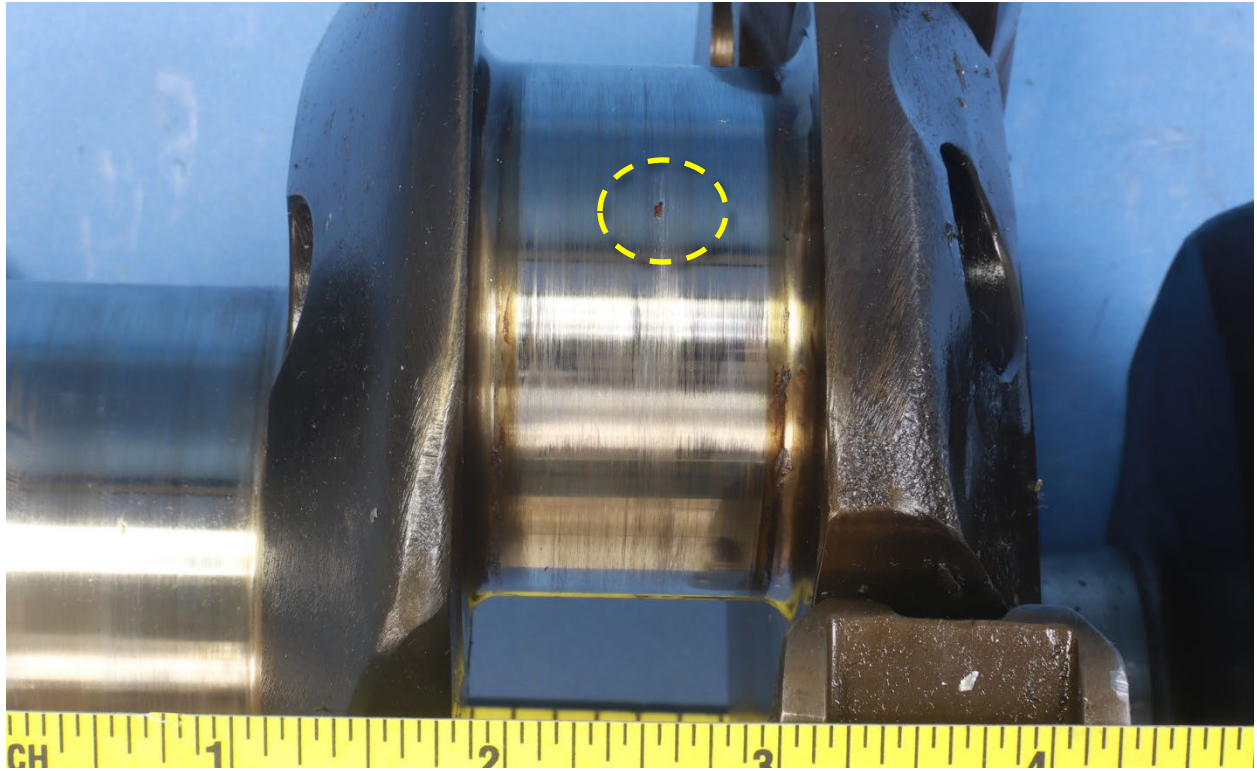
| Bearing | Min. Diameter (in.) | Max. Diameter (in.) | Notes |
|---|---|---|---|
| C5 | 2.245 | 2.246 | Burnt oil and small area of spallation |

Figure 18. The C5 bearing surface on the crankshaft, with an area of material spalling circled.

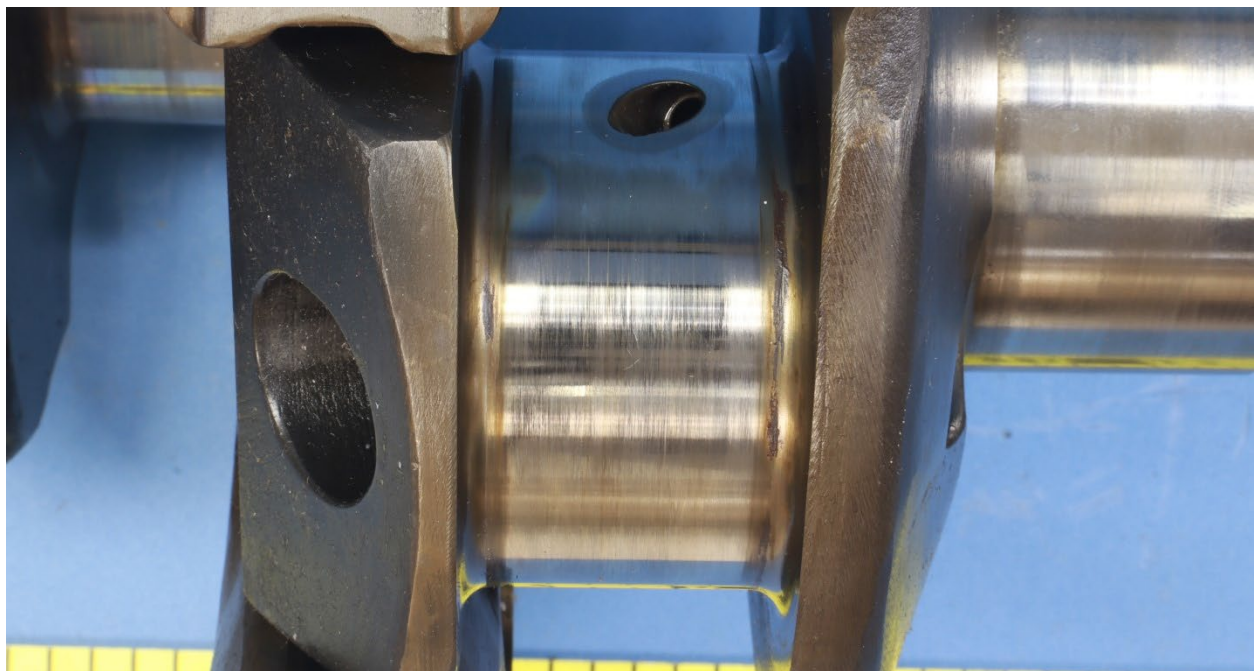
Figure 19. The C6 bearing surface on the crankshaft.

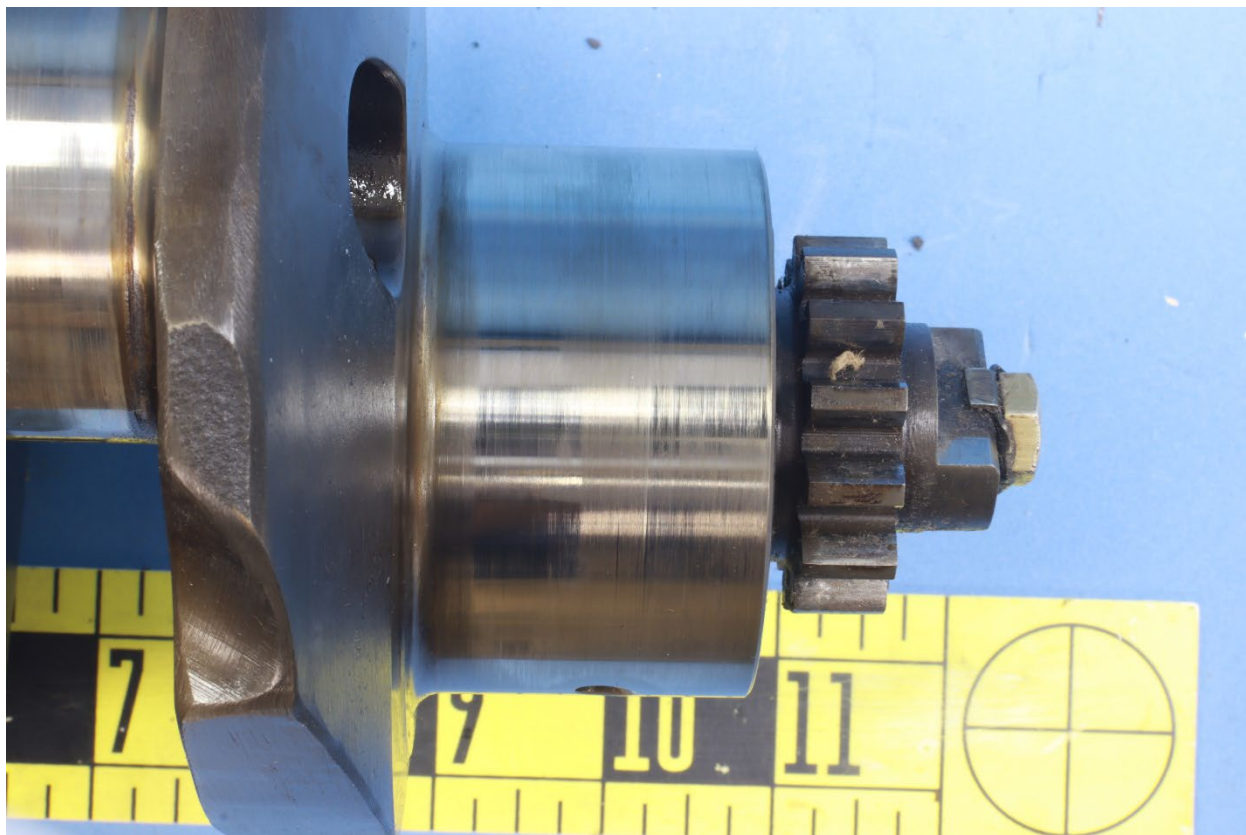
| Bearing | Min. Diameter (in.) | Max. Diameter (in.) | Notes |
|---|---|---|---|
| M4 | 2.619 | 2.622 | Single circumferential wear band |

Figure 20. The aftmost main bearing journal, M4.
