# National Transportation Safety Board

CEN24LA155

## **MATERIALS LABORATORY**

Factual Report 25-052

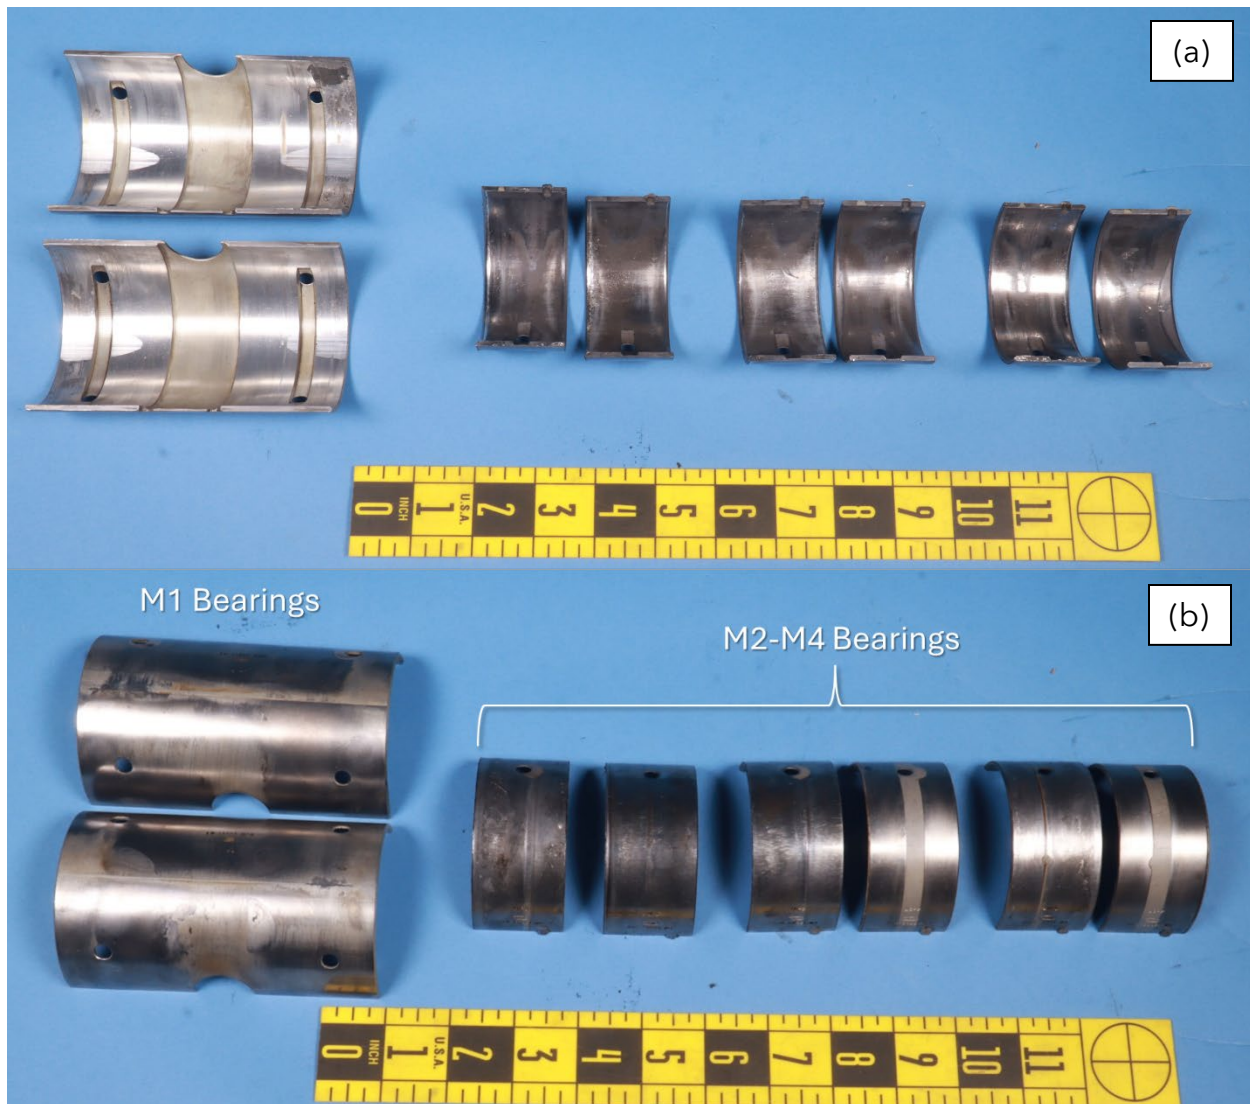
The bearings exhibited wear patterns consistent with rotational contact between the faying surfaces on both sides. On the M1 bearing interior were the hyperbola-shaped wear patterns along the centerline toward the forward and aft edges (see pair to the left in Figure 21a). All three of the smaller main bearings also exhibited similar, but broader, parabolic wear shapes along the ends on the forward and aft edges (see the two pairs towards the left in Figure 21a).

Figure 21. The main bearings, showing the (a) the interior and (b) the exterior surfaces.

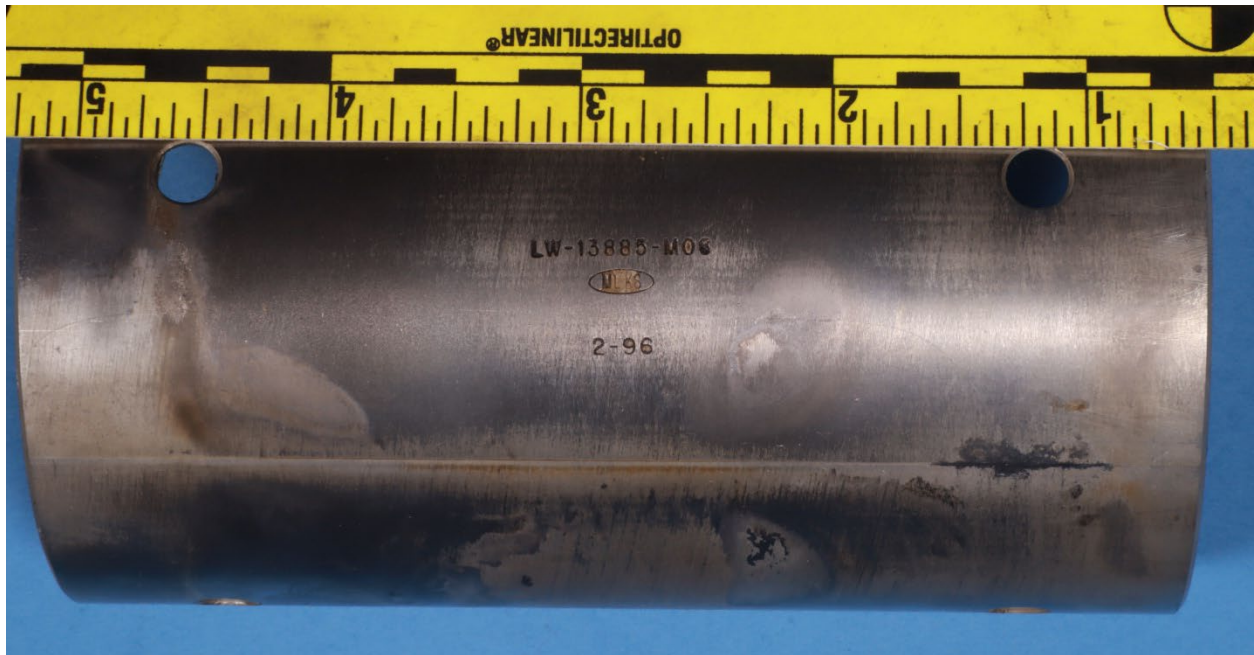
Of note, as illustrated in Figure 22 and Figure 23, were the part numbers on the main journal bearings. The M1 and M2 through M4 bearings each exhibited part numbers that have been superseded by upgraded bearing part numbers, per Lycoming Service Instruction No. 1512.<sup>3</sup> These part numbers, along with those of the C4 connecting rod bearing that was disassembled, are detailed in Table I.

Figure 22. Closer view of the markings on the M1 bearing, stating "LW-13885-M06" and "2-96."

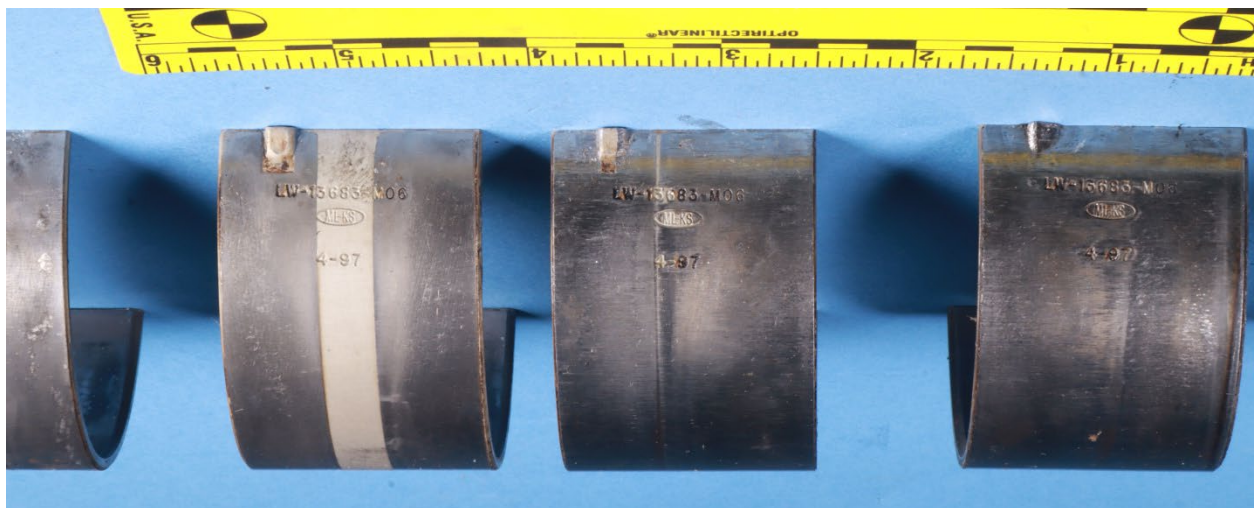
Figure 23. Outer surfaces of several of the other main journal bearings, showing markings stating "LW-136830-M06" and "4-97."

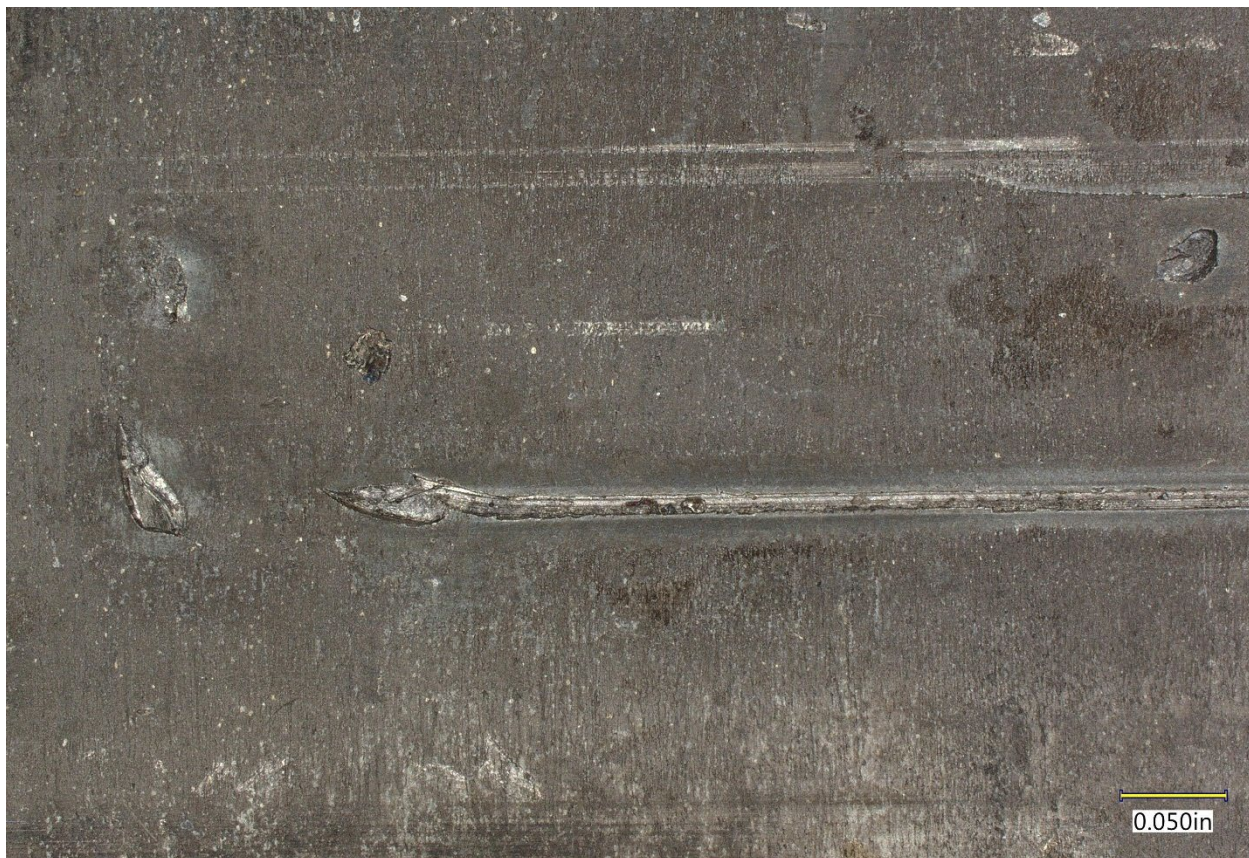
All main bearing interior or inner diameter surfaces exhibited features consistent with prolonged rotational wear. Some of the most severe damage is highlighted in Figure 24 through Figure 26. Most of the inner surfaces exhibited indications of spalling and abrasion. Figure 24 illustrates an area of cracked and spalled material, with circumferential gouging from the entrained material dragging into the inner surface.

Figure 24. Spalling of the interior surface of one of the main bearings, with a gouge and abrasion marks in the direction of rotation.

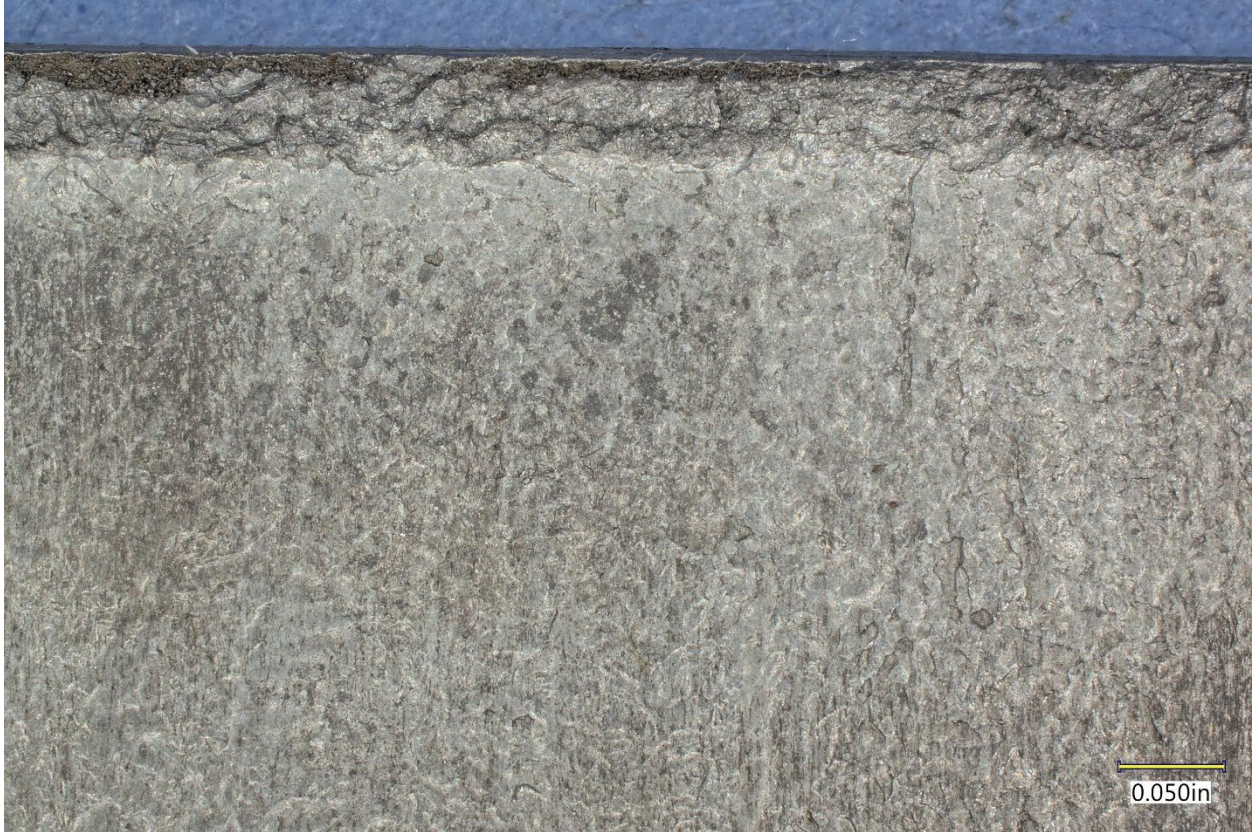
Two of the smaller main bearings exhibited gouging consistent with abrasive wear, material loss, and spalling along the edge (Figure 25). This damage coincided with a thinner bearing thickness on the edge, measured as 0.094 inches for all three sets of shorter main bearings. The edge faces of two of the main bearings exhibited deep gouging and were oriented parallel to the bearing and rotation direction. This gouging was severe enough to have developed into radial cracking, flaking, and material spalling (Figure 26). Along the left side of Figure 26, the babbitt material had spalled off the steel backing exposed the original chamfered edge.

Figure 25. Edge damage, abrasion, and localized spalling on the ID surface of one of the main journal bearings from Figure 23.

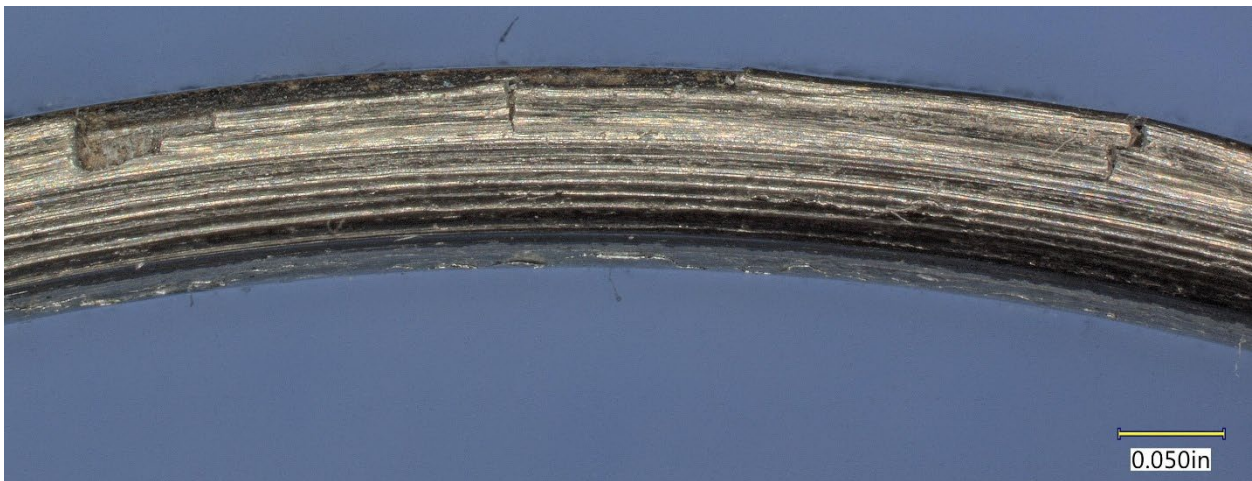
Figure 26. Rotational wear scars on the edge of one of the main bearings from Figure 23, showing cracking, material loss, and flaking.

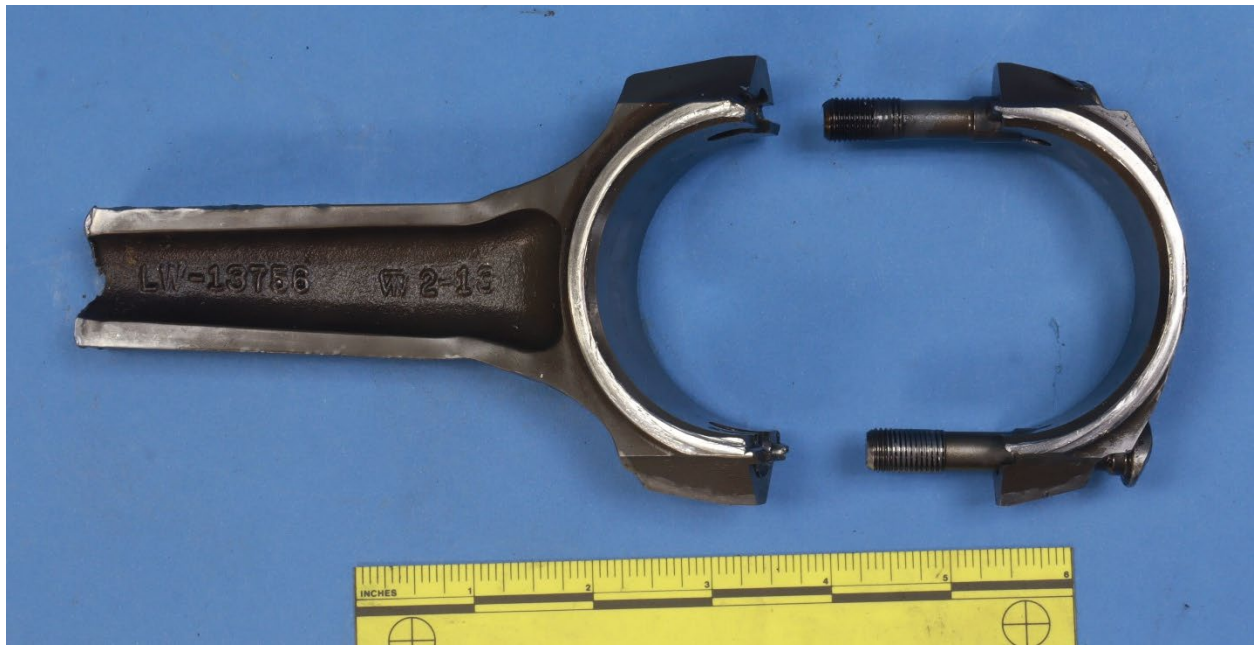
The C4 connecting rod remnants were still attached to the connecting rod at that journal position when received, as shown in Figure 1. These components were disassembled and removed from the crankshaft, as shown in Figure 27. The connecting rod embossed markings along the neck web stated "LW-13756 TW 2-13."

Figure 27. The two halves of the #4 connecting rod, after removal from the crankshaft.

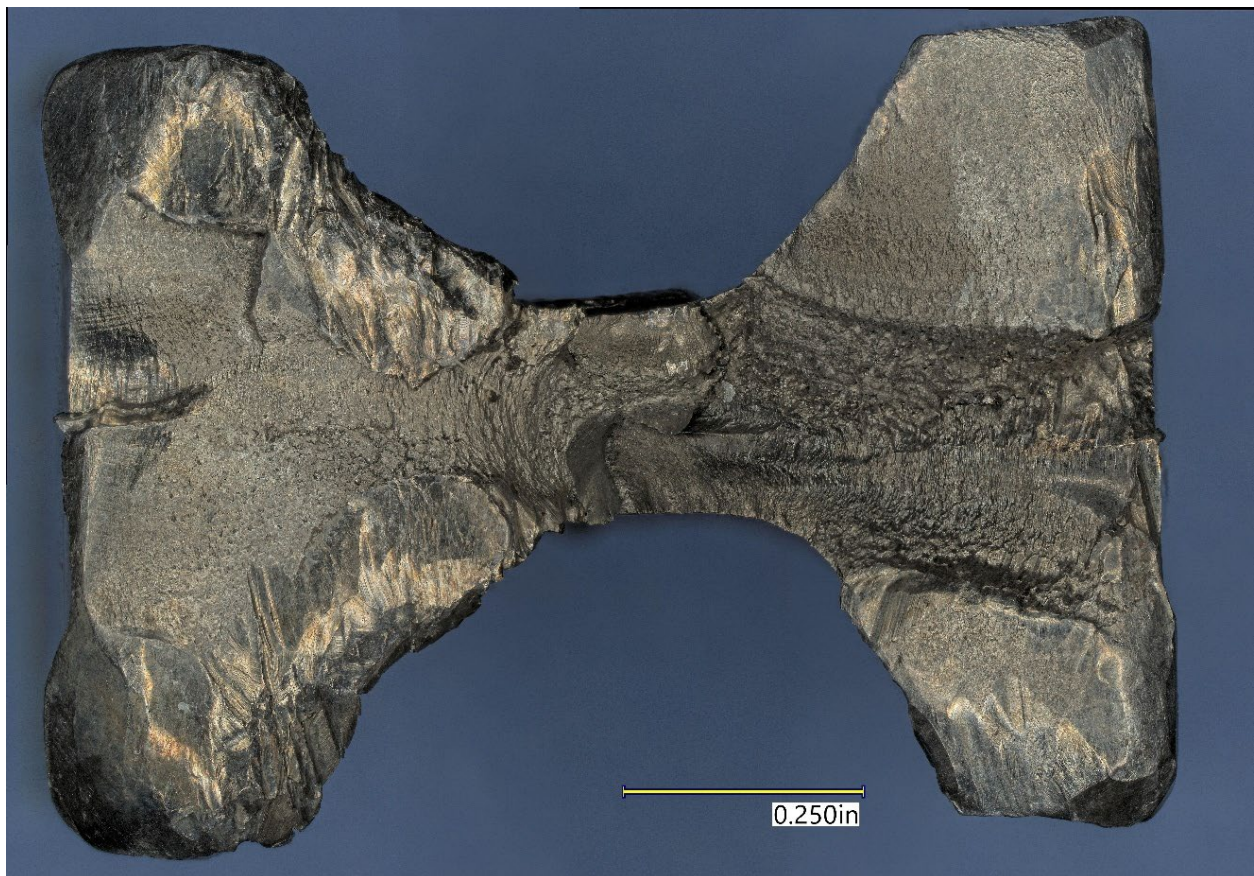
The connecting rod had fractured perpendicular to the neck, located approximately 4 inches from the interior rod bearing surface. This fracture surface was sectioned and cleaned with acetone. Figure 28 shows the fracture surface of the connecting rod, which displays multiple areas of battered, reflective regions, consistent with impacts from post-fracture impacts with adjacent components.

Figure 28. Montage of the fracture surface, showing the corner cracking features.

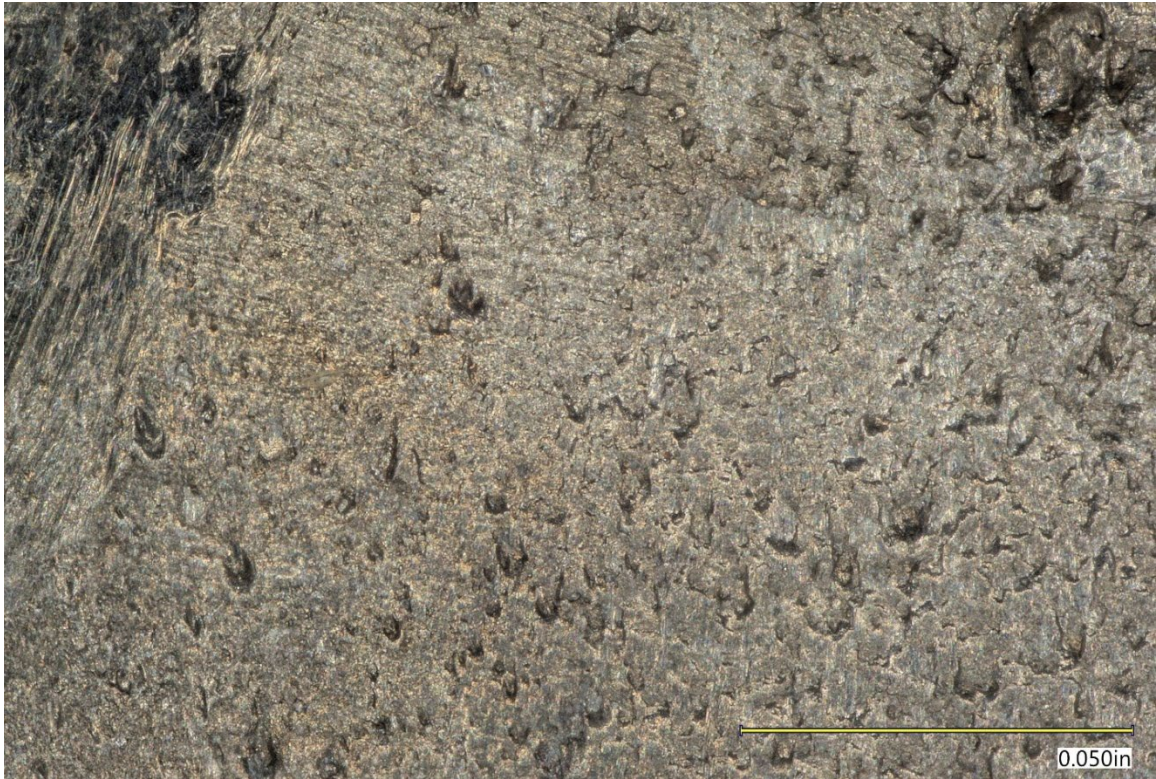
In the undamaged regions of the rod fracture surface, there were areas with visible crack arrest marks, as typified in Figure 29. Examination using a SEM revealed fatigue striations, as typified in Figure 30. The directionality of the crack arrest marks was consistent with crack initiation along the four exterior flange surfaces of the rod. These four fatigue cracks propagated inward before the remaining center of the web fractured from overstress. Due to the post-fracture damage to the surface edges, no observations could be made about any crack initiation sites. The connecting rod failed from reverse-bending fatigue.

Figure 29. Closer view of the crack arrest marks from the lower left of Figure 28.

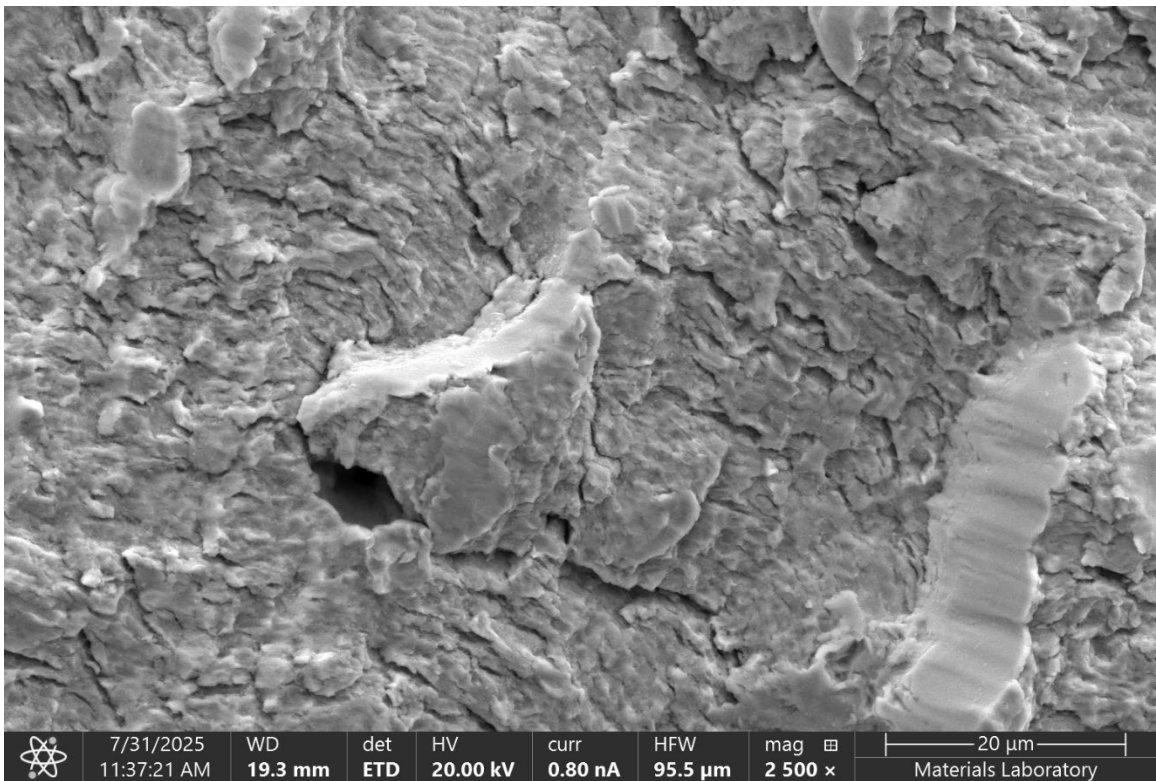
Figure 30. Backscattered electron (BE) micrograph of striations on the connecting rod fracture surface.

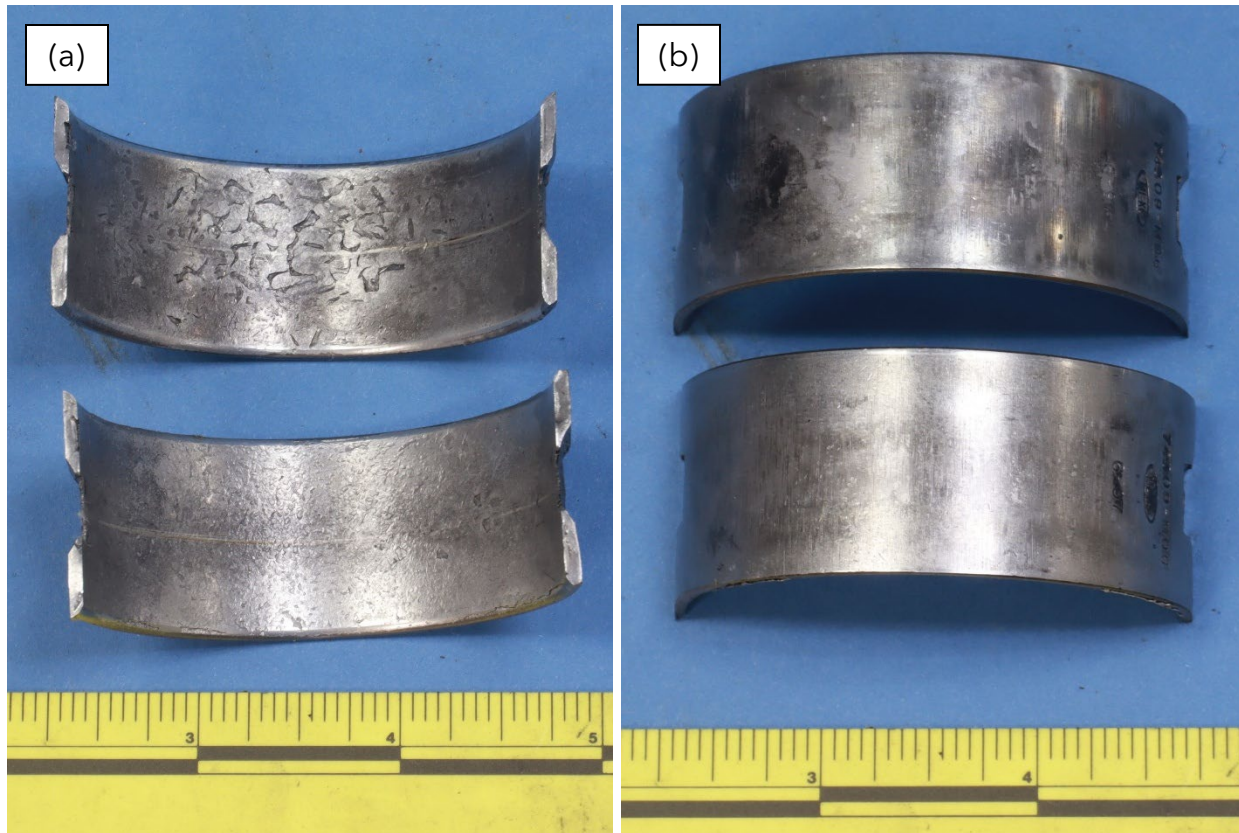
Figure 31 shows the C4 connecting rod bearing from both surfaces, and the exterior markings are shown in Figure 32. The interior of this bearing exhibited an erratic, blotched surface pattern on one side, with a parabolic wear pattern on the other, showing a more reflective surface pattern on the outside and a darker hourglass

Figure 31. View of (a) the interior surfaces of the C4 bearing, and (b) the outside surface of the C4 bearing.

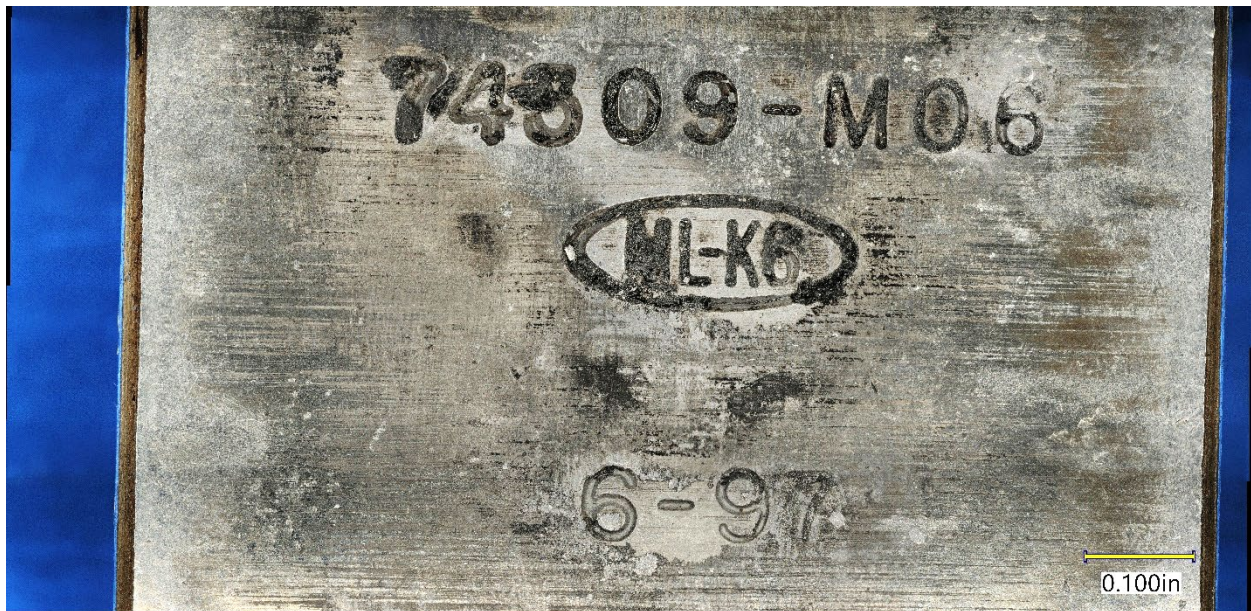
Figure 32. Exterior of the C4 bearing, showing the part numbers and markings.

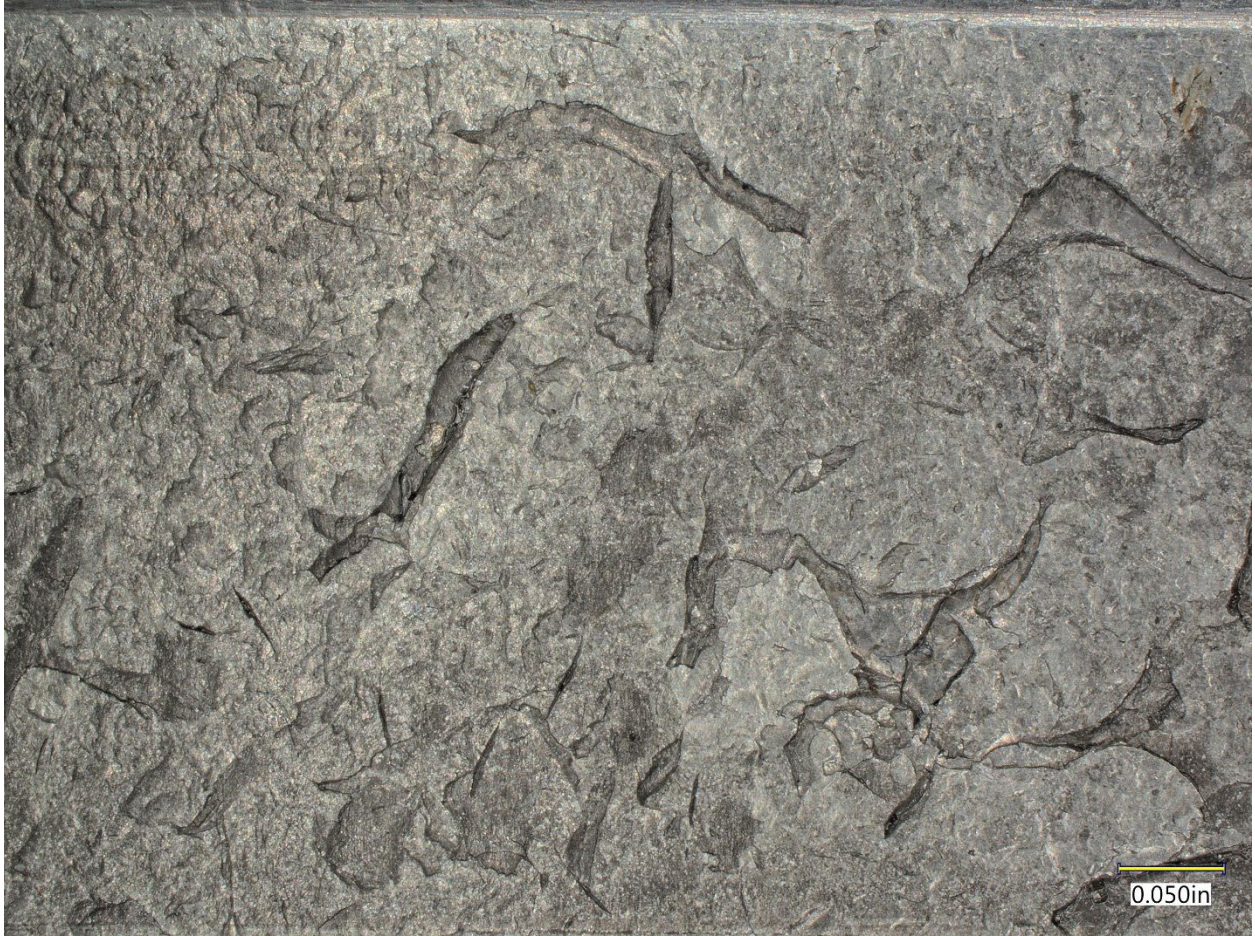
shape towards the center. Both surfaces exhibited a rough texture consistent with abrasive wear. The pattern on the inner diameter surface was severe material spallation, as demonstrated in Figure 33.

Figure 33. Spalling damage on the ID surfaces of the C4 bearing from Figure 31a.
