CEN24LA156

## INVESTIGATION PHOTOGRAPHS

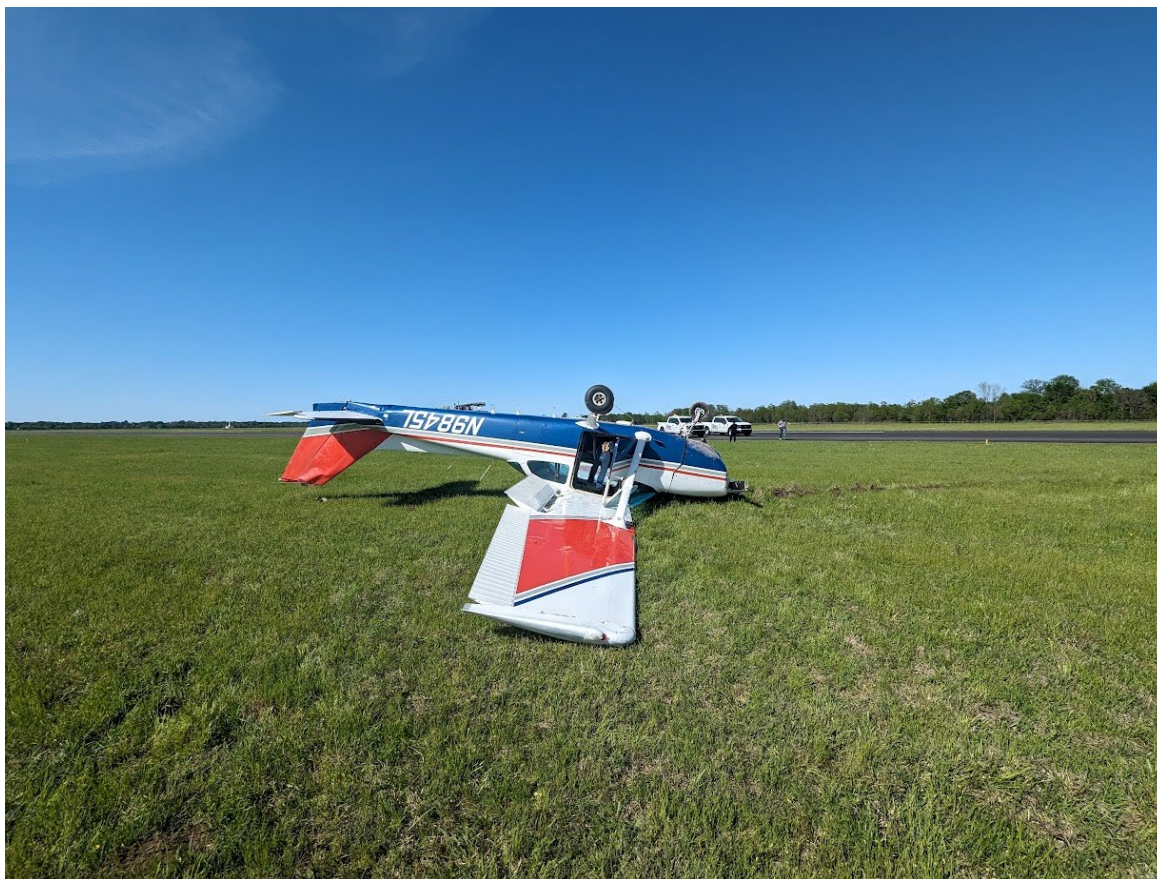
**Photograph 1 - Deformation noted to the vertical stabilizer (Courtesy of Airport Manager)**

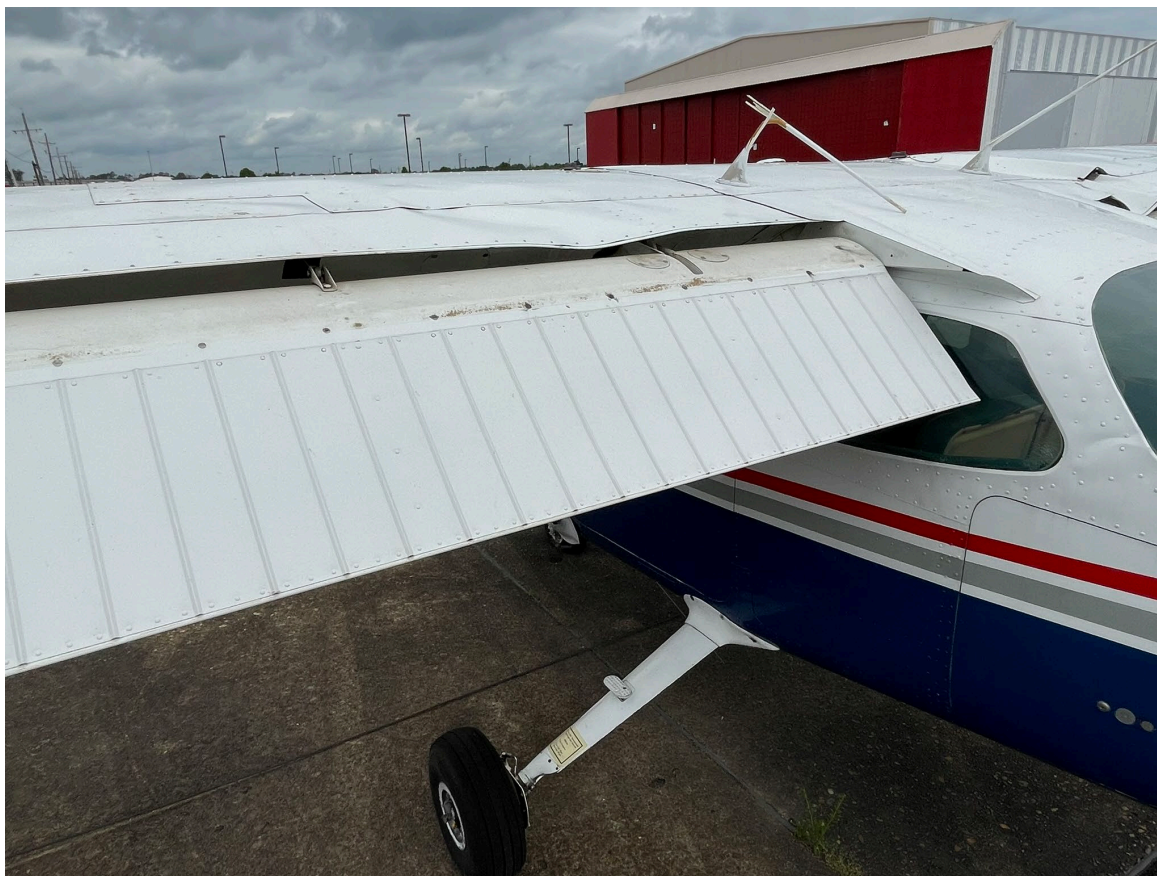
**Photograph 2 - Deformation noted to the left and right wings (Courtesy of FAA)**
